STAFF REPORT: 8/13/2025 MEETING

ADDRESS: 4291 CORTLAND & 4510 CORTLAND

APPLICATION NO: HDC2025-00486 (4291 CORTLAND) & HDC2025-00485 (4510 CORTLAND)

SCOPE: REPLACE HANDRAILS/GUARDRAILS, ALTER PORCH STEPS/WINGWALLS, REPLACE WINDOW

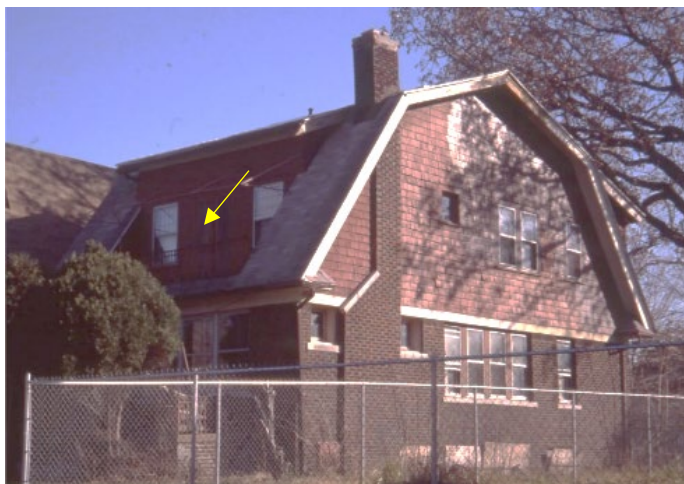
4510 Cortland, designation photo taken in 1999 by HDAB. Yellow arrows indicate historic iron railing, green arrow indicates historic window in gable end, and red arrow indicates historic brick front porch steps and wingwalls

- The historic brick front porch steps at **4510 Cortland** were a distinctive character-defining feature of the property. As they were highly deteriorated, they should have been rebuilt to match the original in dimension, material, design, and texture. The new porch and wingwalls are not an adequate match to the historic as the steps are concrete, the wingwalls appear wider than the original, and the color, texture, dimension, and design of the original brickwork has not been replicated.

- The historic, character-defining wood brickmould, mullion and remaining window at **4510 Cortland** front façade, attic story gable end which were removed and replaced without HDC

approval appeared to be in good condition prior to their removal. As such, the elements should have been retained and repaired in kind as required by the Standards. Also, new the brickmould and mullion are thinner and narrower than the original. As a result, the new window unit appears inappropriately flatter than the original narrower and appears to be set more deeply into the opening versus the original

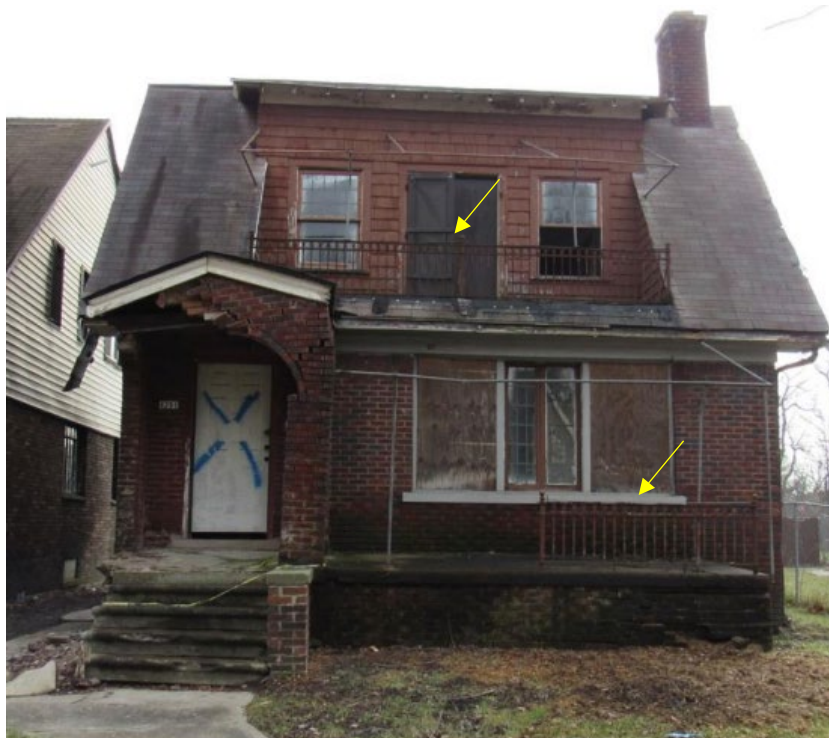
4291 Cortland, photo by staff in 2019 showing remaining iron railing at front porch, first story

- The historic, character-defining railing that was removed without HDC approval at **4291 Cortland** could have been repaired. If the railing needed to be replaced, it should have been
