**STAFF REPORT: AUGUST 13, 2025 REGULAR MEETING**

**APPLICATION NUMBER: HDC2025-00422**

**ADDRESS: 2200 CHICAGO BOULEVARD**

**SCOPE: ERECT FENCE, INSTALL VINYL WINDOW (WORK COMPLETED WITHOUT APPROVAL)**

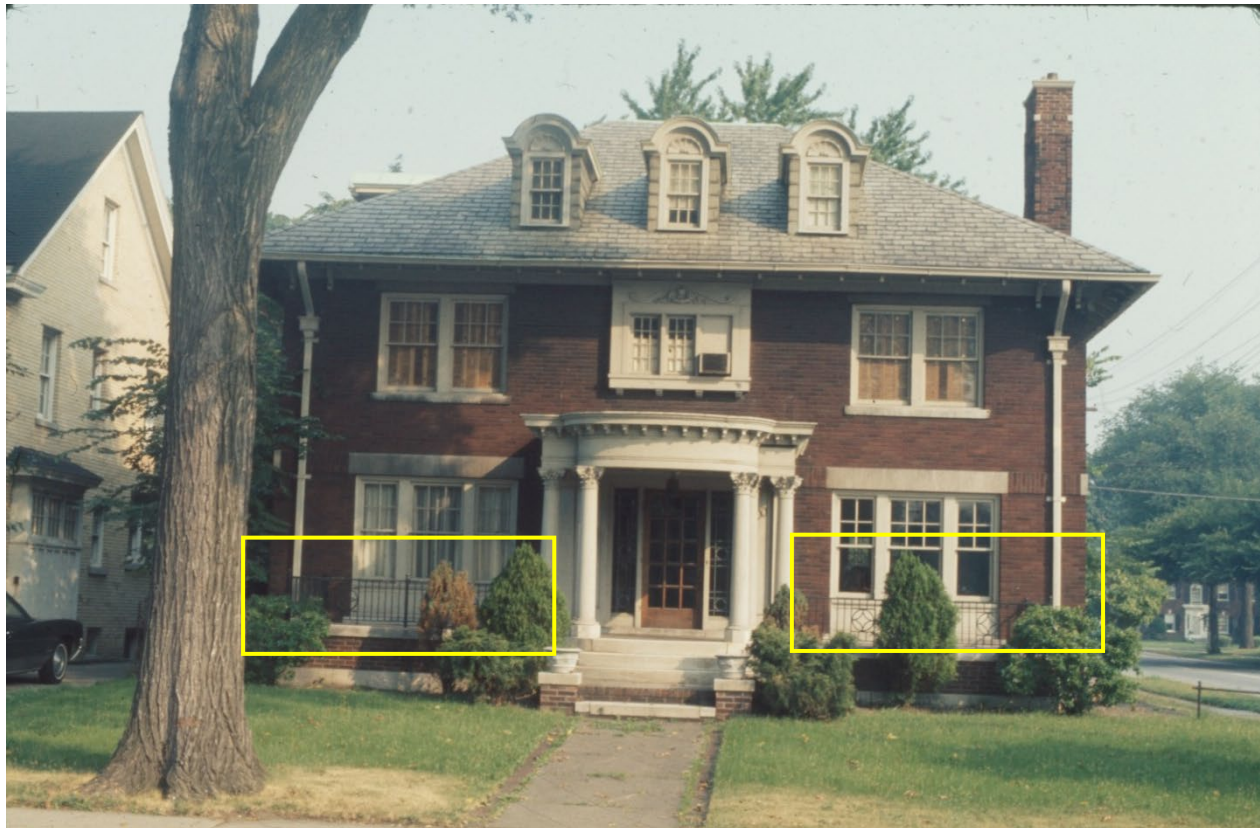
*Designation photos taken 1974 (above)*

- The original wood windows at the front of the house were a distinctive, character-defining feature for this property. The three original wood windows with mullions in the center of the second story were removed without HDC approval. The wood windows were replaced with a three-unit, factory-mulled, white vinyl window.

- The original wood window over the porch was a distinctive, character-defining feature and was replaced without documentation confirming that it was beyond feasible repair, as required by Secretary of the Interior Standards #5 and #6. As such, it should be restored to its pre-violation condition, that of a true wood window with true divided lites and dimensional, wide-mullions.

- It is therefore staff's opinion that the vinyl replacement window is not compatible with the historic district standards and must be replaced with a window type that matches the original historic window.
