STAFF REPORT: 9/10/2025 REGULAR MEETING

APPLICATION NUMBER: HDC2025-00476

ADDRESS: 14833 STAHELIN

SCOPE: EXPAND DRIVEWAY, DEMOLISH GARAGE, ERECT NEW GARAGE (WORK COMPLETED WITHOUT APPROVAL)

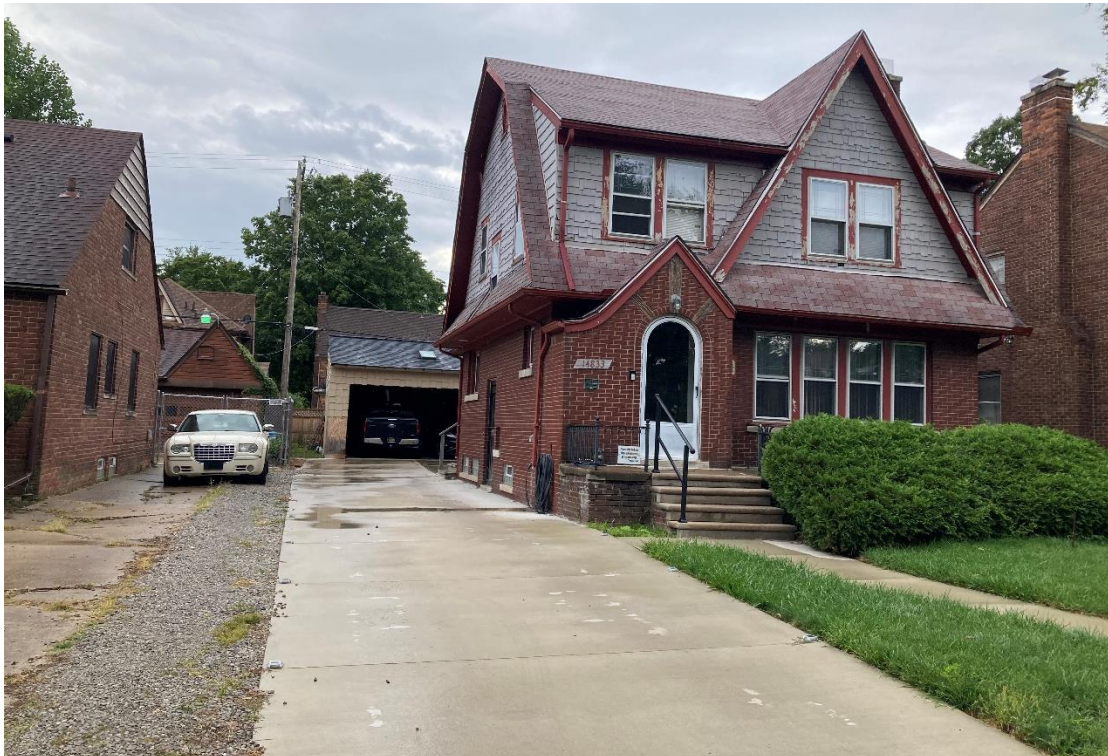
Site Photo 1, by Staff, 8/26/25: (East) front elevation.

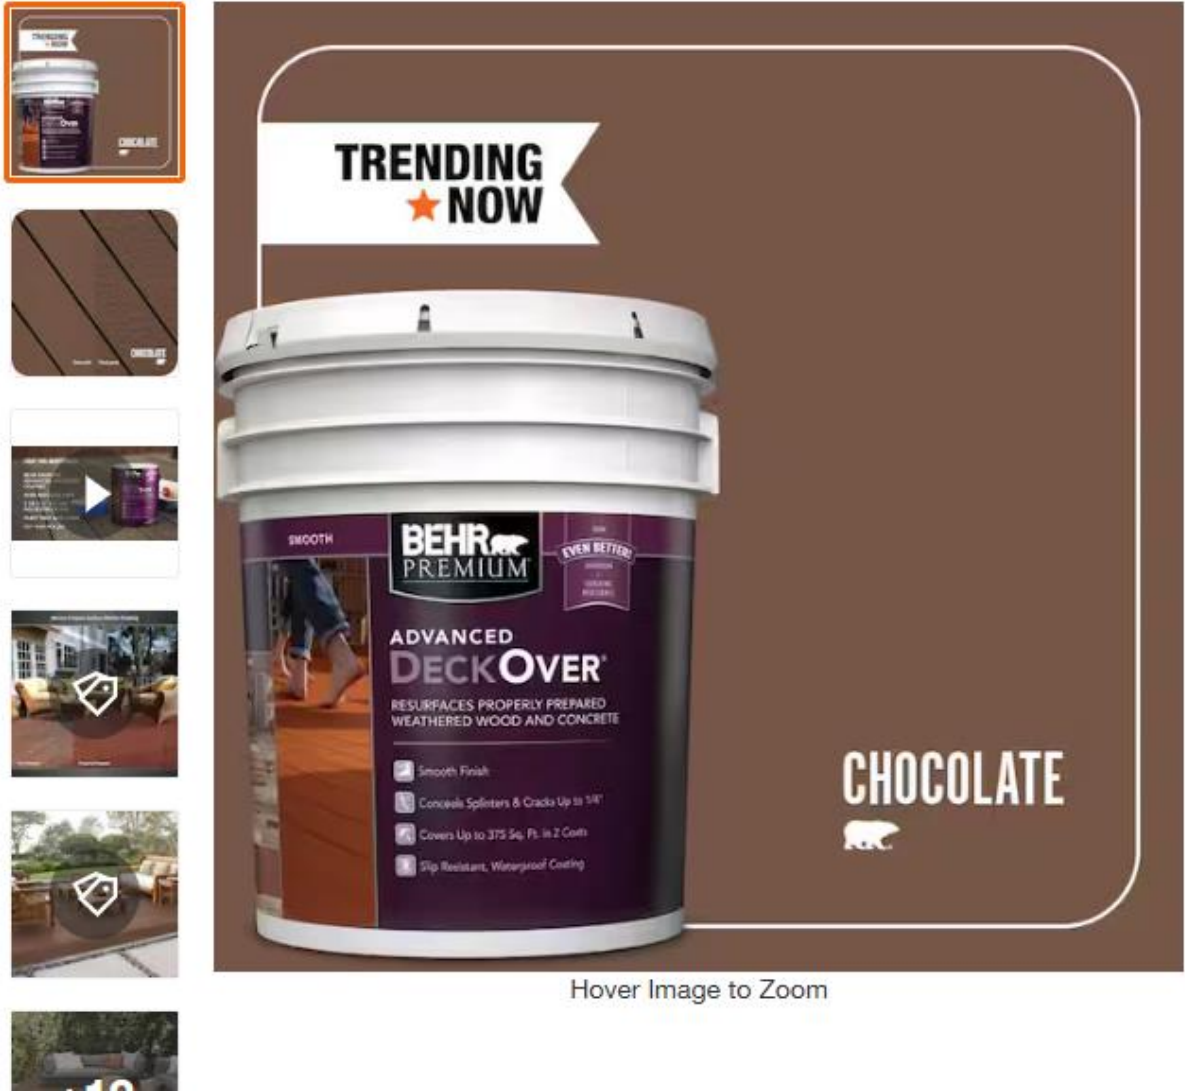
The applicant explained in an August 27 email to staff that “The brand and color of paint that we will be using is Behr Deckover Chocolate. The lower half of the garage will be wood and painted.” It is not clear whether the applicant intends to paint the plywood substrate directly, or if additional wood cladding is proposed. Staff found this color sample on the Home Depot site and provided it below:

BEHR Premium Advanced DeckOver

5 gal. #SC-129 Chocolate Smooth Solid Color Exterior Wood and Concrete Coating

the garage is not found on the historic house, either. **The proposed colors for the new garage do not relate to the colors of the main dwelling.**
