STAFF REPORT: 09/10/2025 MEETING

ADDRESS: 2491 LONGFELLOW

APPLICATION NO: HDC2025-00446

SCOPE: REPLACE FRONT PORCH COLUMNS, REPLACE WINDOWS, INSTALL LANDSCAPING (WORK COMPLETED WITHOUT APPROVAL), INSTALL PATIO AT REAR YARD

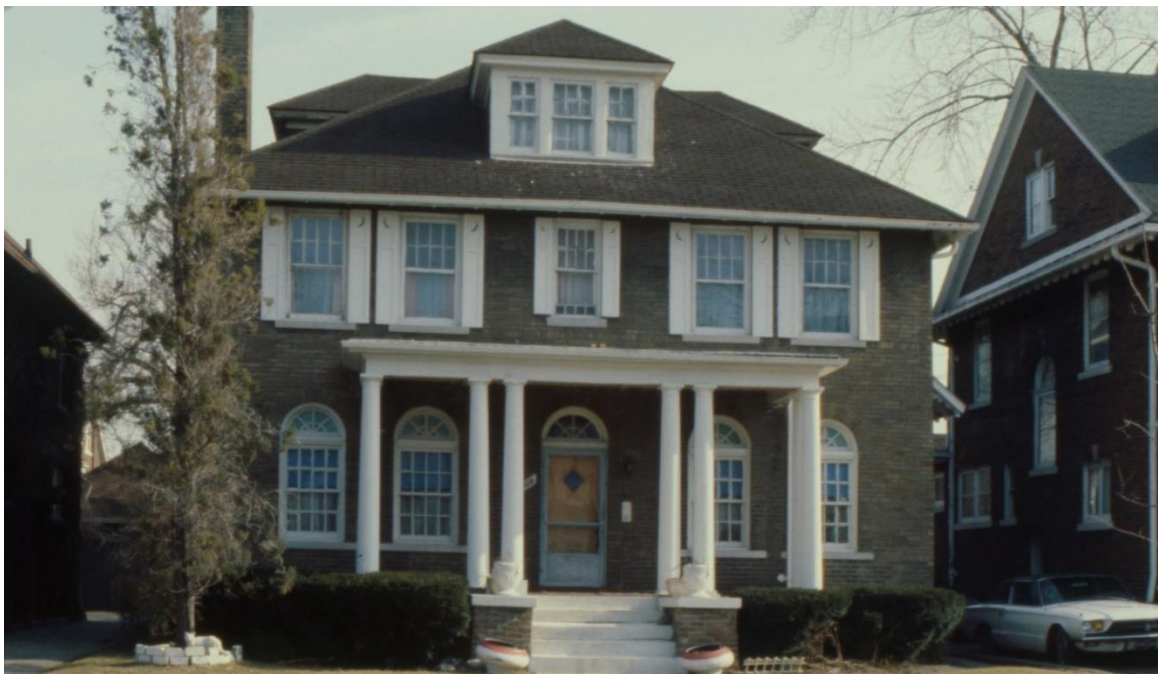
Designation slide by HDAB, 1974. Elements associated with the Colonial Revival style include the wood tapered round columns at the front porch; the four lite arched fanlight transoms at the first story; the 8/8, true divided lite, double-hung wood and associated wood trim/brickmould at the first story; the 8/1, true divided lite, double-hung wood windows at associated wood trim/brickmould at the second story; and the 4/1 and 6/1, true divided lite, double-hung wood windows and associated trim at the dormer
