STAFF REPORT: 09/10/2025 MEETING

ADDRESS: 4000 TYLER

APPLICATION NO: HDC2025-00504

SCOPE: REBUILD BACK PORCH, INSTALL RAILINGS AT FRONT AND BACK PORCH, REPLACE GLASS AT FRONT FAÇADE WINDOWS (WORK COMPLETED WITHOUT APPROVAL)

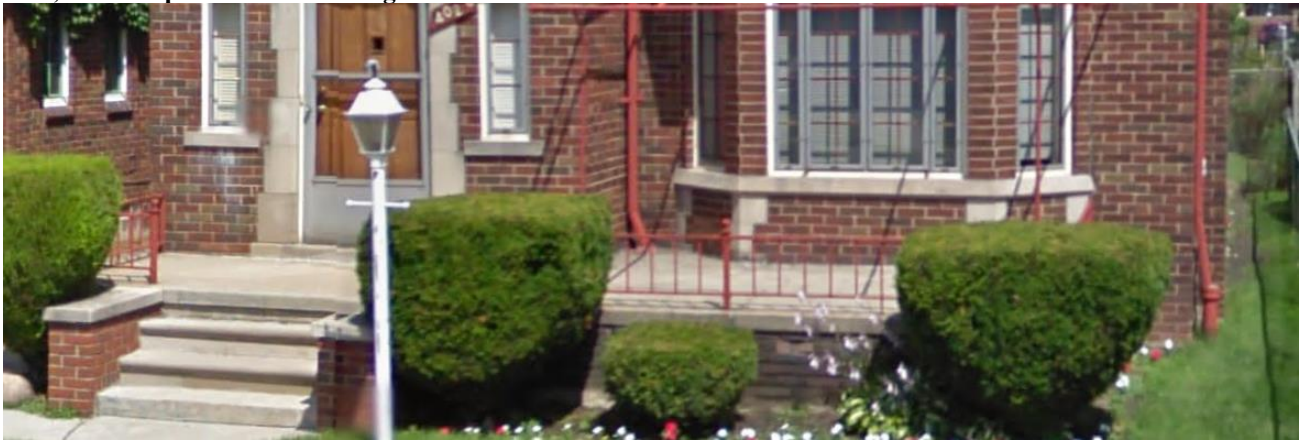
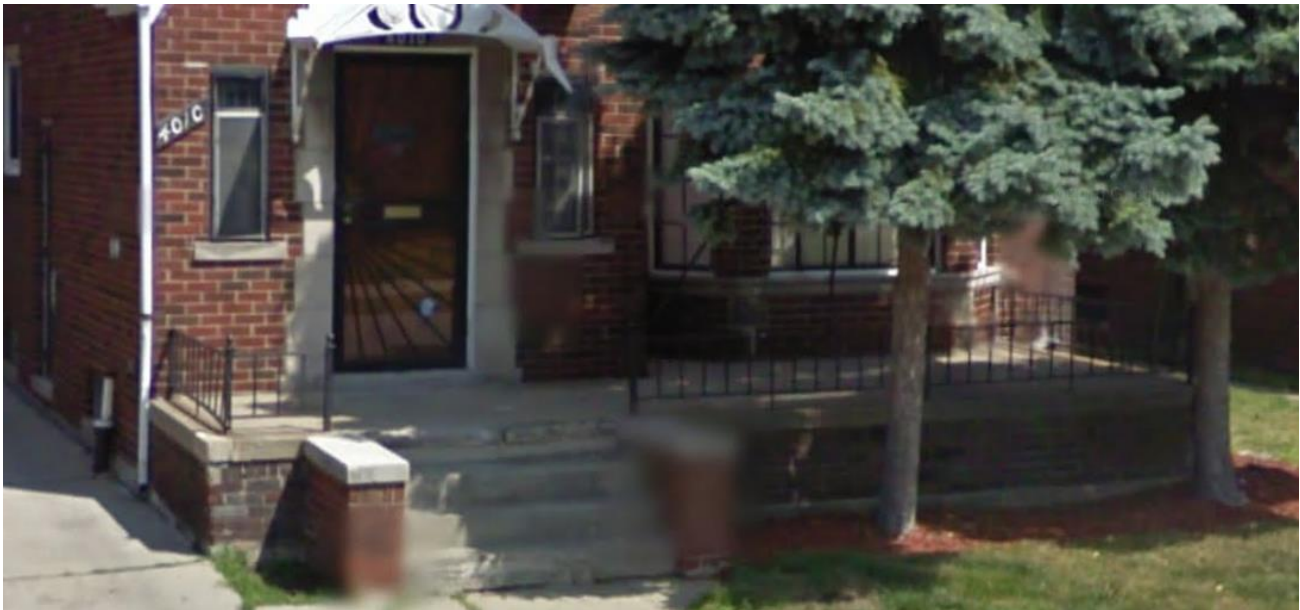
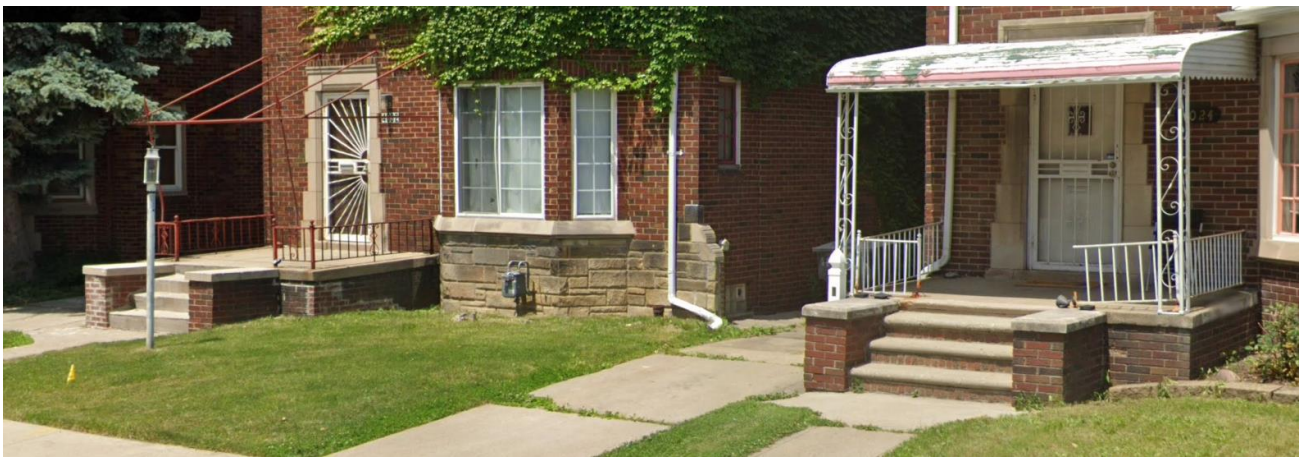
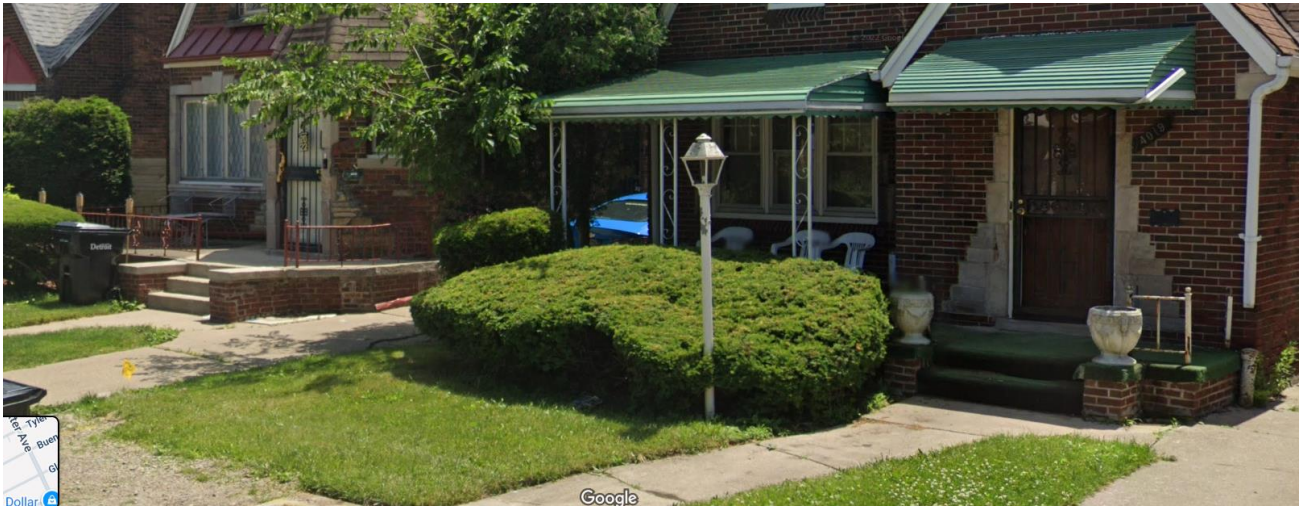
Houses next to and across the street from 4000 Tyler. Note style, material, and height of the guard railing. Also, note the presence of the wingwalls that flank the stairs

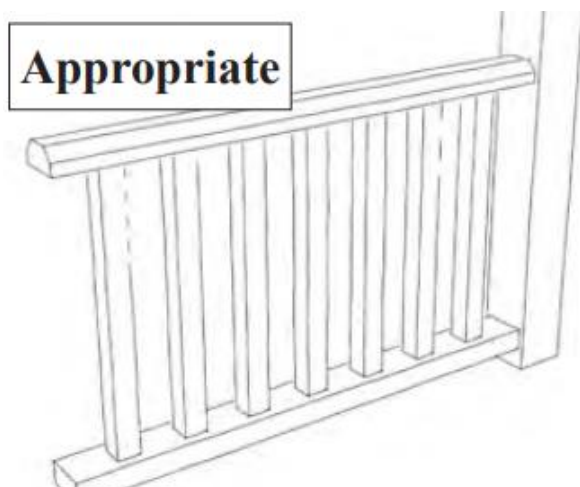
Historic porch railing. Note that the balusters are located between the top and bottom rails.

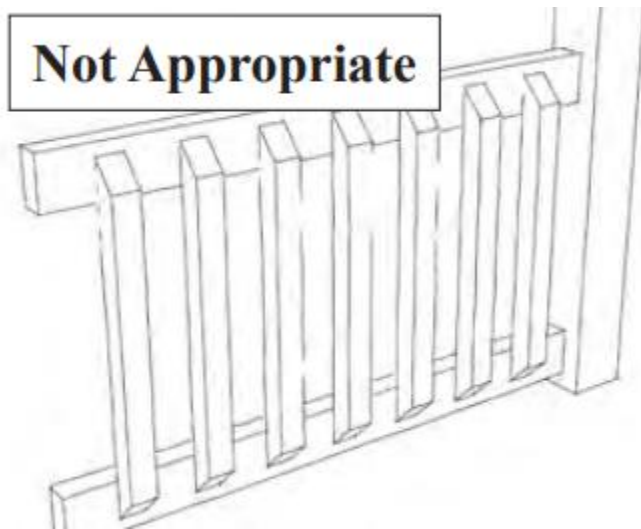
- Also, historic porch railing typically consists of balusters which are integrated into the top and bottom rails (see below graphic). The railings which were installed at the front and rear porches at 4000 Tyler have face mounted balusters, ie, the balusters have been attached to the outside of the bottom and top rails (see the below graphic and photo). Note that it is staff's opinion that face mounted railing systems are only appropriate for modern rear yard decks that represent a contemporary addition to a house and are not visible from the public right-of-way.

Railing that is typically installed at modern rear decks. Note that the balusters have been applied to the outer surface of the top and bottom rails. This type of railing is not appropriate for installation at porches in historic districts
