STAFF REPORT: 9/10/25 REGULAR MEETING

APPLICATION NUMBER: HDC2025-00463

ADDRESS: 4011 TYLER

SCOPE: REPLACE WOOD WINDOWS AND STEEL WINDOWS WITH NEW VINYL WINDOWS

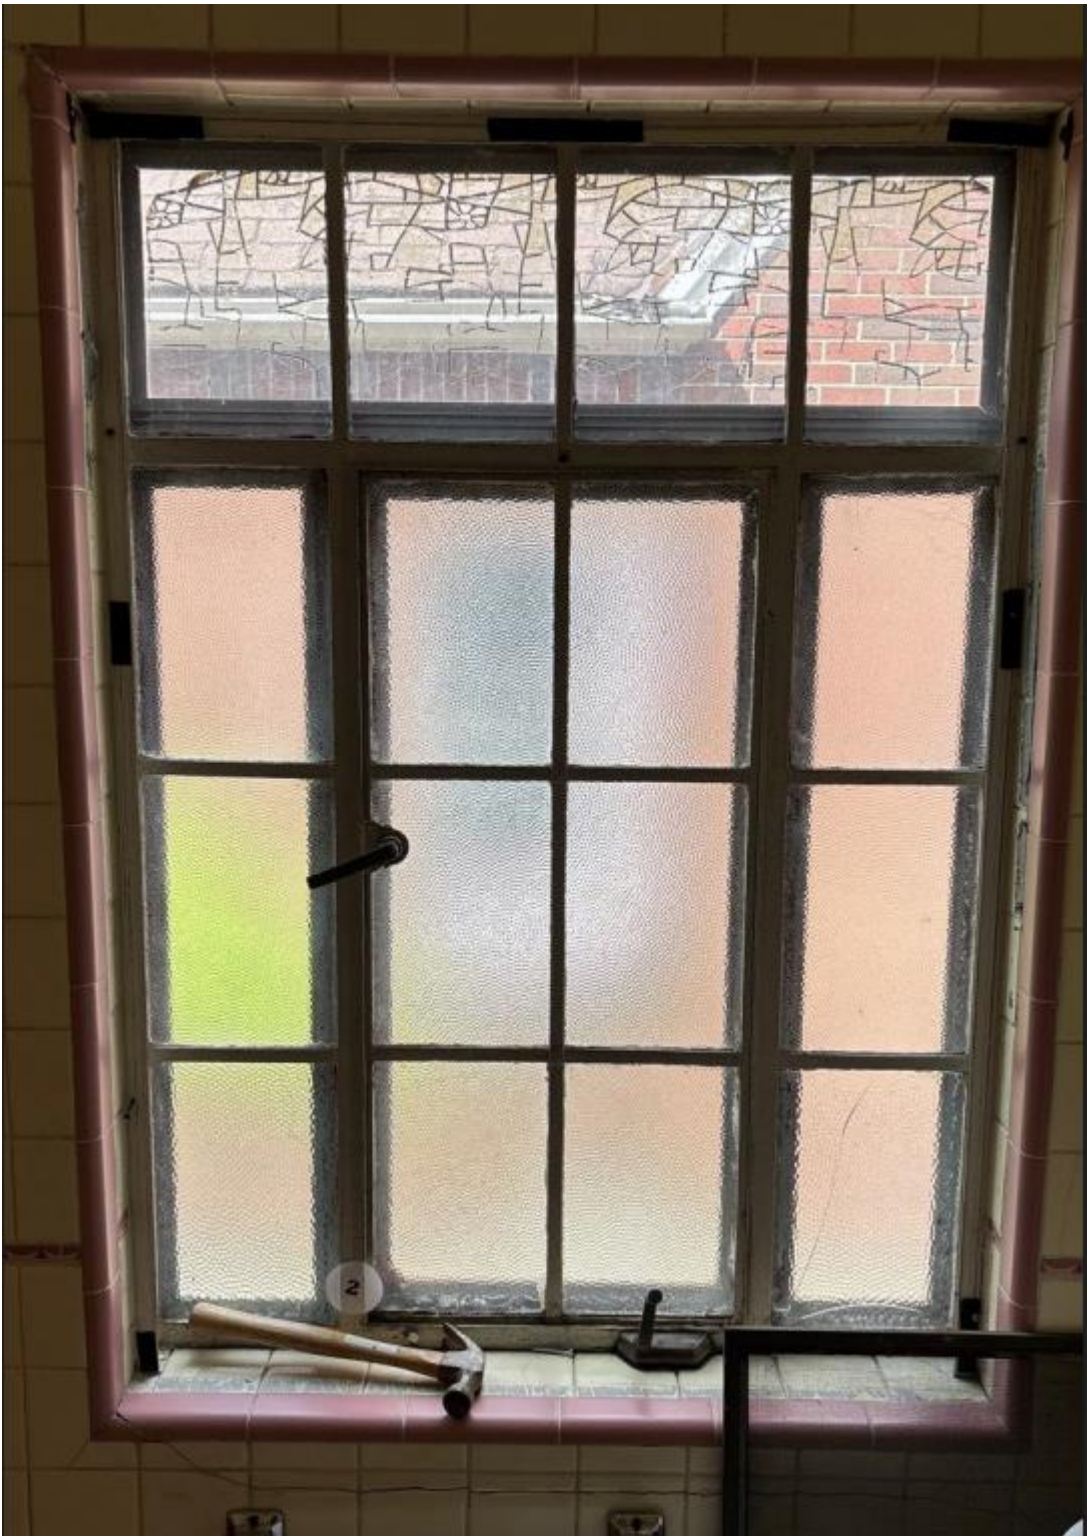
Window 2, interior, from application.

- Staff can see some paint failure on the exteriors of the wood sashes, despite the aluminum storms, and some paint failure near the bottom center of both wood windows from the interior. Staff can't evaluate wood conditions from these photos, however.

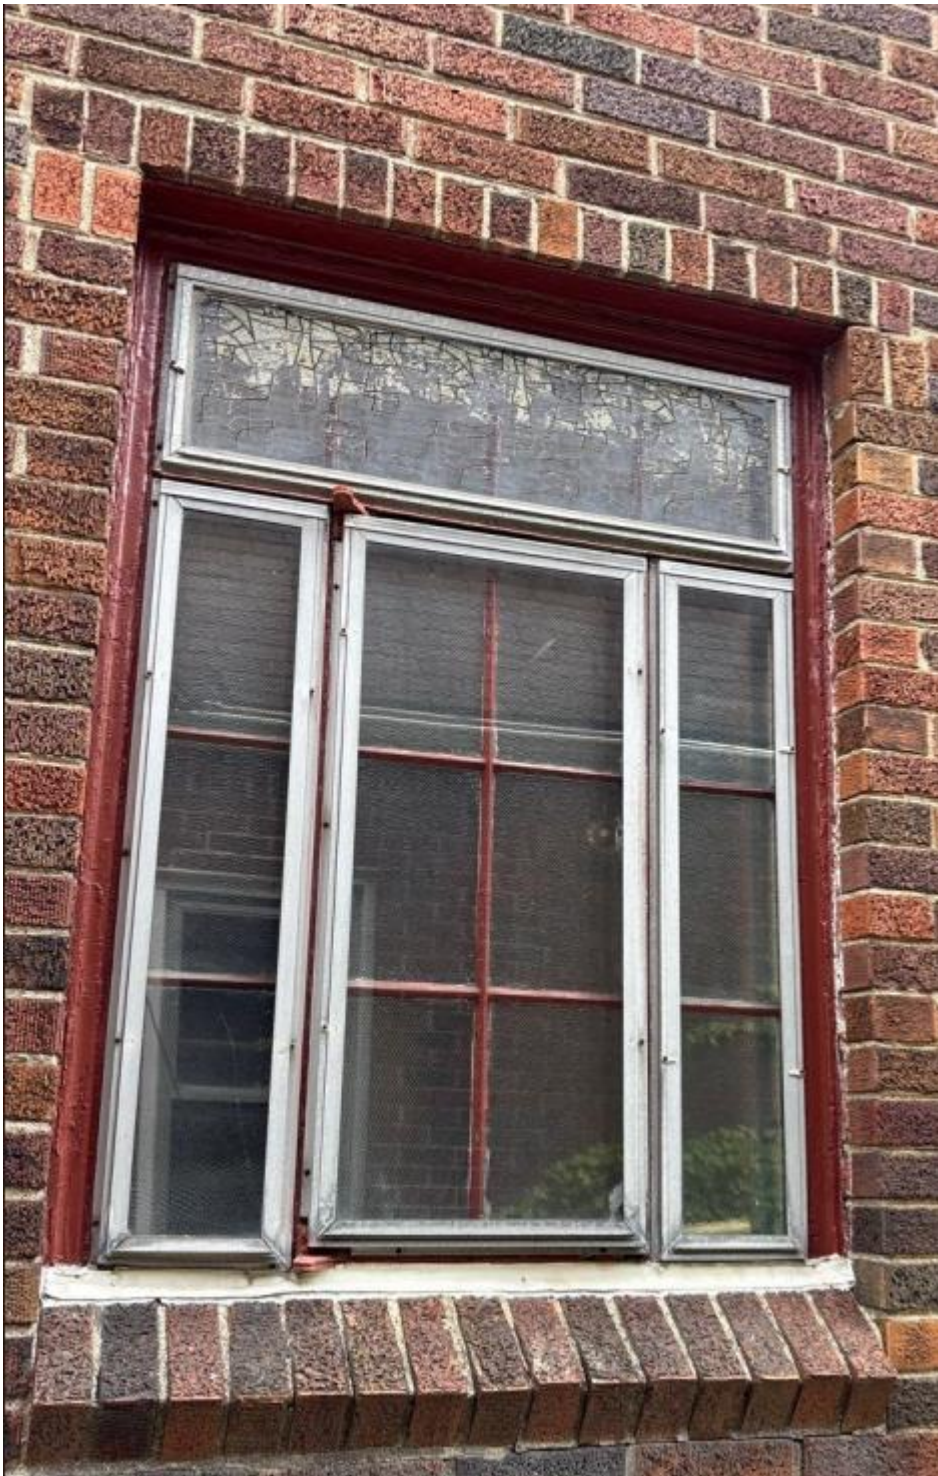
Window 2, exterior, from application.

- Regarding the steel windows, staff sees the uneven surface under the paint on Window 1 in the detailed photo, but staff doesn't see that elsewhere.
 - While more detailed photographs of each window's condition and/or an assessment from a window restoration professional might help provide more complete information for the commission to make their assessment about repairability, staff's current assessment based on available documentation is that these four windows are not beyond feasible repair.

- The steel windows proposed for replacement are distinctive, character-defining features of the property.
- The current application does not provide documentation of each window proposed for replacement that demonstrates that they are deteriorated beyond repair.
