**STAFF REPORT:** 9/10/25 REGULAR MEETING

**APPLICATION NUMBER:** HDC2025-00297

**ADDRESS:** 4758 STURTEVANT

**SCOPE:** REPLACE WINDOWS, REPLACE GUTTERS/DOWNSPOUTS, REPLACE/RESTORE DOORS, HOUSE/GARAGE ROOF, REBUILD PORCH\* (WORK COMPLETED WITHOUT APPROVAL).

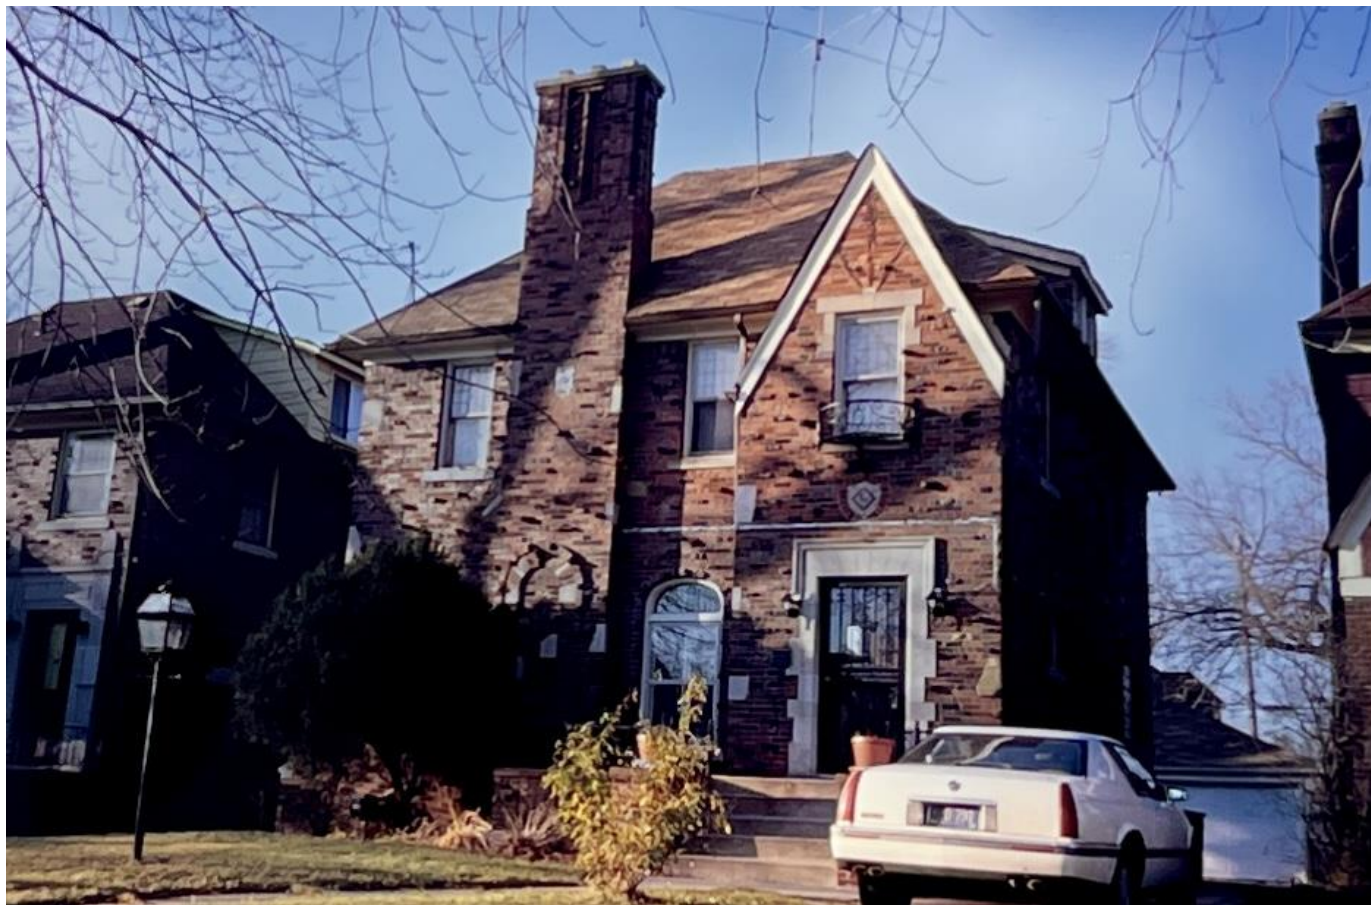
*Photo of designation slide, 1999.*

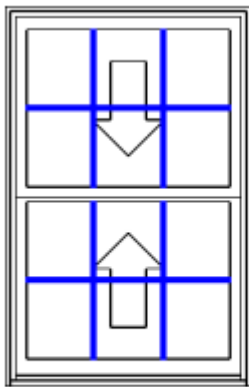
**Viewed from Exterior.**

1. For the **front elevation**, all windows are proposed to be replaced with wood Jeld-Wen windows with between-the-glass grilles installed to simulate muntins:

*Applicant's image from application materials. This is the proposed replacement for all primary elevation windows.*

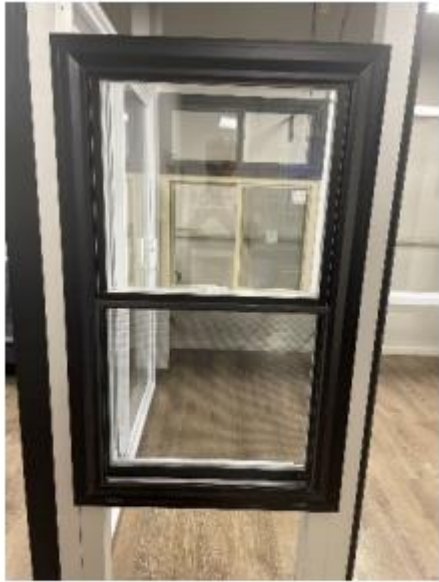
2. For the house's **sides and rear**, most windows are proposed to be replaced with vinyl single-hung windows

with grilles added. (Glass block windows are to remain unchanged and fixed windows are to be replaced with vinyl fixed windows, regardless of their current material.) The application materials mention painting the vinyl beige or that the manufacturer makes the windows in beige.

*Grids will be added*

*Applicant's image from application materials. This is the proposed replacement window for most secondary elevation windows, in beige.*
