STAFF REPORT: SEPTEMBER 10, 2025 MEETING

APPLICATION NUMBER: HDC2025-00530

ADDRESS: 913 CHICAGO

SCOPE: REPLACE SLATE ROOF WITH DIMENSIONAL ASPHALT SHINGLES, REPLACE FRONT PORCH AND COLUMNS, INSTALL FENCE (WORK COMPLETED WITHOUT APPROVAL)

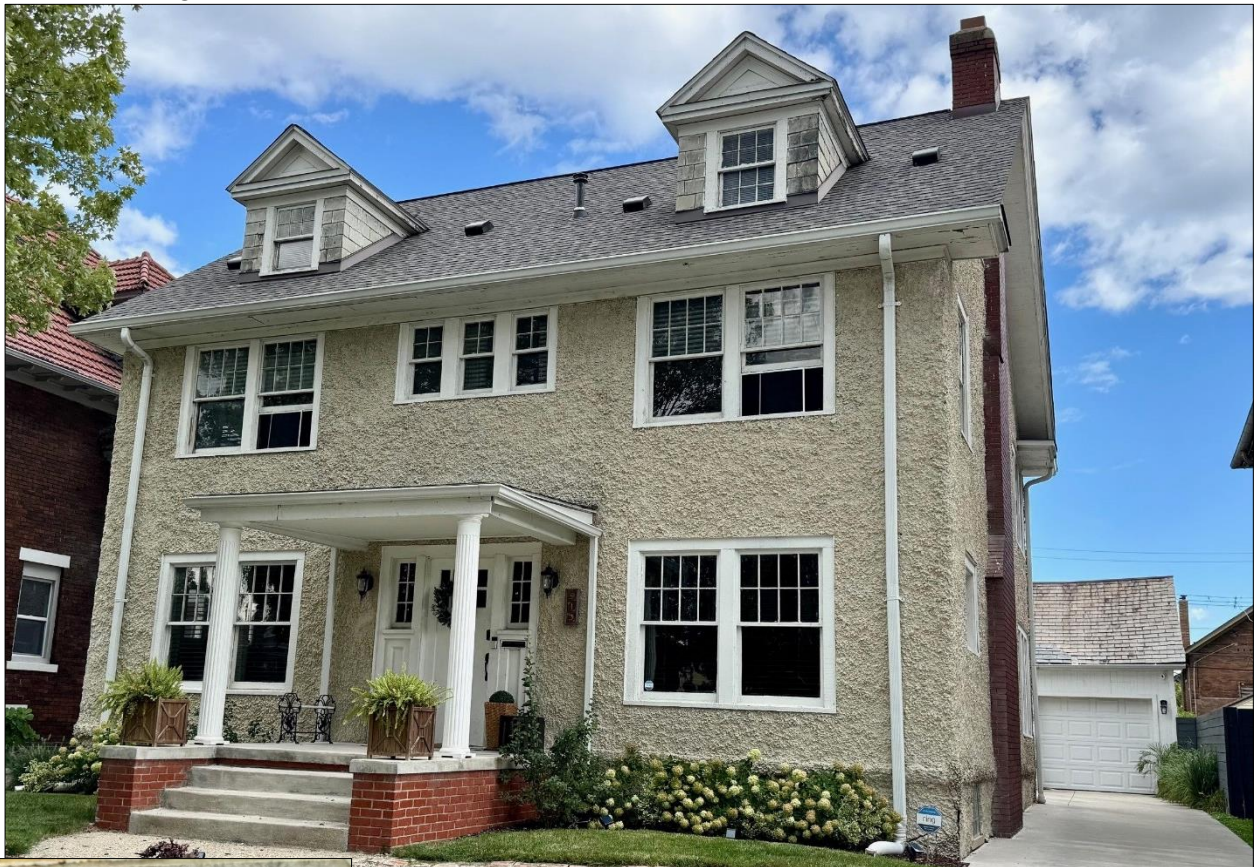
Above: Façade. HDC staff photo, August 26, 2025.

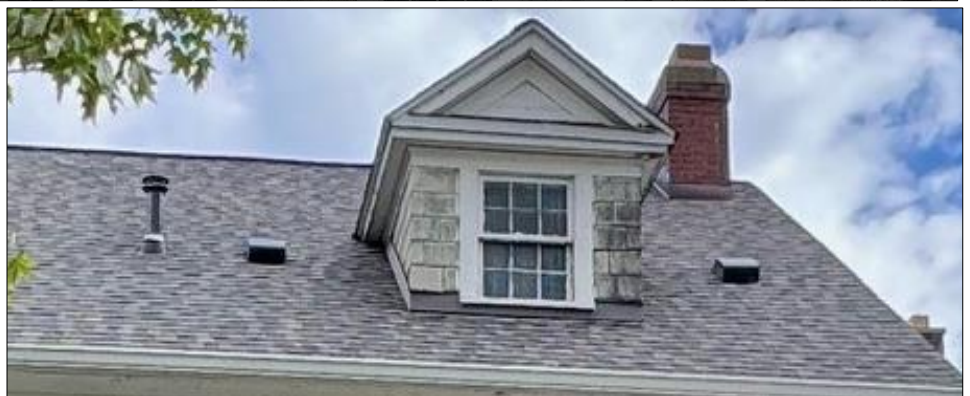
Staff photos, August 2025.

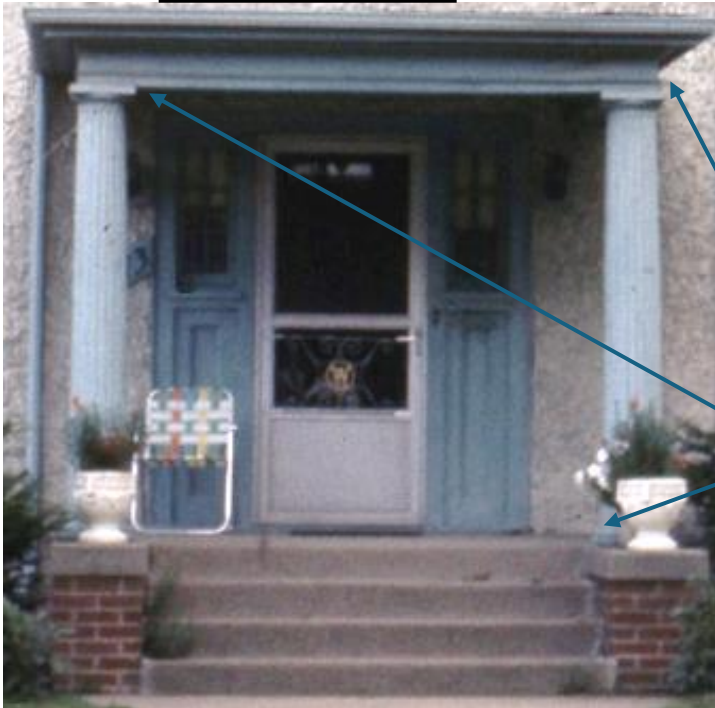
Historic Porch - 1974

- The designation photo shows:
 - brick wing walls extending from the porch;
 - concrete porch pad, stairs, and coping;
 - flat porch roof with over-hanging eaves
 - two wood fluted, tapered Doric columns.
- The top of the columns attached to the outer corner of the porch roof structure. The fascia board was detailed with a singular narrow trim piece that wrapped the three sides.
- The base of the columns were set upon a plinth (a flat, thin, square wooden block), which separates the column from the porch floor. The top of the column has a similar detail, which is commonly called an abacus.
- The front entry was comprised of a single wood door (not visible in the 1974 photo) with an eight light (glass) opening at the top. The lower portion of the door had two solid inset panels.

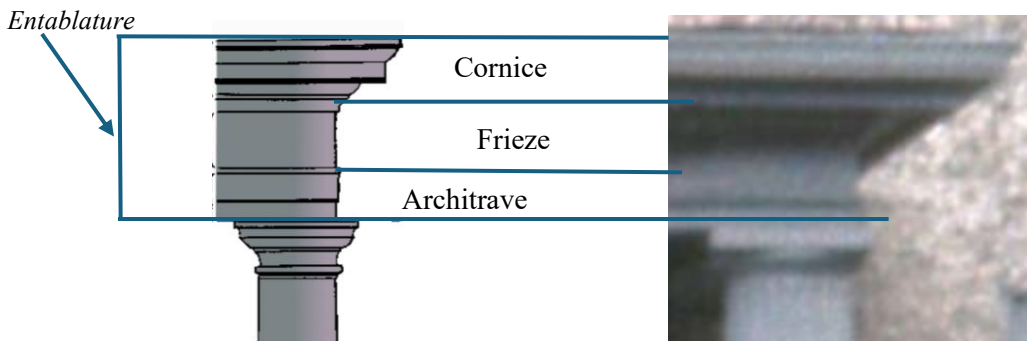
- The placement of the historic capital offered a prominent view of the substantially sized columns. The columns were a dominant, character-defining feature of the property.
- The area above the original columns was the entablature, and has been removed, further destroying character-defining features of this property. The below drawing explains the many parts of a structure that makes up an entablature.

- It is staff's opinion that the lower and upper roof structures, i.e., the entablature, are a distinctive character-defining feature.

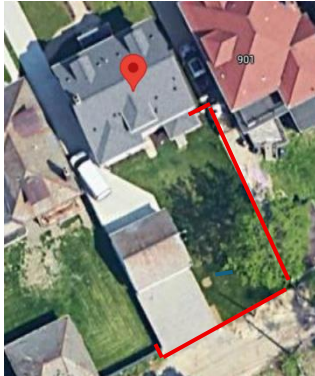
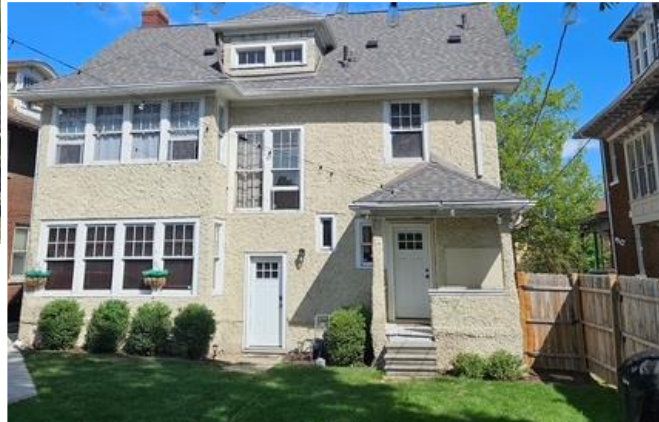
- The applicant installed a vertical panel wood privacy fence enclosing the rear yard. It starts at the southeast rear corner of the house, extends to the side/east property line, runs along the east property line to the alley, where it extends across the width of the lot, and returns north a few feet at the west/side property line, adjoining the neighbor's existing privacy fence. A double-gate of same panel design opens to the alley.
- The specification is to apply a natural stain.

Above left: Google maps aerial view of property – red denotes location of fencing as shown in the applicant's photographs. In the photo below, the fence attaches to the neighbor's fence.

- The fence will be painted with an opaque solid color stain or paint. The selected finish and color will be submitted to HDC staff for review.
