**STAFF REPORT:** 9/10/25 REGULAR MEETING

**APPLICATION NUMBER:** HDC2025-00544

**ADDRESS:** 97 ARDEN PARK BOULEVARD

**SCOPE:** PRIMARY ELEVATION WORK, REBUILD PORCHES AT FRONT, REAR, AND SIDE\* (WORK STARTED WITHOUT PERMIT), RESTORE/REPLACE WINDOWS, REPAIR/REPAINT TRIM, REPOINT MASONRY

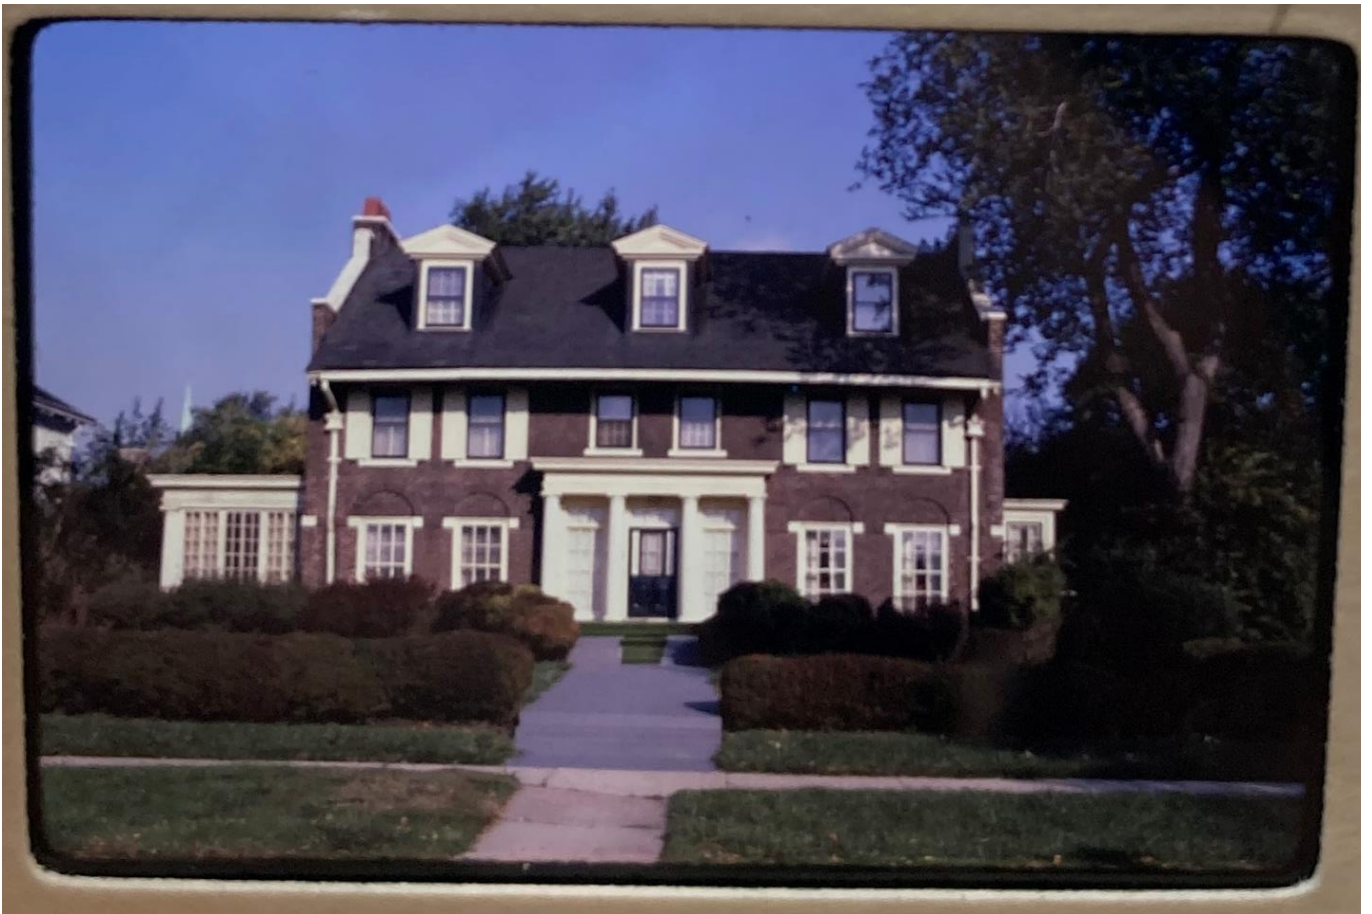
*Designation slide, 1981. Here, the importance of the west, front, and east entablatures all echoing and balancing each other is evident.*

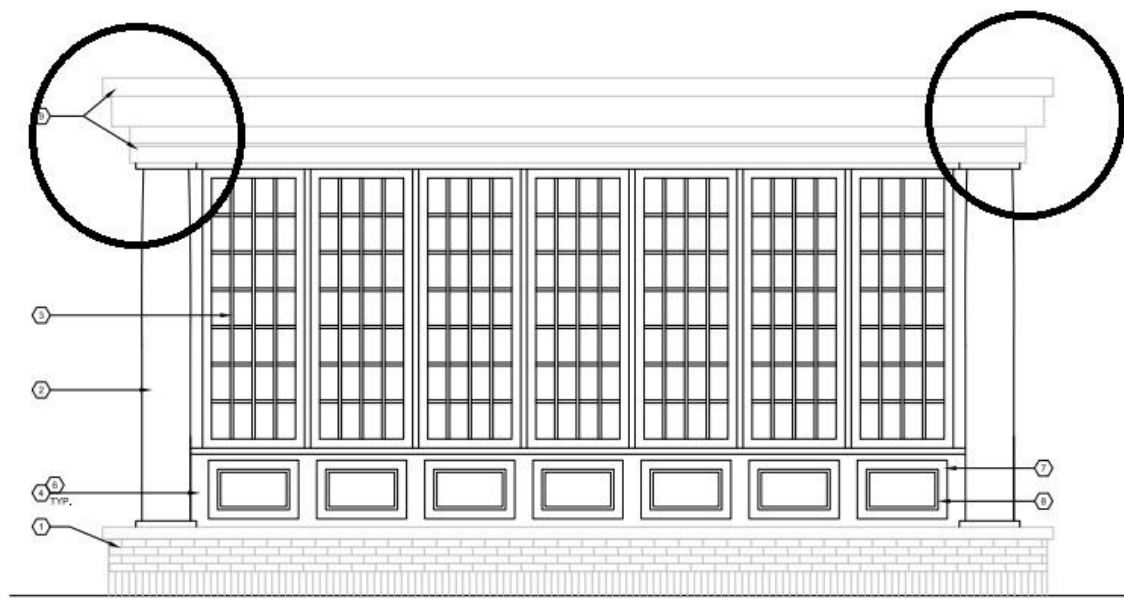
1 ENCLOSED PORCH WEST ELEVATION  
SCALE: 1/2" = 1'-0"

*Detail from applicant's materials, west porch entablature and portion of front portico entablature. It appears to staff from this angle that it is intended for the west entablature to copy the front historic one, but to add a fascia above the cornice for a gutter. Even if this is the case, staff remains uncertain that the west and front entablatures will appear to an observer on the sidewalk to be the same as is necessary for this house's design, proportions, and balance.*

*Applicant drawing, west elevation, entablature and rest of enclosed porch as proposed.*

- b. Repair/repaint pilasters; reconstruct missing wood pilaster bases
  - c. Construct new enclosed porch on existing (new) porch base
    1. 2 corner columns to be same style, size, and color as others
