STAFF REPORT: OCTOBER 8, 2025 MEETING

APPLICATION NUMBER: HDC2025-00305

ADDRESS: 6108 28th STREET

SCOPE: REPLACE 42 STEEL WINDOWS WITH ALUMINUM-CLAD WOOD WINDOWS, REPLACE WINDOW WALL

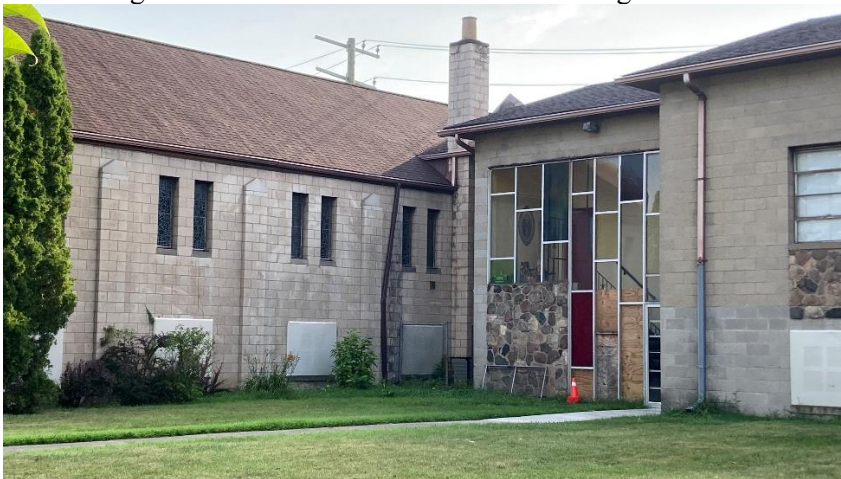
St Cyprian's Church, west side (front) from 28th Street, July 2025, staff photo. 1938 sanctuary to left and 1963 window wall and addition to right.

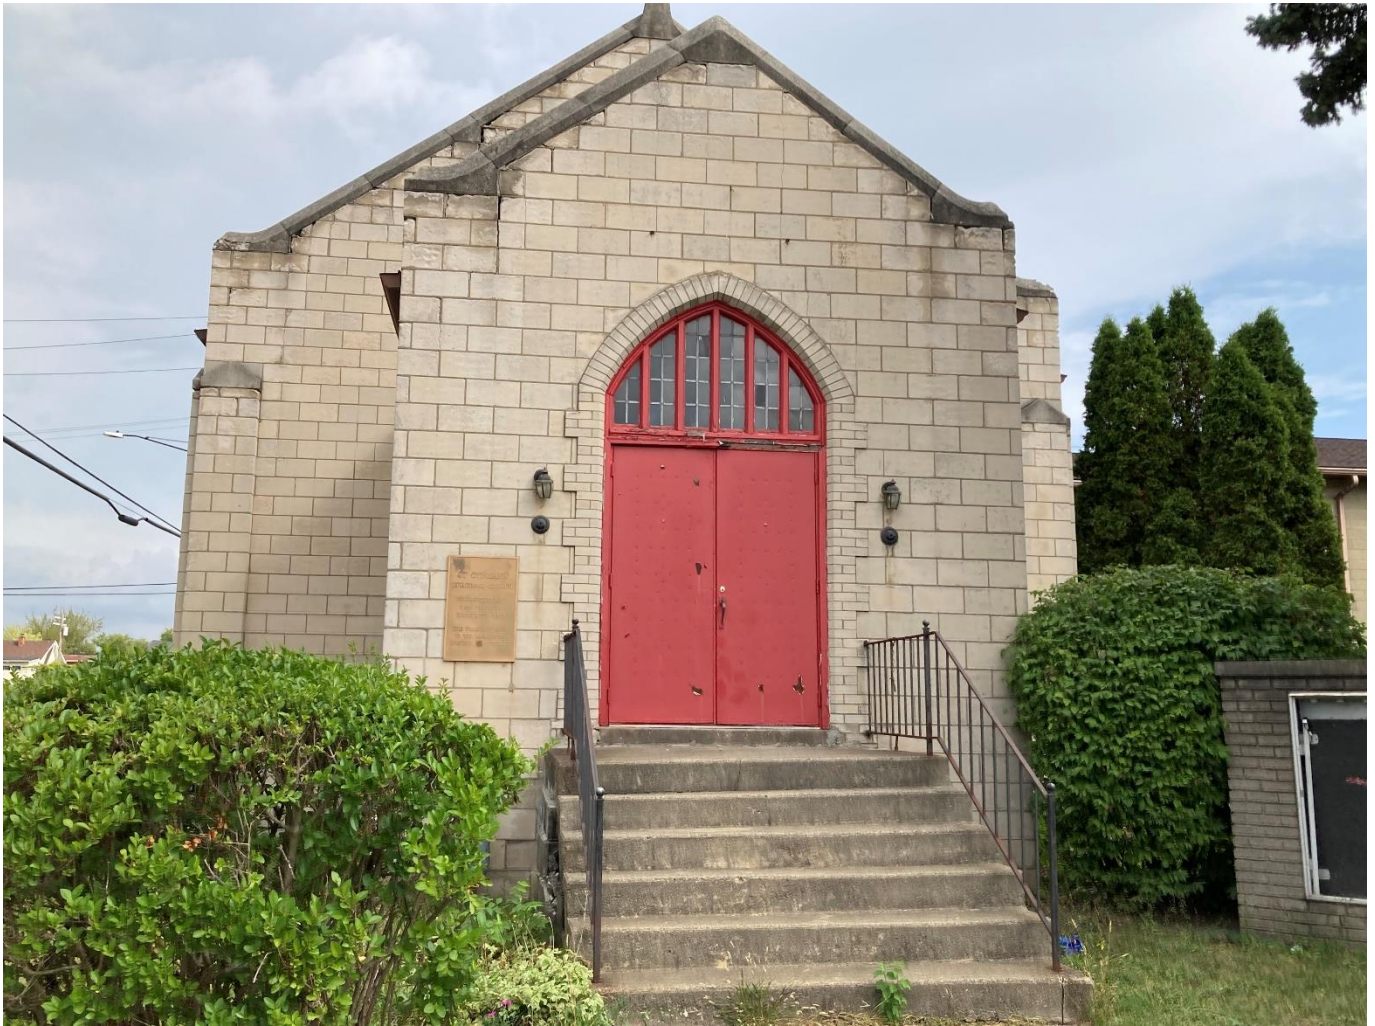
The 1938 entry, September 2025, staff photo.

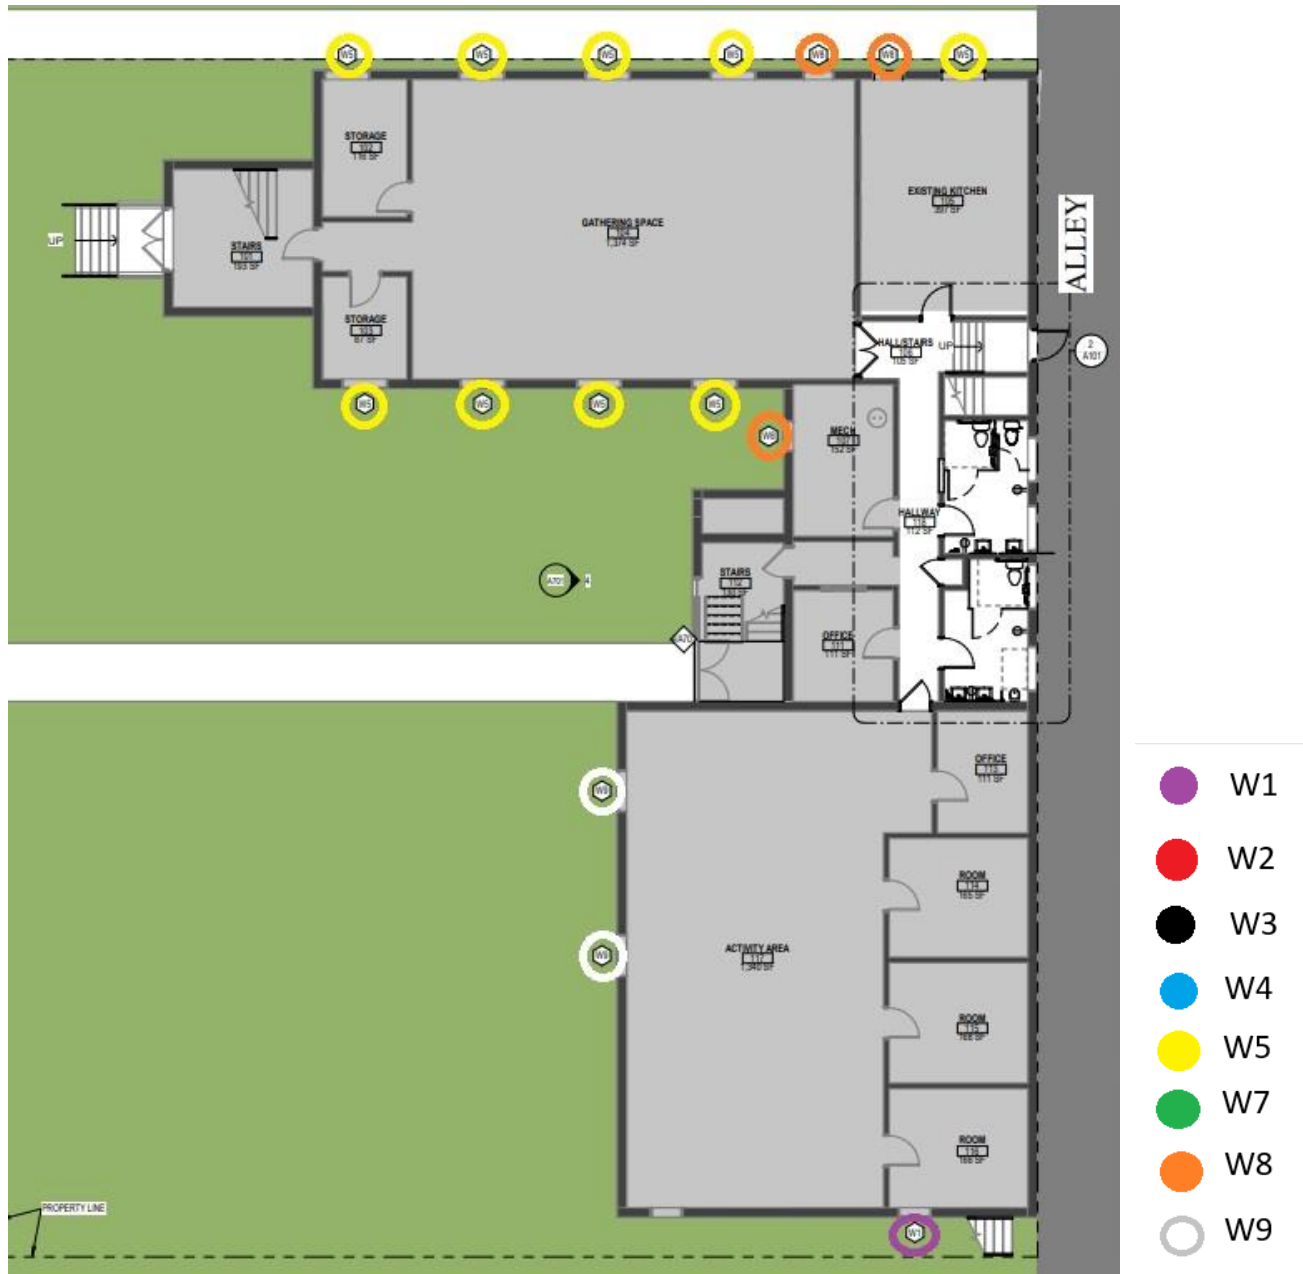
Church, ground floor/basement, architect's drawing from submitted materials. Windows proposed for replacement were labeled by window type by the architect and color-coded by HDC staff for easier reference.

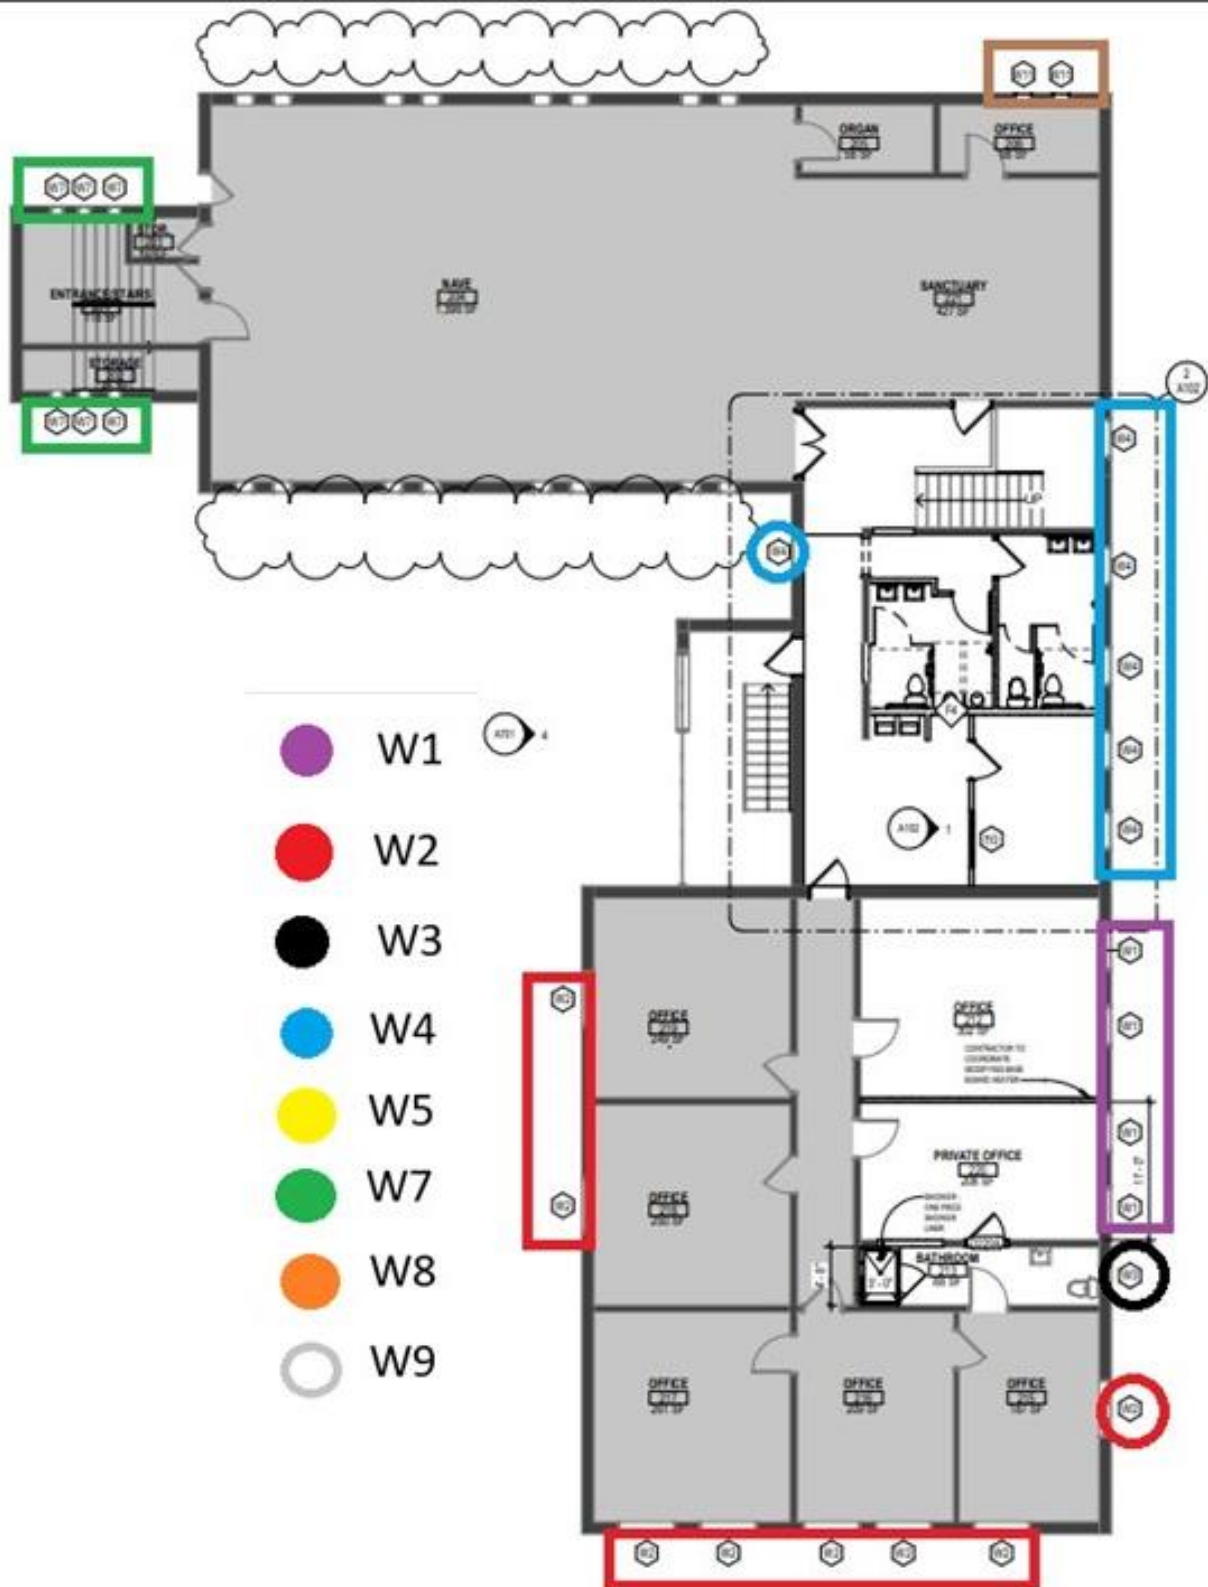
Church, first floor over raised basement, architect's drawing from submitted materials. Windows proposed for replacement were labeled by window type by the architect and color-coded by HDC staff for easier reference. Windows outlined in brown are W11s.

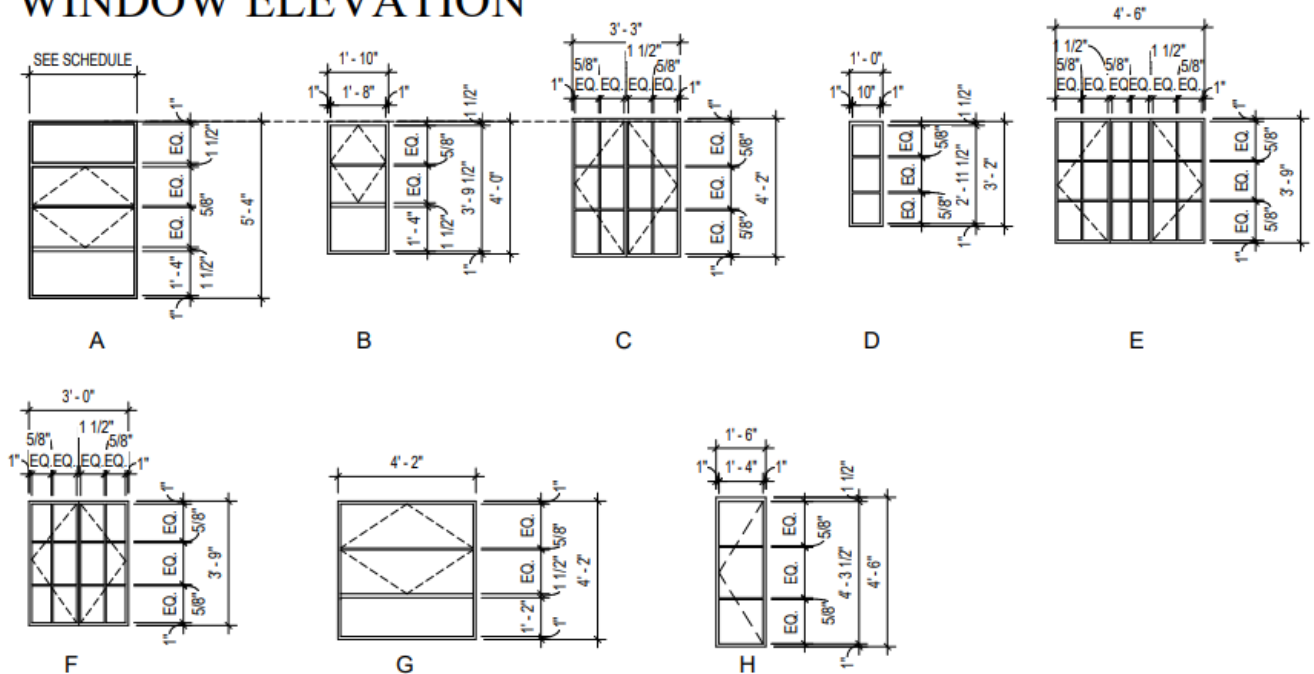
Architect's measured drawings of **existing** window types proposed for replacement, from submitted materials. Some proposed replacement window elevations are shown on the draft order form in the application materials.

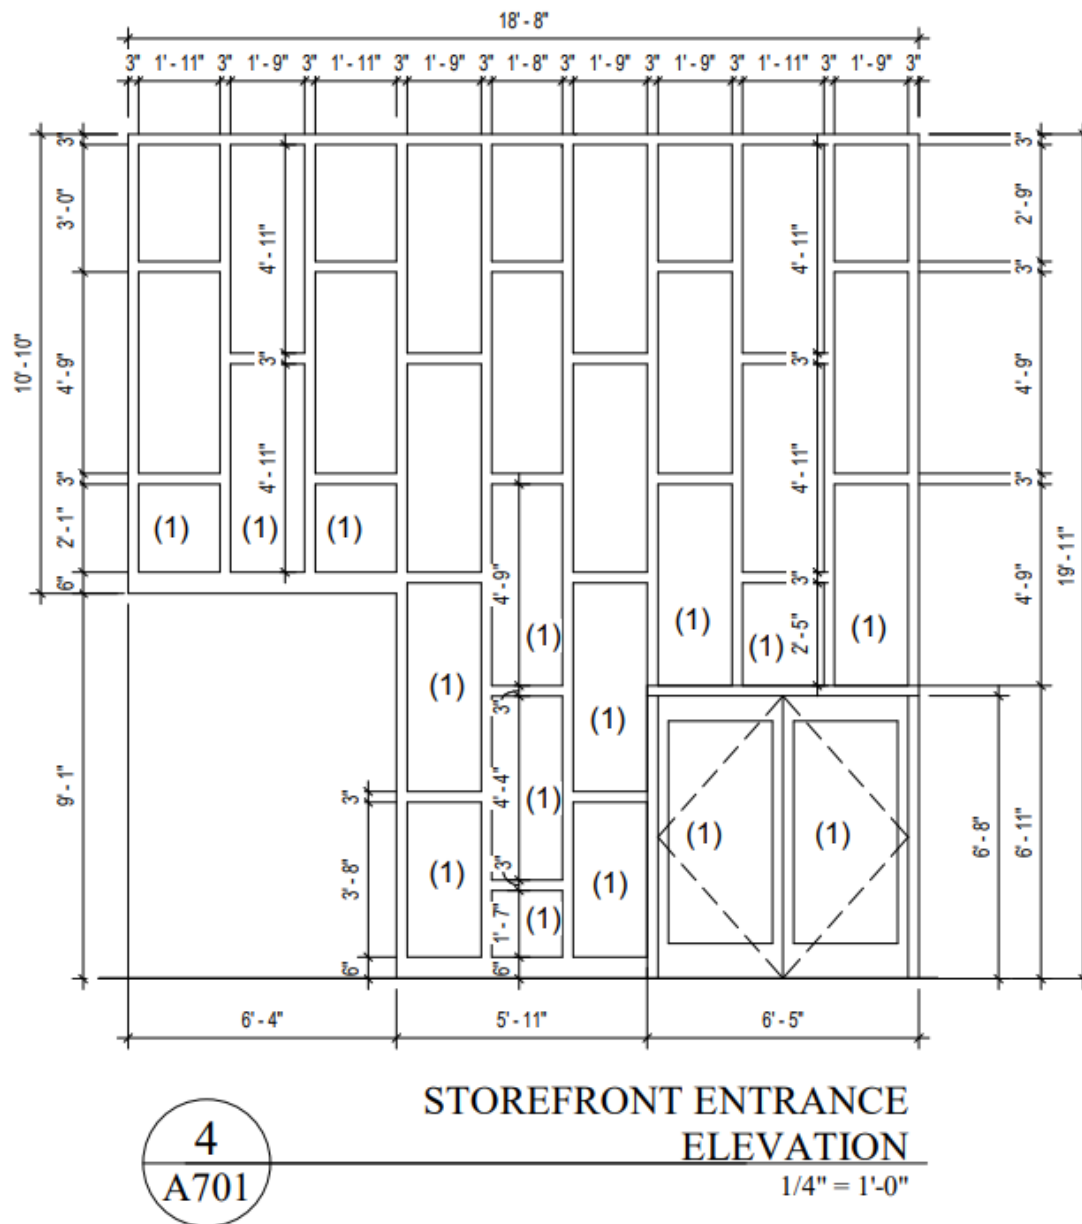
Architect's measured drawing from submitted materials of **existing** ground floor window wall (1963) proposed to be replaced. There is no elevation drawing of proposed replacement in the application materials.

The **1963 window wall** is composed of 3-inch-wide aluminum framing and 1'11" x 4' 11" glass rectangular panes (some cut to fit) installed in a staggered layout. Some panes have colored film applied or non-glass inserts to appear as stained glass. Staff is not clear as to whether the glass panes in the existing window wall are flush with the aluminum framing or (more likely) recessed. The proposed replacement aluminum framing for the new window wall is 2" wide. It is not clear to staff if the proposed storefront can replicate the existing window wall's staggered pattern or if the new storefront system for the window wall would require all the glass to be in a straight stacking grid-like layout. In the new proposed replacement, the glass can be recessed up to 3.5" into the frame, or the panes can be installed flush with the frame. It is not clear if the stained glass effect will be replicated in the proposed replacement.

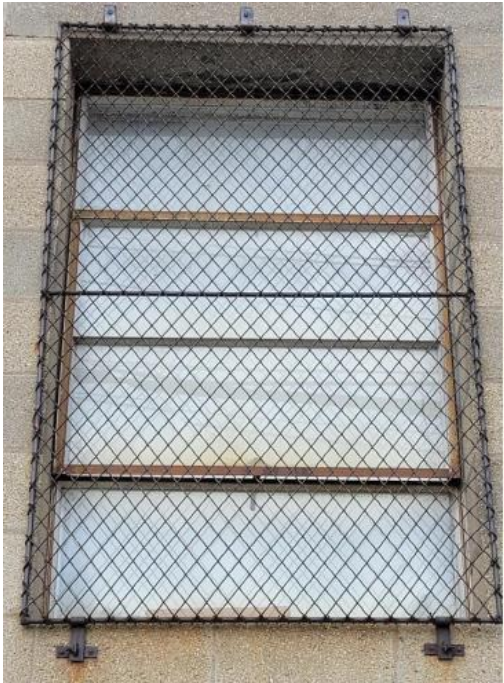
W1

The **windows in the 1963 portion** also have 5/8" center muntins, and they also commonly have two horizontal 1.5-inch bars (one above and one below the thin muntin). The proposed replacements for all of these 1963 windows have uniform 7/8" muntins. The 1963 window types shown on the architectural drawings are Window Types W1, W2, W3, and W9. (Samples from the materials are shown below). Proposed for replacement are five W1s, eight W2s, one W3, and two W9s for a total of 16 windows to be replaced from 1963.
