**STAFF REPORT: OCTOBER 8, 2025 MEETING**

**APPLICATION NUMBER: HDC2025-00591**

**ADDRESS: 2233 PARK AVENUE (AKA IODENT BUILDING)**

**SCOPE: REPLACE WOOD WINDOWS WITH ALUMINUM-CLAD WOOD WINDOWS**

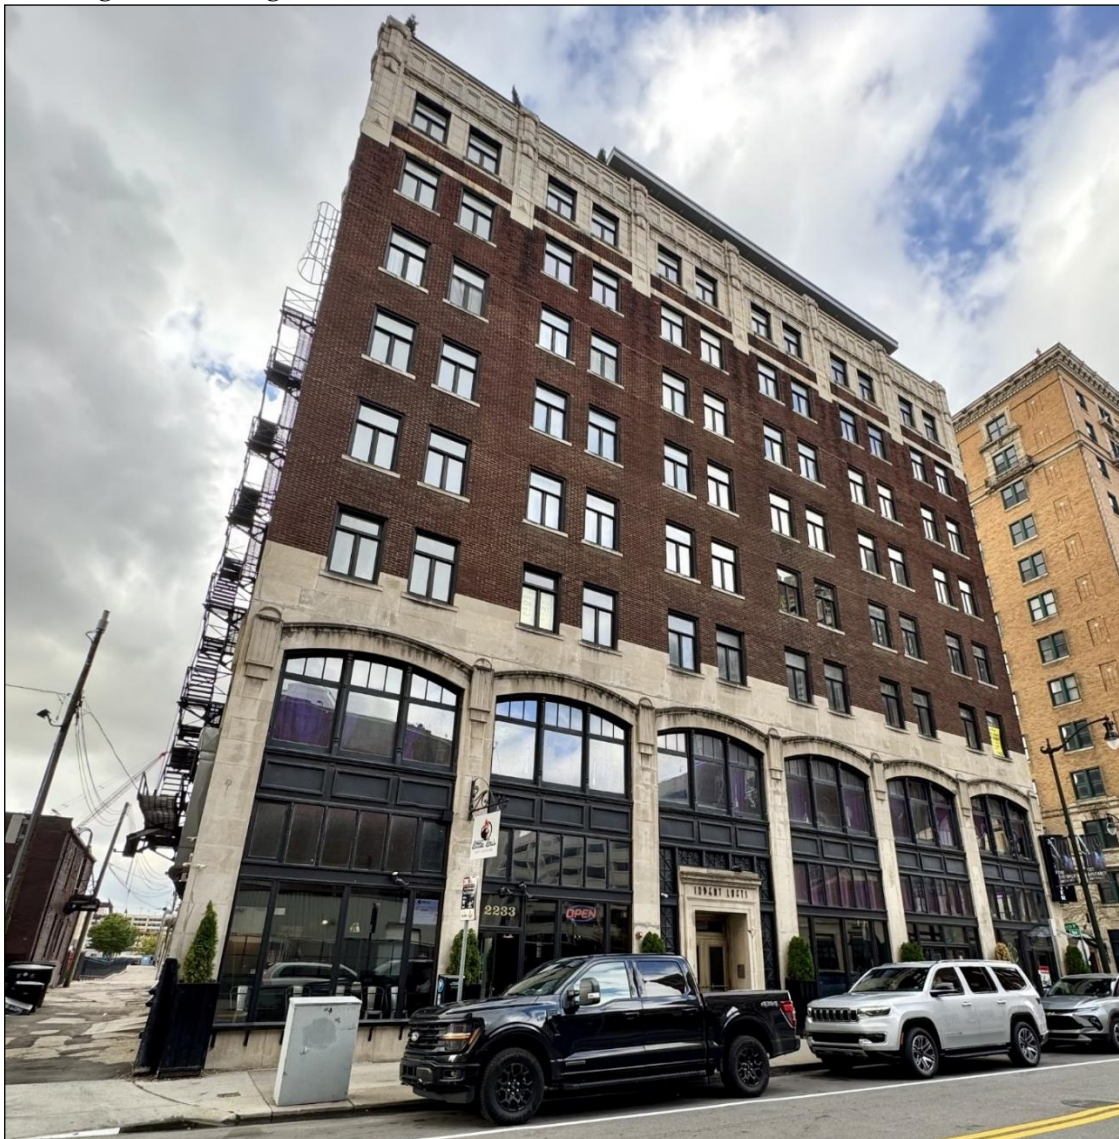
*Facade of the building facing Park Avenue. Staff photo, September 25, 2025.*

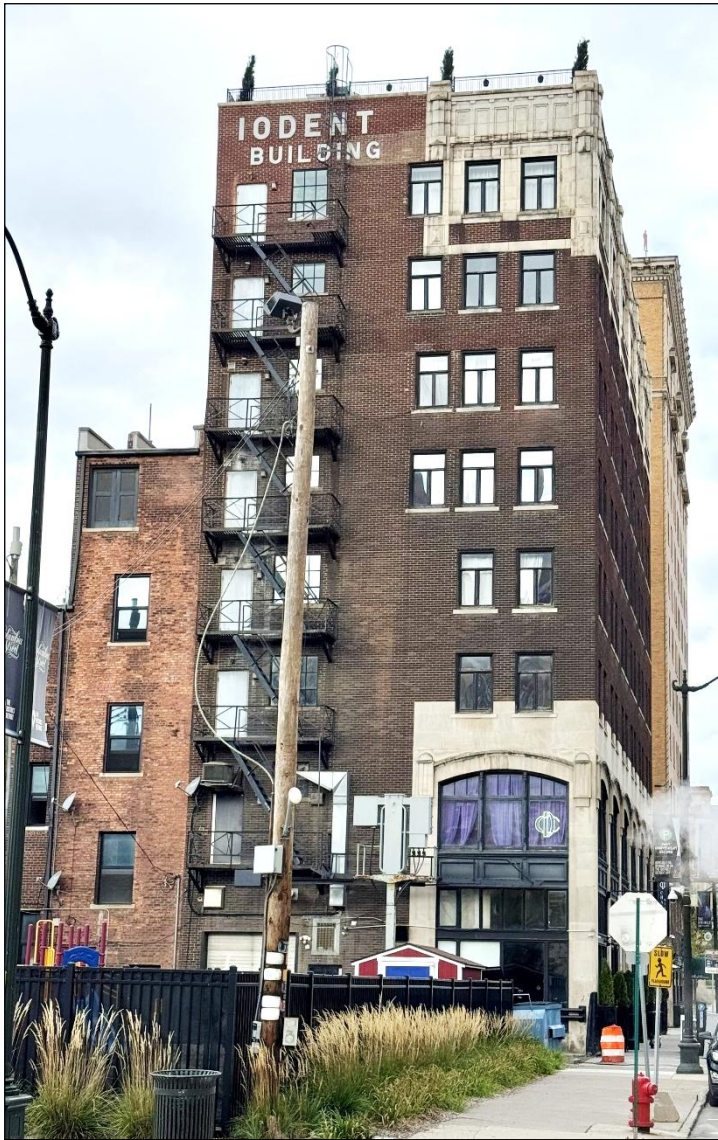
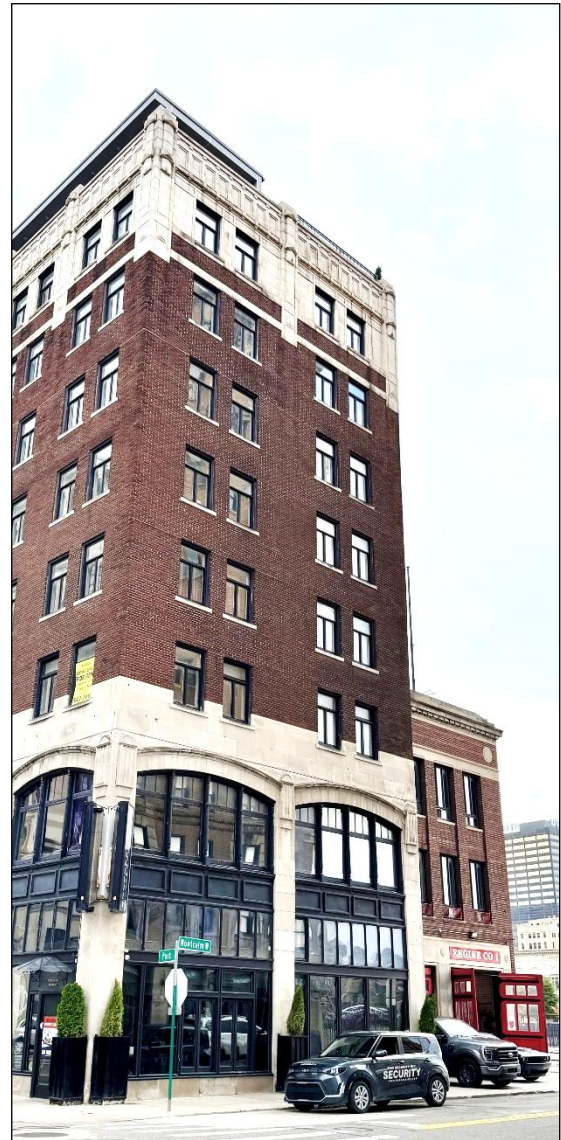
*Staff photos of south (left photo) and north (right photo) walls, May 2, 2025.*

The limestone wraps the north and south side walls; however, different percentages of the side walls were architecturally articulated, based on their street-facing location. The north wall faces Montcalm, while the south wall is adjacent an alley.

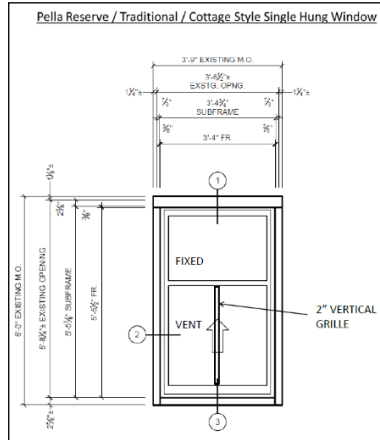
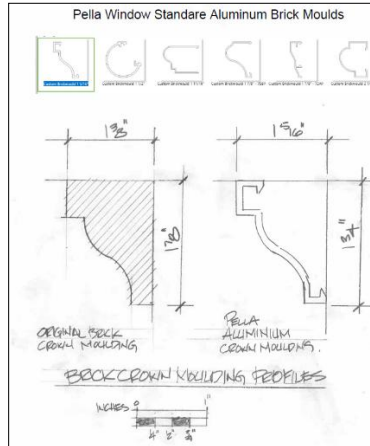
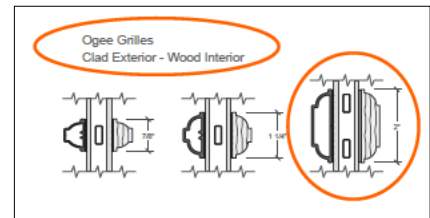
Applicant drawings.

1. Remove existing wood windows (front and side walls, floors 3 – 8), sashes, and trim.
2. Repair or replace wood bucks at the jamb, head and sill that is anchored to the masonry.
3. Install new aluminum-clad windows and trim; Pella Reserve, cottage-style window. Color: black
4. Install new exterior aluminum brick mould trim and masonry. Color: black.
5. Install aluminum flashing at sill.

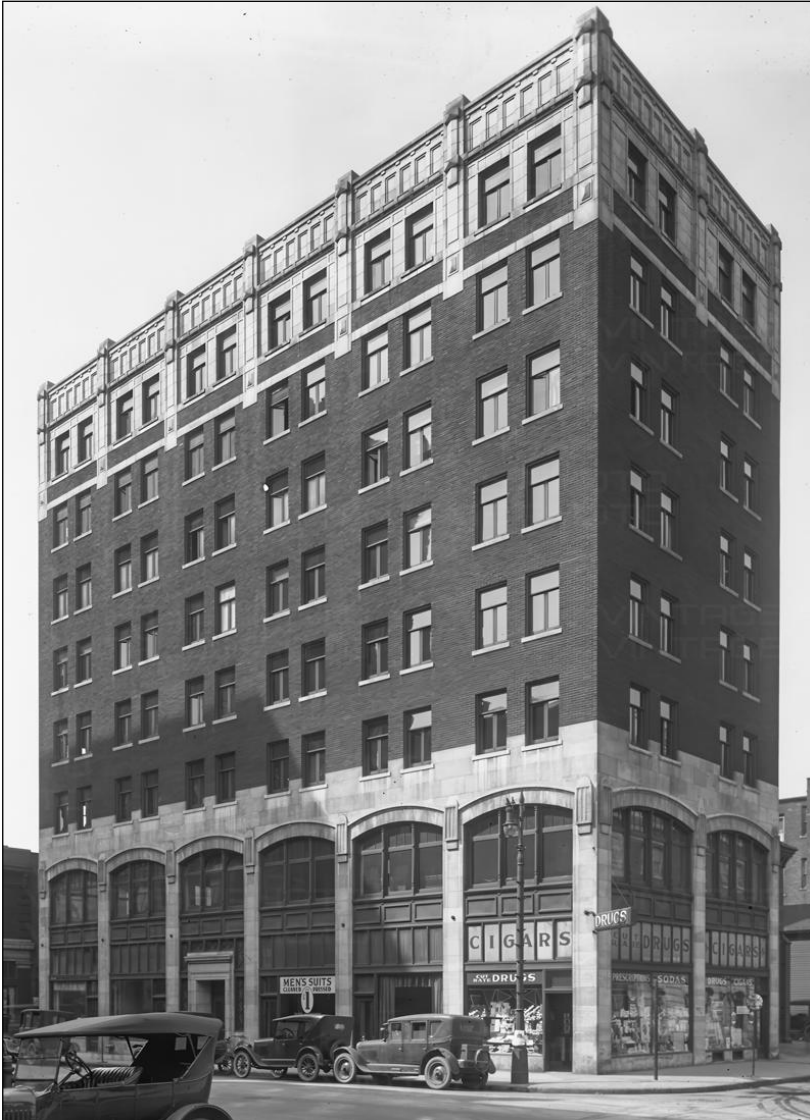
Left: Undated photo, Burton Collection.

- The perspective of the building in the above photo offers a clear view of the proportional width of the vertical element created by the closed French windows against the width of the fixed transom’s lower frame, creating an equally dimensioned “T”.

- It is staff's opinion that the existing historic windows are a distinctive character-defining feature of the building. The "T" design creates a uniform division of the window opening, equaling emphasizing the horizontal and vertical patterns of the stone detailing on the three primary exterior walls.
- The applicant's photos of the historic windows (an interior and exterior photo of each historic window is included in the application documents, only one opening is shown here) show wood frames that don't appear to be deteriorated beyond repair; they are intact and retain a smooth paint finish. The level of deterioration to the exterior framing is greater but is proportional to its daily exposure to the elements. The 100+ year old windows appear to be repairable, with most weathering at the horizontal components.

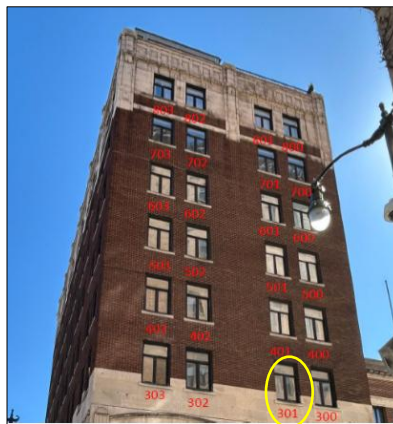
*Left: North wall of building. Window 301 is circled. Applicant photo.*

- The applicant's "Existing Window Building Survey" offers a numerical condition assessment but does not include a correlating written assessment detailing the problems and assessed deterioration of the historic windows. It isn't clear to staff the methodology of the factors used to determine the repair classifications. All original windows were given numbers of 3 (partial replacement) or 4 (total replacement) in conflict with staff's visual assessment; none of them had a 2 (stabilization) or 1 (routine maintenance).
