**STAFF REPORT: OCTOBER 8, 2025 MEETING**

**APPLICATION NUMBER: HDC2025-00129**

**ADDRESS: 863 IROQUOIS (A.K.A. MARTIN S. SMITH II HOUSE)**

**SCOPE: REPAIR/REPLACE LIMITED TRIM AND STUCCO, REPLACE FRONT PORCH COLUMN, REPLACE RIBBON DRIVE (WORK STARTED WITHOUT APPROVAL)**

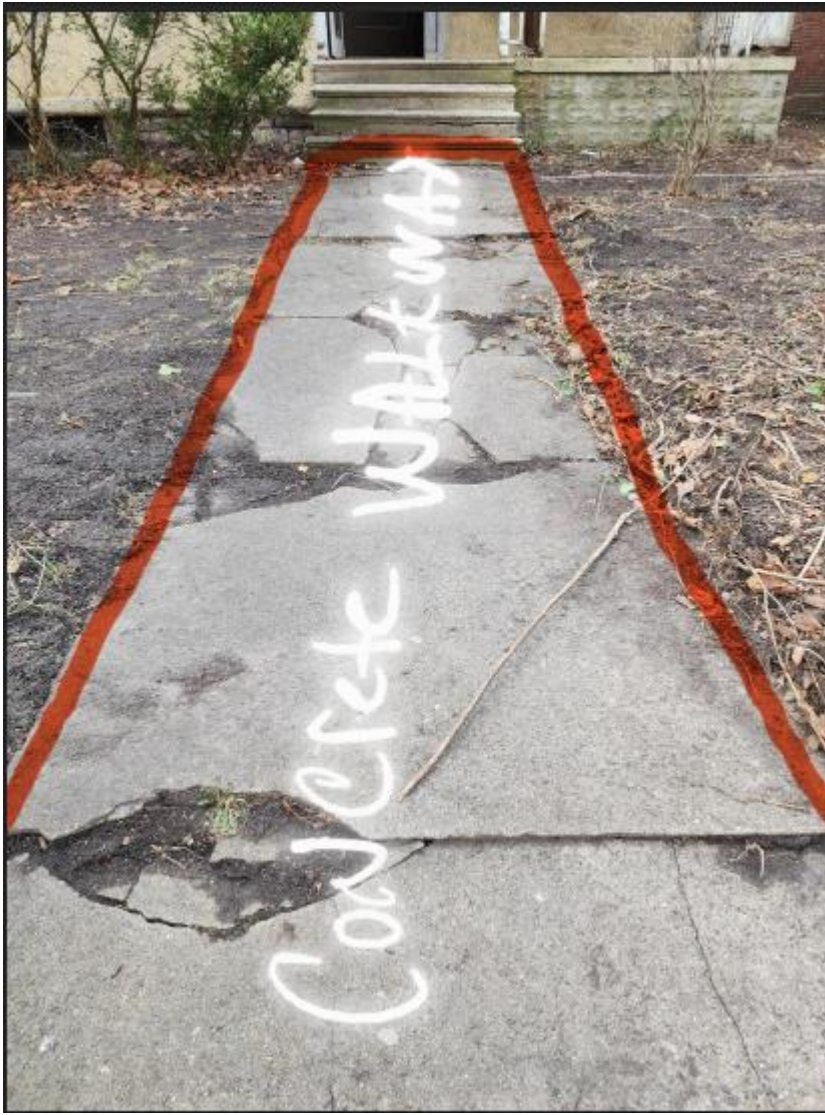
*Applicant's photo, May 2025 from Cycle 3 materials, clarifying proposed walkway only in concrete.*

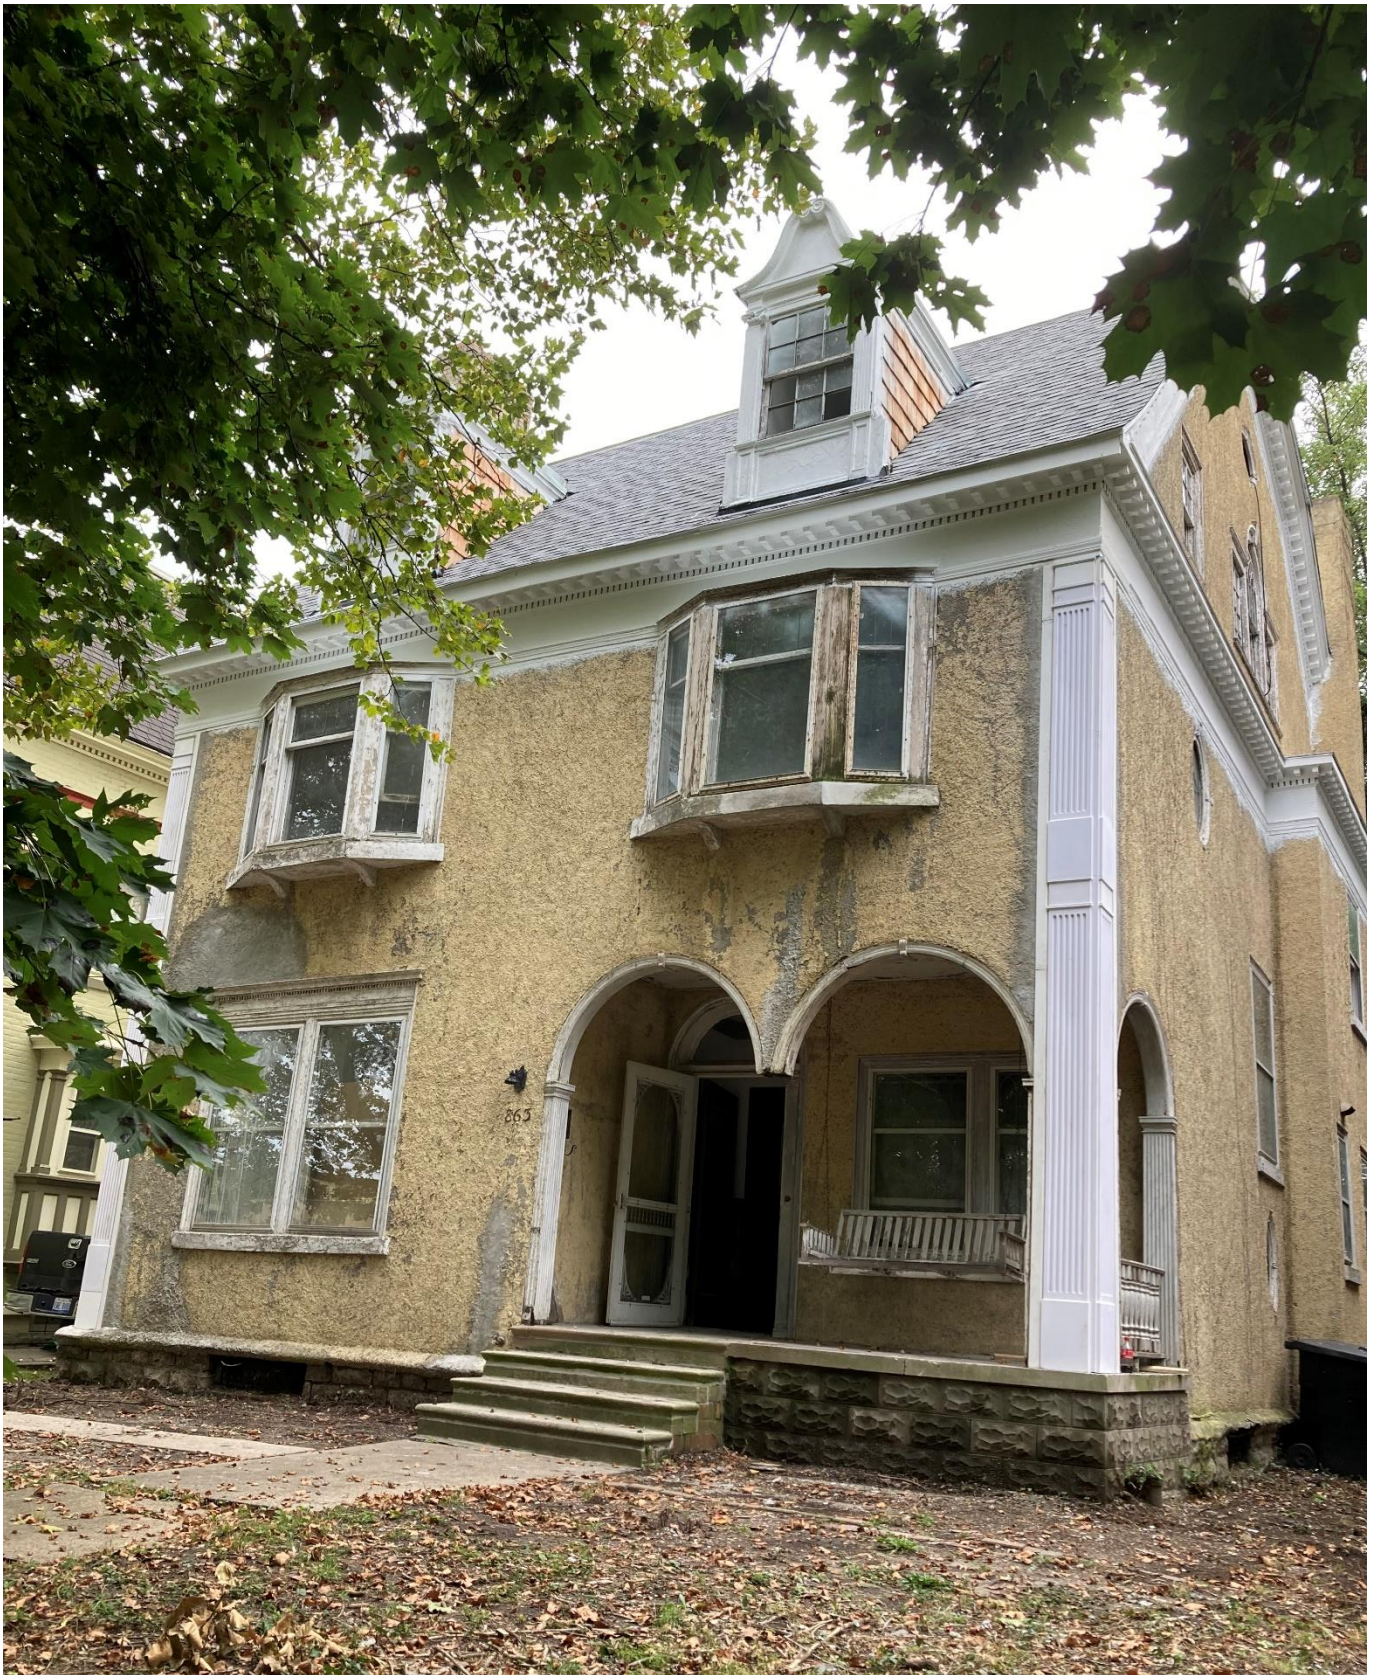
*Staff photo, September 2025, east end and some of the north side visible.*

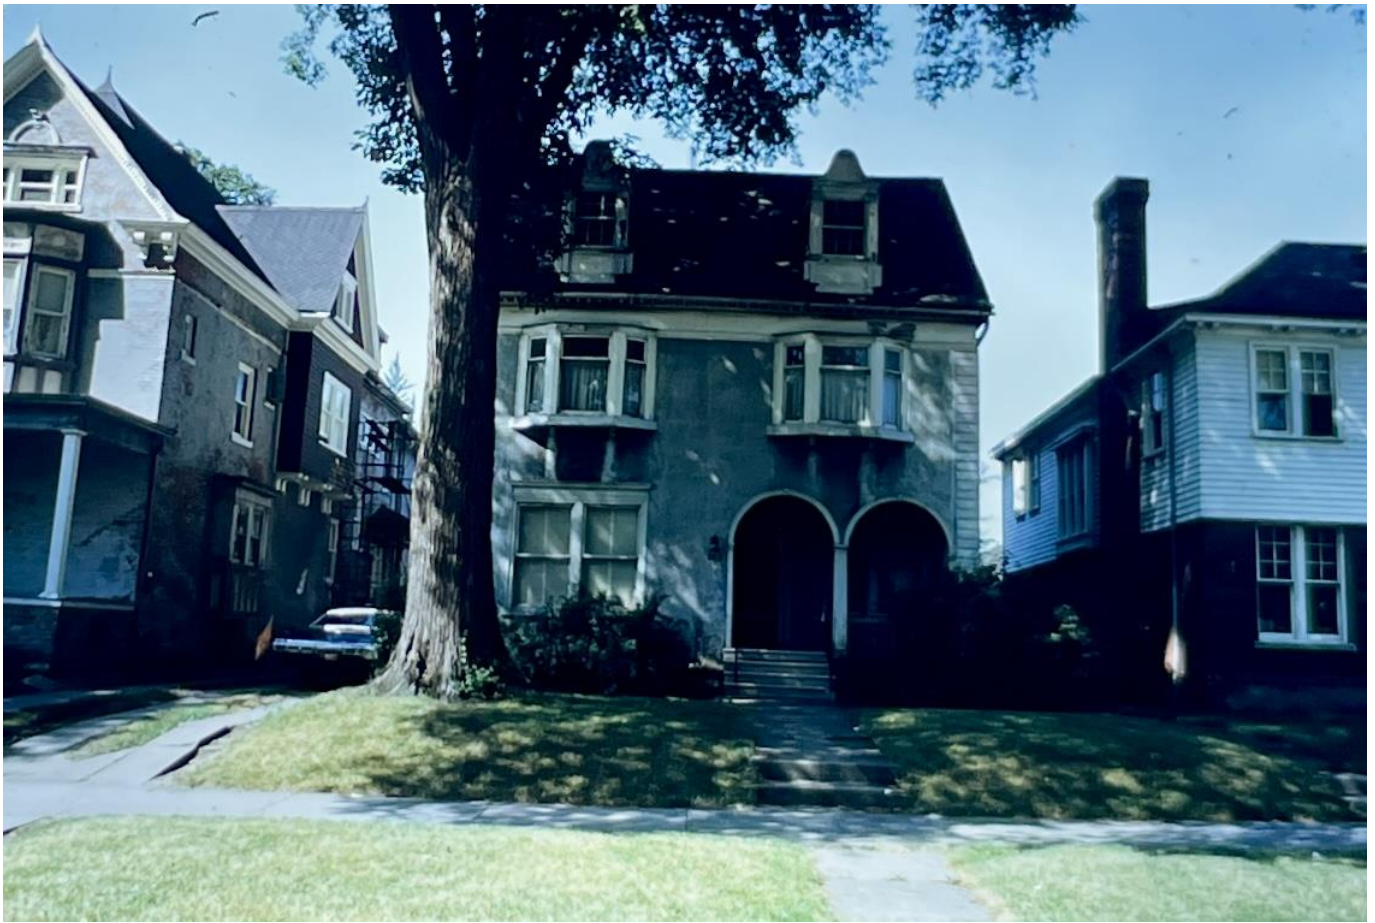
*863 Iroquois, designation slide, c. 1971. Ribbon drive and quoins at northeast corner are visible.*

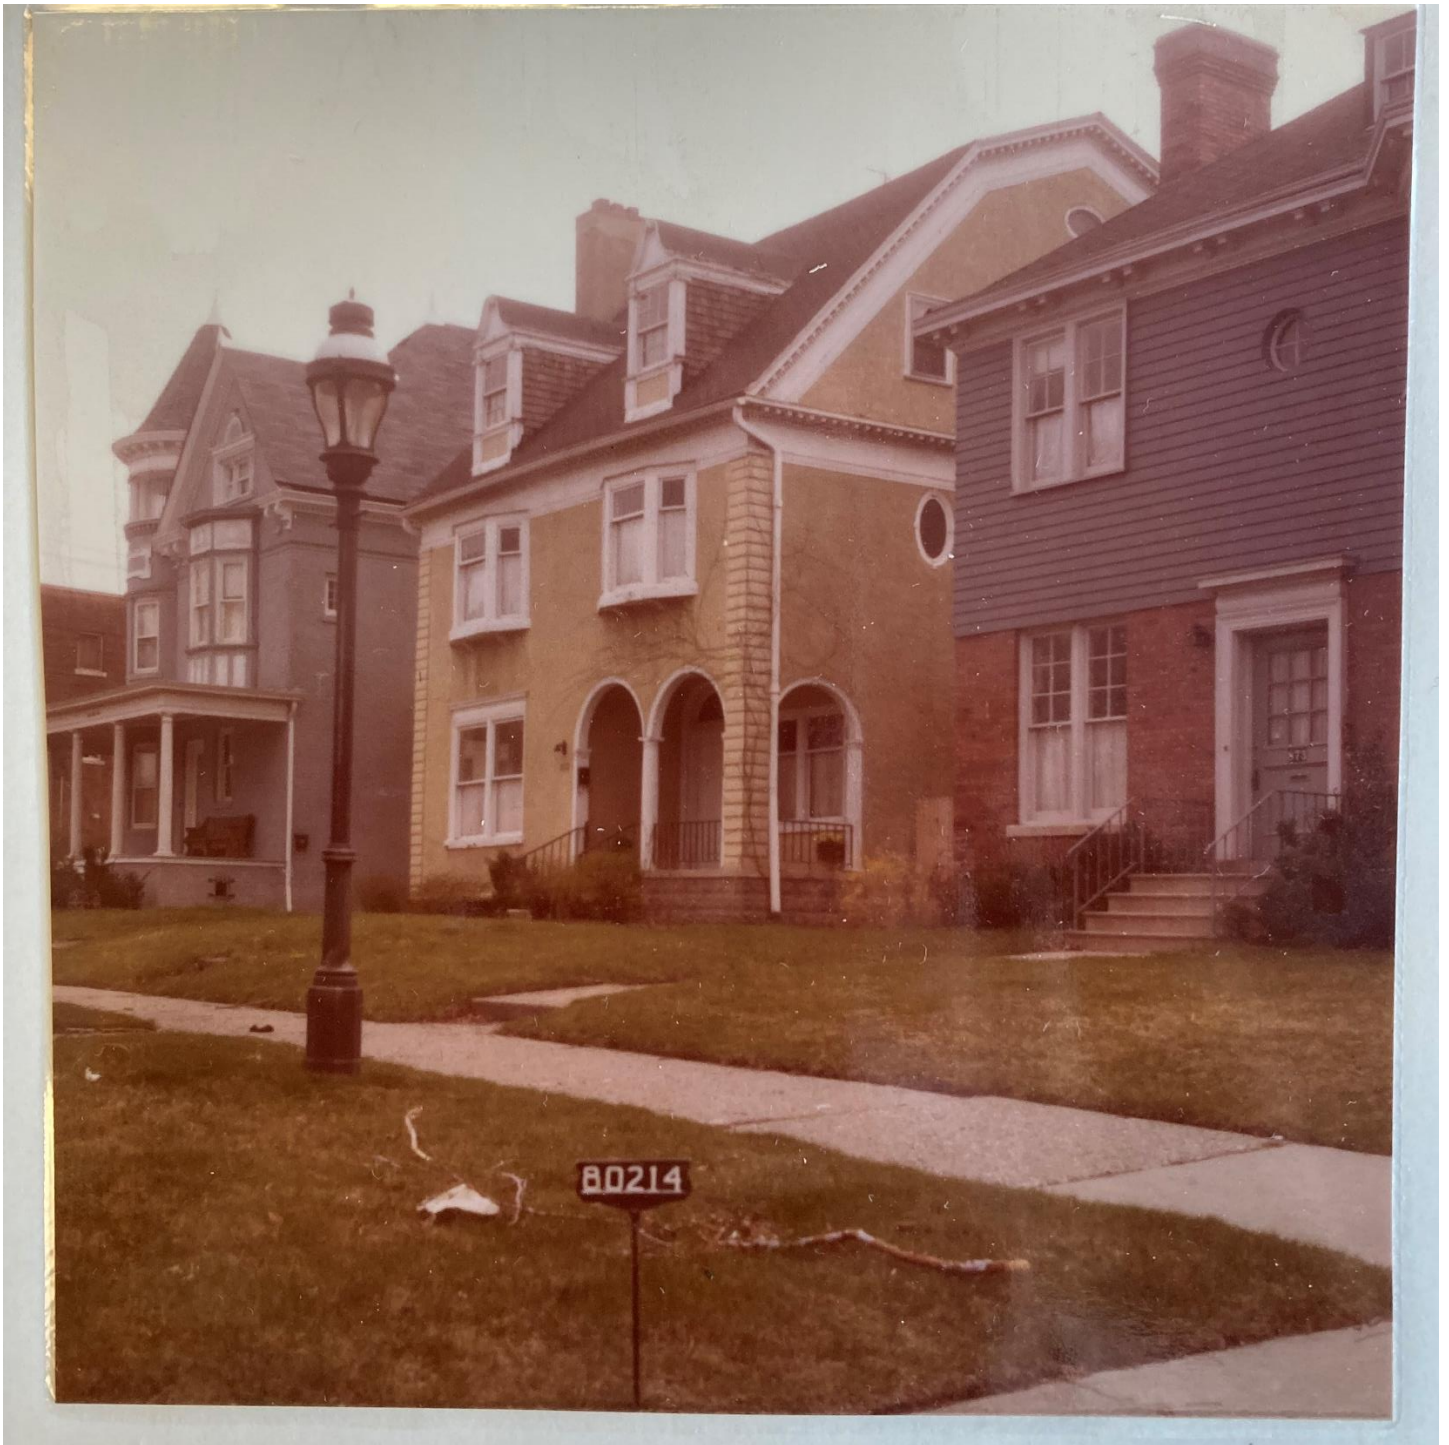
*Photo from 1979 that accompanied the mortgage survey, PDD files. Notice the quoining at the front corners, material unknown. Porch guardrails and handrails for steps are black metal.*

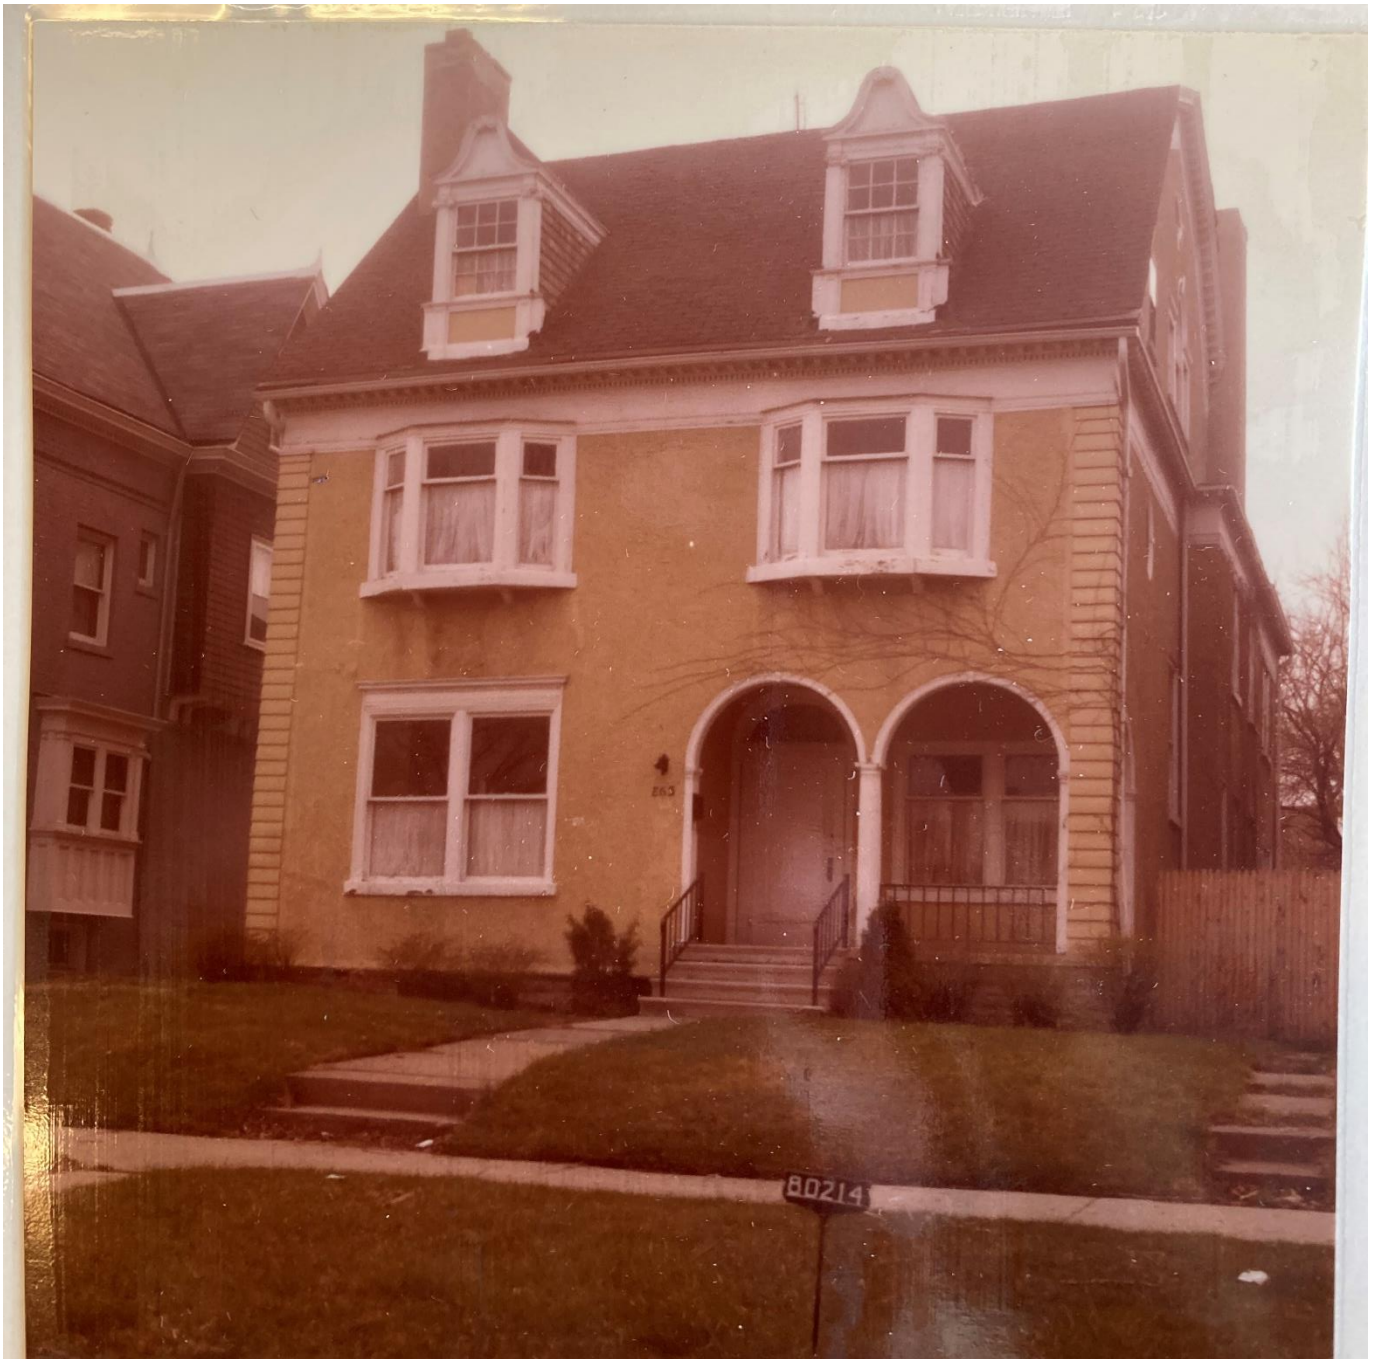
*Photo from 1979 that accompanied the mortgage survey, PDD files. Notice the quoining at the front corners, material unknown. Porch guardrails and handrails for steps are black metal.*

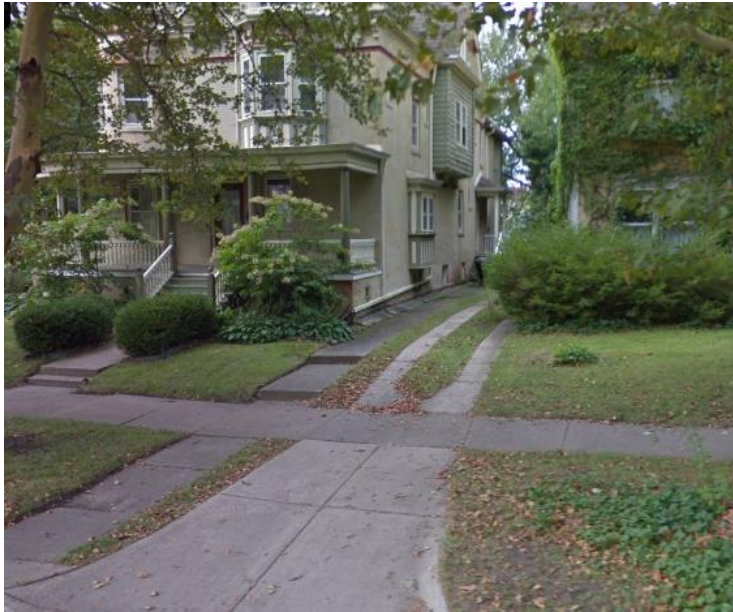
*2013 Google Street View of 863 Iroquois and its ribbon driveway. The greenery between the ribbons softens the effect of the driveway and makes it appear more like walking paths to the rear of the house, which are common features in Indian Village.*

- Regarding the ribbon drive, the Standards and Guidelines call for a historic feature of a site to be preserved, and staff believes the ribbon drive is a historic feature for this site since it was present on this site at the time of designation and likely long before that (since it had to be replaced in 1981). A ribbon driveway is characteristic of "first-generation" driveways added to properties and is historically significant in understanding changes to the resource during the period of significance.

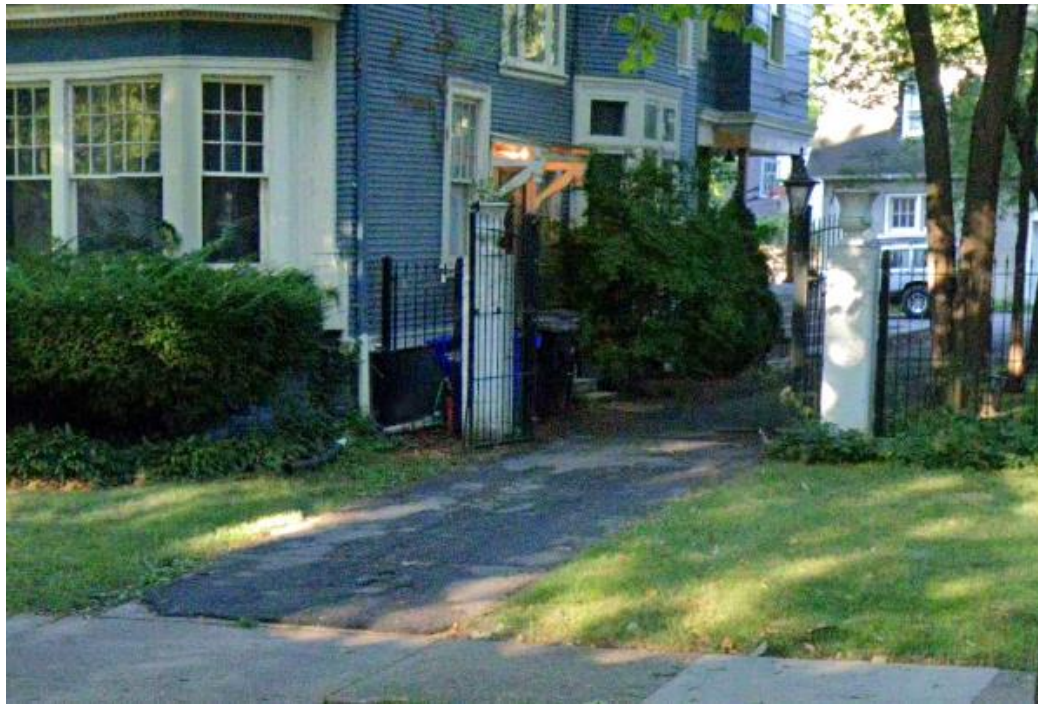
*1037 Iroquois retains a planting bed alongside the house that softens the effect of the driveway. 863 Iroquois's lot is narrower, of course, so a planting bed that could support sizable shrubs like this would not be possible. (Google Street View, July 2022)*

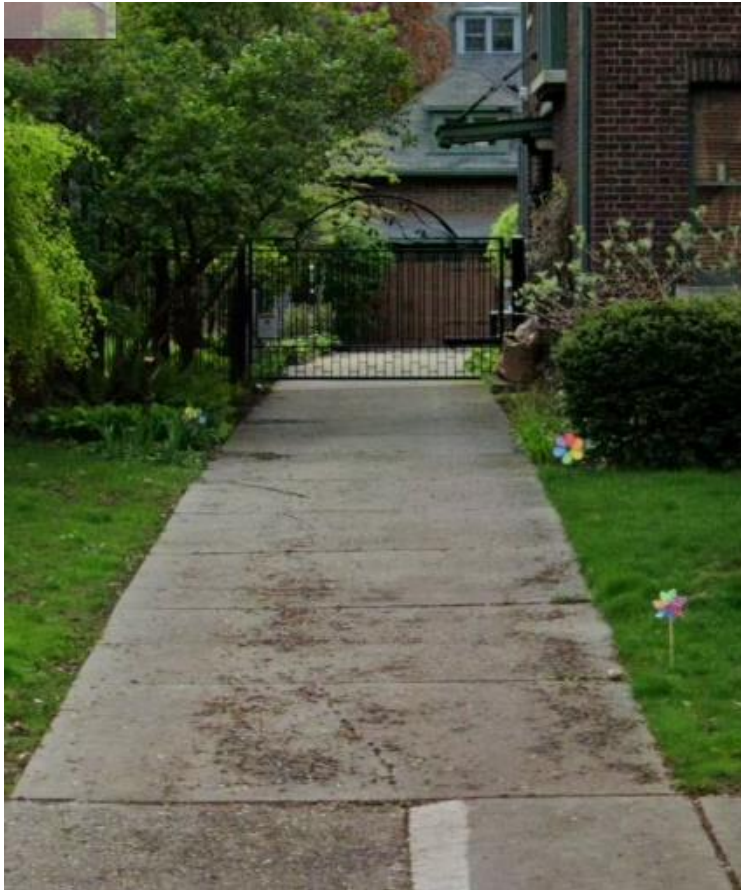
*A house on the next block to the north, 1438 Iroquois (to the right of this photo) has retained a small planting bed along the driveway and it softens the effect of the drive somewhat; the house at 863 has a similar planting strip right next to the house. (Google Street View, May 2019)*

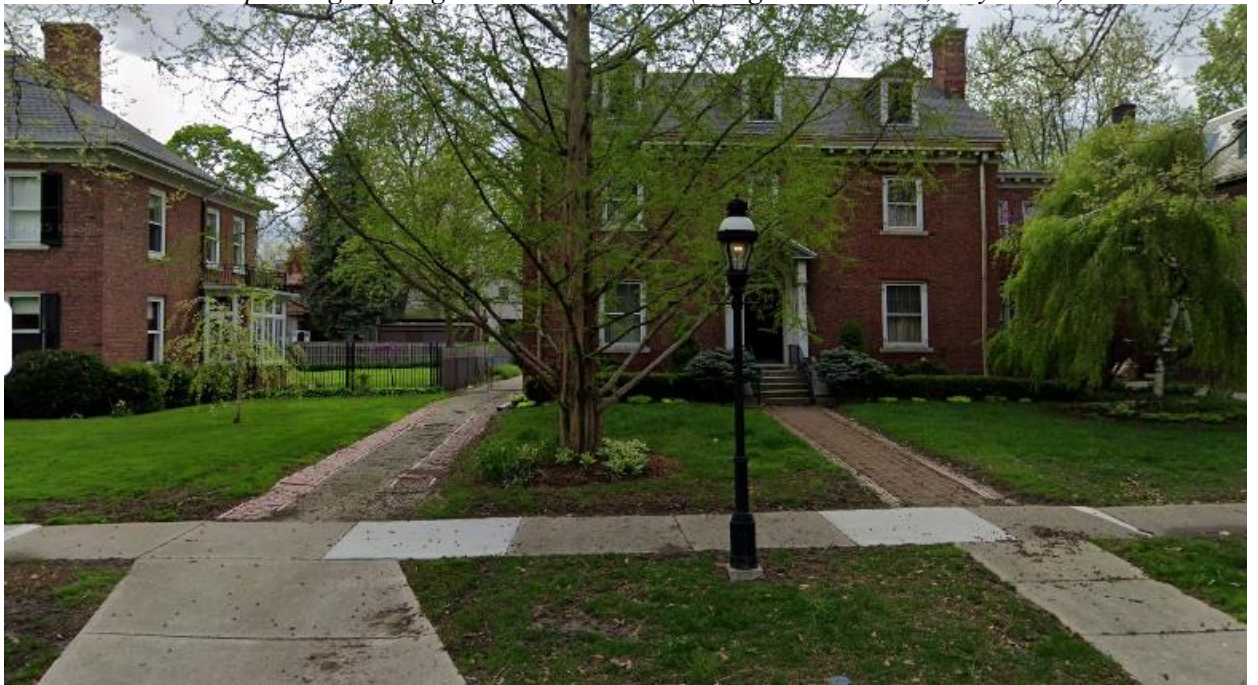
*1450 Iroquois, up two blocks from 863 and next door to 1438 above, shows evidence of a ribbon drive, but without any greenery between the strips. (Google Street View, May 2019.)*
