STAFF REPORT: 10-08-25 REGULAR MEETING

APPLICATION NUMBER: HDC2025-00243

ADDRESS: 14501-14523 EAST JEFFERSON

SCOPE: DEMOLISH THREE (3) COMMERCIAL BUILDINGS

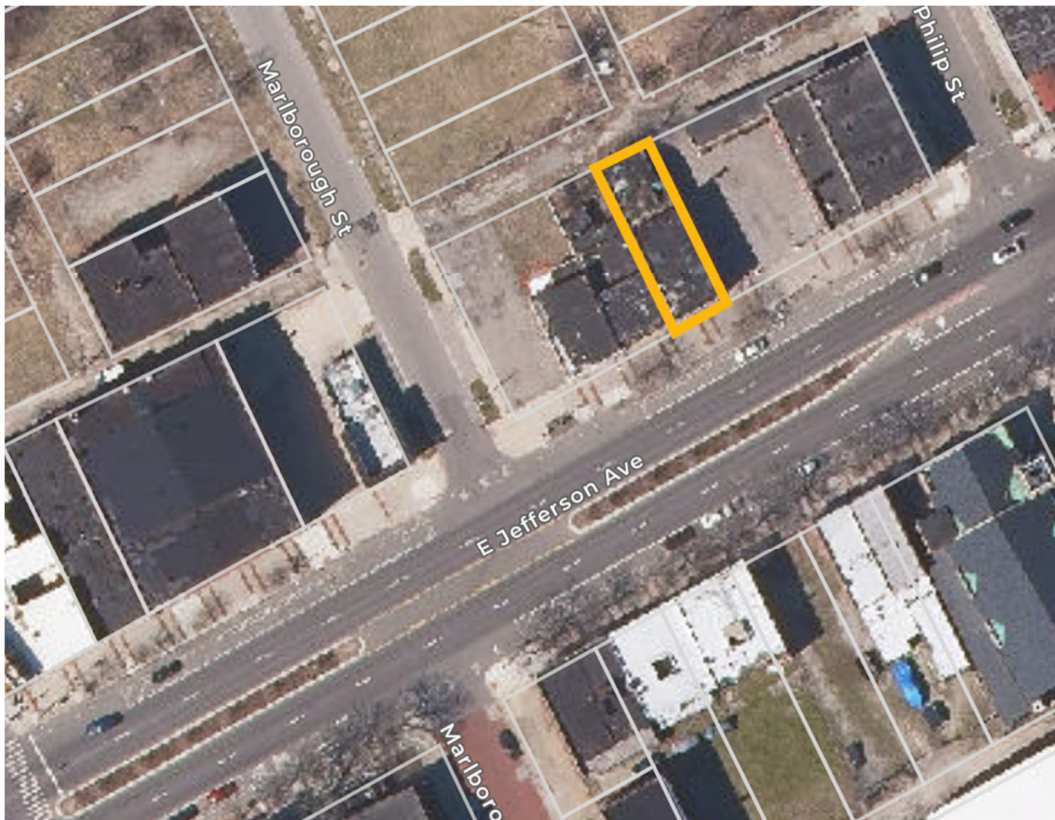
14521 East Jefferson outlined in yellow (easternmost building). The larger combined parcel holding 14501 East Jefferson (two buildings) is to the immediately left, or west, extending to Marlborough Street. North is up. Detroit Parcel Viewer.

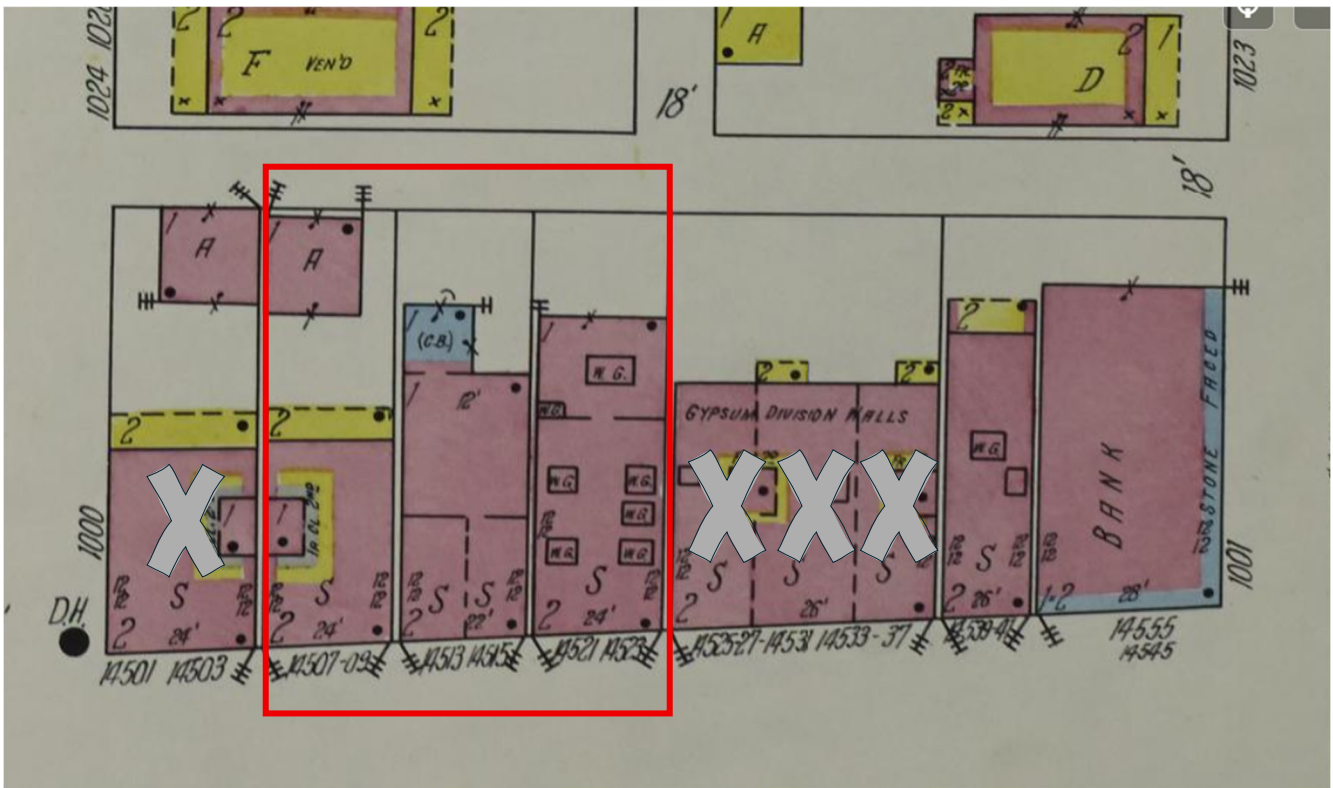
1929 Sanborn map of the commercial block between Marlborough (left) and Phillip (right). The subject properties are outlined in red. Buildings marked with an "X" have been demolished; note that the original 14501-14503 East Jefferson at the corner is long gone. The combined building now known as 14501 East Jefferson are the two buildings here addressed as 14507-09 and 14513-15 East Jefferson. 14521-14523 East Jefferson completes the three.

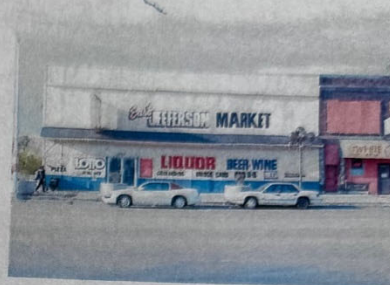
Photo

Filename: East Jefferson\14507-19 East Jefferson.JPG
Roll: Frame:
View: north
Credit: Rebecca Savage
Caption: 14507-19 East Jefferson (pre-alterations)

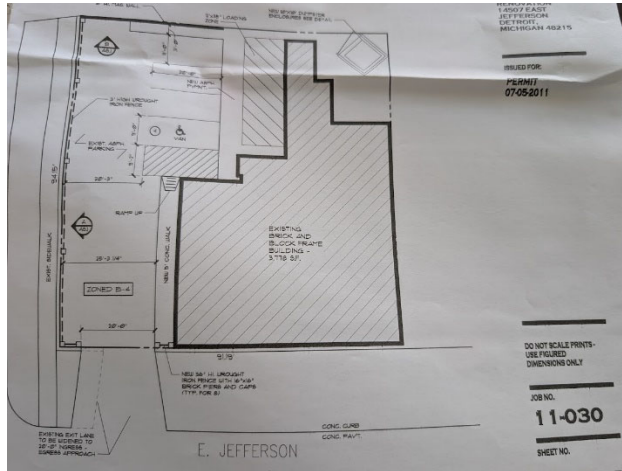
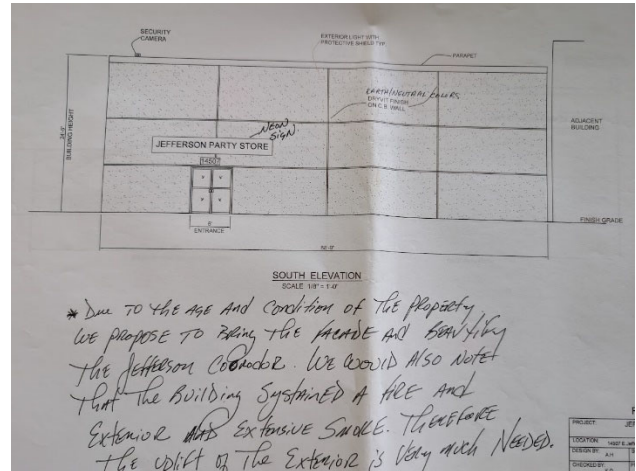
From HDC files, 2010-11: site plan showing single combined building, and one of several proposed EIFS façade systems.
