APPENDIX A
HISTORIC RESOURCE INVENTORY
APRIL 2020
FORT WAYNE HISTORIC DISTRICT

HISTORIC FORT WAYNE LANDSCAPE COMPONENTS

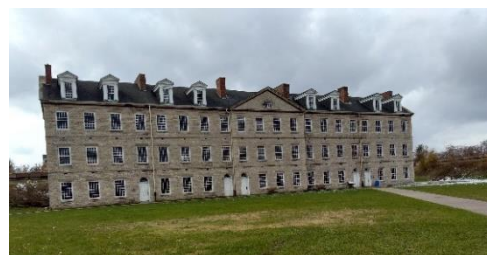
BUILDING 507: STAR FORT BARRACKS

By 1934 the building was in poor condition due to failure of the roof system; many of the rods had previously been cut to provide better access on the upper floors. Repairs in 1956 corrected this issue and the building now appears to be in good structural condition. In the 1970s the lowest two floors were developed as museum space with military exhibits and period rooms. These items were removed, however, during a 2004–2006 restoration of the interior to its prior character. Above the second floor, the upper floors demonstrate poor condition.

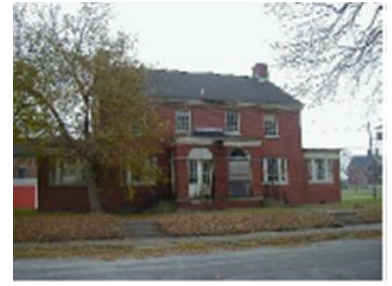
The exterior and interior of this building is similar to Building 216 in appearance and condition, but it has a gable roof and Georgian-style porches.

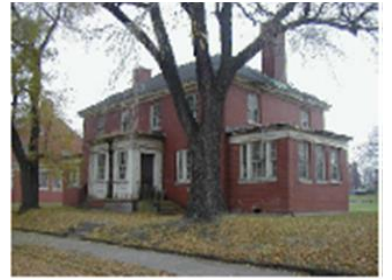
Building 218: NON-COMMISSIONED OFFICER'S DUPLEX

The exterior and interior of this building matches Building 216 in appearance and condition.

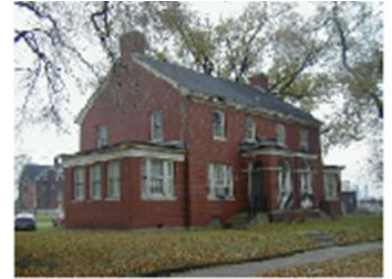
Building 219: NON-COMMISSIONED OFFICER'S DUPLEX

The exterior and interior of this building is similar to Building 216 in appearance and condition, but it has a gable roof and Georgian-style porches.

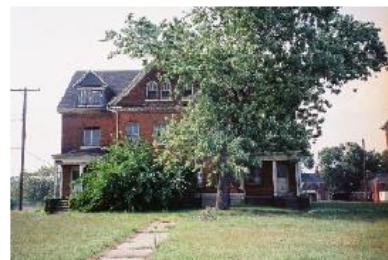
The exterior and interior of this duplex residence is identical to Building 102 A/B in appearance and condition.

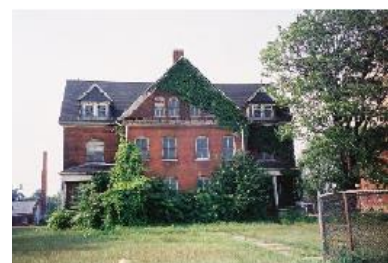
BUILDING 104 A / B: OFFICER'S QUARTERS DUPLEX

The exterior and interior of this duplex residence is identical to Building 102 A/B in appearance and condition.

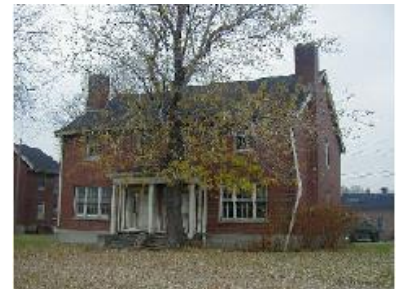
The exterior and interior of this duplex residence is identical to Building 105 A/B in appearance and condition.

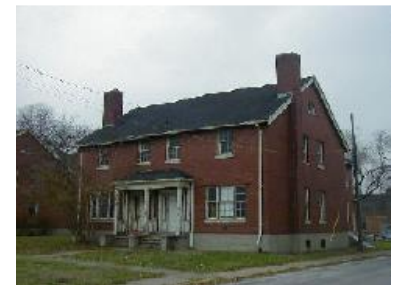
BUILDING 107 A / B: OFFICER'S QUARTERS DUPLEX

The exterior and interior of this duplex residence is identical to Building 105 A/B in appearance and condition.

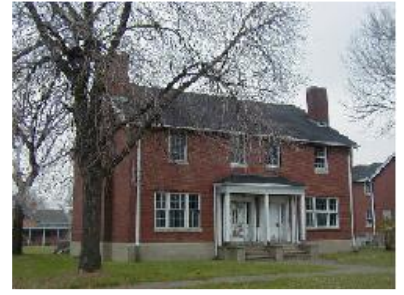
BUILDING 108 A / B: OFFICER'S QUARTERS DUPLEX

The exterior and interior of this duplex residence is identical to Building 105 A/B in appearance and condition.

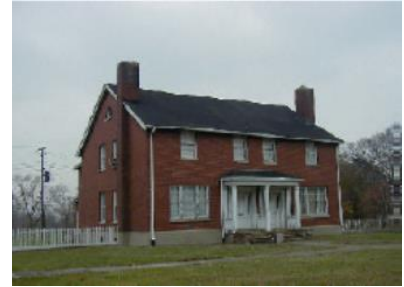
BUILDING 111 A / B: OFFICER'S QUARTERS DUPLEX

The exterior and interior of this duplex residence is identical to Building 105 A/B in appearance and condition.

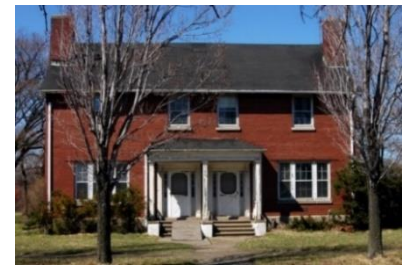
BUILDING 112 A / B: OFFICER'S QUARTERS DUPLEX

This duplex residence is similar to Building 105 A/B in appearance and condition. This building, however, has been partially rehabilitated to accommodate its function as the offices of the Recreation Department's Historic Fort Wayne project manager and the Fort Wayne Coalition. A new roof was put on the building in 2012.

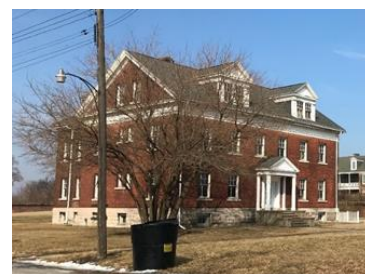
In 2005-2006 numerous modifications were made to the building. The entire basement level was rehabilitated and converted to handicapped accessible restrooms, locker rooms, shower rooms, mechanical rooms and storage rooms. Two new gas fired furnaces with ductwork were added to heat the entire building. A high capacity water heater was also installed. All plumbing and electrical service above the basement level were disconnected during the project. No work was done on the upper floors interior spaces. This building has undergone considerable renovation to adapt for museum display and interpretation. Existing openings have been closed, new openings constructed, and considerable original detail removed or destroyed. The exterior was restored, except for the original slate roof, which was replaced with asphalt shingles. A ramp and stairs descending to the basement level were added to the east side of the building to provide public access. Building 114 remains in good condition as a result of 2005–2006 interventions.
