STAFF REPORT: 10/08/2025 REGULAR MEETING

APPLICATION NUMBER: HDC2025-00561

ADDRESS: 14635 E. JEFFERSON

SCOPE: ALTER AND REHABILITATE BUILDING, CONSTRUCT NEW PARKING LOT

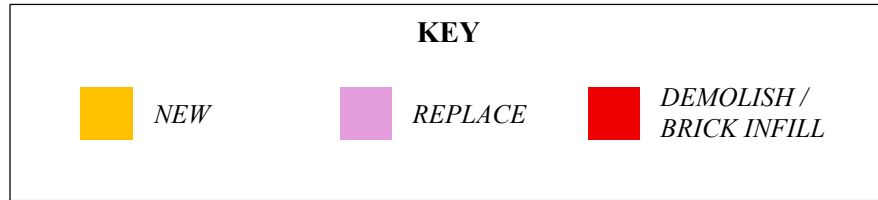
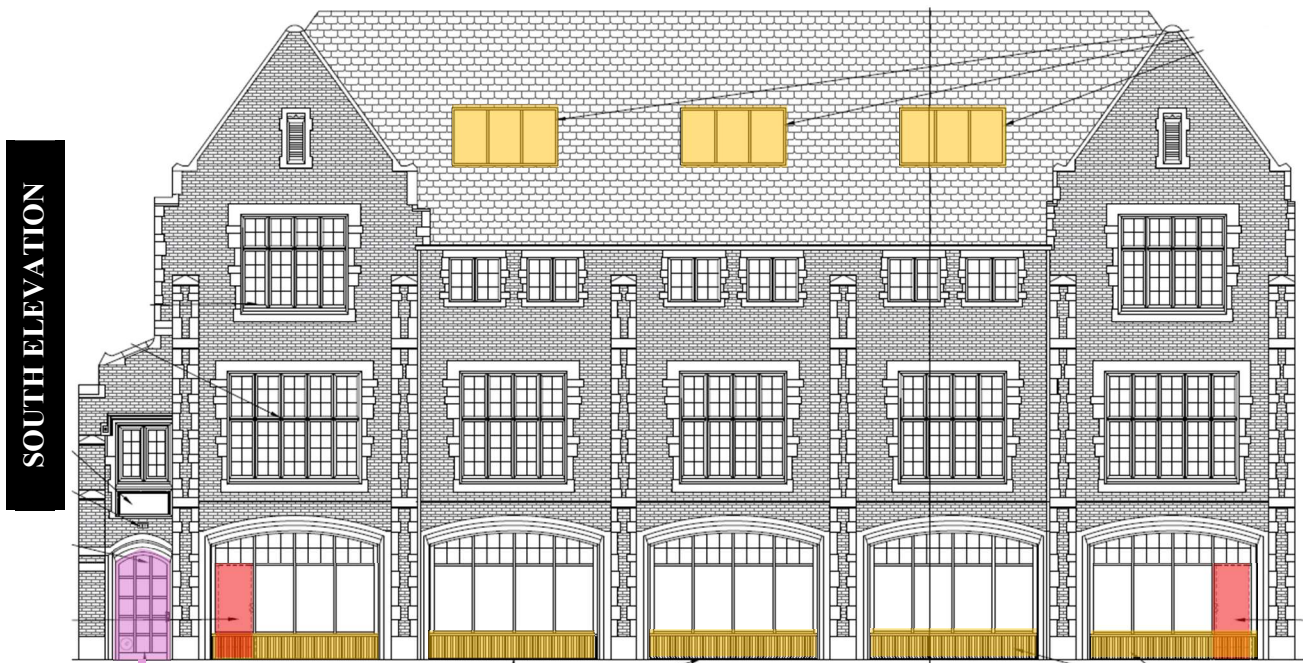
DEMOLISH EXISTING DOOR.
INSTALL NEW SOLID CORE OAK WOOD DOOR IN
WOOD FRAME TO MATCH HISTORIC FEATURES.
PAINT WITH COLOR B:6 (MODERATE BROWN
MS) PER HDC COLOR CHART. INSTALL BALDWIN
LOCKSET (SEE SHEET A-17 FOR SPECS.)

- The existing, historic wood door is a distinctive, character-defining feature and has not been proven to be beyond repair.

- The applicant proposes to replace the door with a replica wood door and paint it B6: Moderate Brown.

- The historic wood door at E. Jefferson is a distinctive, character-defining feature of the property that has not been proven to be beyond repair.
- The proposal is missing the design, material, and specifications for the storefront system panels, the material for the gate, the type and color of mortar to be used for any repointing, and the infill brick specifications.

- The proposed storefront system panel design, materials, and specifications shall be provided to staff for review and approval.
- The proposed material for the gate shall be provided to staff for review and approval.
- The existing historic door at the E. Jefferson Avenue entrance shall be restored, and not painted, instead of replaced.
- A historic mortar mix shall be used for the proposed repointing, as the mortar must be softer than the historic brick and match the composition of the existing historic mortar.
- A photo of the sample of the infill brick next to the existing historic brick shall be provided to staff for review and approval to ensure that it is suitable for exterior use and is compatible in texture, color, and dimension with the adjacent historic brick.

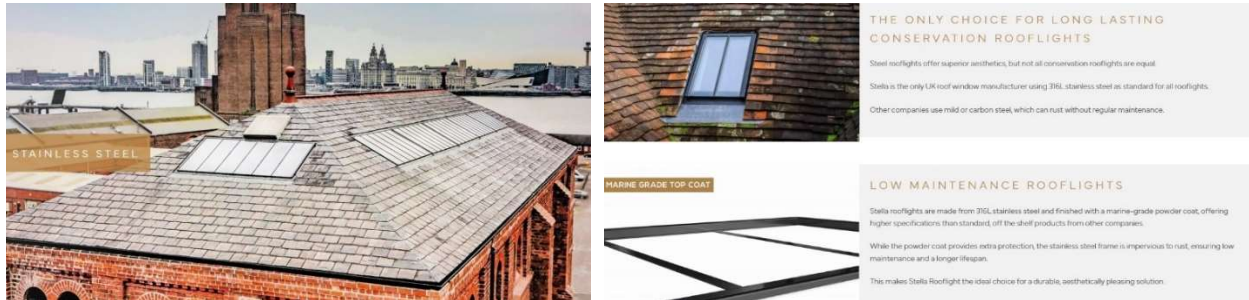
Materials from applicant

- The application proposes to install skylights at the south roof surface, facing E. Jefferson. The submitted materials for the product indicate that the skylights will be steel, fixed, and flush mounted. Although we do not have the measurements of the proposed skylights, the applicant is seeking to install three groupings of skylights, which will extend nearly the full length of the south roof surface. When viewed from the public right-of-way, especially from E. Jefferson, the proposed skylights will present as a highly visible modern intrusion that is not compatible with the building's historic character. Considering this building is on the corner, staff does not recommend the installation of skylights on any of the sloped roof surfaces, as they will be visible from the public right-of-way.

- The installation of the proposed skylights does not follow NPS guidelines. Specifically:
 - *Illustrated Guidelines on Sustainability for Rehabilitating Historic Buildings*

Recommendation 1 of 2 – Denial – Install skylights

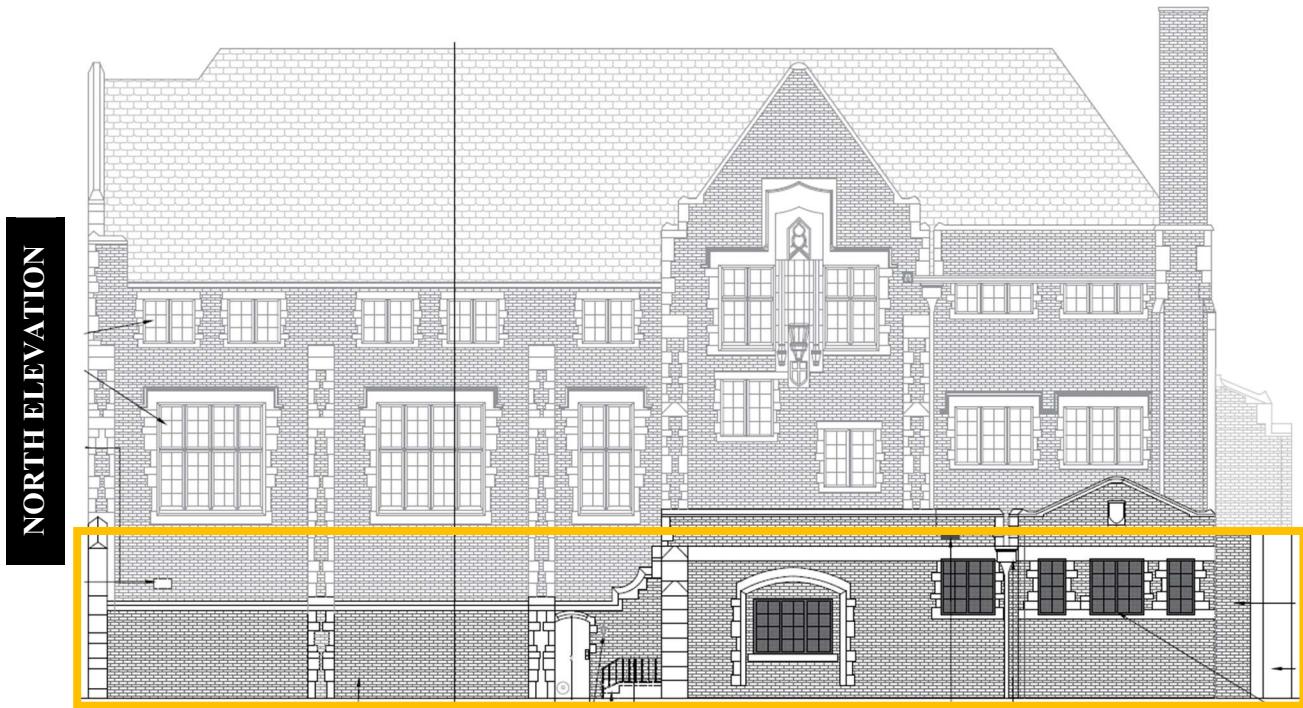
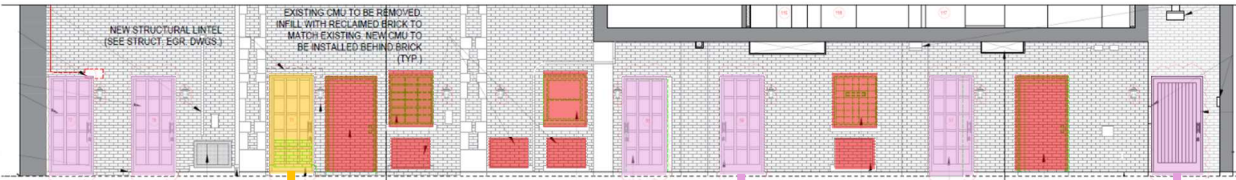
NORTH ELEVATION

- Staff would like to note that the application doesn't specify the material or finish of the proposed gate.
- Considering the existing conditions for both entrances are not historic, it is staff's opinion that the proposed replacements are appropriate due to their material and style.

REMOVE EXISTING DOORS. INSTALL NEW SOLID CORE OAK WOOD ENTRY DOOR IN WOOD FRAME WITH SURFACE APPLIED HORIZONTAL OAK STILES AND RAILS TO REPLICATE HISTORIC DOOR FEATURES. PAINT WITH COLOR B-6 (MODERATE BROWN MS) PER HDC COLOR CHART. INSTALL BALDWIN LOCKSET (SEE SHEET A-17 FOR SPECS.) ADJUST FRAME TO FIT EXISTING MASONRY OPENING WHERE NECESSARY
