**STAFF REPORT: NOVEMBER 12, 2025 MEETING**

**APPLICATION NUMBER: HDC2025-00635**

**ADDRESS: 12512 BROADSTREET**

**SCOPE: REPLACE WOOD WINDOWS WITH FIBREX WINDOWS**

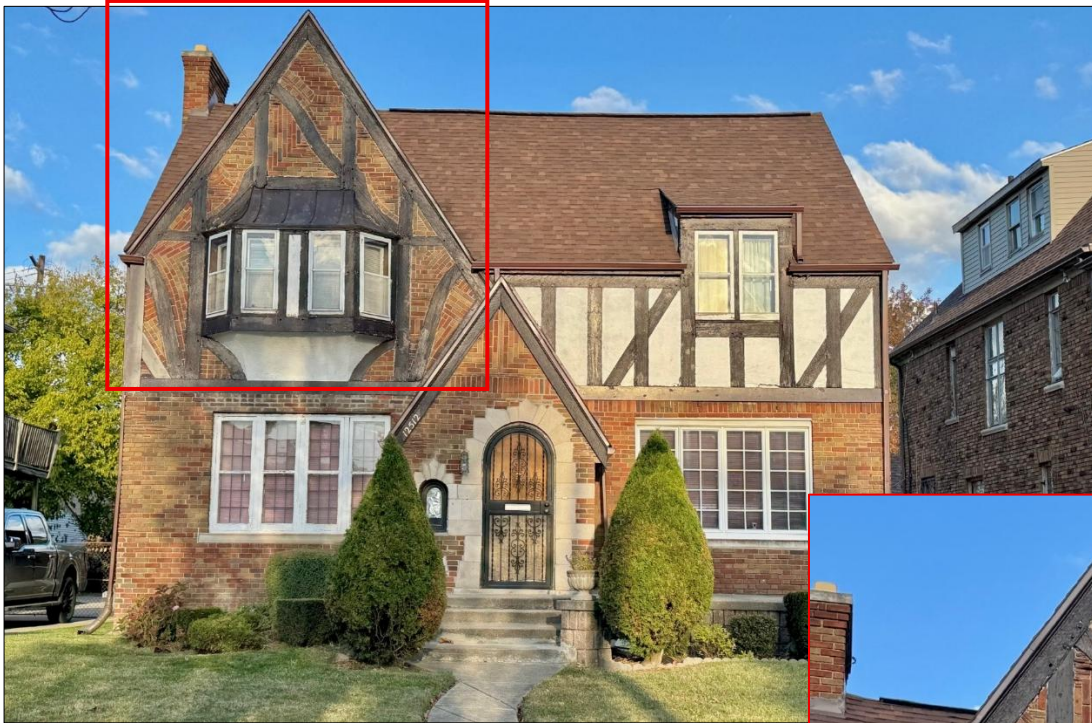
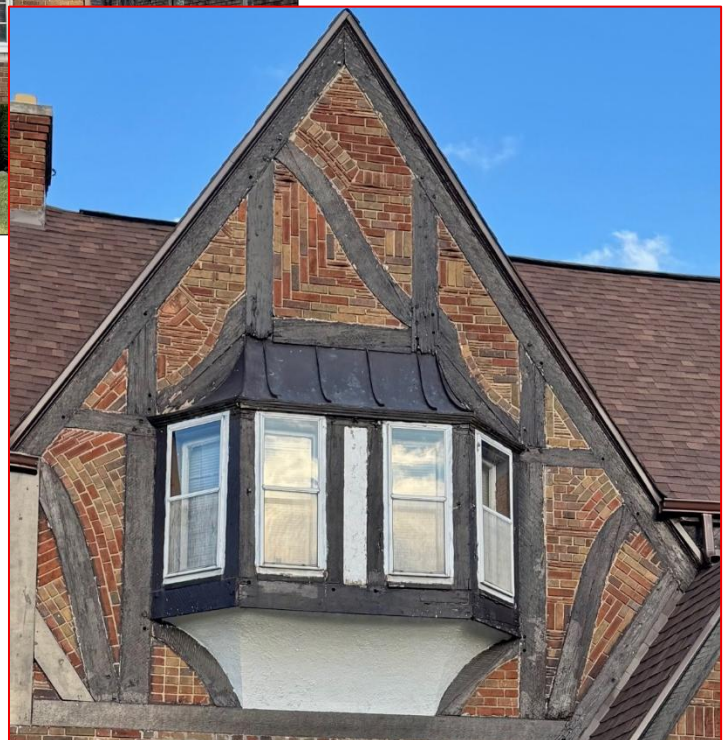
*Above and right: Staff photos, October 2025.*

Stone is used for sills at the window openings at the first floor, as well as irregularly shaped pieces to create a surround for the front door and adjacent arched window.

Leaded glass casement windows remain at the first floor, to the left of the front door. The remaining windows on the front and side walls are either wood double-hung or casement windows or replacement units (most of which are casement in operation) which appear to pre-date the local historic district.

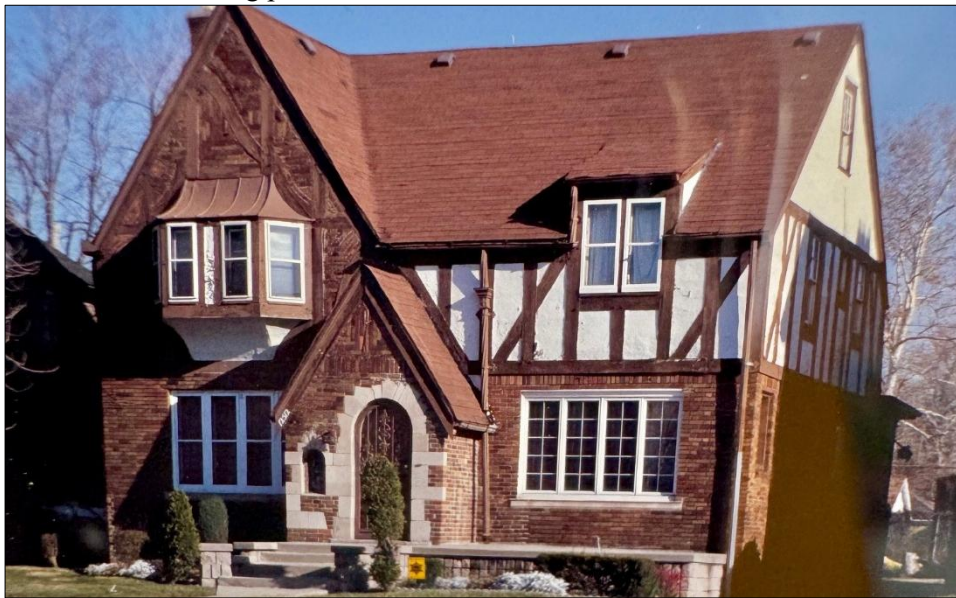
*Above: Permit card, BSEED.*

- The Russell Woods-Sullivan Historic District was enacted on November 12, 1999.
- The building permit for 12512 Broadstreet was issued on March 11, 1929.

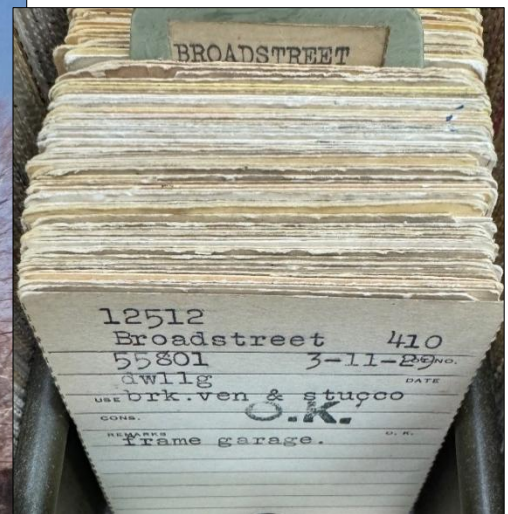
*Left: Designation photo, 1999. HDAB.*

- Replacement windows at the first floor, right of the entrance are visible in the designation photo. Based on this image, staff assumes that the other existing replacement windows on the side walls pre-date the district.
- Leaded glass casement windows to the left of the front entrance are distinctive character-defining features, remain intact, and not part of this application.
- The windows on the façade at the second floor are casement units, with wood frames and undivided glass. The storm windows with a central meeting rail obscure the casement operation.
- The double-hung wood windows on the side walls, four with a six-over-one pattern and two with a four-over-one pattern are proposed for replacement.
- Two openings: front, second floor shed dormer and south side wall, first floor near the rear, have wood mullions that are part of the larger window opening.

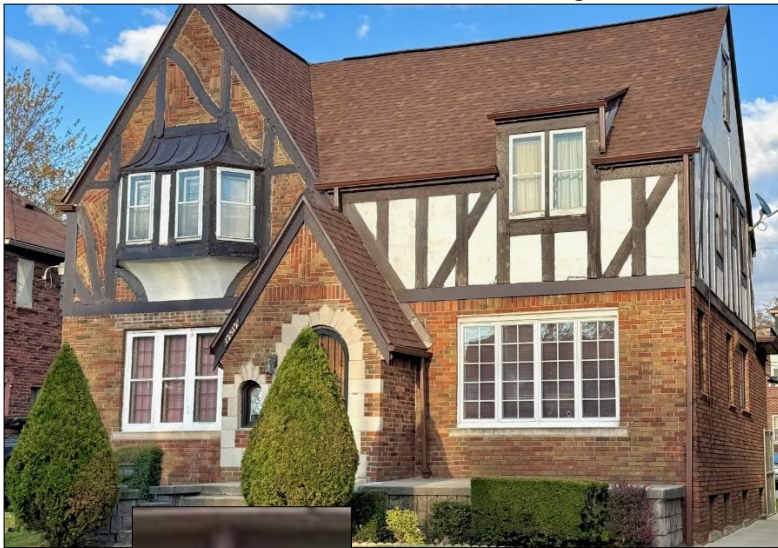
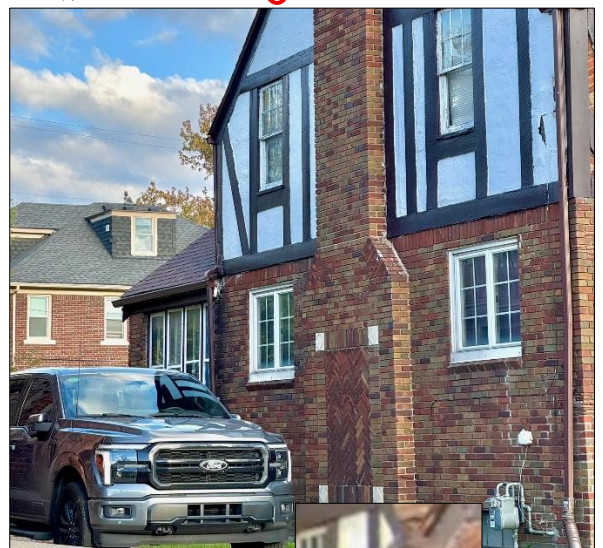
*Staff photos, October 2025.*

- During staff's research of the property for this application, the following alterations were identified:
  - Replacement of asphalt shingle roof with new asphalt shingle roof
  - Removal of downspouts (which appear to be round) and collector boxes.
- Staff will notify the applicant of the unapproved work and to see if they would like add the roof and gutter/downspout scope of work to this application.
