**STAFF REPORT:** NOVEMBER 12, 2025 MEETING  
**APPLICATION NUMBER:** HDC2025-00498  
**ADDRESS:** 3768 TYLER

**HISTORIC DISTRICT:** RUSSELL WOODS-SULLIVAN HISTORIC DISTRICT  
**APPLICANT:** STEPHEN WASHINGTON, GRANDIOSE REAL ESTATE SOLUTIONS LLC  
**PROPERTY OWNER:** GRANDIOSE REAL ESTATE SOLUTIONS LLC  
**DATE OF PROVISIONALLY COMPLETE APPLICATION:** 10/17/25  
**DATE OF STAFF SITE VISIT:** 9/15/25; 10/24/25

**SCOPE:** INSTALL FRONT PORCH NEW GUARDRAIL, REBUILD GARAGE ROOF, REPAIR GARAGE'S CONCRETE BLOCK WALLS, REPLACE GARAGE HINGED DOOR AND OVERHEAD DOORS

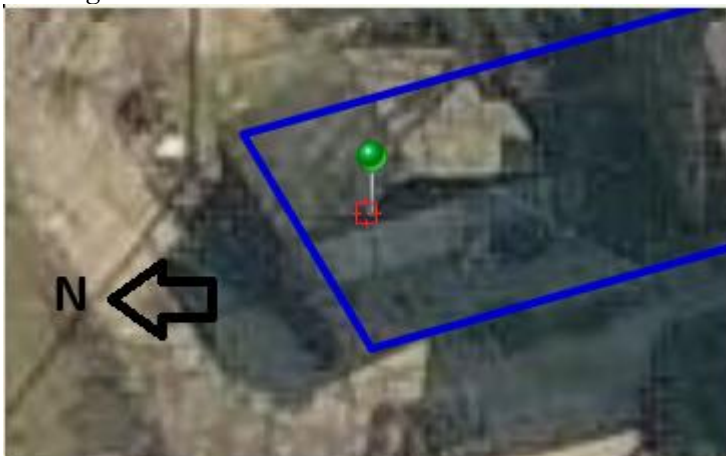
*Same 2006 image, now from the west, showing garage doors under a gable roof. Proposed are new garage doors replacing the old, in the same locations.*

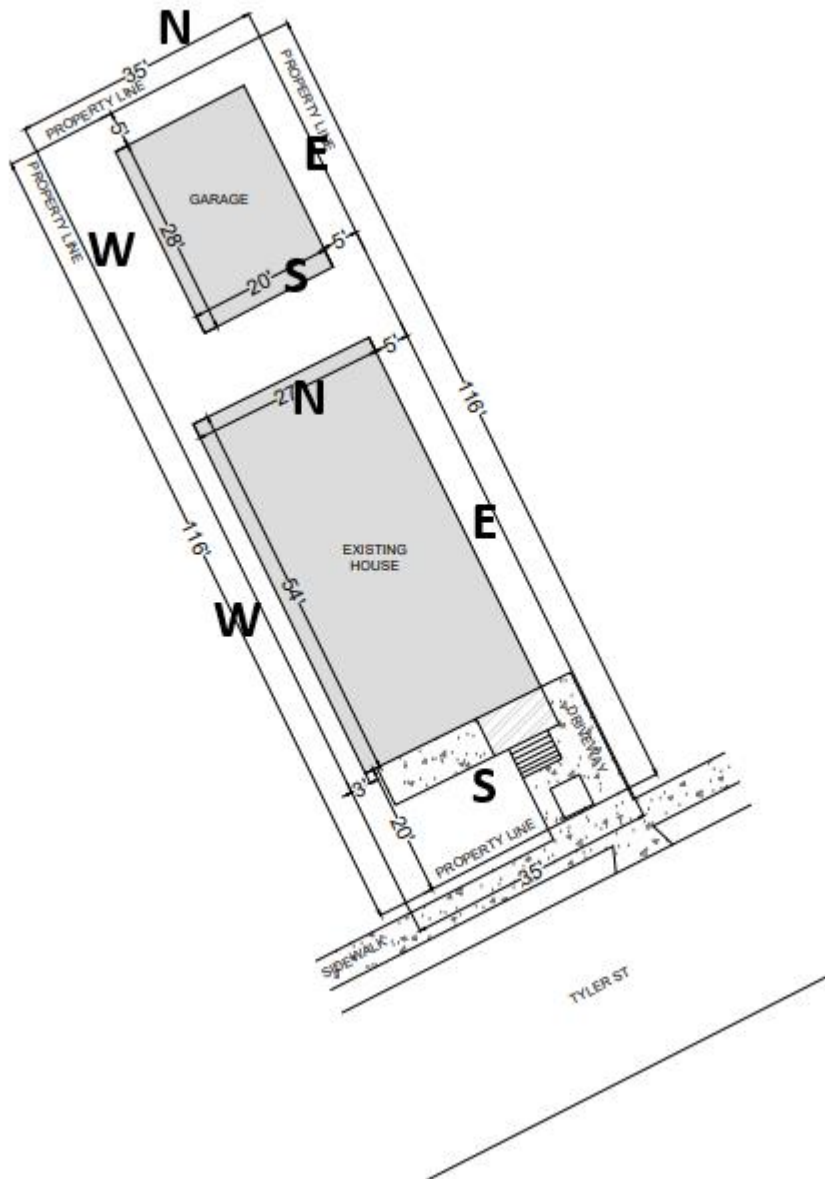
*Site plan from applicant's materials. Staff labeled the directions here. Staff believes that the applicant's elevation drawings are mislabeled regarding directions. See captions below.*

- The garage's height and footprint are not proposed to change. The walls are proposed to remain in place and be repointed (but ultimately may need to be rebuilt, depending on condition), and the roof structure is to be rebuilt to match the proportions of the original. This work would meet the Secretary of the Interior's Standards for Rehabilitation.
- The metal frame window is proposed to be retained but if it cannot, it is proposed that it get blocked in with concrete block. Since the current garage is a 1966 replacement for the historic building, the metal window is not a historic feature. If a replacement window is desired, product cut sheets have not been provided.
- The service door and overhead doors are both to be replaced to match the existing. Product cut sheets were not provided.
- The garage elevation drawings seem to staff to be mislabeled.

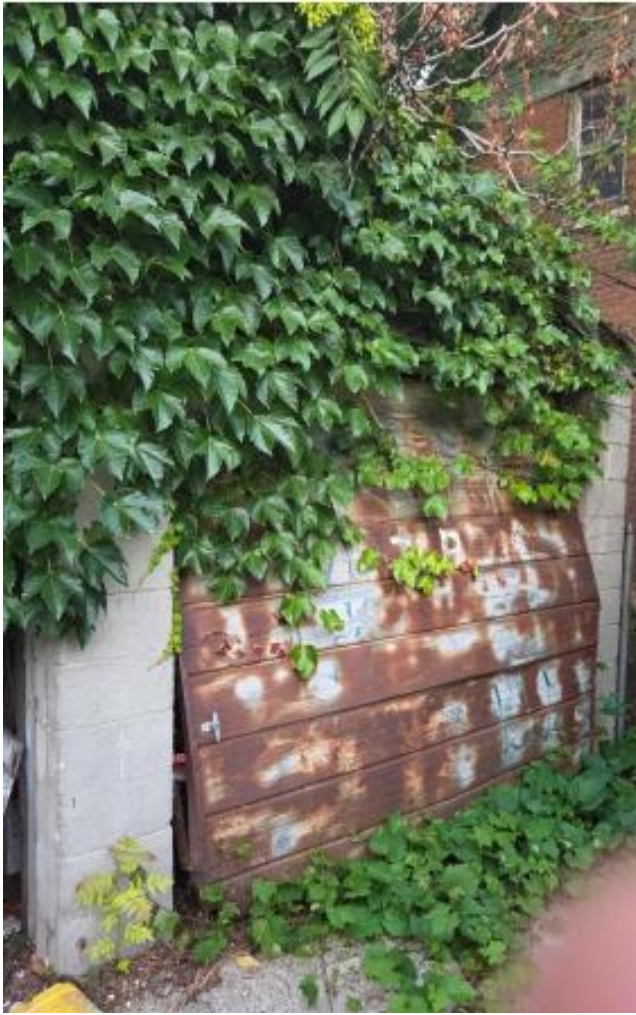
*3768 Tyler, garage, west side near southwest corner, applicant-provided photo from materials. This door was also shown in the 2006 aerial photo. These overhead doors on the garage's west side open onto a concrete driveway or pad connecting to the alley.*

- Replace the garage doors with new steel paneled doors that mimic the original designs and dimensions. Retain original door opening dimensions and framing.
- Repair window opening, install historically compatible fixed window or block it in with matching cement block if beyond repair.
- Clear and treat vegetation. Apply root barrier or eco-friendly vegetation control solution. Ensure base of garage is clear of overgrowth to prevent future damage.
- Paint new exterior elements (trim, door surround) to match house body or trim color.

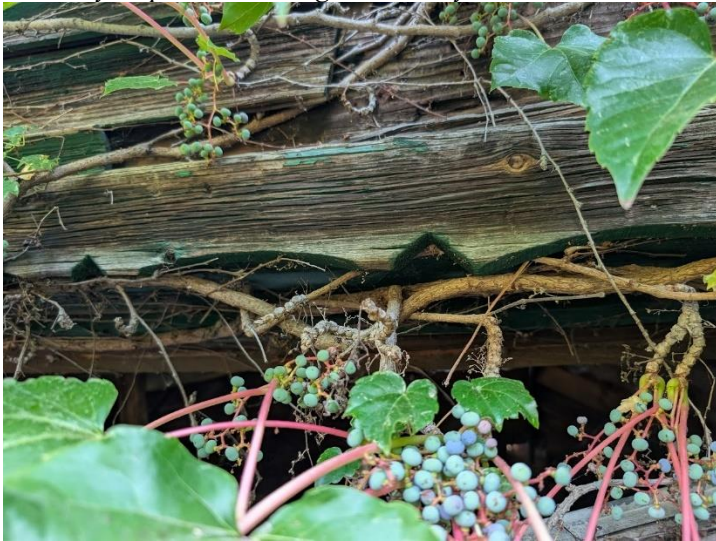
*3768 Tyler, garage, west side, detail of scalloped trim below the gable roof and above the overhead doors. This kind of trim is typically found at primary elevations of midcentury garages. (Staff site visit, September 2025)*

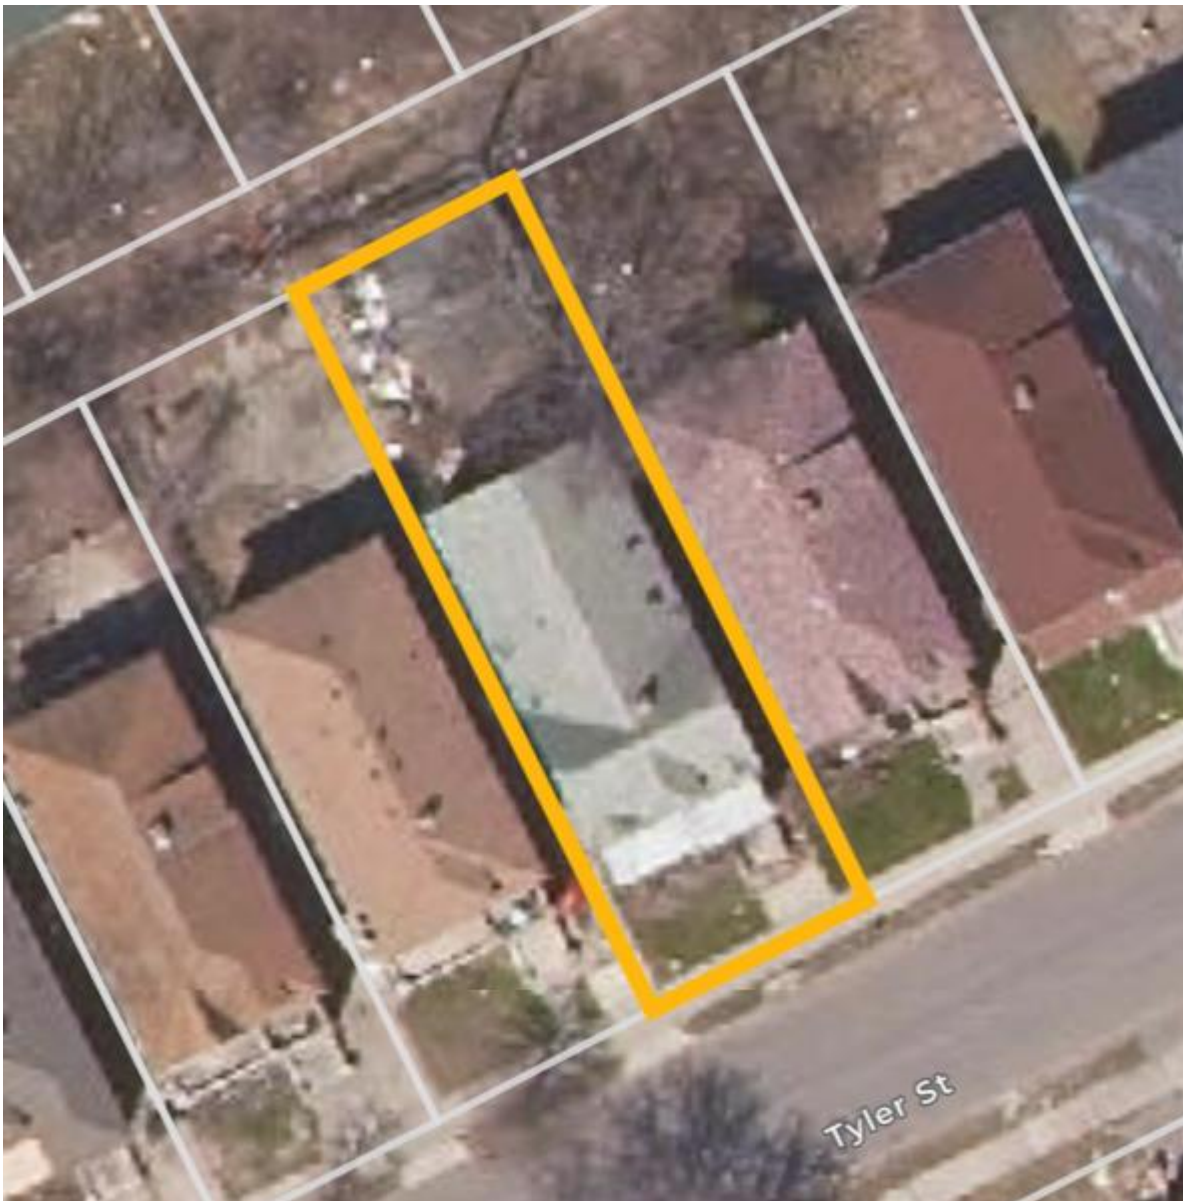
*3768 Tyler highlighted in yellow on Detroit Parcel Viewer. The garage is behind the house and immediately west of the garage is the driveway/concrete pad; it is partially covered in visible debris.*

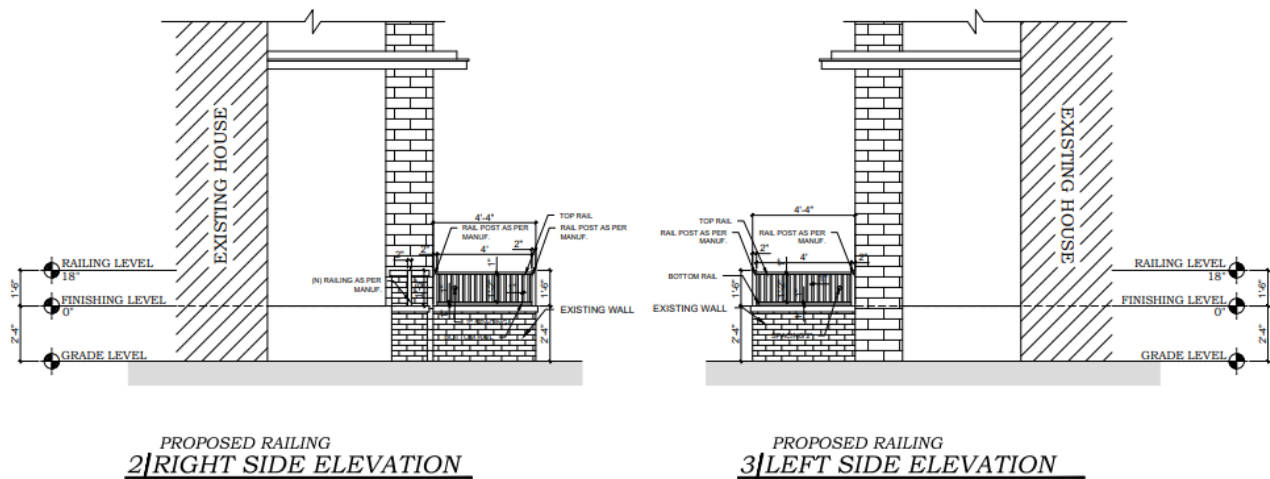
*Drawings from the applicant's materials. The proposed handrails flank the steps.*

- the applicant will submit corrected front porch drawings for staff review and approval that preserve the historic, character-defining features including the curved masonry sections between the brick column and pier and the brick and stone details below the front porch concrete cap, and the applicant will duplicate the missing porch guardrail based on the historic second-floor balcony guardrail.
- the applicant will submit corrected garage elevation drawings for staff review and approval that accurately reflect the proposed design.
- product cut sheets for the garage doors (both overhead and service doors) and any garage window will be submitted to staff for review and approval before the work begins.
