REVISED 12/10/2025**ADDRESS: 1815 SEMINOLE****APPLICATION NO: #HDC 2025-00473-#HDC2025-00705****HISTORIC DISTRICT: INDIAN VILLAGE****APPLICANT: ALISSA JACOBS (4545 ARCHITECTURE)****OWNER: RACHEL AND TROBAUGH NELSON****DATE OF STAFF SITE VISIT: 11/20/2025****DATE OF PROVISIONALLY COMPLETE APPLICATION: 11/17/2025****SCOPE: REPLACE WINDOWS****EXISTING CONDITIONS**

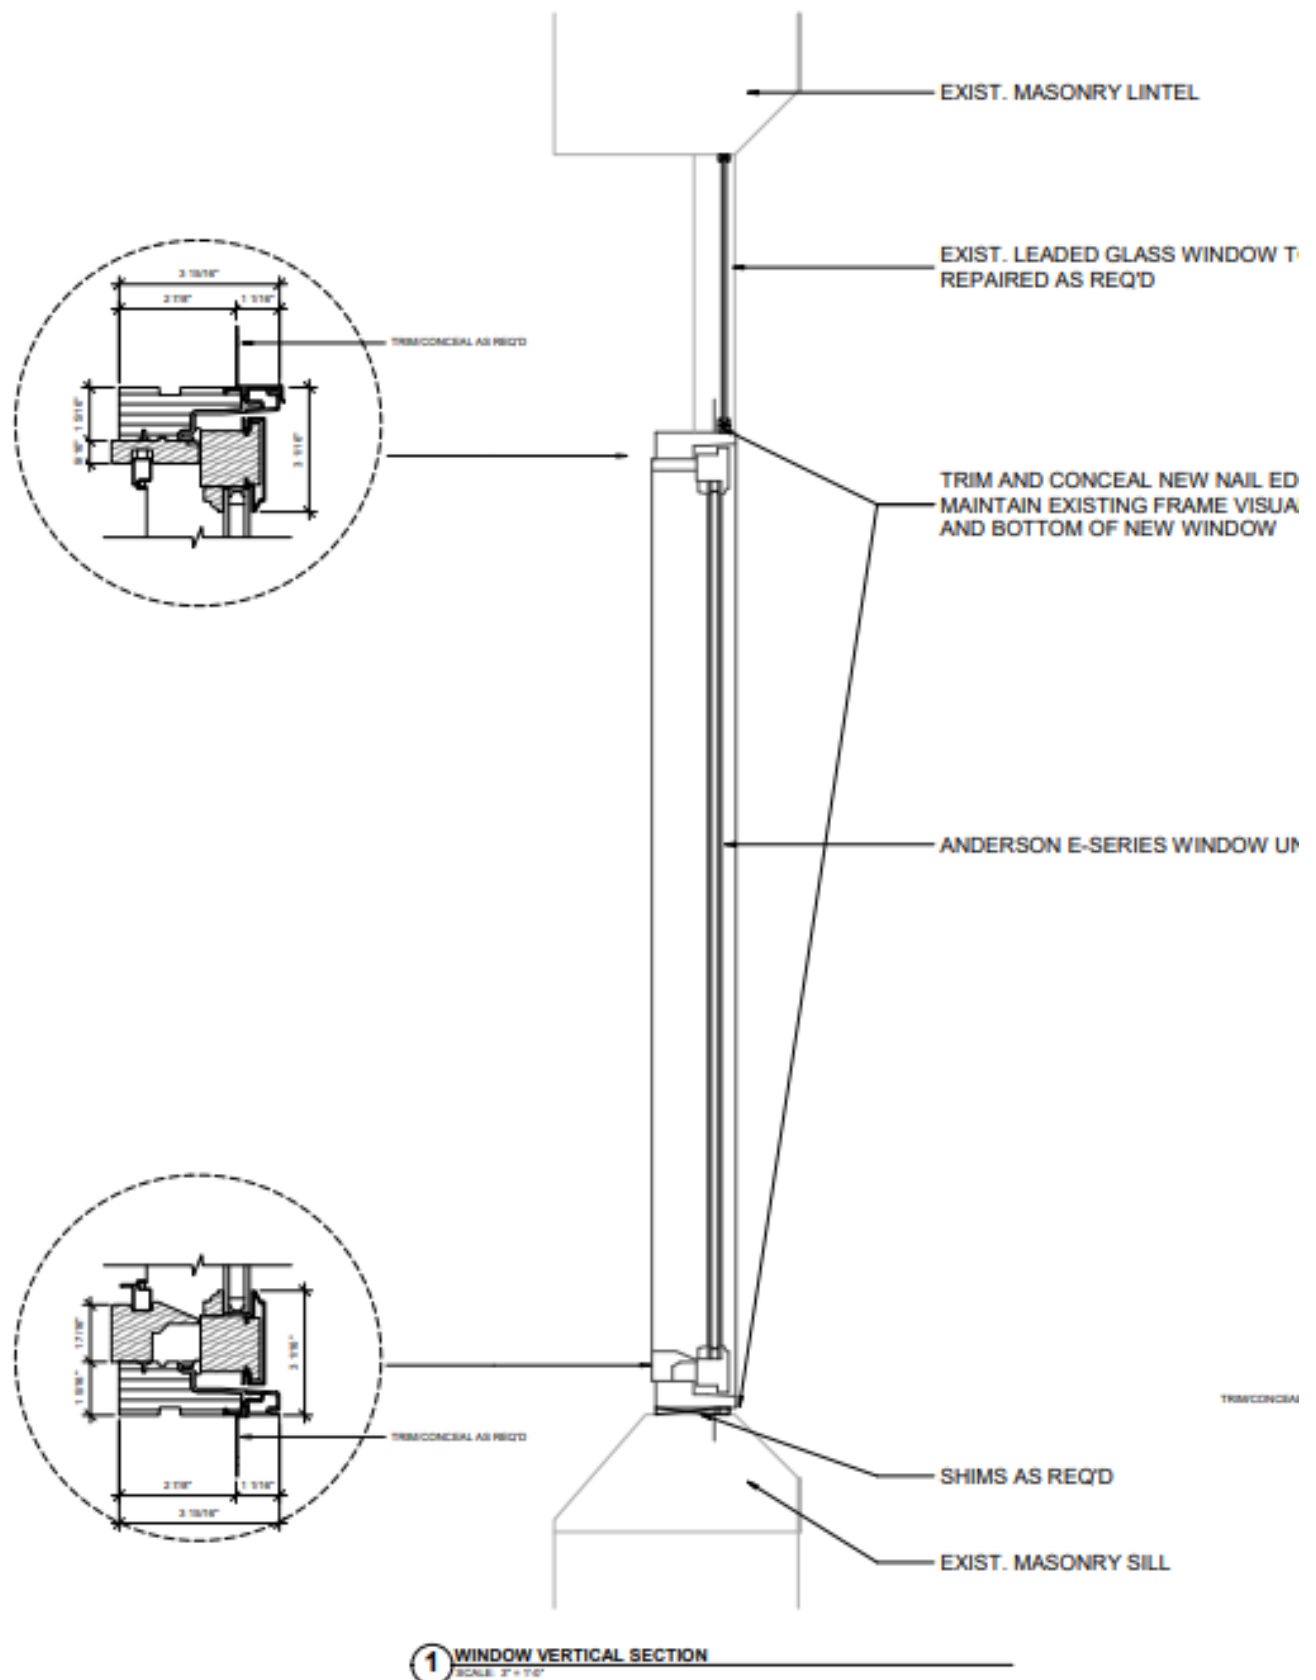
Vertical section showing proposed condition

- See the below photos drawings which the applicant submitted in response to the above request. Staff notes that the submitted drawings do not adequately document the existing conditions/dimensions at the top and bottom portion of the frame to compare to the proposed. However, a review the below horizontal sections (drawings #2 and #3) revealed that the side portions of the frame for the proposed new windows will be significantly wider than the existing. Also, each of the proposed new casement windows will include a single, undivided panel of glass while the existing casement units are divided to include four panes of glass each. Staff therefore concludes the proposed casement windows are not an adequate match to the existing historic steel units

NAIL EDGE TO
BE VISUAL AT TOP
OF WINDOW
