**STAFF REPORT: DECEMBER 10, 2025 MEETING**

**APPLICATION NUMBER: HDC2025-00616**

**ADDRESS: 4325 LESLIE**

**SCOPE: REPLACE HISTORIC WINDOWS, ALTER DWELLING**

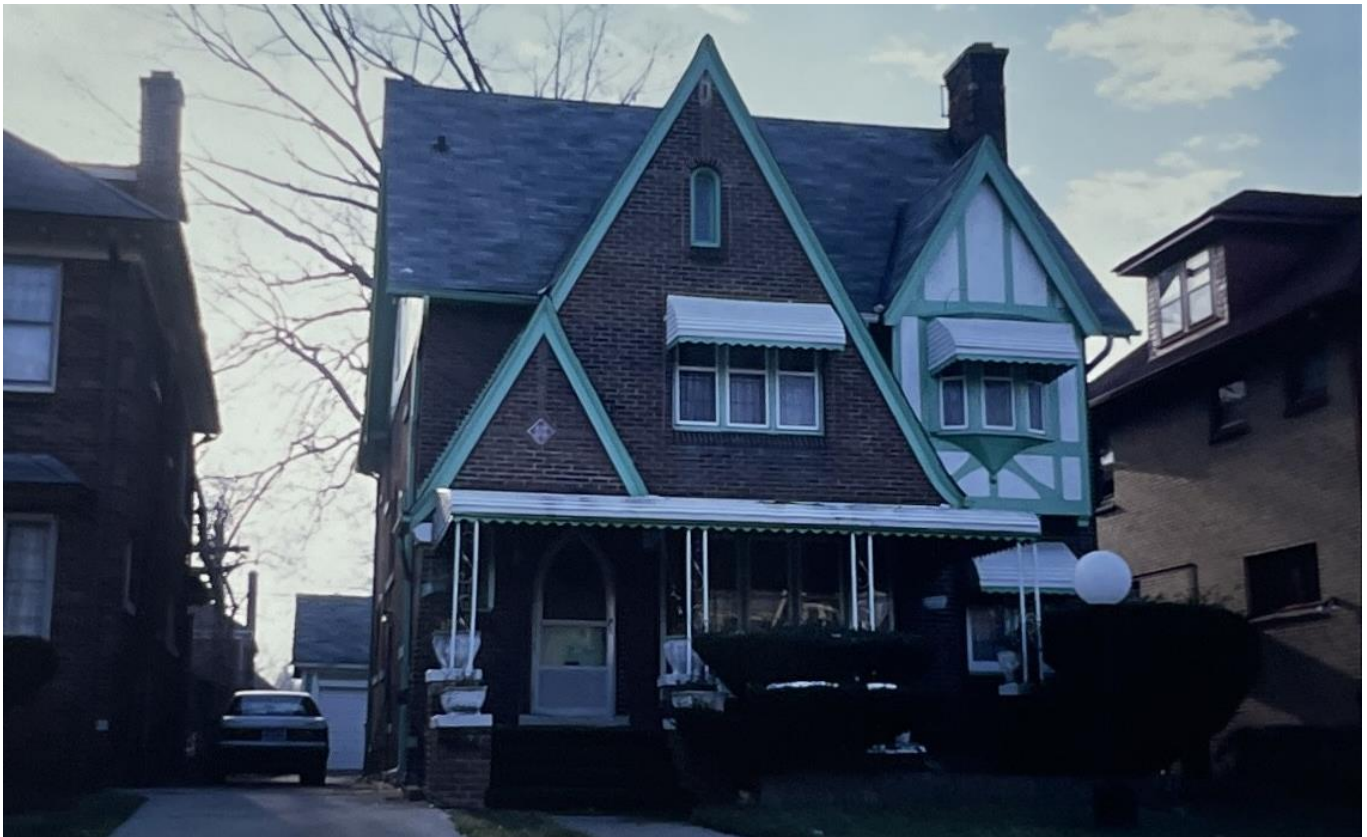
*4325 Leslie, designation photo, HDAB, 1999.*

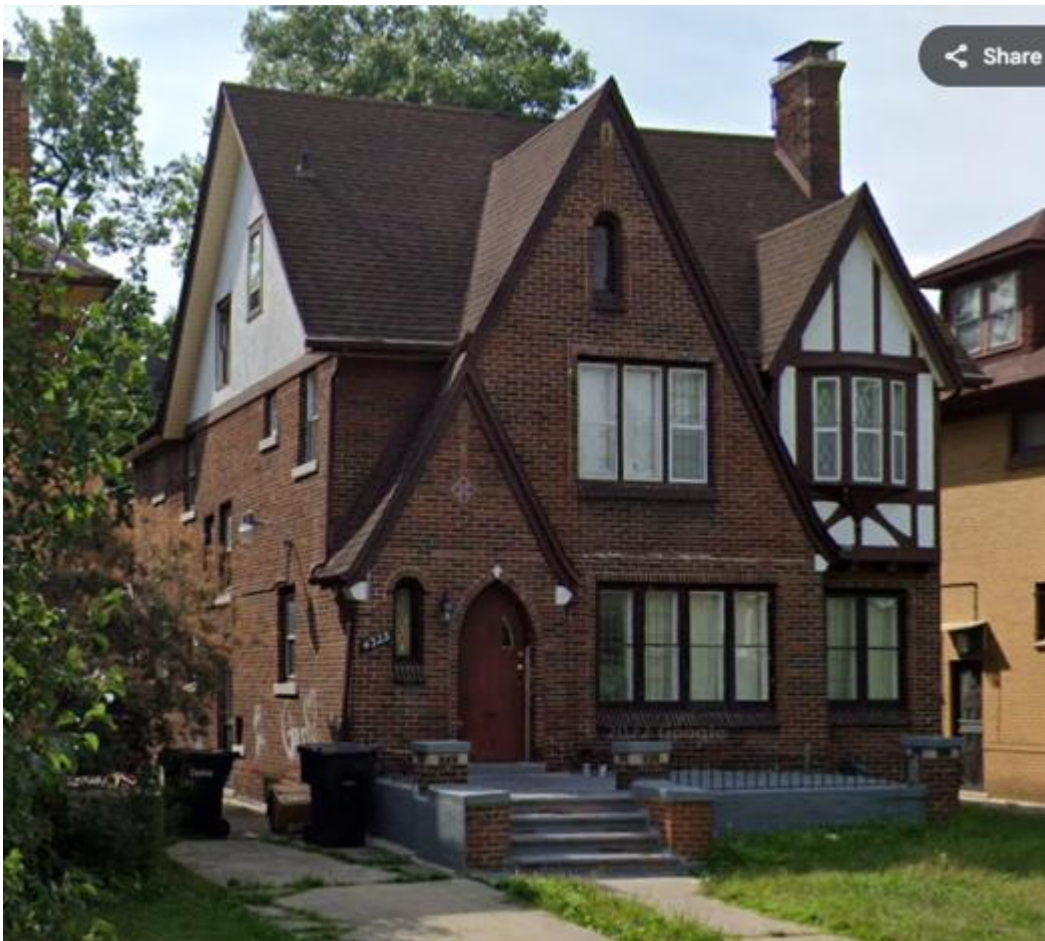
*Google Street View August 2018. Here, the narrow arched gable window remains, the bay window on the house's upper right has the lattice-patterned leaded glass, the window on the furthest right of the triple windows at the second floor has its leaded glass, the two windows to the left of the group of four on the first floor have their leaded glass, the left window of the first-floor pair to the house's right retains its leaded glass, the arched window next to the front door remains in place with its leaded glass, the pointed-arch doorway and original door are still in place, and the three brick piers, low guardrail, and the capped wing walls are still in place at the front porch. (The side rail on the front porch is still in place as well.)*

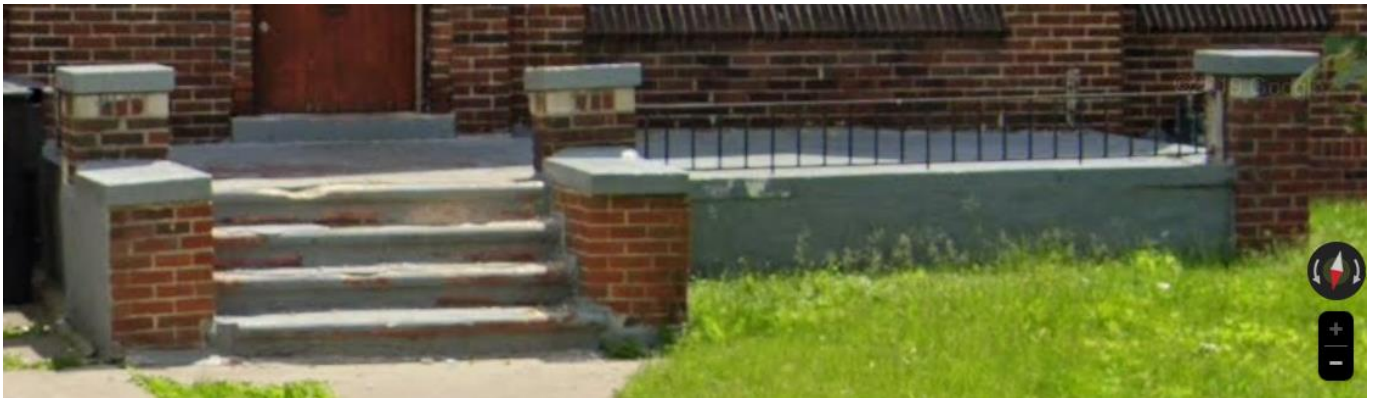
- The **historic front porch** was historically brick that matched the house, with a concrete cap. It had three brick piers that supported a low, black, iron guardrail. Two wing walls flanked the concrete steps, and concrete caps topped the piers and wing walls. Google Street View shows that between 2013 and 2018, either the brick below the cap was replaced with another material, like concrete block, or it was simply parged. Either way, the base of the porch was painted by 2018. The character-defining brick piers, brick wing walls, and low black iron guardrail all were still in place in April 2022. By March/April 2024, the front porch had been rebuilt with concrete and its brick piers, brick wing walls, and low black iron guardrail have all been removed. Those historic, character-defining features should have been retained and repaired, and if that was not possible, those details should have been replicated as per Standard 6. Instead, the new front porch lacks all of those details that the historic porch had.

*Historic porch with three historic brick piers, two historic wing walls, and the low, black iron guardrail that are all character-defining features of this house.*

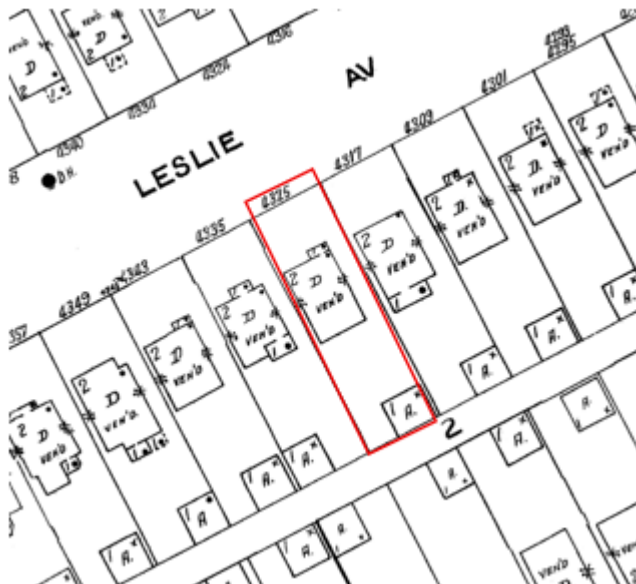
- The house also had (and retains) **a rear sunroom**. The sunroom was not present as of 2002, per the 2002 Sanborn map, below. However, it has been present at the rear wall since at least 2005. The exterior cladding materials and windows remained consistent through April 2022. It likely had aluminum storm windows and aluminum siding. Its windows and siding were both replaced with vinyl by March/April 2024 without Commission approval.

*Sanborn Fire insurance map, August 2002. 4325 Leslie is outlined in red. Note that the current rear sunroom addition is not present at this time.*
