**STAFF REPORT:** 02/11/2026 MEETING  
**APPLICATION NUMBERS:** HDC2025-00741  
**VIOLATION NUMBER:** 1077  
**ADDRESS:** 2008 LONGFELLOW  
**HISTORIC DISTRICT:** BOSTON-EDISON  
**APPLICANT/PROPERTY OWNER:** NEVAR JAHWARY, STONEBRIDGE DEVELOPMENT  
**DATE OF PROVISIONALLY COMPLETE APPLICATION:** 01/20/2026  
**DATE OF STAFF SITE VISIT:** 01/28/2026

**SCOPE:** DEMOLISH AND REBUILD FRONT AND REAR PORCHES; DEMOLISH AND REBUILD UPPER WALLS AND WINDOW OPENINGS AT SIDE PORCH; REMOVE WOOD WINDOWS AND INSTALL NEW WOOD WINDOWS; INSTALL FOUR (4) ENTRY DOORS AT REAR; INSTALL ASPHALT SHINGLE ROOF AND REBUILD EAVES (WORK STARTED WITHOUT APPROVAL)

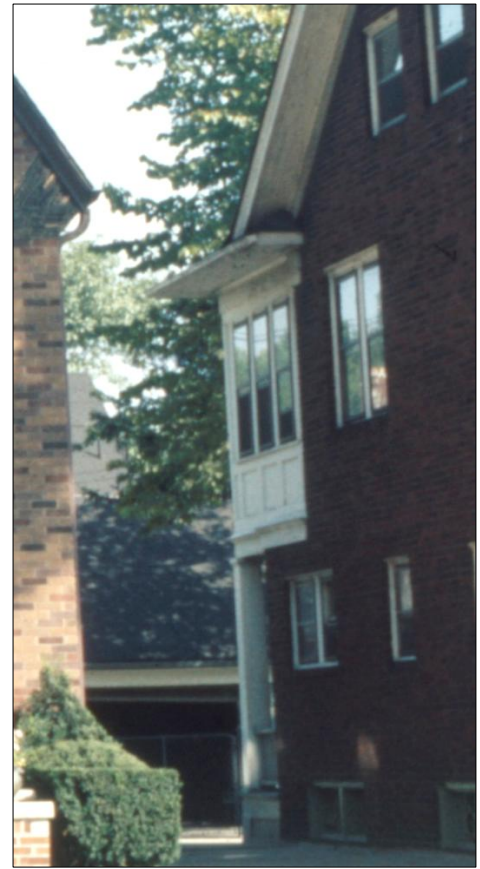
*Left: Outer side wall of the one-story porch on the east side of the house. A metal shed/awning roof is visible and covered an open porch at the rear of the house. This awning has since been removed.*

*Right: Outer side wall of the rear porch and supporting wood column and railing at the first floor.*

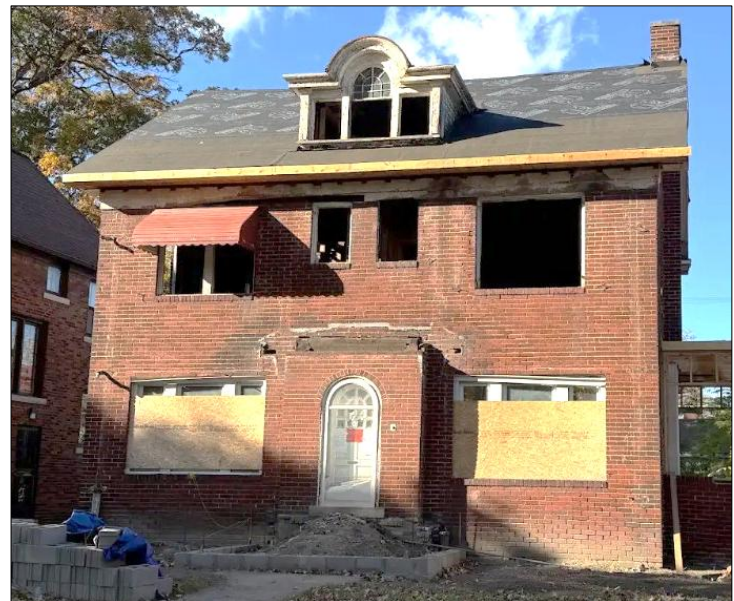
- The drawings appear to show a close replication of the half-round raised and covered porch, except for the columns. The original columns were tapered, with a smooth finish and Tuscan capitals and bases. Staff doesn't know if the columns remain on site, nor their dimensions. The drawings do not replicate the original columns. Also, there is a square shaped concrete block foundation outline at grade, which doesn't match the previous curved porch, stairs and splayed side walls.

- Chimney is not depicted on elevation drawing.

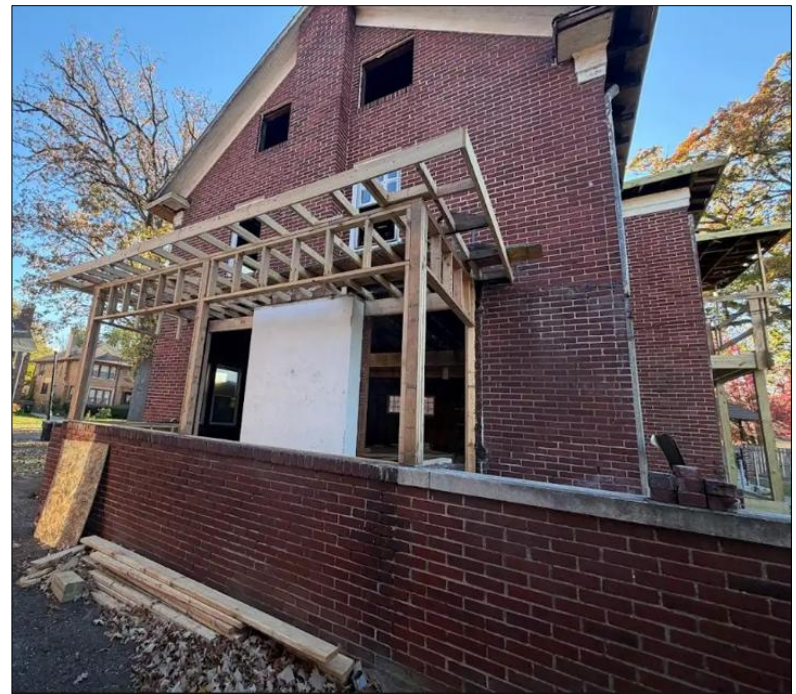
Applicant photo.

- Chimney height has increased (existing 6-7 brick courses vs. 11-12 courses on drawing).
- The window openings at the third floor are almost square in shape. 2019 photos show double-casements with a central mullion; each casement had a division of glass offering a 4-over-1 glass pattern. Single 4-over-4 double-hung windows are proposed for these openings. Staff also notes the dimensions of the openings on the elevation are rectangular, offering concern that the openings will be reduced in size/proportion.

- Window openings at second floor had double-hung sash with 6-over-1 pattern. Single, 4-over-4 double-hung windows are proposed here.
- Mullied casement windows were in place on all three walls of the enclosed porch and trim was detailed to offer the effect of columns and an entablature. Applicant proposes mullied, narrow 4-over-4 windows and no detailing is shown at the fascia and corners, although the drawings state “matching previous existing trim and wall design”.

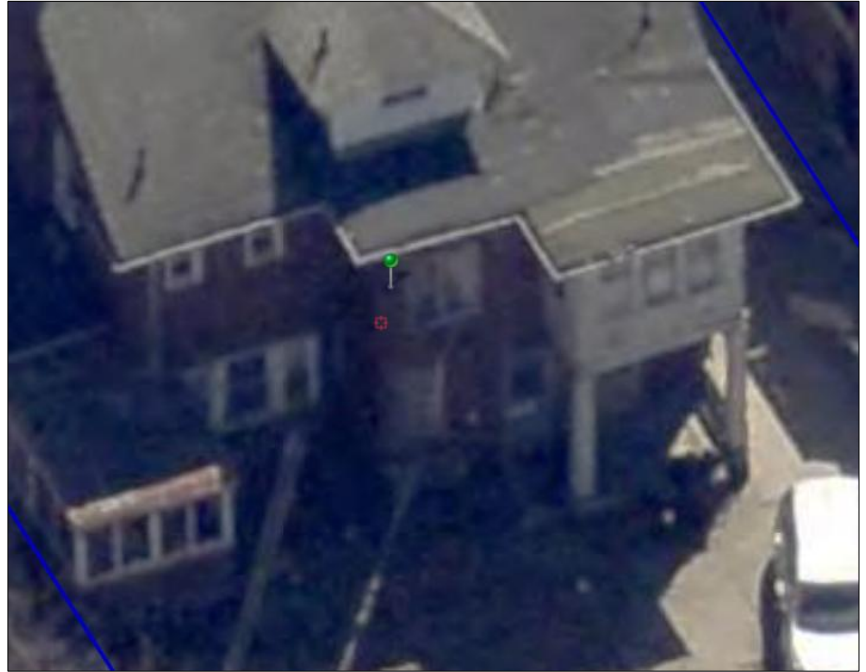
*EagleView image, April 2022.*

- The massing and roof pitch for the central dormer is drawn differently than existing conditions.
- Detailing for the second floor enclosed porch walls appears to be similar to photo documentation of the area prior to its demolition. However, staff doesn't believe the proposed 4-over-4 double-hung is compatible for this property and location based on evidence of windows having a 4, 6, or 8-over-1 pattern.

- Operation and dimensions of some window openings on the rear wall drawing (i.e., the central bay openings at the first and second floor) differ from existing conditions. The windows that remain in place at the first and second floor are replacement units similar to those at the front wall and west wall and were not approved by the HDC. Therefore, new double-hung windows at this location must match the original windows in design, operation and material (which likely would have matched the documented three-part window on the front wall that had two narrow 4-over-1 windows and a central 8-over-1 window).

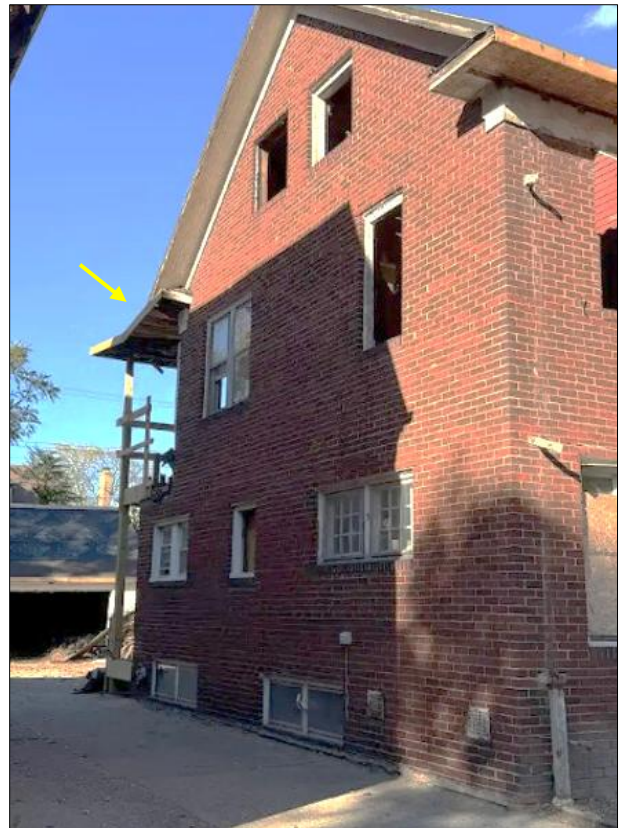
- At the second floor, the single window opening appears to be narrower on the drawing than existing conditions and 4-over-4 double-hung windows proposed for all three windows; counter to the historic (and still existing in a few window openings) pattern.

- At the first floor, the window openings at center and near the rear had replacement windows in them recently (and the mullied opening may still have them), which staff confirmed were not approved by the HDC. Original windows are intact at the forward positioned windows, with 9 or 12-light casement (or fixed) windows.

- From the angled view of the applicant’s photo, it looks as though a butterfly roof has been constructed at the second floor rear porch, rather than a generally flat/low pitched roof.

- The elevation drawing shows the mullied openings at the first floor will be enlarged and window operation will change from casement to double-hung.
- Basement window openings are not drawn on the elevation, so staff assumes the openings will be removed. Details are needed on how this will be done (such as retain inset openings with new brick and retention of sills?).
