STAFF REPORT: 02/11/2026 REGULAR MEETING

APPLICATION NUMBER: HDC2025-00740

ADDRESS: 19597 SHREWSBURY

SCOPE: REPLACE WOOD WINDOWS WITH ALUMINUM-CLAD WOOD WINDOWS

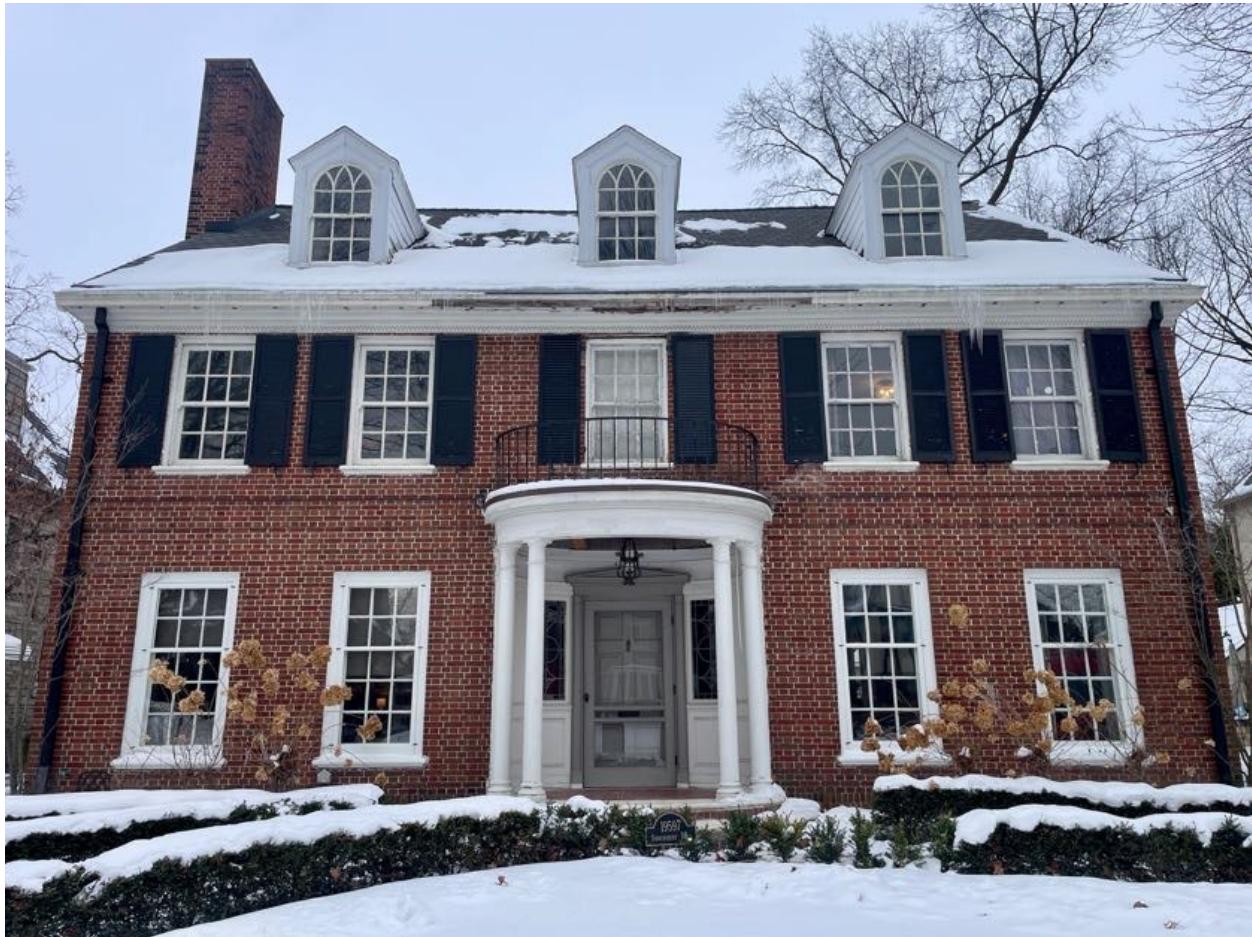
Staff photo, 02/05/2026

Built in 1927 by Robert McFate, this brick residence is located in the Sherwood Forest Historic District. The Georgian Revival house exhibits a symmetrical façade clad in red brick, featuring multi-pane wood windows, and organized around a central entrance and evenly spaced fenestration. It is capped by a side-gabled roof punctuated by three dormer windows with wood lap siding. The central entrance is emphasized by a rounded, columned portico with an upper-level “Juliet” balcony.

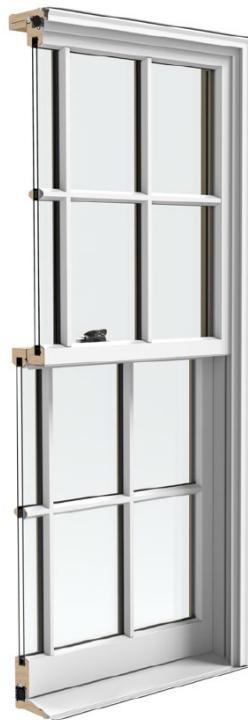
PROPOSED

*Pella Reserve
Traditional Double-Hung
in white, 7/8" SDL*
