SR-2 – ADVISORY STAFF REPORT (03-06-2026)

ADDRESS: 2105 BURNS

HISTORIC DISTRICT: INDIAN VILLAGE

SCOPE: DEMOLISH CONTEMPORARY SUN ROOM, CONSTRUCT REAR DECK,
REHABILITATE HOUSE AND GARAGE

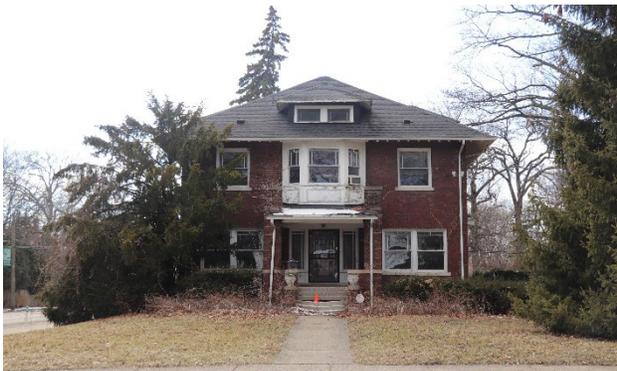
Photo taken by Staff 02/25/26

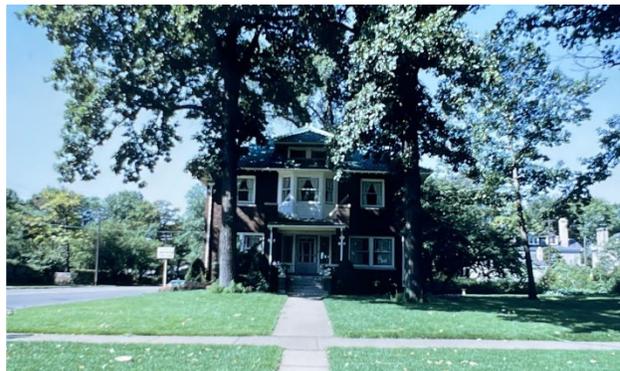
Designation Photo 1971, HDAB
