**SR-2 – STAFF ADVISORY REPORT (Rev. 03-11-2026)**

**ADDRESS:** 2050 ATKINSON

**APPLICATION NUMBER:** HDC2026-00729

**SCOPE:** REMOVE WOOD WINDOWS, INSTALL VINYL WINDOWS, REHABILITATE HOUSE  
(WORK STARTED WITHOUT APPROVAL)

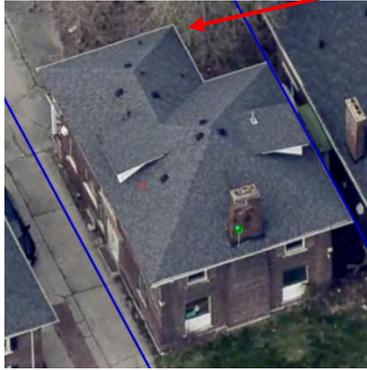
- The west-side wall of the two-story rear wing is a continuous extension of the house’s masonry wall; the other walls were covered with stucco. The hip roof with deeply overhanging closed eaves matches the body of the house. The applicant’s photo shows the wing retained its historic character, materials and primary features of an early 20<sup>th</sup> century rear wing with service porches.

*Aerial view of 2050 Atkinson; ConnectExplorer, 2024.*
