SR-2 – STAFF ADVISORY REPORT (03-06-2026)

ADDRESS: 2008 LONGFELLOW

APPLICATION NUMBER: HDC2025-00741

SCOPE: REHABILITATE HOUSE AND GARAGE (WORK STARTED WITHOUT APPROVAL)

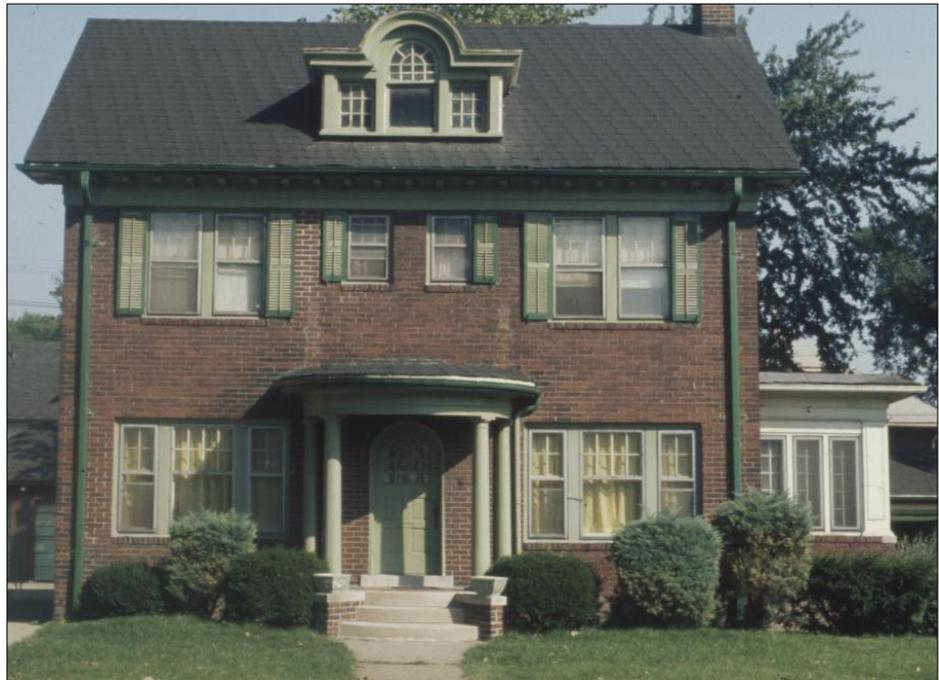
Permit Cards, BSEED.

2008	Longfellow	878
63212	4-28-38	LOT NO. DATE
USE	dwllg	O. K.
CONG.	brick	
REMARKS	reroof house and garage	O. K.
	with asphalt roof.

2008	Longfellow	878
47008	5-12-70	LOT NO. DATE
USE	Frame Pvt. Garage	
Cons.	600.	
Remarks	Repair fire damage only	O. K.

- It is interesting to note that the original roof for the house and garage were replaced within 20 years of the structures being built.
- The 1970 fire damage at the garage may have led to the installation of one large 2-car door opening, as this larger opening was in place at the time of district designation.

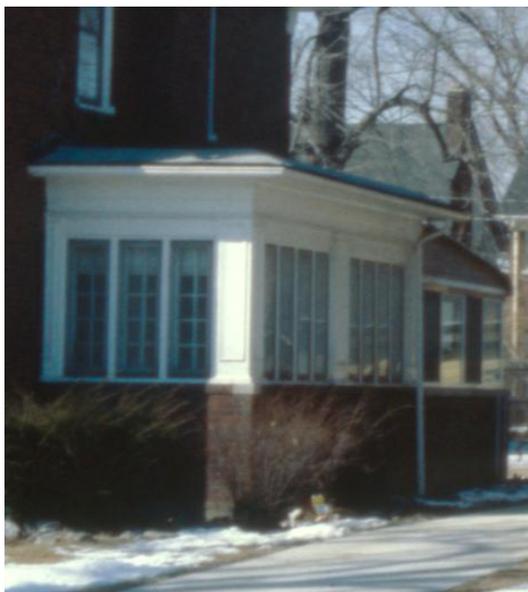
Historic photos of the houses adjacent to 2008 Longfellow offer angled views of the side walls of 2008 Longfellow.

Left: Outer wall of the one-story porch on the east side of the house. A metal shed/awning roof and wall enclosure is visible extending from the historic/original enclosed porch. The non-historic enclosure was recently removed. 1980, HDAB

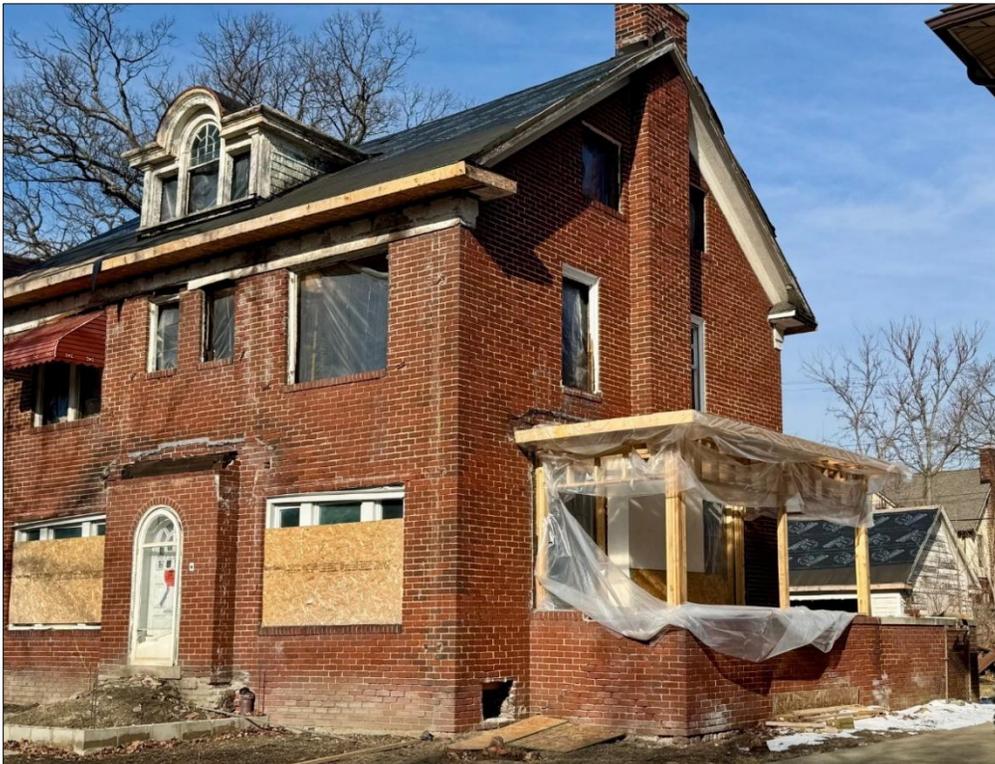
Staff photo, looking northwest, of the east-side wall and porch. The property's garage can be partially seen in the background. 02/26/2026.

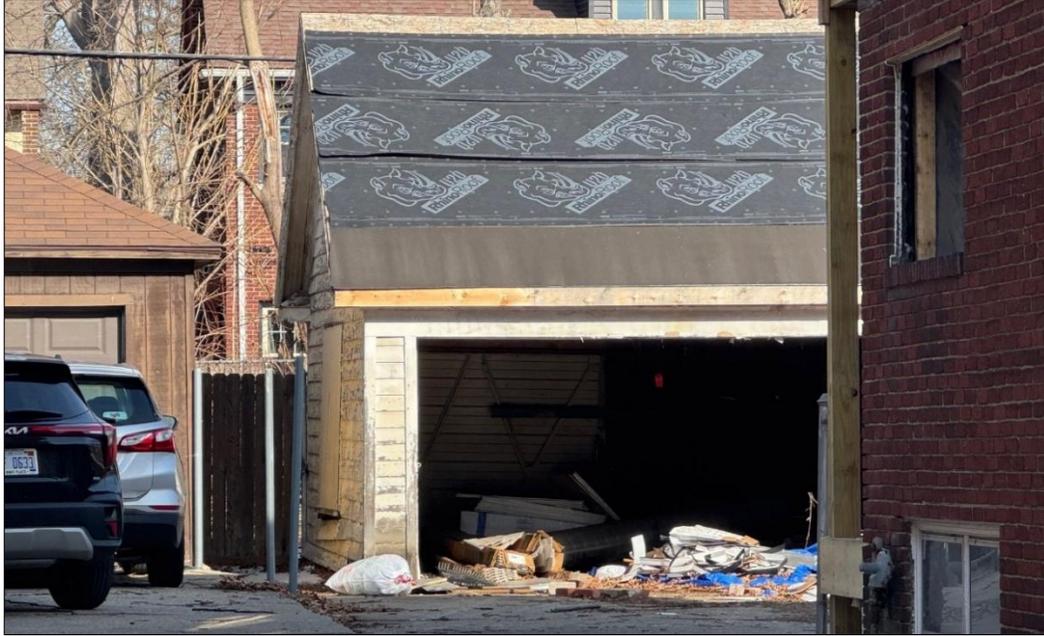
View of garage from Longfellow. Staff photo, 02/26/2026.

- According to the building permit, the garage was erected the same year as the house (1919). The deep boxed eaves, mullied window openings, side gable roof and eave returns, match details found on the house and are distinctive character-defining features. Staff identifies the garage as a contributing structure within the historic district.
- Similar to the house’s dormers, a proposed work item specifies “new clapboard style wood siding system” to be installed on the garage walls. The historic wood siding and trim are intact and in repairable condition. Even if some replacement boards are necessary, wood siding is readily available and can be purchased/milled to match the exposure and profile of the historic wood siding.
- Staff offers similar concerns on the illustration of the eave returns, as discussed on the house’s gable walls.

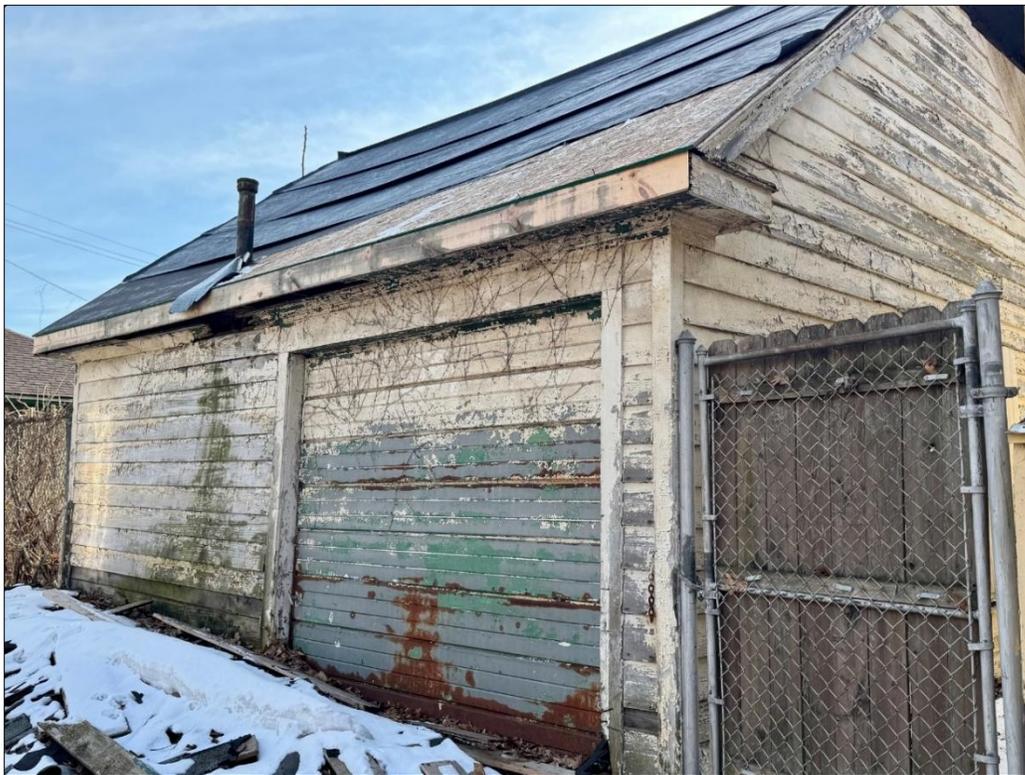
View of rear side of garage from alley. Staff photo, 02/26/2026.

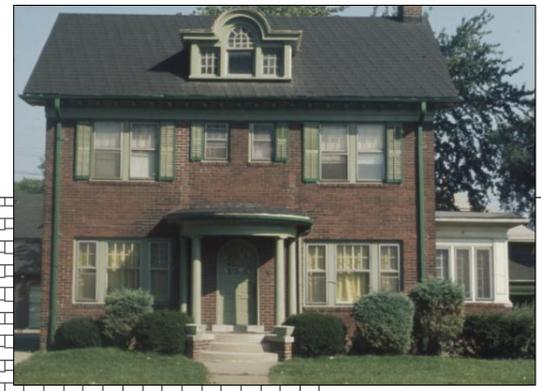
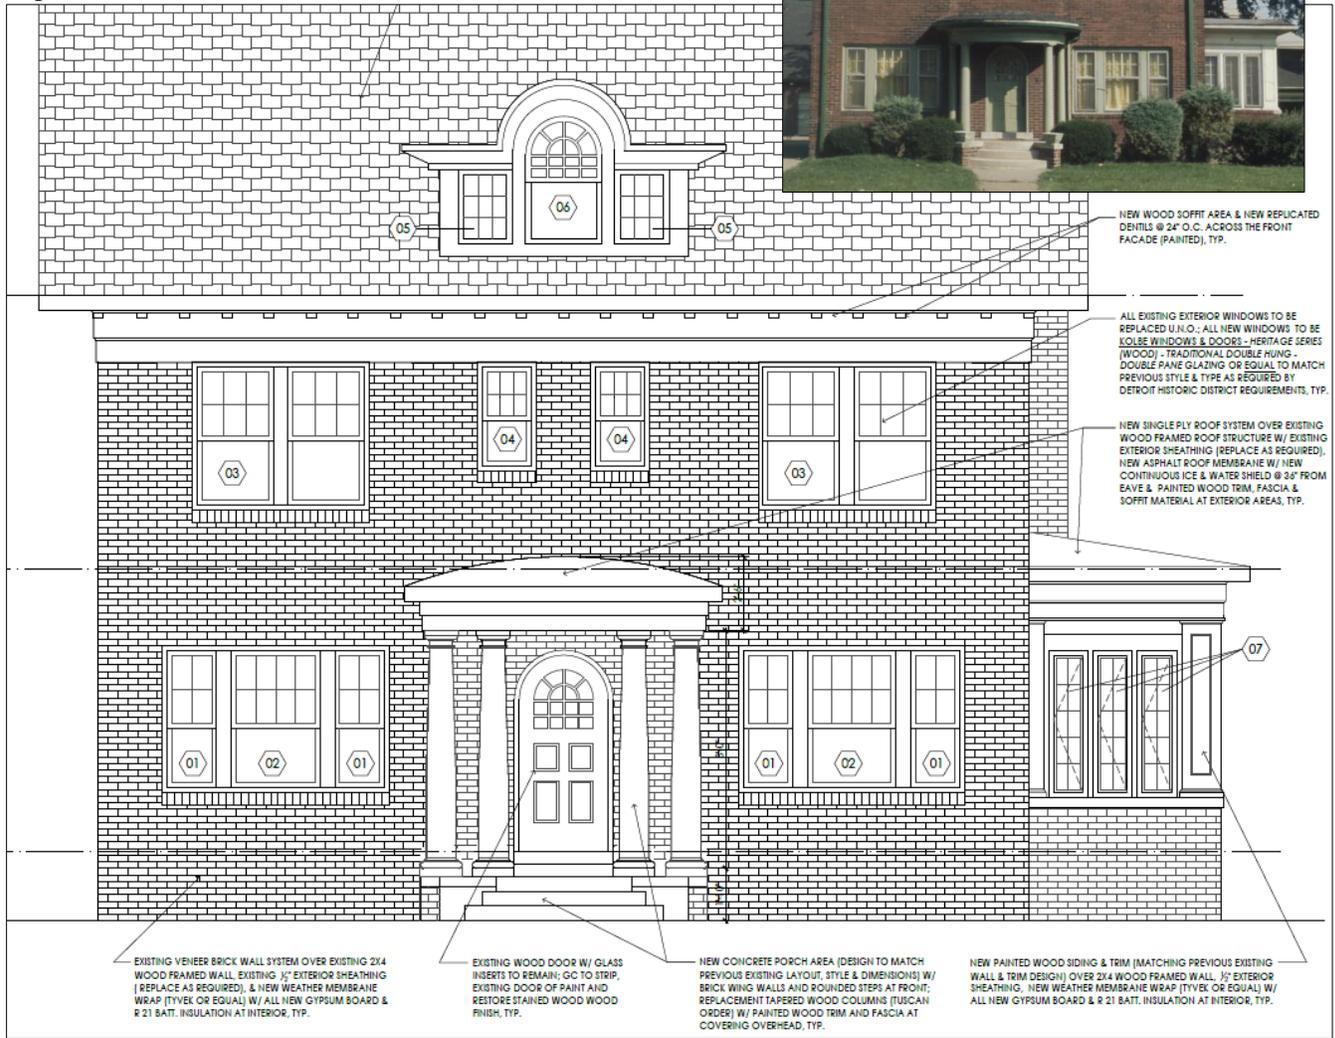
Applicant drawings. Above: Façade/front wall. Below: Porch plan.

- The proposed portico matches the historic portico, and wood Tuscan columns have been selected. The floor plan shows structural mullions will be built within the multiple window openings. The new wood windows will match the old windows in operation and material. Staff has requested and will continue to require dimensions of existing windows (frames and setback in opening) to compare against the selected windows to confirm an appropriate match. Additional information needed includes the window line within the Heritage Series, glass and screen specifications, muntin profile and dimension, placement/setback in window opening and confirmation that brickmold will be retained.

6. Should staff determine the selected replacement window is not a match to the historic windows, another window line will be submitted for review.
7. Existing wood brickmold will remain and be repaired. Where brickmold is missing, new wood brickmould, matching the dimension and profile will be installed and painted.

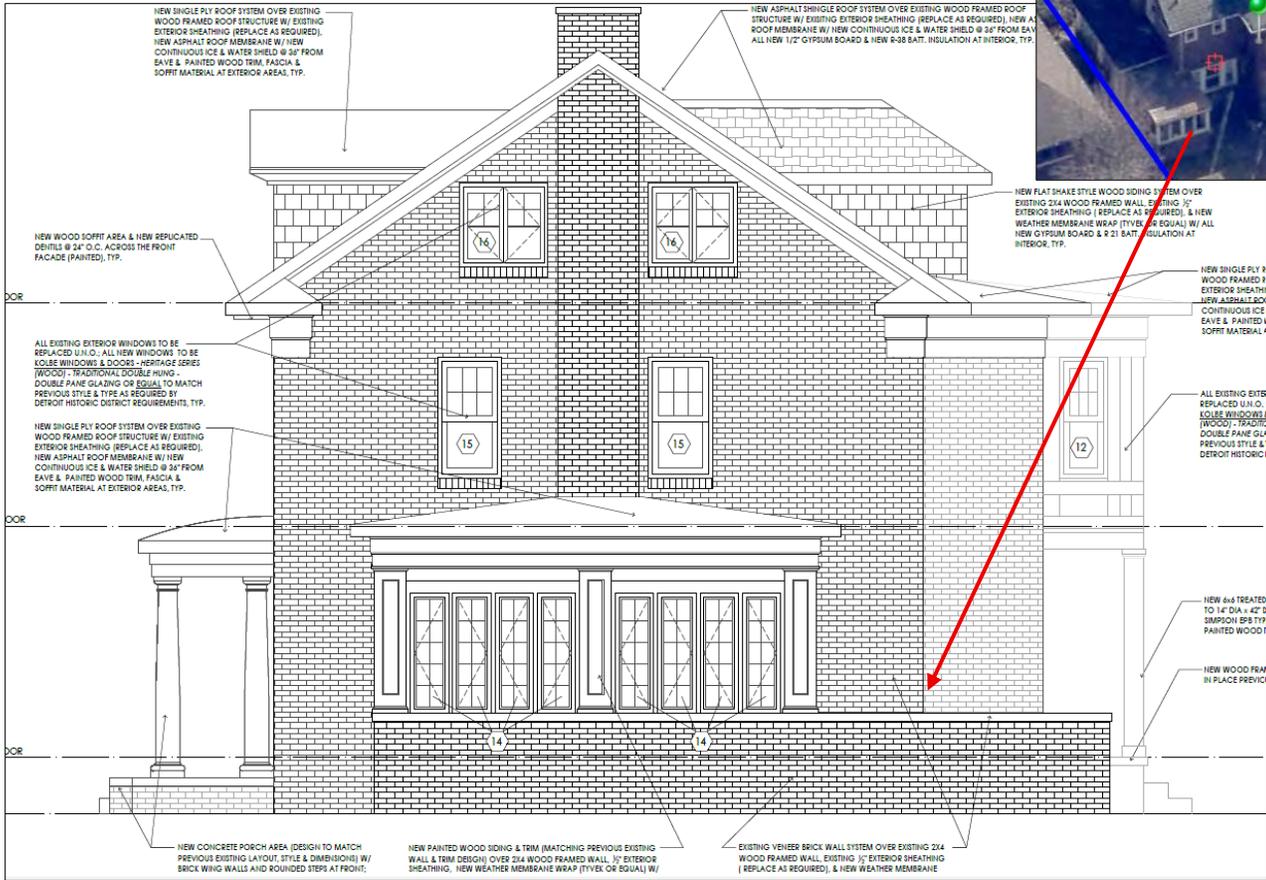
Applicant drawing of east side wall. Above: Aerial view of house from the rear yard. ConnectExplorer, May 2024.

- The historic roof/wall/window structure that enclosed more than half of the side porch was demolished by the applicant, rather than repaired. The applicant proposes to rebuild this feature to match the historic design. Additional demolition work recently completed at the property was the removal of a non-historic enclosure of the remaining porch. Ghost lines remain of the now removed roof structure, showing how it wrapped around the side and rear walls, covering a portion of the downspout. This removal (unlike that of the historic porch enclosure) is an improvement to the property, restoring a historic and character-defining element.
