687, 689, 691 W. ALEXANDRINE

REHABILITATION AND NEW CONSTRUCTION

THE CITY OF DETROIT HISTORIC
DISTRICT COMMISSION HEARING

DECEMBER 9, 2020

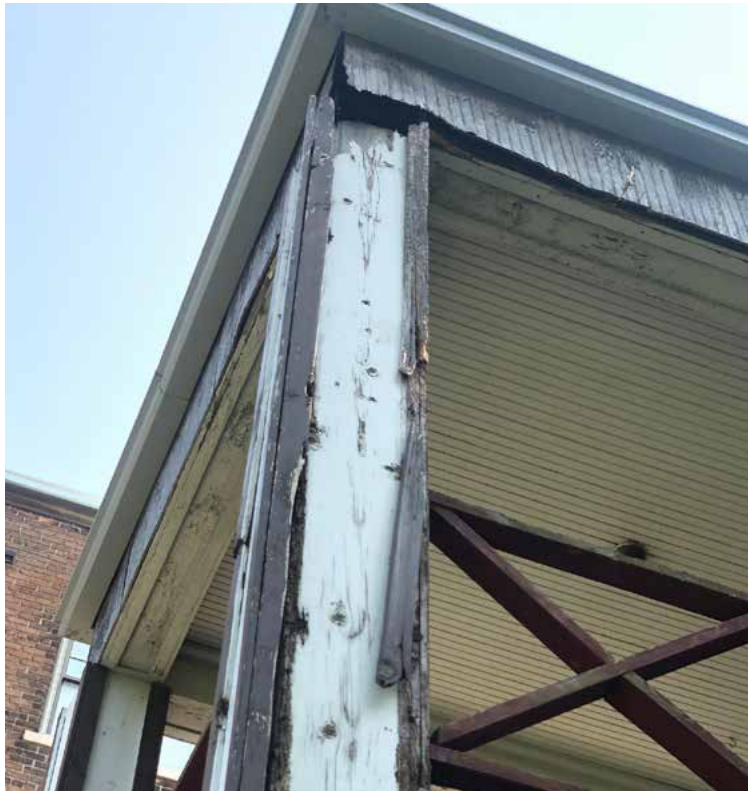
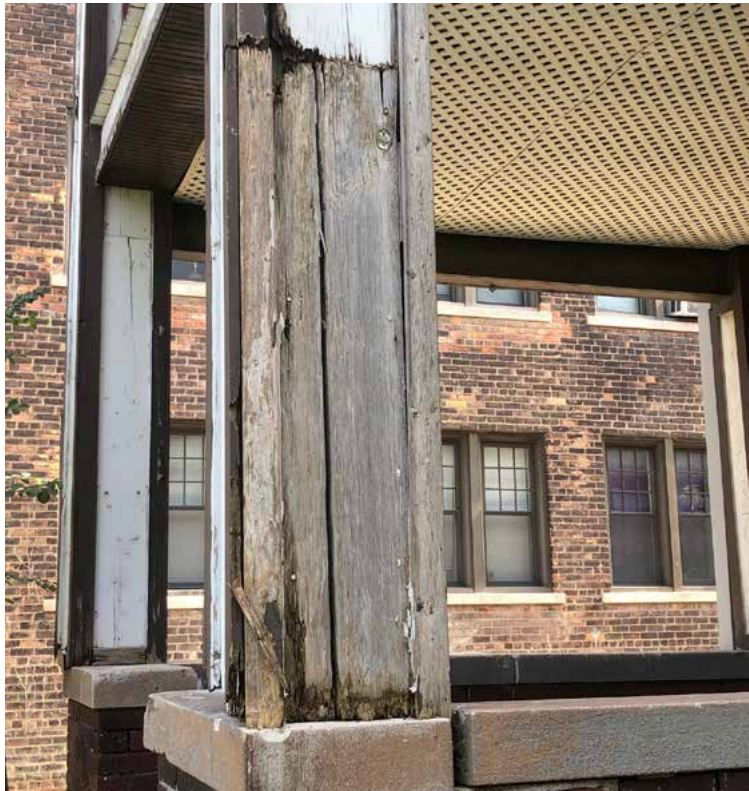
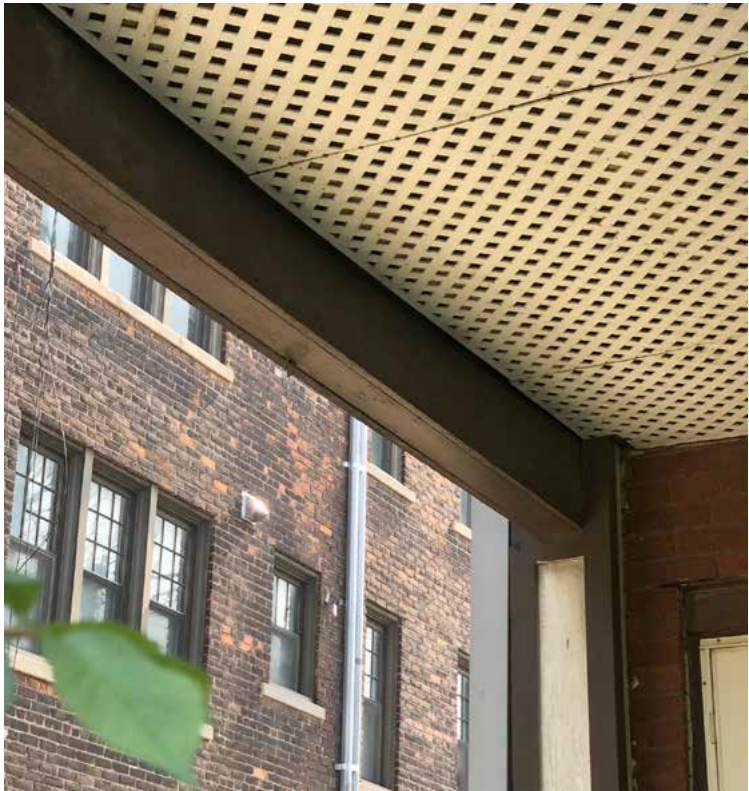
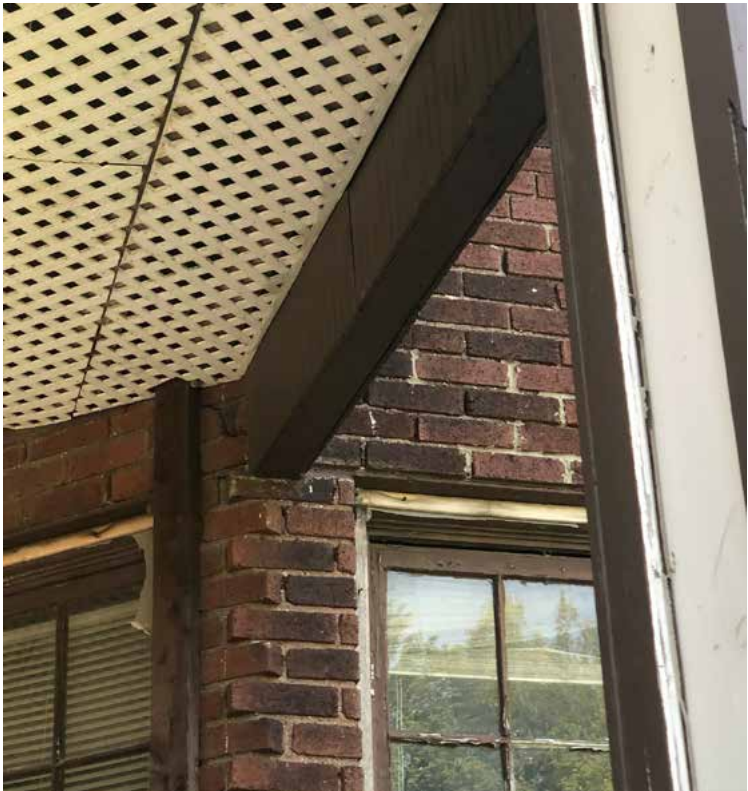
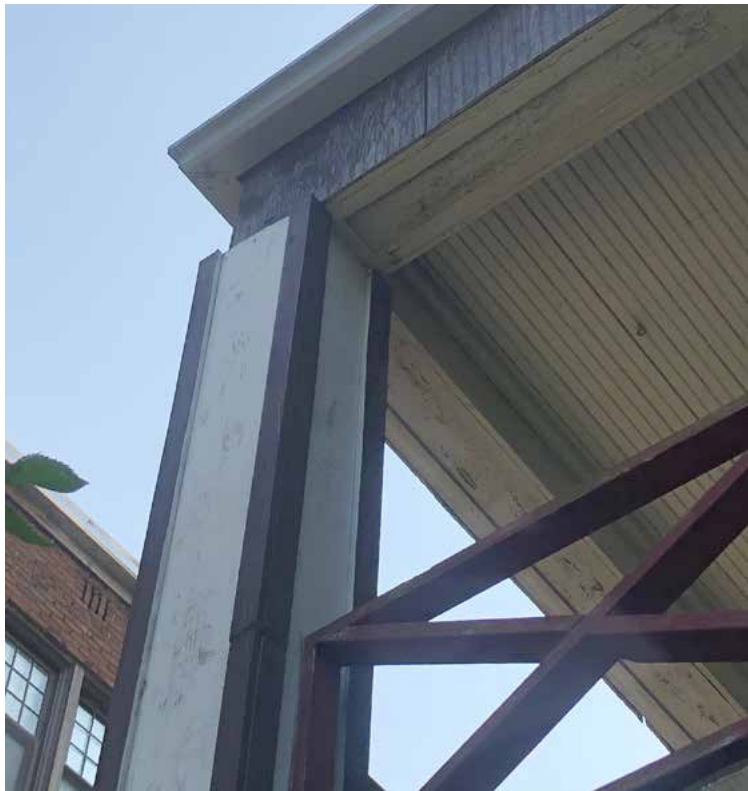
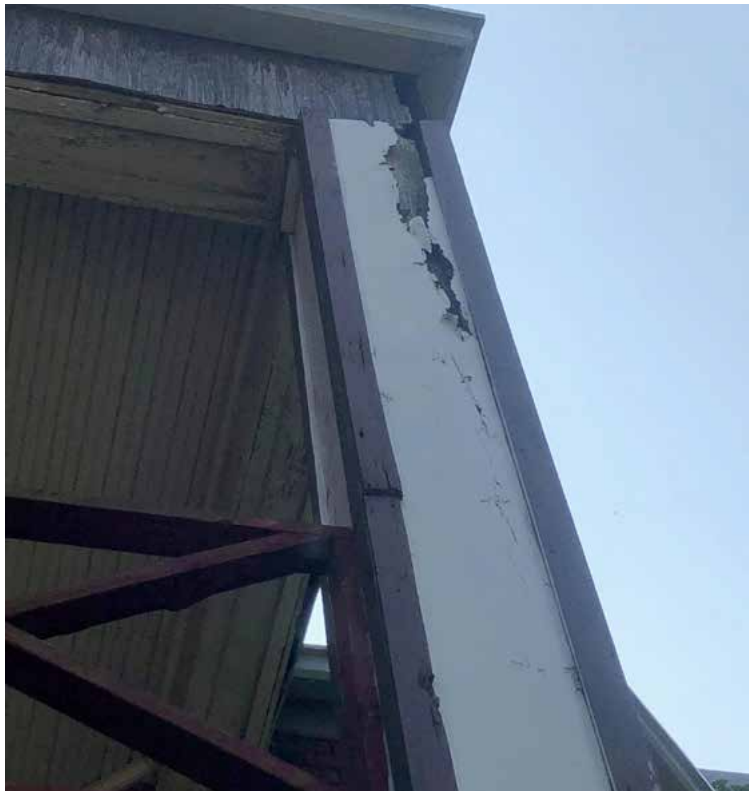
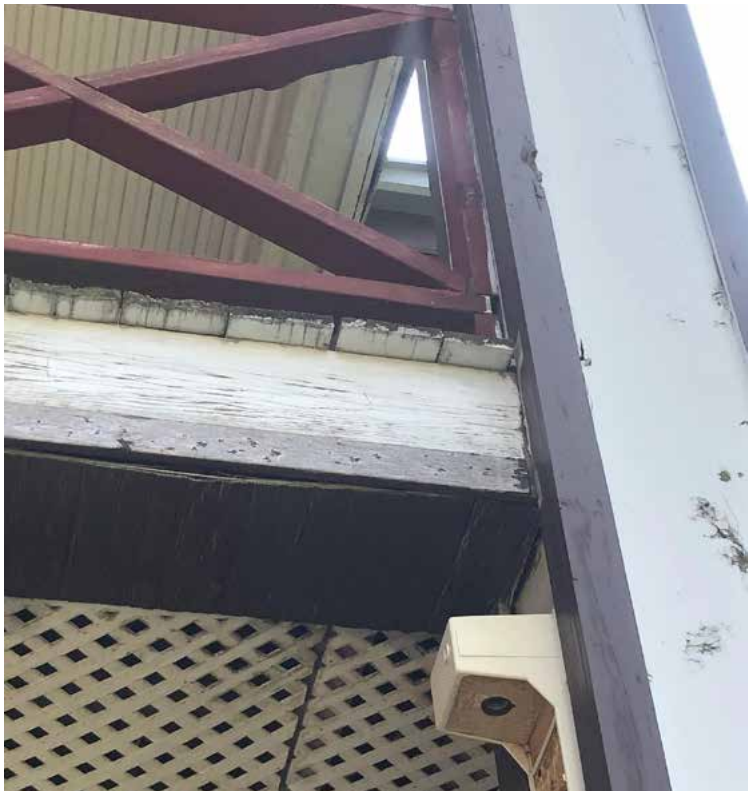
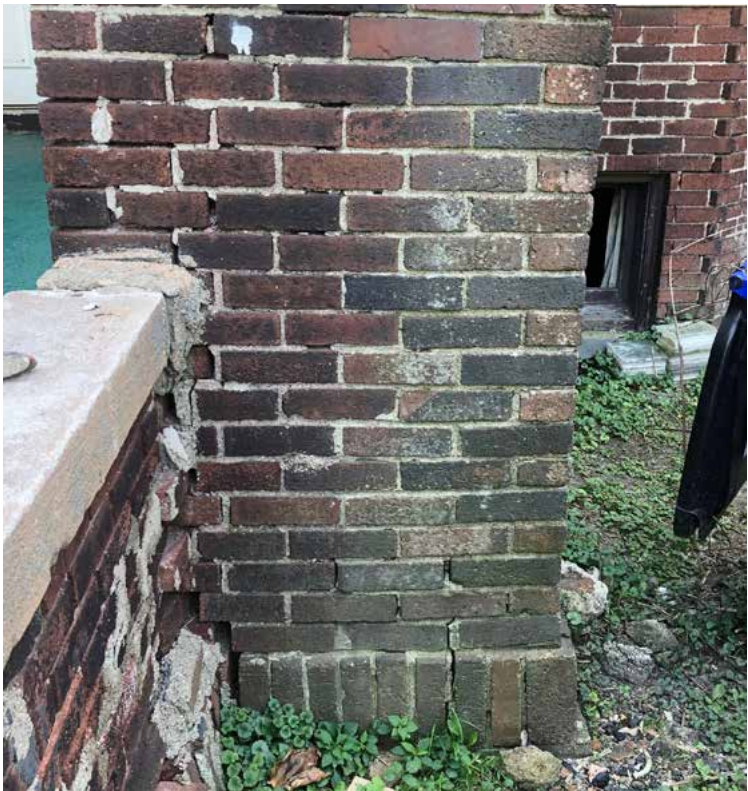
PHOTOS OF CONDITIONS OF PORCH AND STOOP

- COLUMNS HAVE SEVERE ROT AND DECAY
- TRIM BOARDS ARE MISSING

- BOARDS HAVE BEEN REPLACED
- COLUMNS HAVE SEVERE ROT AND DECAY
- SUPPORT FOR THE UPPER PORCH IS IN RISK

- BOARDS HAVE BEEN REPLACED
- TRIM BOARDS ARE MISSING
- COLUMNS HAVE SEVERE ROT AND DECAY COULD COLLAPSE CAUSING THE UPPER PORCH TO COLLAPSE.
- FACIA BOARDS HAVE ROTTED AWAY

- UPPER PORCH HAS SOME ROT IN THE SUPPORTS
- THE FLOORING HAS A LOT OF ROT (WOULD NOT RECOMMEND ANYONE VENTURE ONTO THE PORCH)
- THE CEILING OF THE LOWER DECK HAS BEEN REPLACED WITH VINYL LATTICE.

- UPPER PORCH CEILING IS BEADBOARD AND IN GOOD CONDITION. WOULD SUGGEST REMOVING AND REINSTALL ON REBUILT PORCH.

IT IS OUR OPINION THAT THE WOOD ON THE PORCH HAS SEVER ROT AND IS IN DISARRAY. THE UPPER PORCH IS DANGEROUS AND SHOULD NOT BE USE. THE WOOD ON THE PORCH NEEDS TO BE DISASSEMBLED WHILE SUPPORTING THE ROOF. THE PORCH TO BE REBUILT USING NEW WOOD AND SUPPORT COLUMNS. TRIM BOARD TO BE INSTALLED TO MATCH EXISTING AND PAINTED TO REDUCE THE CHANCE OF ROT.

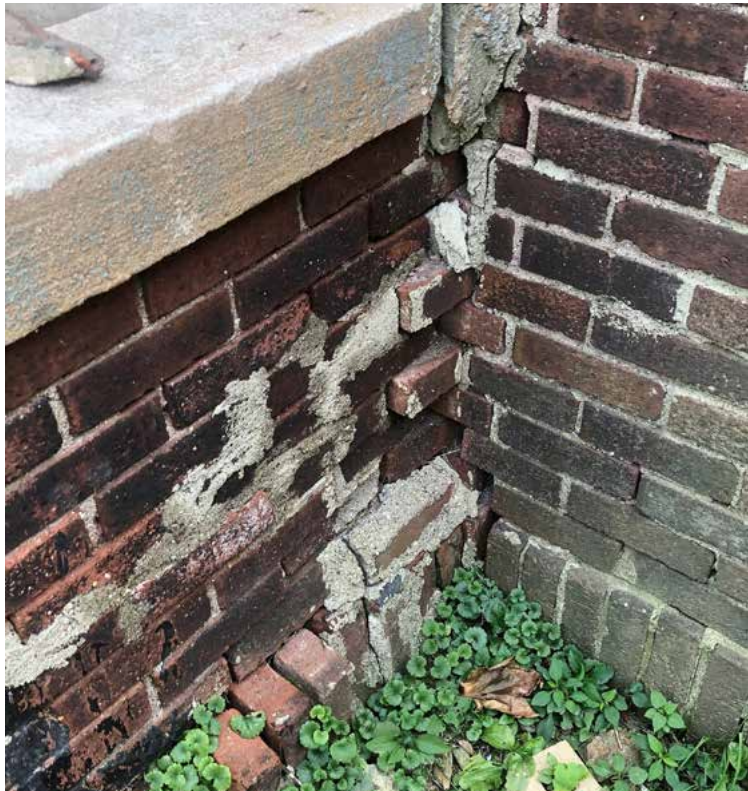
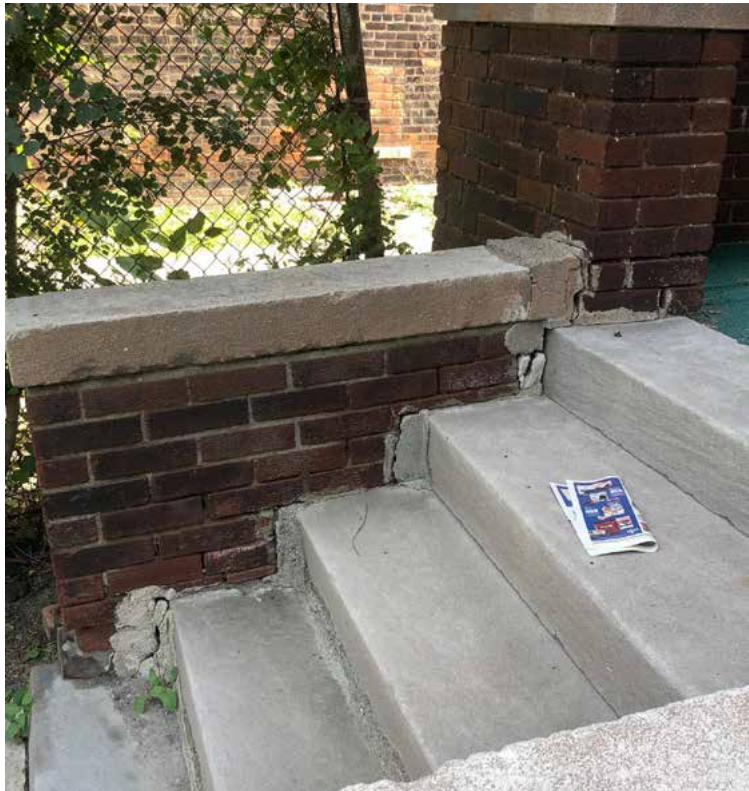
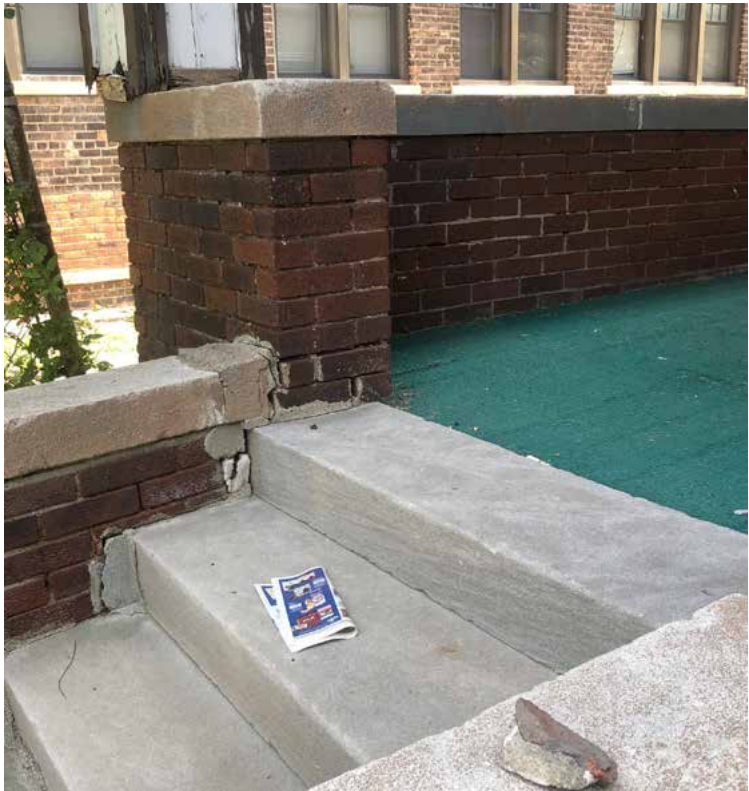
PHOTOS OF CONDITIONS OF PORCH AND STOOP

- STEPS HAVE PULLED AWAY FROM THE PORCH AND WAS IMPROPERLY FILLED
- WALL HAS PULLED AWAY FROM THE PORCH AND WAS IMPROPERLY FILLED
- STEPS ARE NOT TO CODE OR ADA COMPLIANCE.
- THERE ARE GAPS BETWEEN THE STEPS AND HAVE BEEN FILLED

- WALL IS 2 LAYERS OF BRICK
- WALL HAS PULLED AWAY FROM THE PORCH AND WAS IMPROPERLY FILLED
- WALL IS FALLING APART. WILL NEED TO BE TORN DOWN AND REBUILT TO MAKE RIGHT.
- THE GAPS IN THE BRICK HAVE BEEN IMPROPERLY FILLED AND LOOK BAD.
- BRICKS ARE LOOSE AND FALLING OUT

- WALL IS 4 LAYERS OF BRICKS
- THE GAPS IN THE BRICK HAVE BEEN IMPROPERLY FILLED AND LOOK BAD.
- BRICKS ARE LOOSE AND FALLING OUT
- WALL IS FALLING APART. WILL NEED TO BE TORN DOWN AND REBUILT TO MAKE RIGHT.
- SOME BRICKS HAVE BEEN REPLACED WITH NON-MATCHING BRICKS.

- WALL IS 4 LAYERS OF BRICKS
- THERE ARE SEVERE CRACKS IN THE PORCH WALL
- THE GAPS IN THE BRICK HAVE BEEN IMPROPERLY FILLED AND LOOK BAD.
- BRICKS ARE LOOSE AND FALLING OUT
- WALL IS FALLING APART AND IS UNSAFE. WILL NEED TO BE TORN DOWN AND REBUILT TO BE CORRECTED.
- SOME BRICKS HAVE BEEN REPLACED WITH NON-MATCHING BRICKS.
- WALL SUPPORTS THE UPPER PORCH AND IS LEANING OUT AND COULD COLLAPSE CAUSING THE UPPER PORCH TO COLLAPSE ALSO.
- BRICKS ON CORNER ARE MISSING.
- THE REST OF THE PORCH WALLS IS IN GOOD CONDITION. BRICKS NEED TO BE CLEANED.

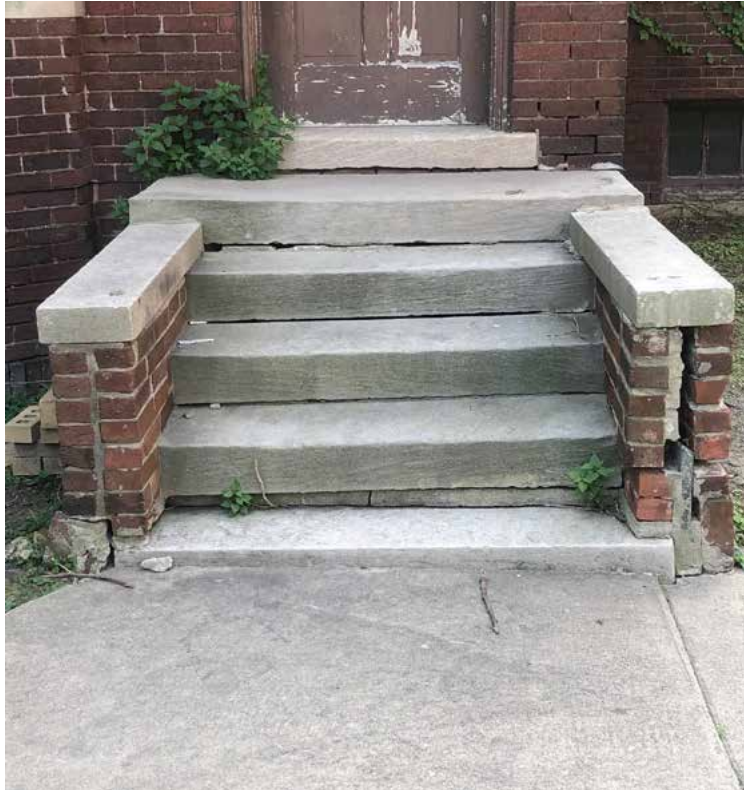
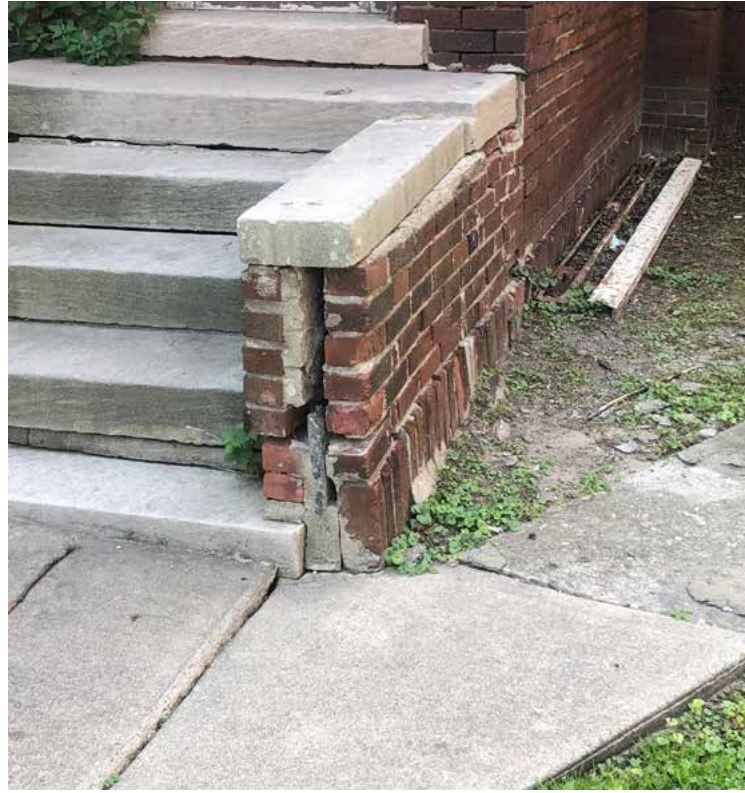
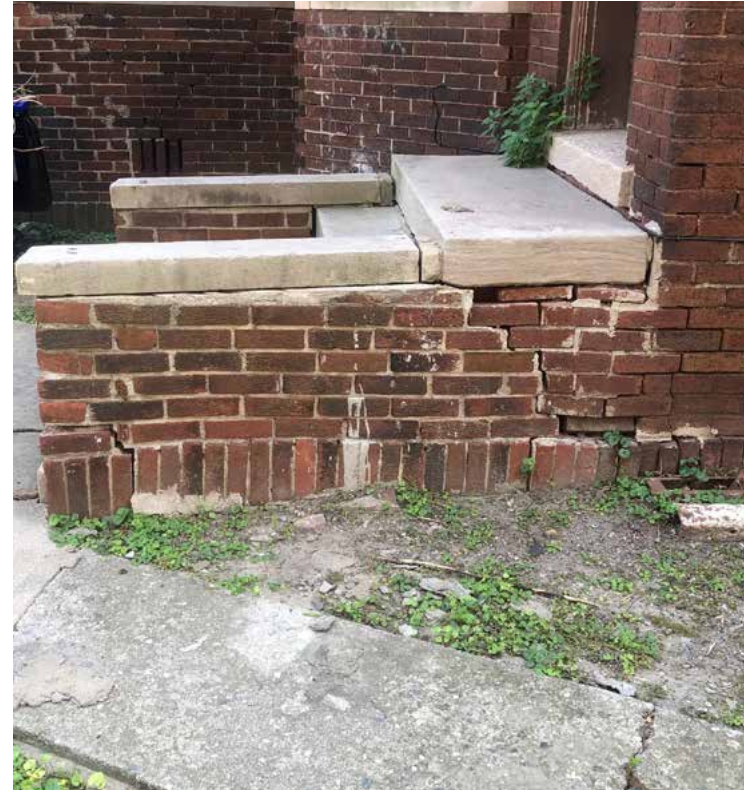
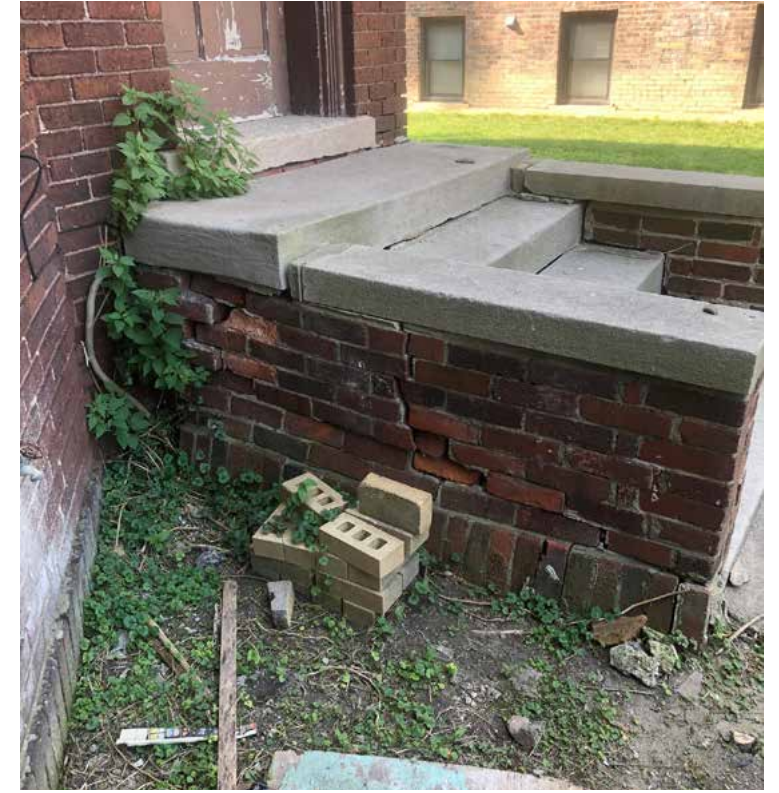
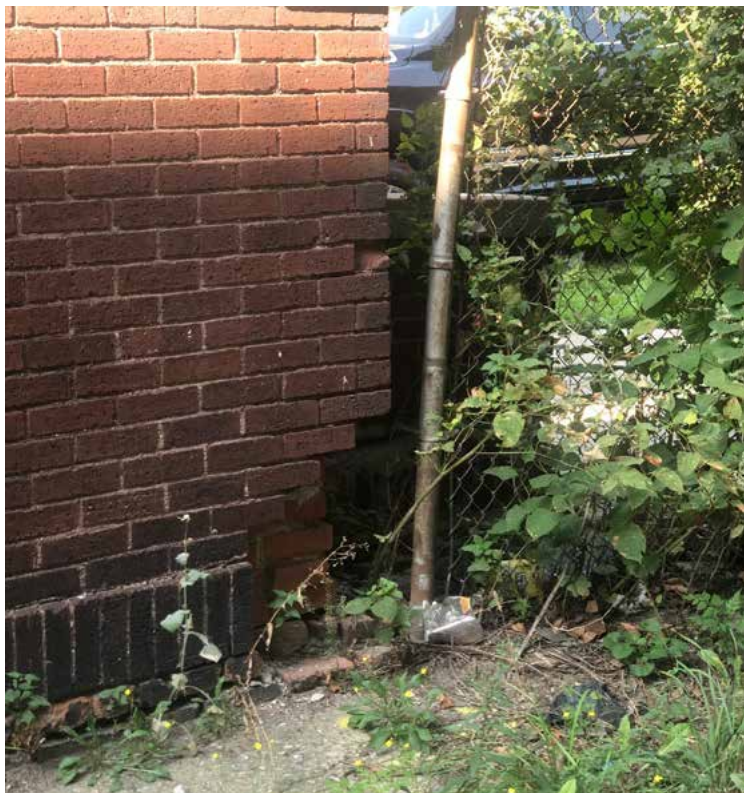
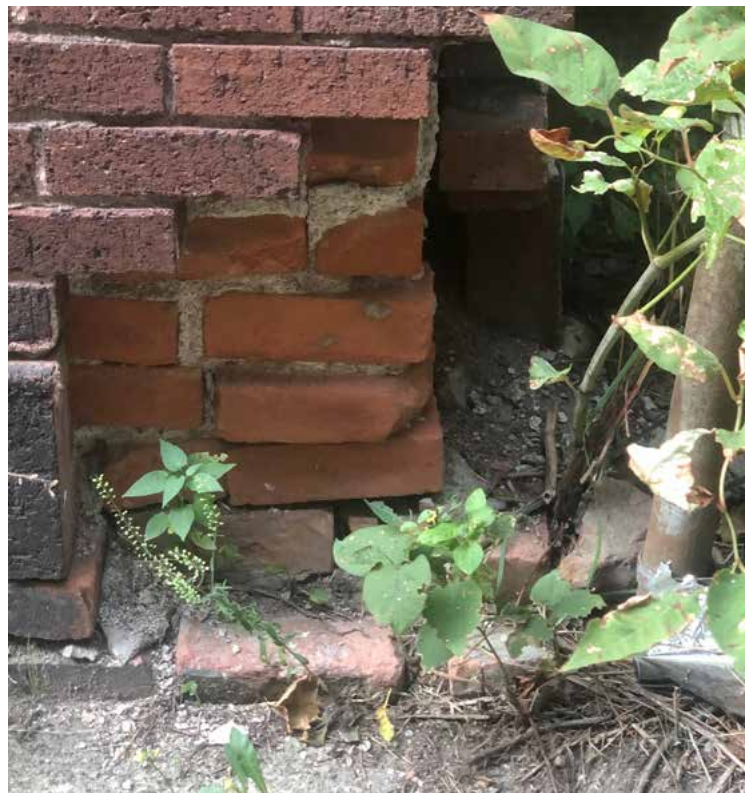
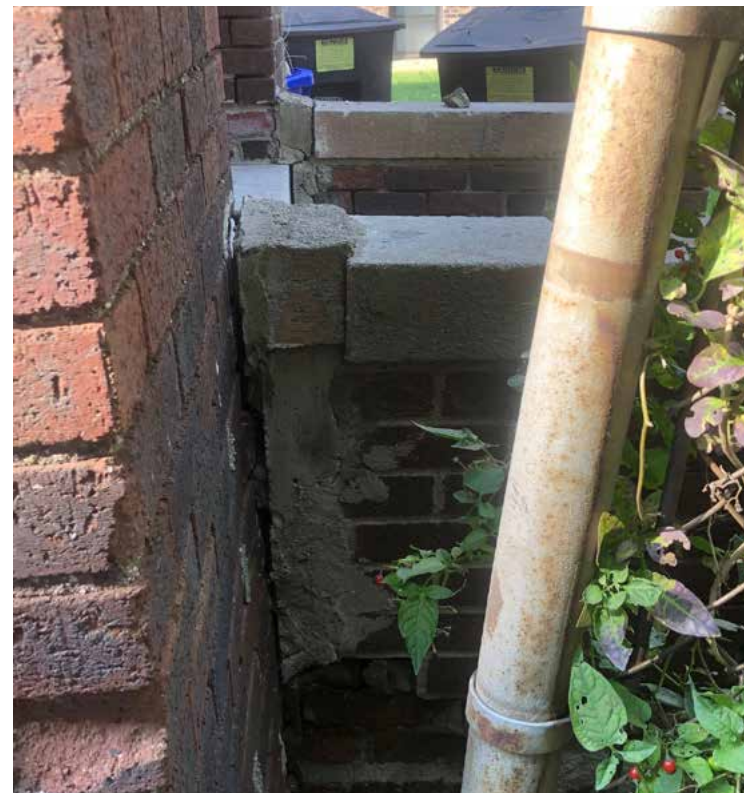
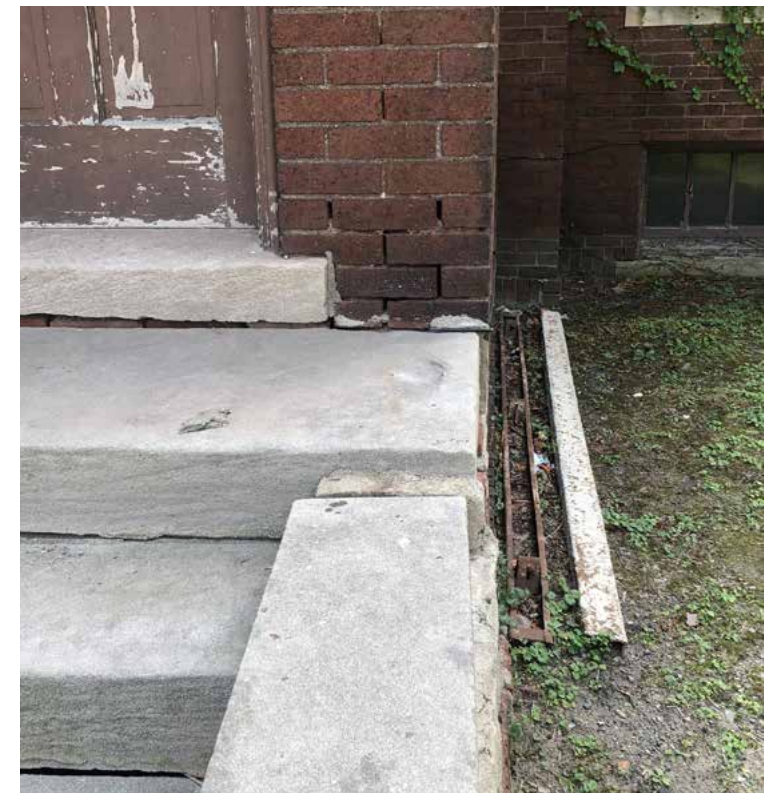
PHOTOS OF CONDITIONS OF STEPS AND WINGWALLS OF UNIT 2 ENTRANCE

- STEPS HAVE PULLED AWAY FROM THE PORCH AND WAS IMPROPERLY FILLED
- STEP WALL HAS PULLED AWAY FROM ITSELF AND WAS IMPROPERLY FILLED
- STEPS ARE NOT TO CODE OR ADA COMPLIANCE.
- THERE ARE GAPS BETWEEN THE STEPS AND HAVE BEEN FILLED

- THE GAPS IN THE BRICK HAVE BEEN IMPROPERLY FILLED AND LOOK BAD.
- BRICKS ARE LOOSE AND FALLING OUT
- THERE ARE SEVERE CRACKS IN THE PORCH WALL
- WALL IS FALLING APART AND IS UNSAFE. WILL NEED TO BE TORN DOWN AND REBUILT TO BE CORRECTED.
- SOME BRICKS HAVE BEEN REPLACED WITH NON-MATCHING BRICKS

IT IS OUR OPINION THAT THE PORCHES ARE IN SERVER DISARRAY. THE PORCHES ARE DANGEROUS AND NEEDS TO BE DISASSEMBLED, AND THE BRICK BE CLEANED OF OLD MORTAR, THE LIMESTONE STEPS, AND CAPS TO BE REMOVED AND CLEANED. THE PORCH TO HAVE A CONCRETE FOOTING AND THE PORCH TO BE REBUILT USING THE EXISTING BRICK AND LIMESTONE STEPS AND CAPS.
