14111 & 14131 East Jefferson Buildings
EXISTING CONDITIONS AND RESTORATION PROPOSAL REPORT

Fenelon Diaz, CPBD

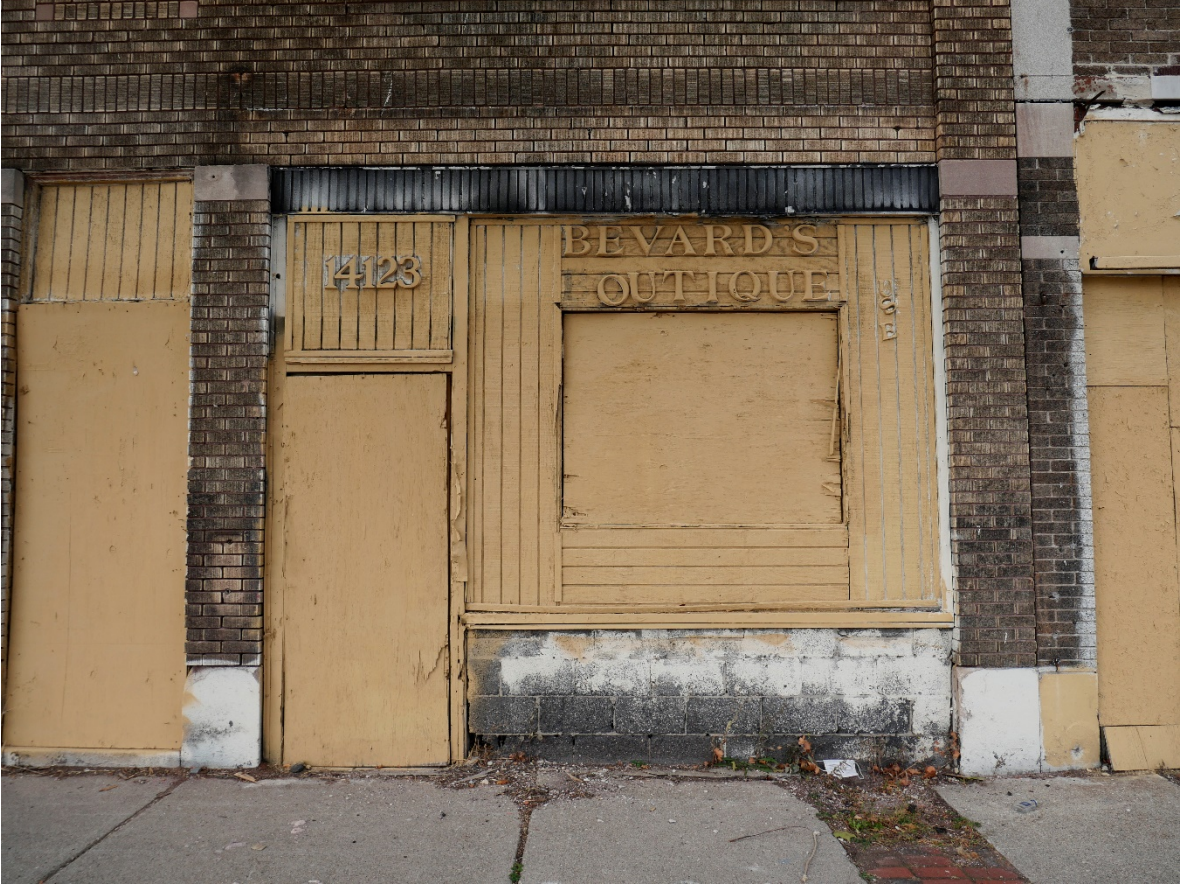
Existing Masonry restoration will provide new bricks as needed, matching the current one, as well as the stone trimming detailing for each floor.

First floor store-front will be built as new framing and finishes, matching as much as possible the character of the building.
