# 14894 Greenview Rd

## Window Replacement

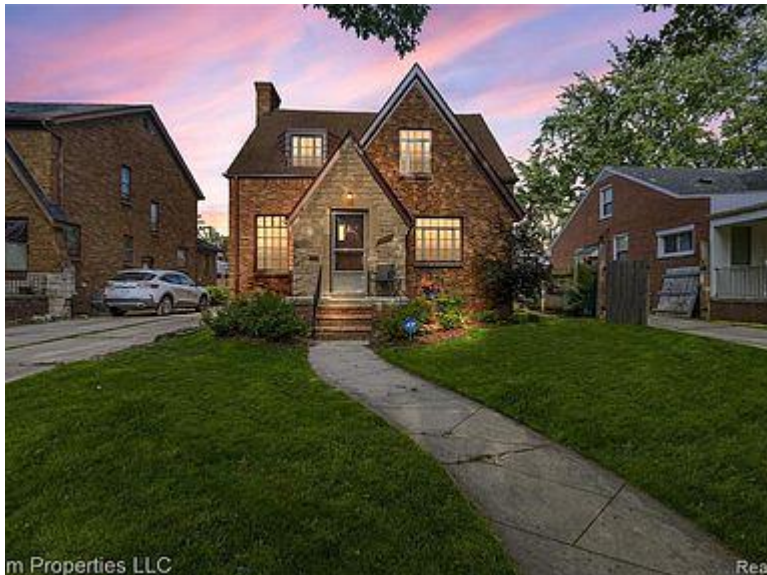
-Almost all painted shut, many have cracked panels, and have rotting wooden framing around the window.

-Replacement with vinyl double hung windows, with dark grid pattern to preserve grid appearance of current windows
