Building Permit Application: **913 Chicago Blvd – Boston Edison District. ePLANS Permit number BLD2022-02869** Removal of Slate roof, installation of CertainTeed PRO Asphalt shingle roofing system.

Request: The planning division requires photos of the existing roof and specifications/details (color, material) of new roofing material to better understand the project scope and what additional applications (if any) may be required from the planning division.

Existing Conditions: Built in 1913, 2.5-story colonial home. The Gable roof featured dark-grey slate with open valleys, slate also featured on the sides of the two dormers. 5" k-style aluminum gutter system in place. The house roof replacement is the subject of this application.

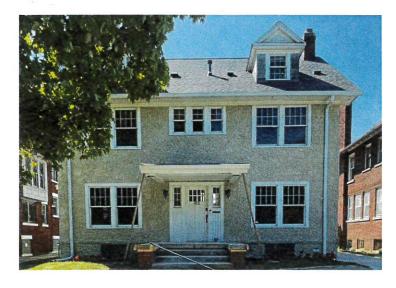
Rationale: The slate size was 12x12", age approximated at 108 years with a typical life expectancy of 80 years. The roof was not well maintained over time having been vacant for many years. The slate was cracked and uneven throughout the roof field with many signs of age and wear apparent including missing and broken tiles, staining, accelerated fade and overall penetration failure. Inside of the home there were damages throughout with some leakage making its way down to the first floor. Damages include but not limited to exterior stucco, window trim, wood floor, walls, and ceilings.

House Roof Replacement: Remove all slate roofing from the house. Install CertainTeed Pro dimensional asphalt shingle, Driftwood in color.

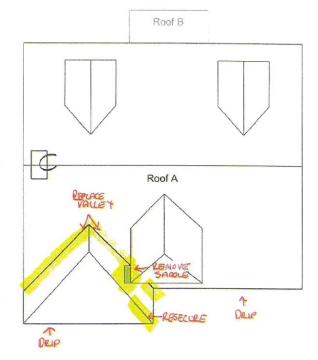
Please Note: An estimate to repair the entire roof really could not be written. The damages were so extensive, the estimates to piecemeal and repair would be close to the cost of replacement considering the additional time each section removal and tie-in would require. This option would not offer any guarantees, the additional time required would drive up already high costs, and technician safety would be of concern. The partial repair estimate was written with no information on the condition of the underlying roof deck and would have easily turned into much more extensive repairs that covered much larger areas of the roof once the deck condition was discovered. This roof was considered unrepairable with the safety issues it presented, the age of the roof, and the degree of failure present.

- Remove 36" of slate and existing steel valleys (Approx.34 L.F.) and 1 saddle highlighted on the attached roof plan.
- Install 36" of a high temperature ice and water shield at the exposed valley and saddle area.
- Fabricate and install a new 24" wide 16oz copper valley over the new ice and water shield. Reinstall slate over the newly installed copper valley to provide a watertight system.
- Resecure 1 loose steel hip cap highlighted on the attached roof plan.
- Remove the bottom course of slate at the eave to allow access to install a new drip edge. This area is highlighted in red on the attached roof plan.
- Fabricate and install a new 16-ounce copper drip edge at the eave (Approx. 84 L.F.). Re-install all necessary state to provide a watertight system.
- Clean all debris created form this work,
