City of Detroit
Planning & Development Department
2 Woodward Avenue, Room 808
Detroit, Michigan 48226

The following sheets describe the restoration projects at my home at 2405 Burns Street in Indian Village. This is in response to a letter sent on March 24, 2023 describing "Replaced Windows" and "Installed Fence" sent by Daniel Rieden. The fence work is described within, and has been partially completed. There have not been any windows replaced since my ownership in 2019. I have, however, been restoring original windows, which is described within. There are also several restorations described which have also been completed

FENCES

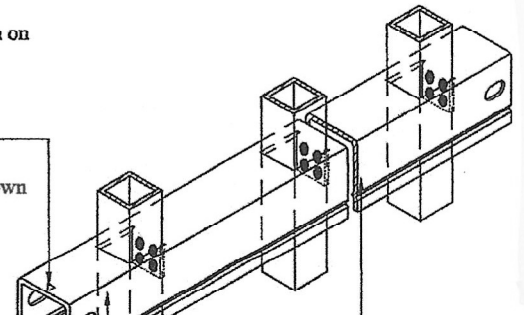
Pictures 5 through 8 are of the current iron fence on the front of the house. This is to be replaced as in Picture 7 and 8 which is an identical construction as originally put it. This work has not been started to date

REMOVE EXISTING 3' TALL IRON AND HAUL AWAY, FURNISH AND INSTALL 3' TALL MONTAGE CLASSIC 2 RAIL (SPEARTOP) OR GENESIS 2-RAIL (SQUARE NO POINT PICKET) BLACK ORNAMENTAL STEEL FENCE - AND DOUBLE GATE, ADD \$250 TO HAVE US HAUL AWAY DIGGING SPOILS.
