APPLICATION NUMBER 04-342

104 EDMUND PLACE

Applicant/Owner: Debroe Co./Platinum Building &amp; Development

Brush Park Historic District

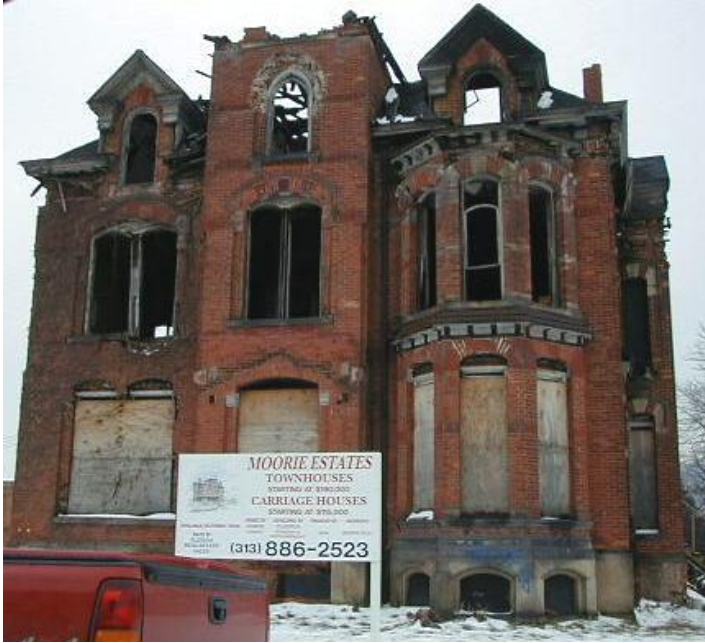
96-104 Edmund Place, front elevation

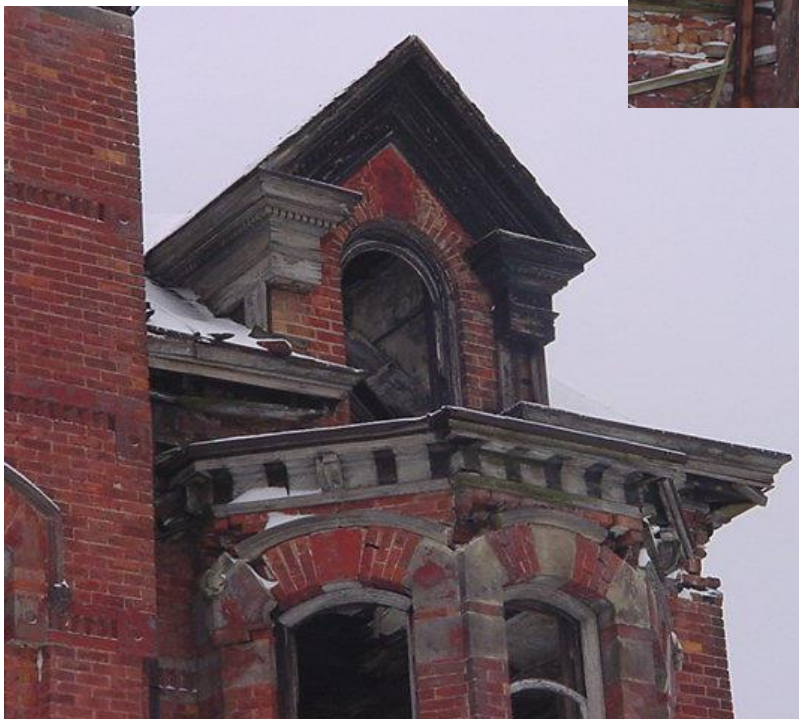
96-104 Edmund Place, detail of a side dormer with return cornice, arched window, bay window cornice and arched window lintel.

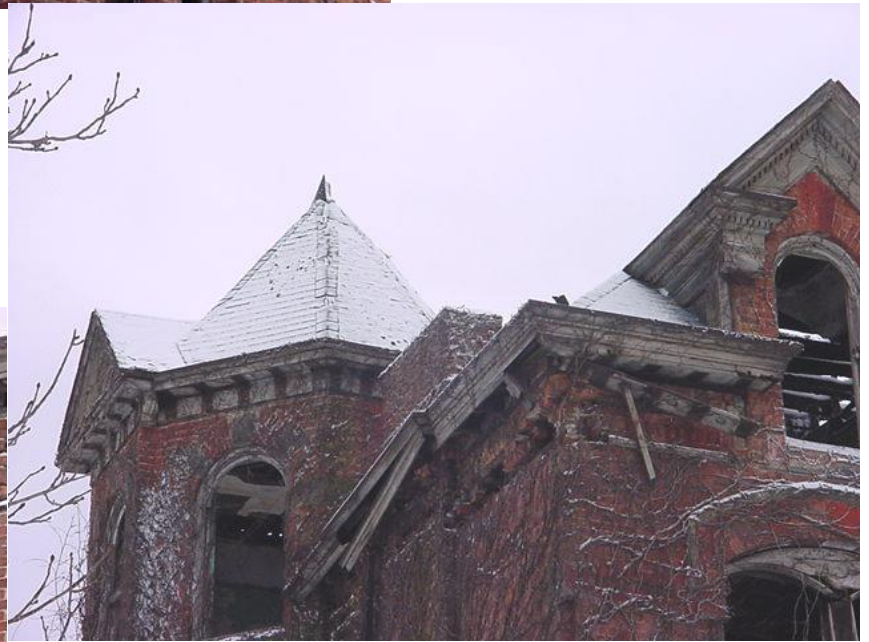
96-104 Edmund Place, detail of the conical roof on the east elevation showing the variations of roof shape on the property.
