1490 Iroquois
Detroit, MI 48214
Homeowner: Tammie Soto & Mike Wong

Carriage house roof:

Carriage house railing:

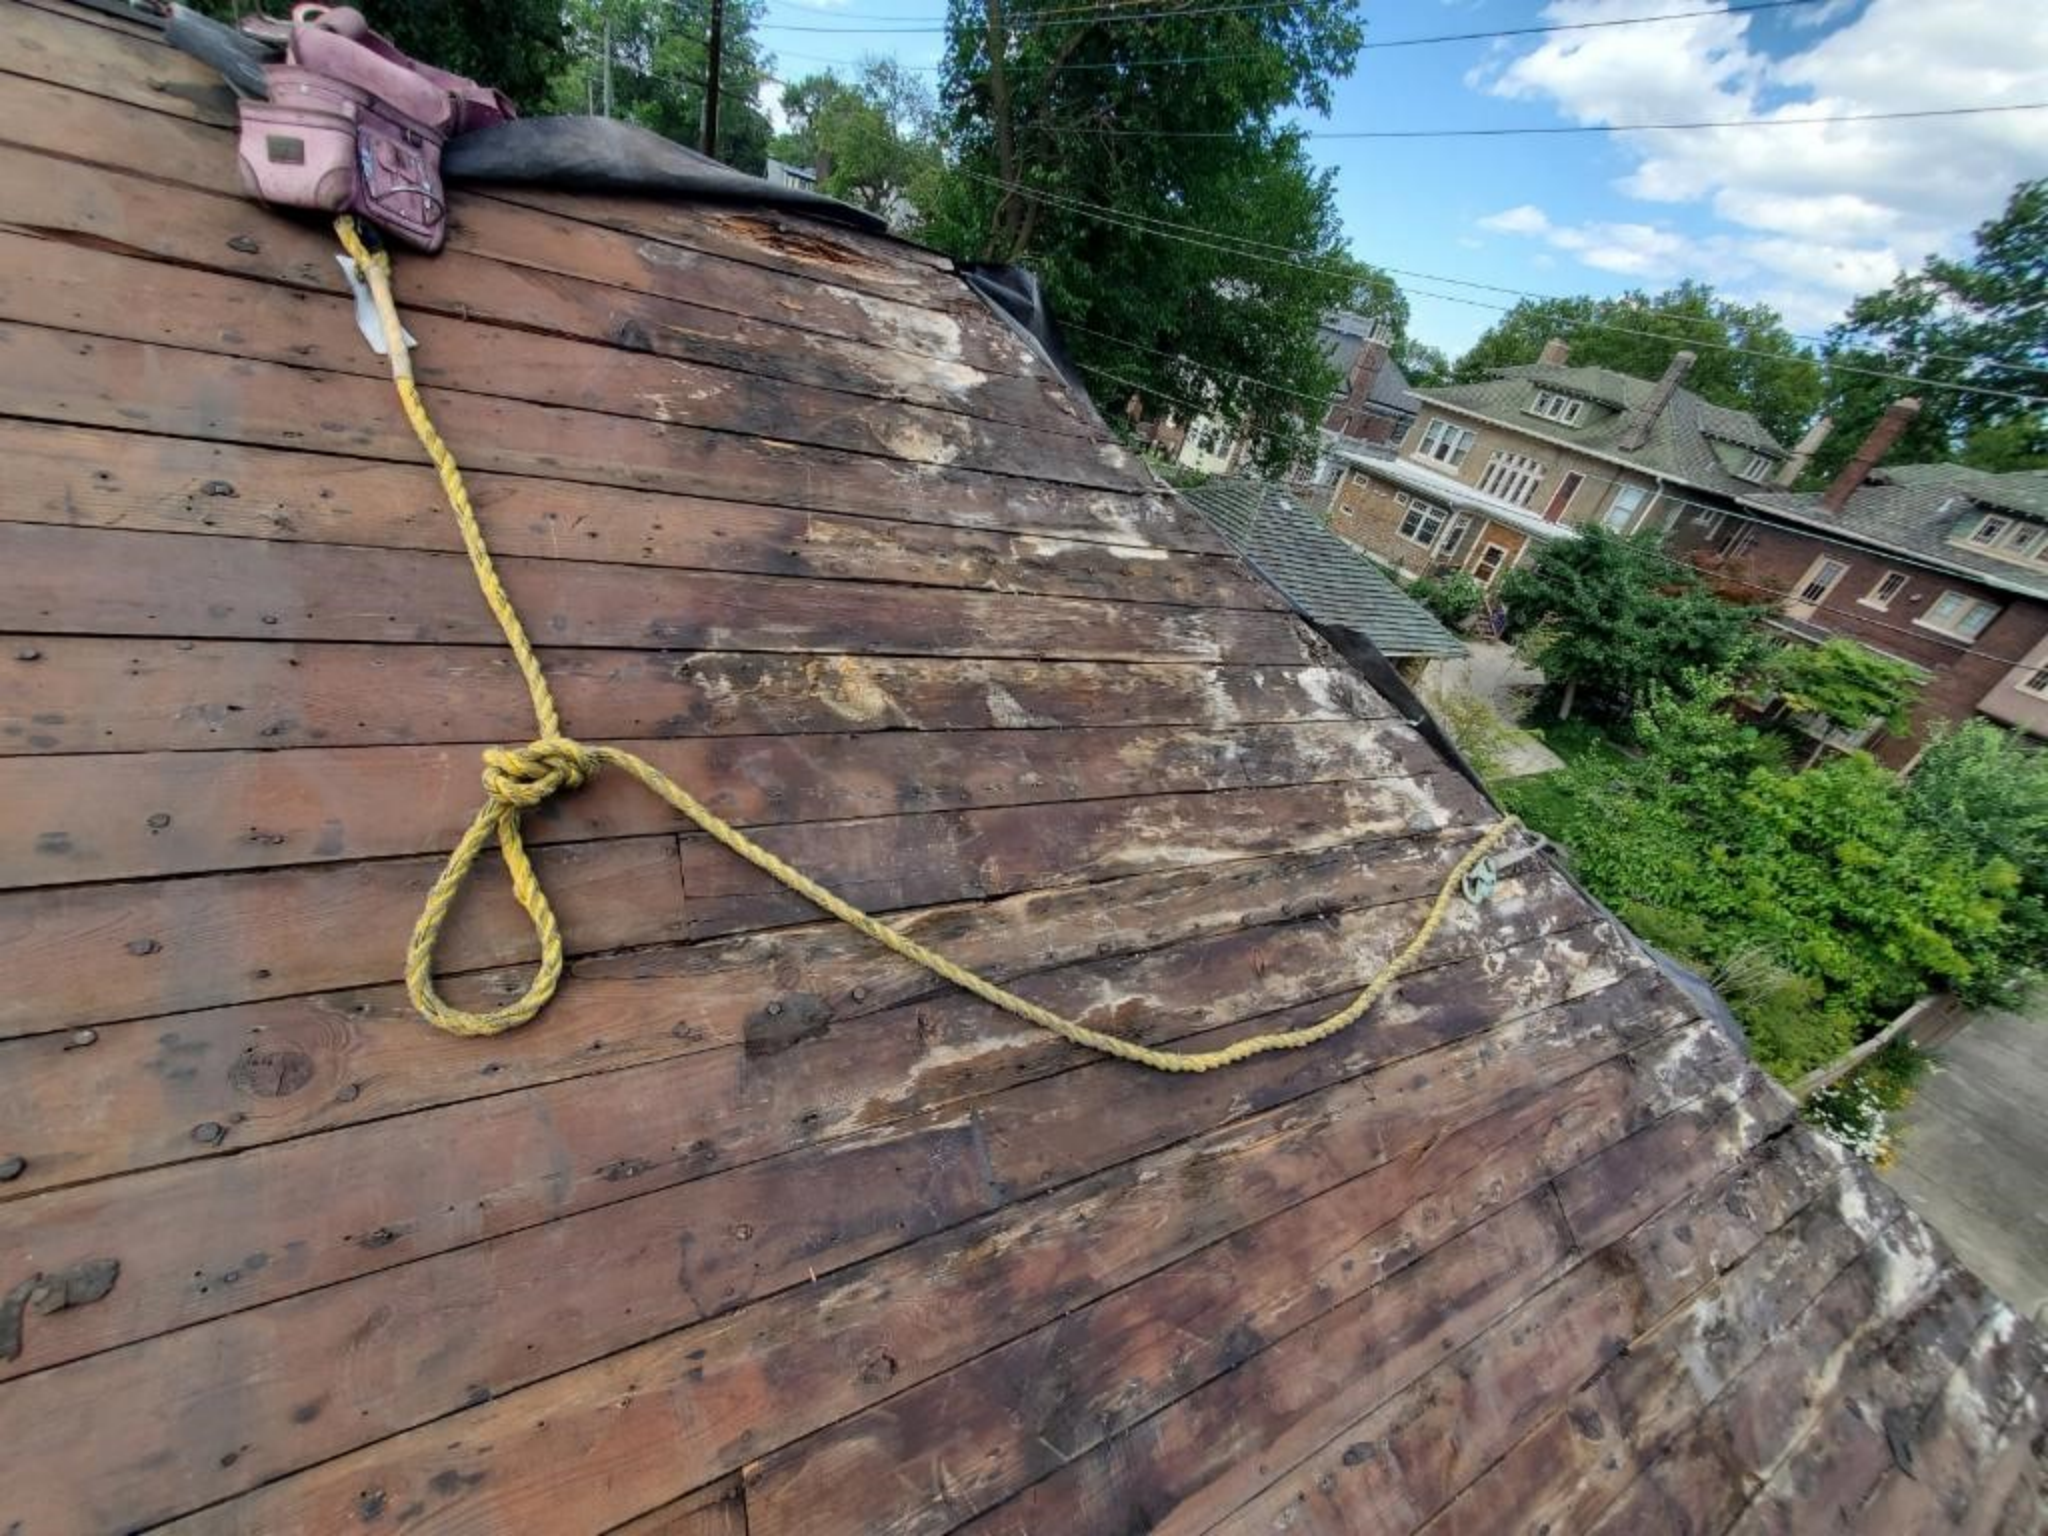
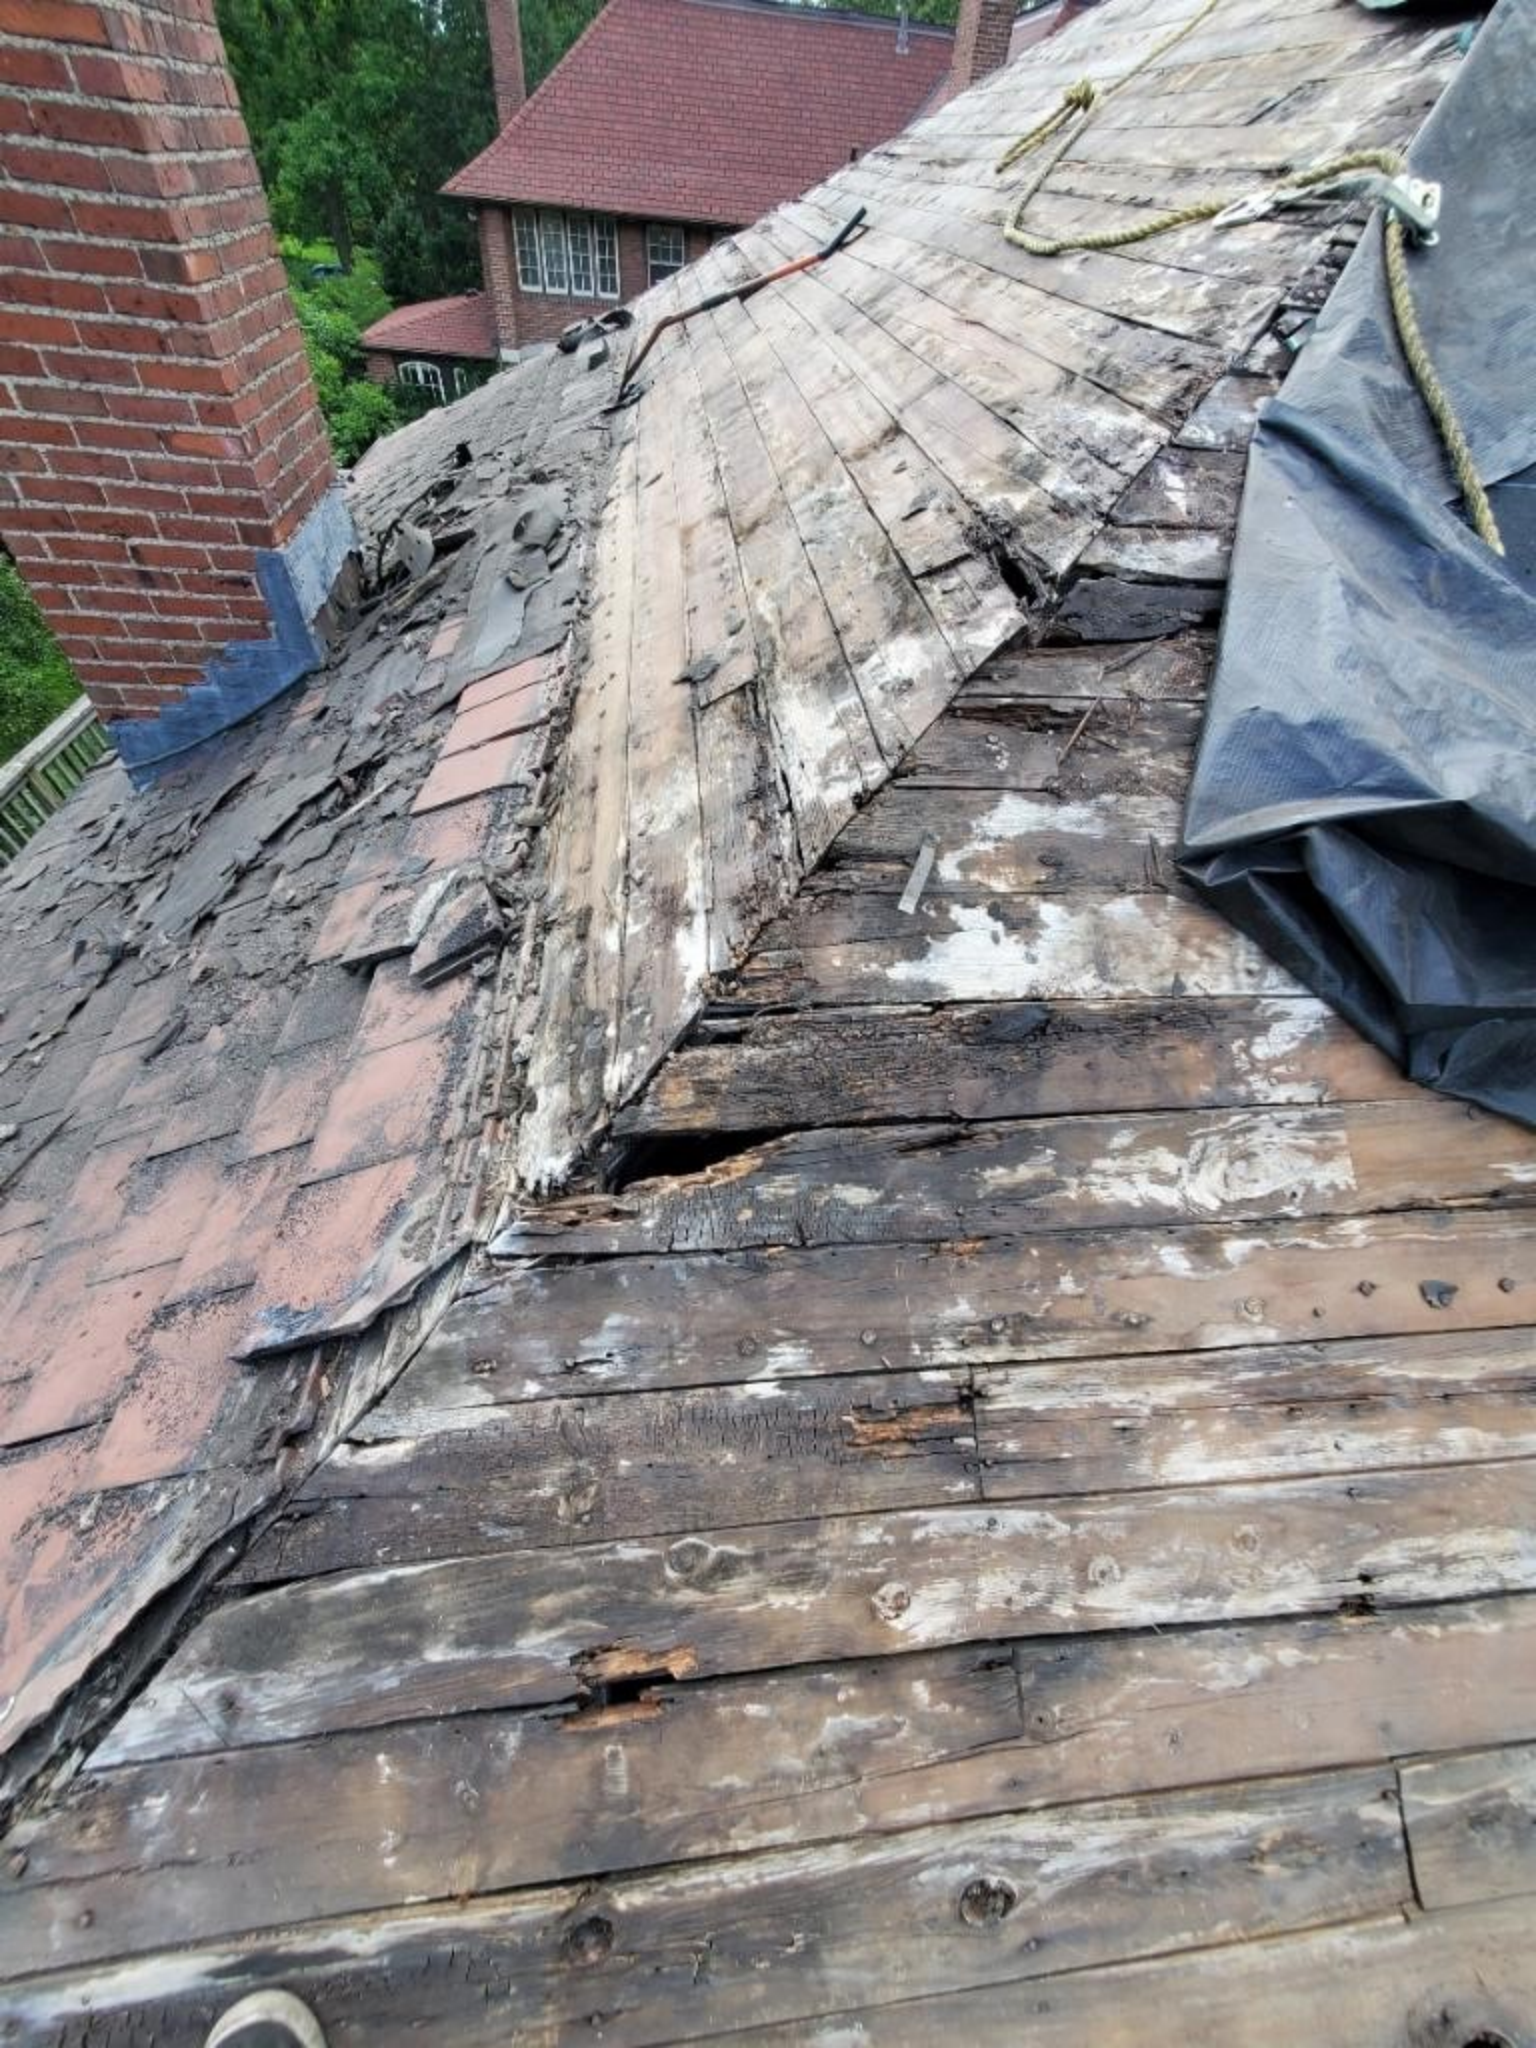
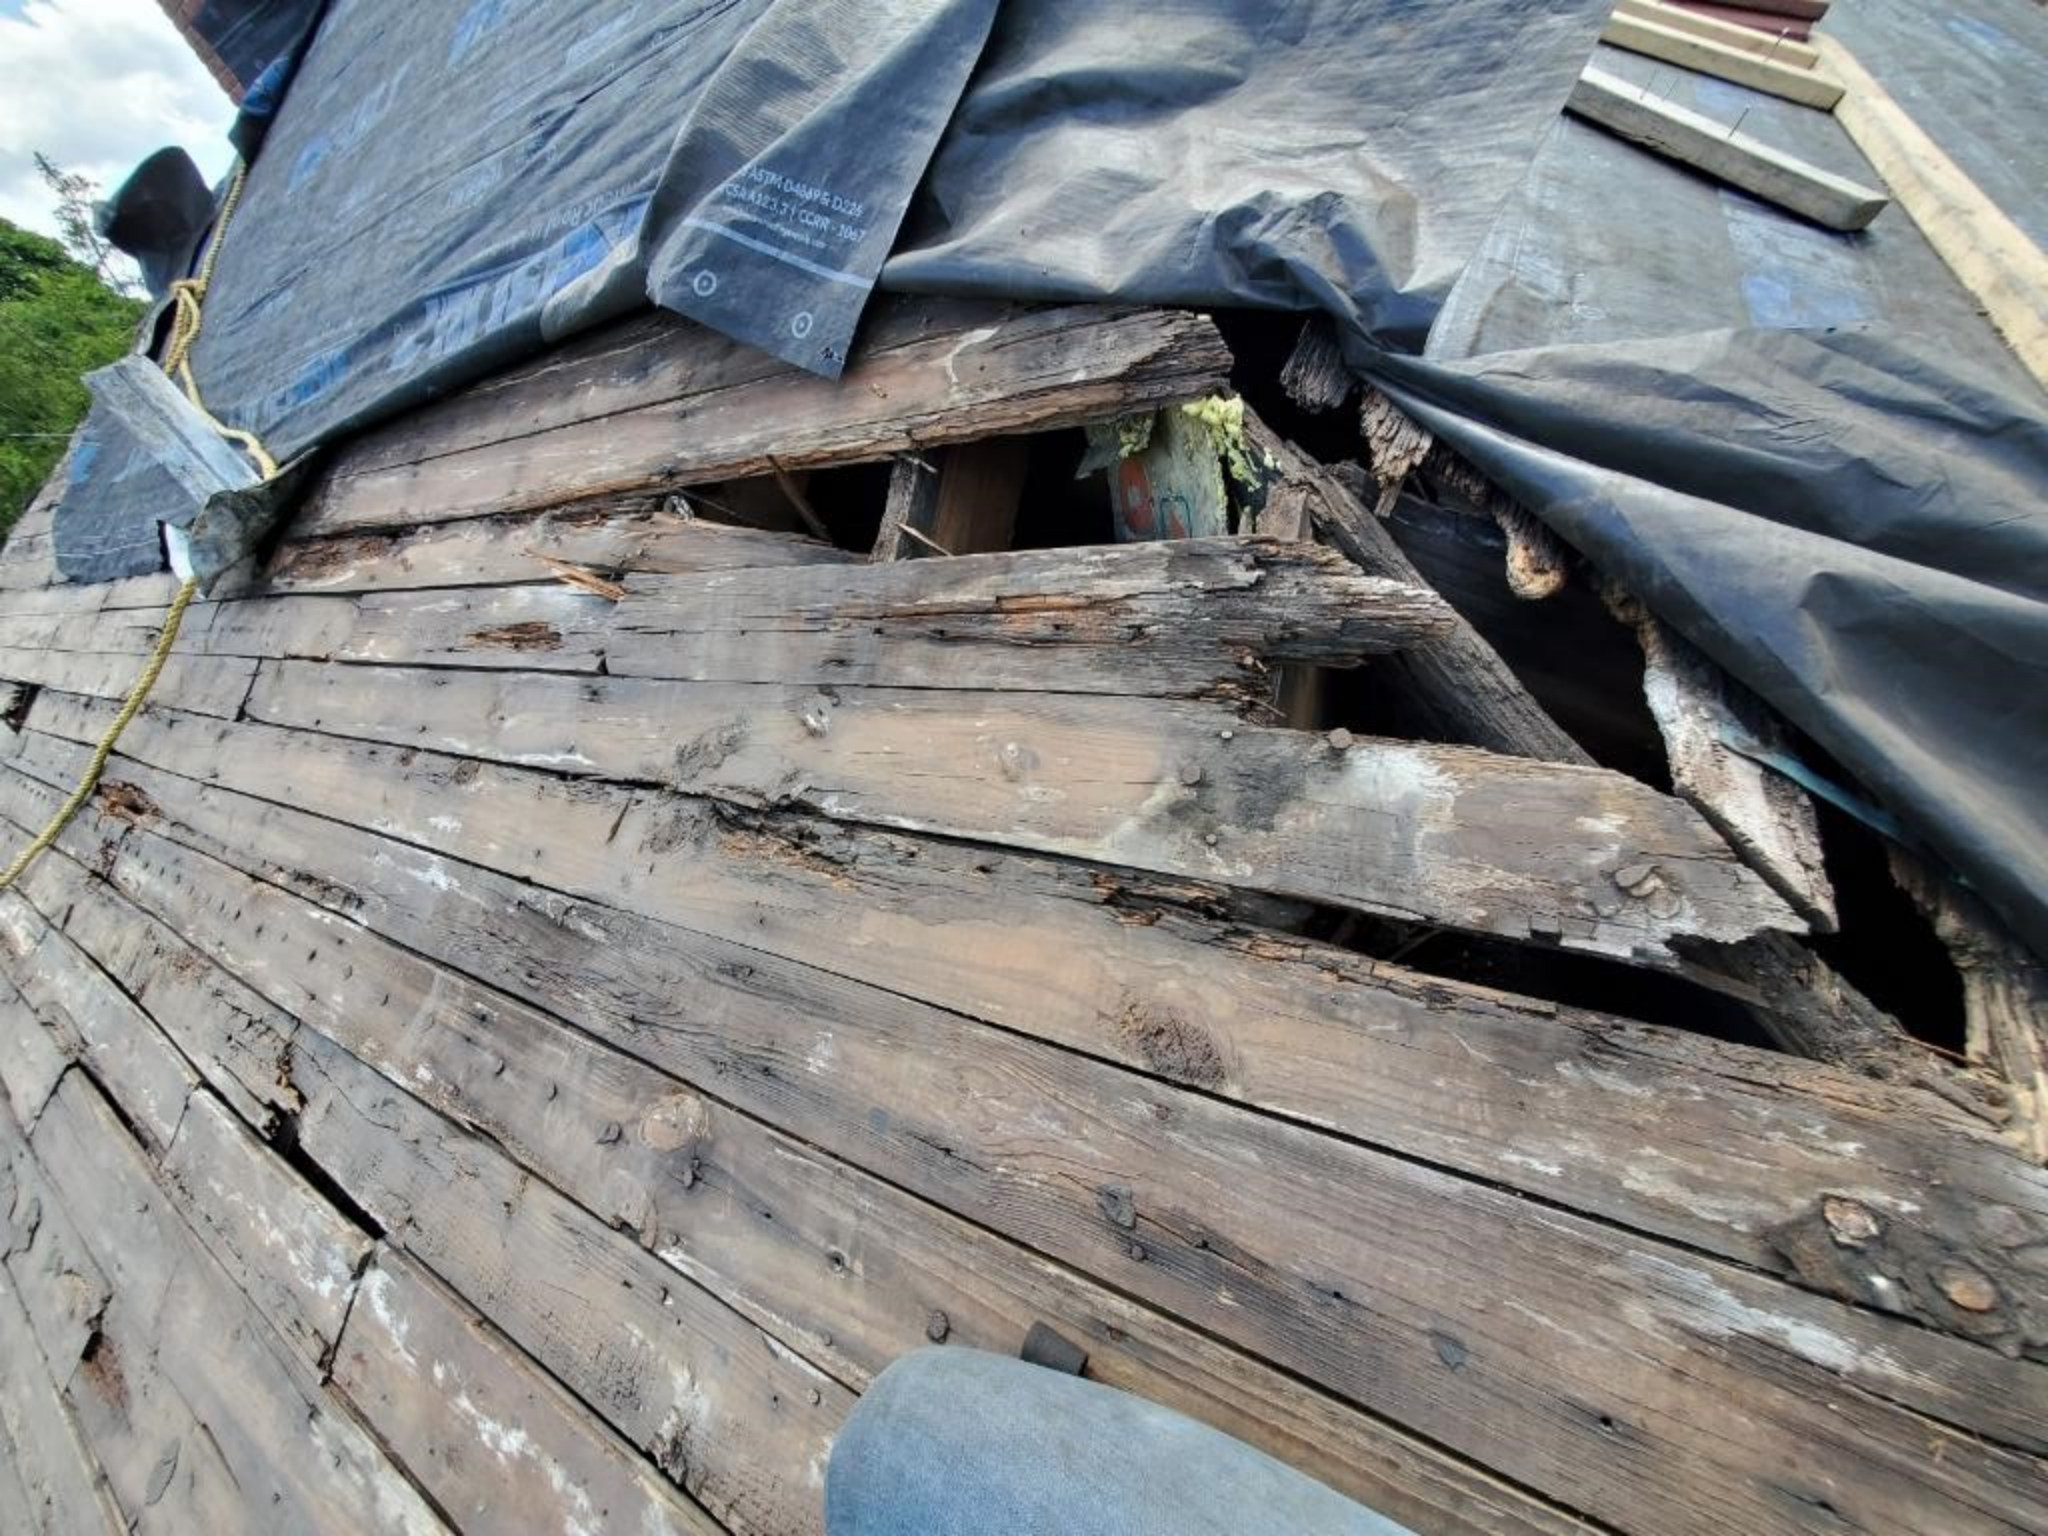
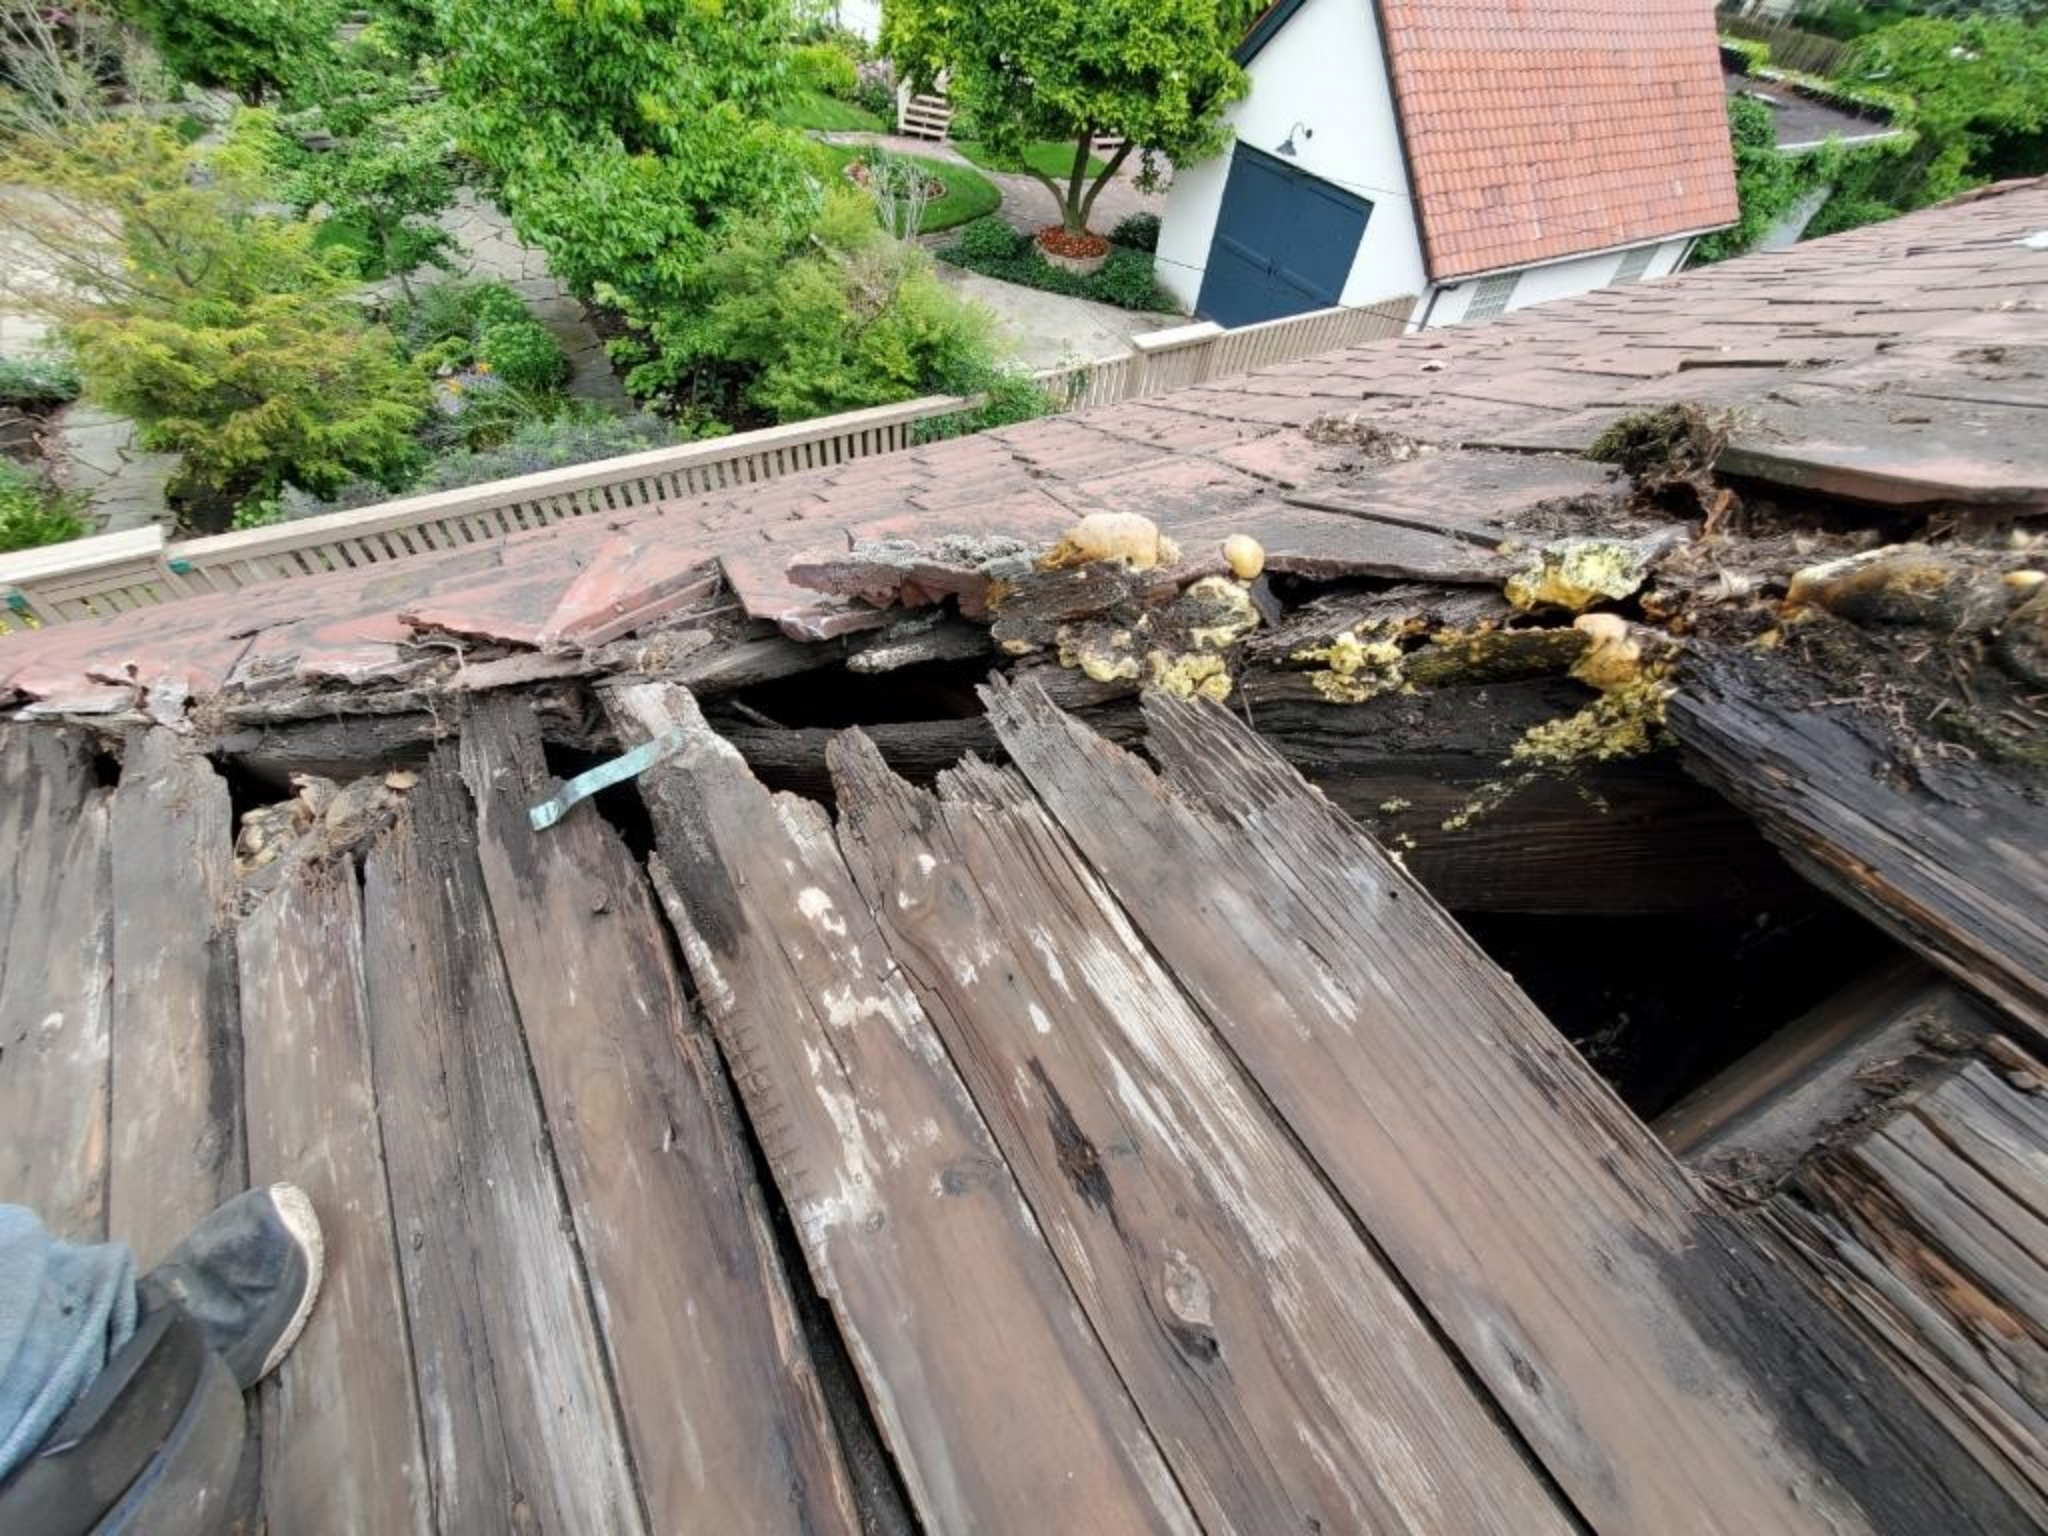
When we (Detroit Build) were contracted to perform work at 1490 Iroquois, the carriage house had significant water damage caused by the deteriorating roof deck. There is plaster damage on the interior of the house and there were areas where water would pour into the house when it rained. The clay tile has since been removed and disposed of. There are no clay tiles left onsite. Currently the carriage house roof remains tarped to prevent any further water damage. I have attached photos of the deteriorating roof deck on the carriage house. There are also photos from the inspection that show where there were failing tiles prior to removal.

(2) The carriage house roof covering is at the end of its useful life and should be replaced at this time. Cost estimates should be obtained.

There is evidence of past leaks in the carriage house. In our opinion, leaks could still exist in one or more areas. - SUGGESTION: A qualified roofing contractor should evaluate the roof and make repairs or modifications as necessary.

Damaged/missing/loose tiles should be replaced to reduce risk of leaks.

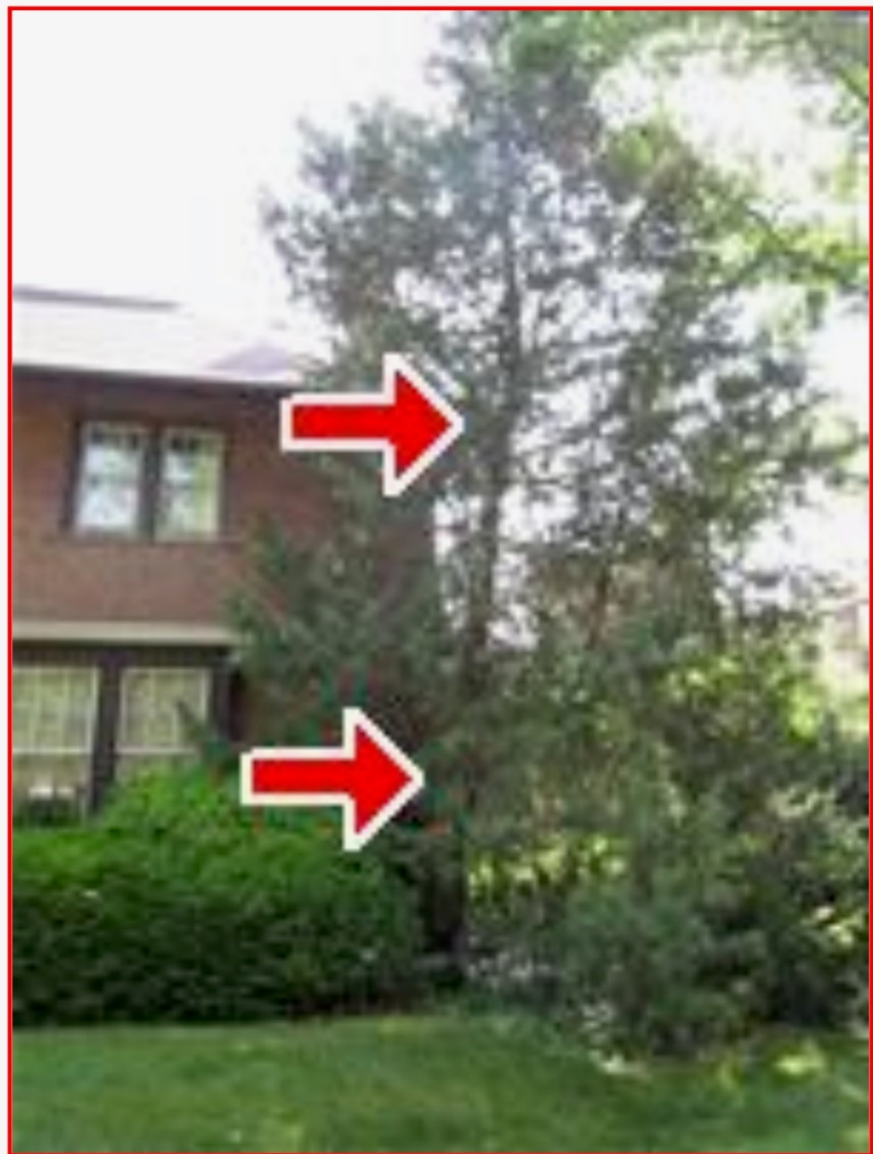
There was a large Juniper tree that was removed from the front yard. Attached is a photo of the tree as well as a letter from the arborist.

My Client, Tammy Soto, who lives at 1490 Iroquois in Indian Village, recently had a juniper tree removed from the front of her house. This tree was planted, extremely close to the structure of the building. It is my opinion that it was planted 40 years ago as part of a new landscape plan but the full grown size of the species was not taken into account when the landscaper placed it one foot from the house. In addition, a foliar fungal disease was causing a large number of leaves to fall which made the tree look sparse. In conclusion, I recommended removing this tree in order to replace it with a tree that will be planted farther away from the house. Please note that this client is interested in preserving many of the original features of the yard including a 100+ year old lilac. I have consulted with the homeowners and have suggested historically appropriate replacements. Please do not hesitate to reach out to me if necessary. My cell phone number is 734-417-7910 and my email is emibrent@umich.edu.
