STRUCTURAL REPORT NOTES

SISTER PIE RENOVATION

ISSUED DATE Historic Commission Review 09/21/2023

EXISTING CONDITIONS

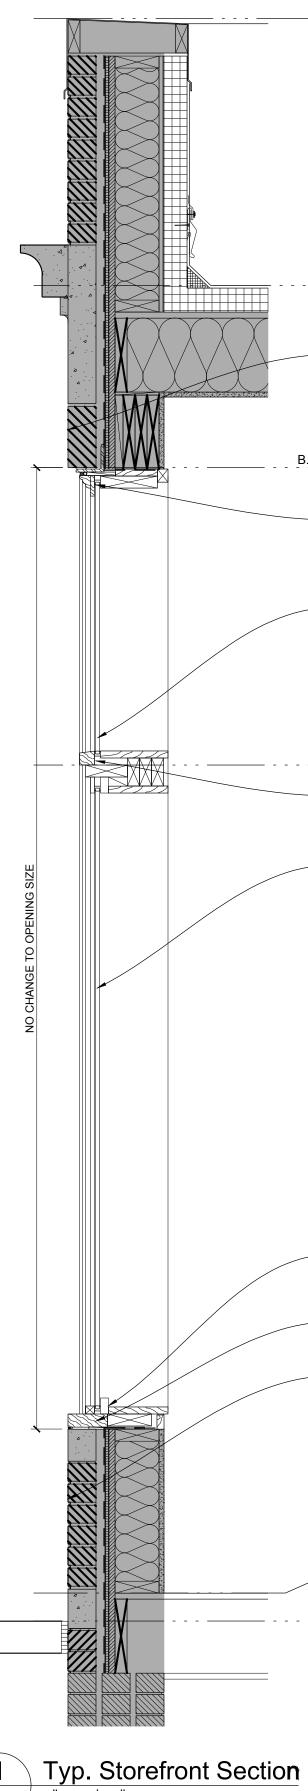
SINGLE PANE 1.5" ALUMINUM STOREFRONT WINDOWS TO BE REMOVED

1" ALUM STOREFRONT 2X WOOD TRIM TO BE REPLACED

STONE SILL TO BE RESTORED AS EXIST.

MASONRY TO BE RESTORED MATCHING EXIST.
