3964 W Lafayette

Sunroom Rebuild Plan

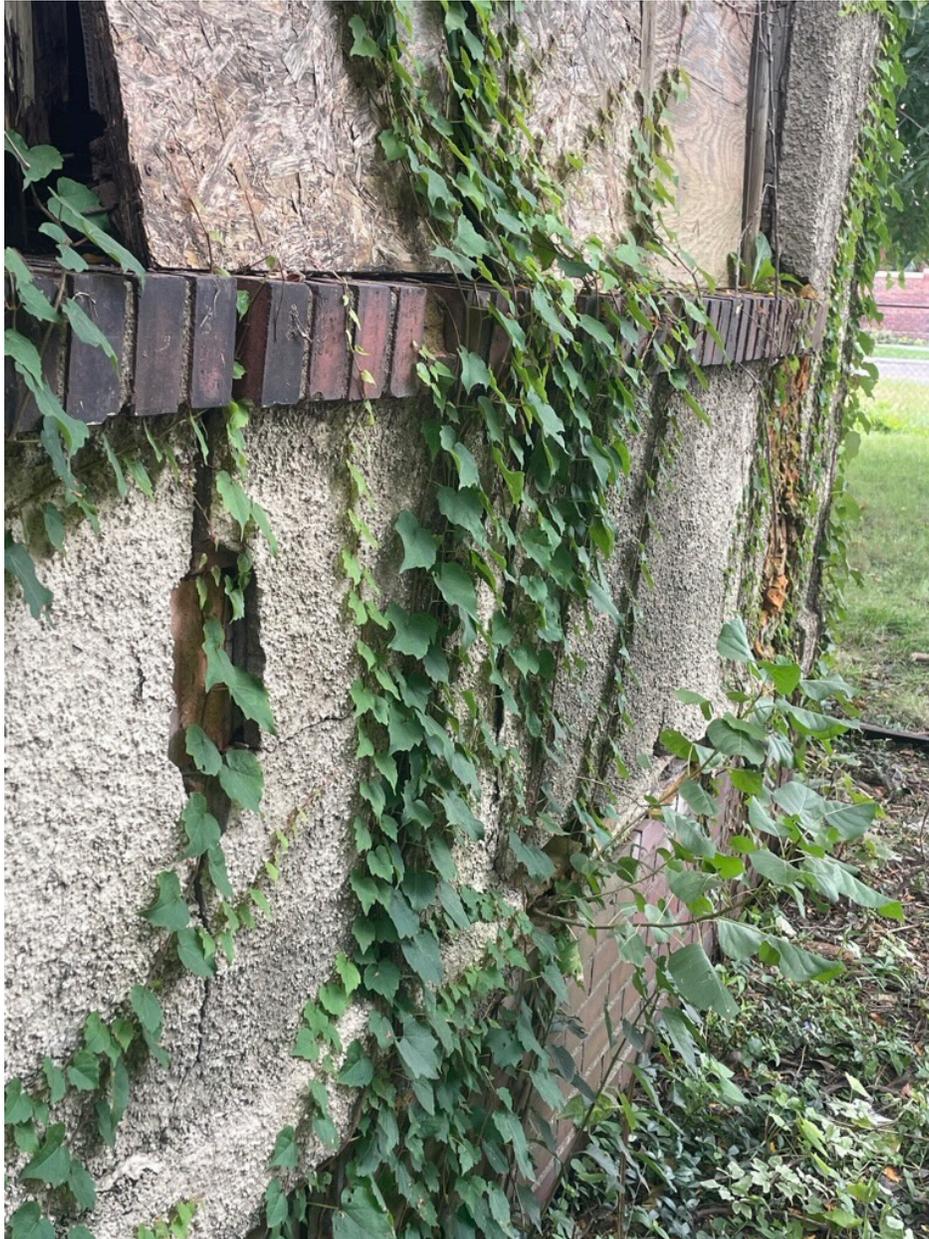
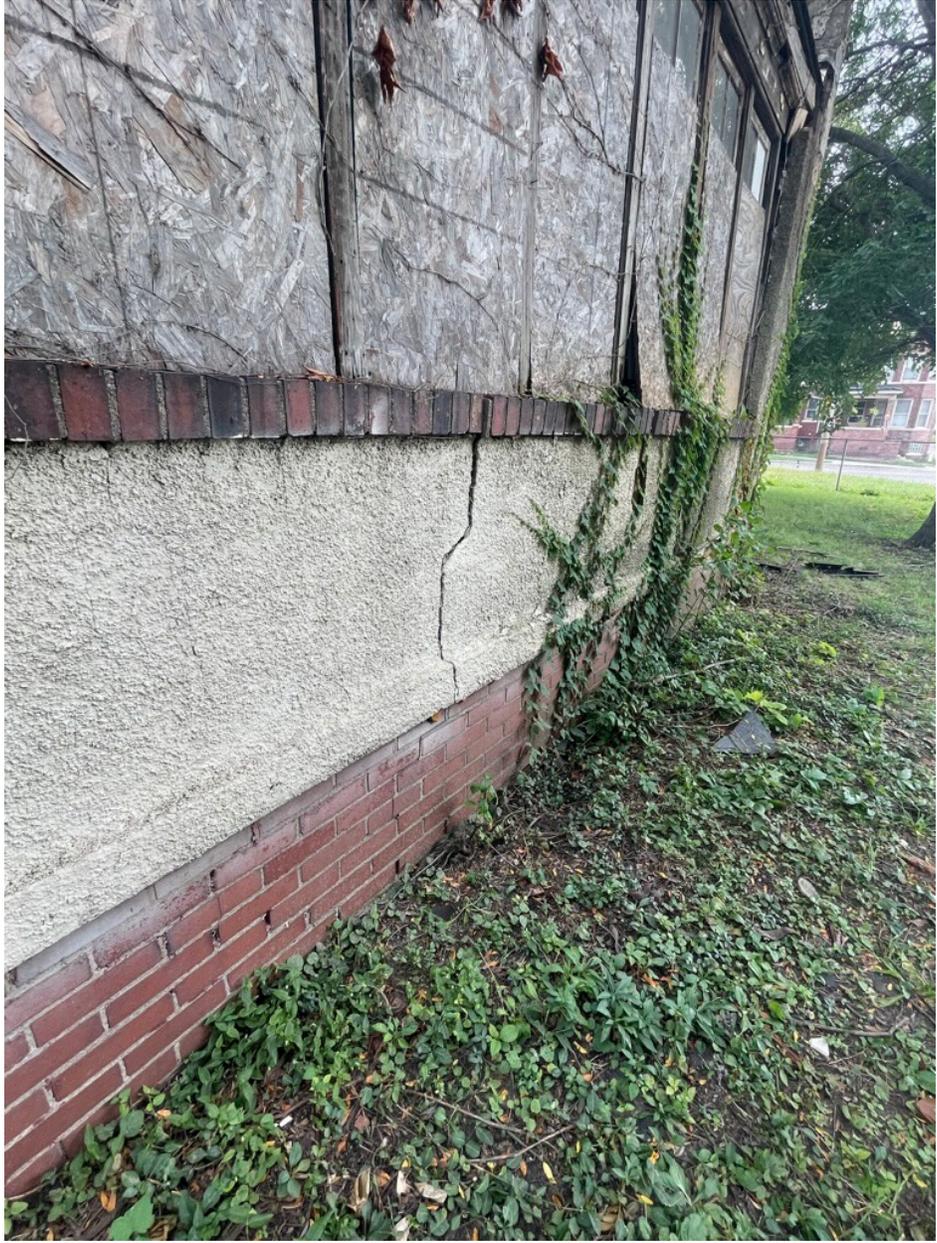
Foundation wall is cracked and leaning out 1”+ on the western face. It can be seen at the brick sill in this picture. The crack continues vertical to the roof line.

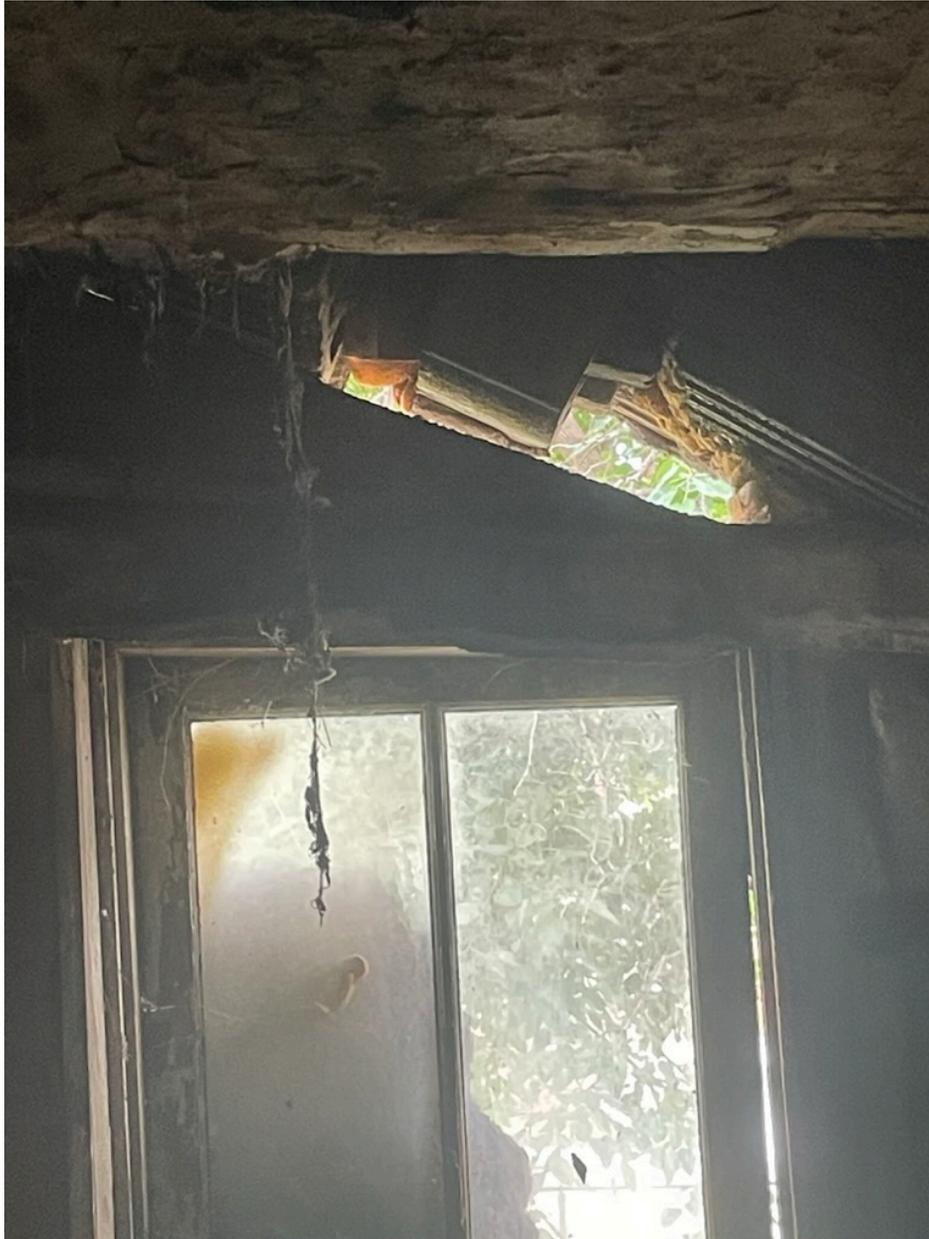
Daylight can be seen from the inside of the structure, further detailing the extent of the damage. Individual clay blocks can be seen slipping out of place and crushing the window causing all the sash to shear.

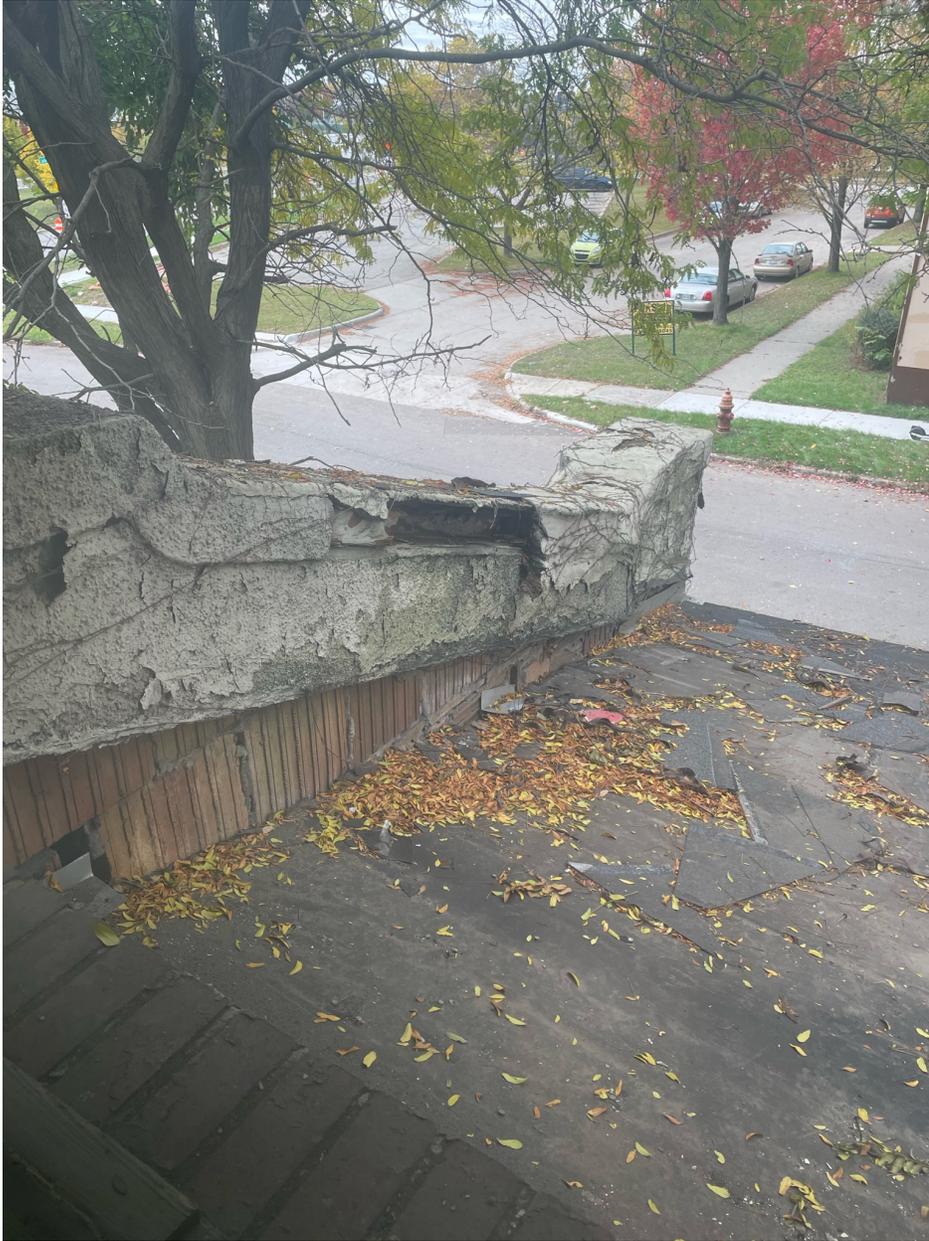
Parapet walls are deteriorating at the top. Roof has collapsed and can be seen leaning down more than 12 inches. The roof should be sitting at the edge of the stucco, but in this picture you can see that the clay block wall is exposed where it was once covered by the roof.

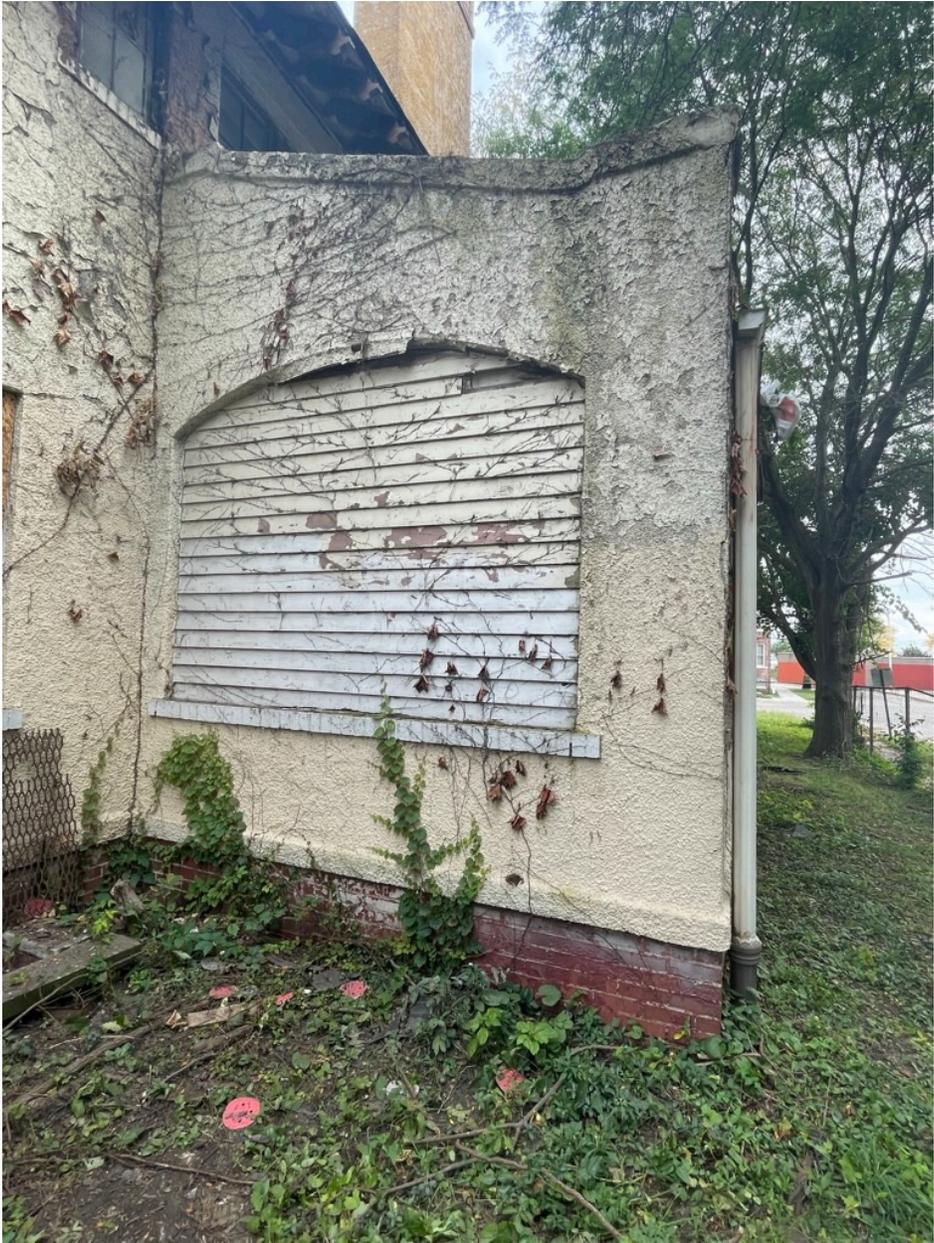
This wall is intact and will be preserved. Windows will be installed where clapboard siding is.
