HDC2024-00149

EXTERIOR IMPROVEMENTS APPROVAL, INCLUDING RESIDENTIAL GARAGE ASSESSMENT AND NEW CONSTRUCTION CONSIDERATIONS.

Project: Exterior Improvements and New Garage Improvements
570 Lodge Drive
Detroit, MI 48221

Joseph Berry Historic District
Lot 42
City of Detroit Project No. - RES2024 - 00816

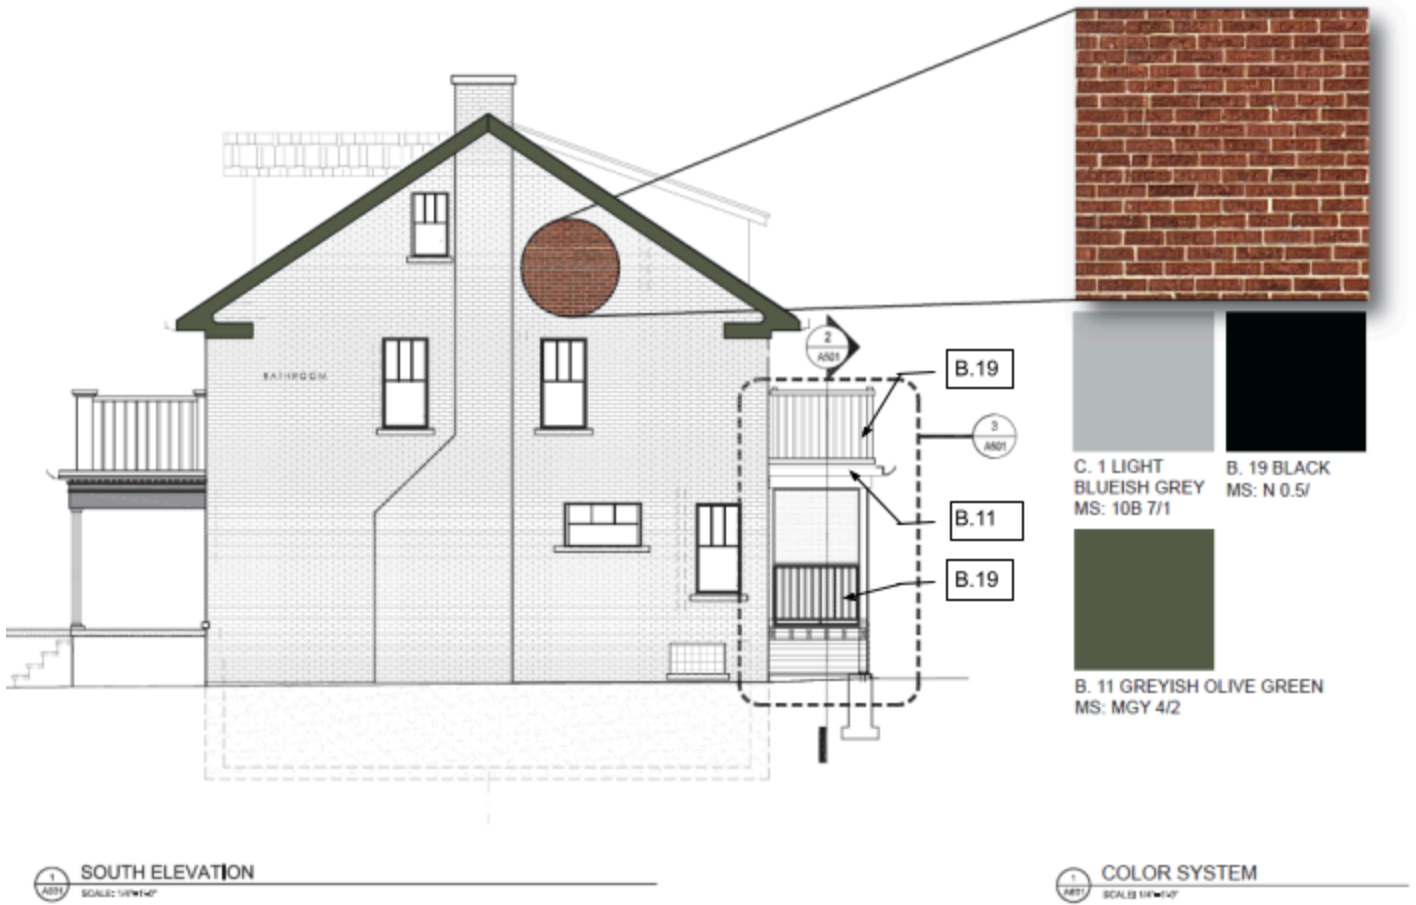
A. Existing Porch Addition

Existing Rear Office is 9' x 14'. The foundation of the existing porch was severely damaged prior to the house fire. Owner indicated the interior wood floors were sloping toward the back of the office. This highlights a failure of the foundation. Unfortunately, due to the fire the structure needed to be demolished.

Fig. 15.0 - Fire severely damaged interior of "office" (Dashed Black)

Due to unsafe structural and fire related issues identified the owner moved to have the structure demolished.

Building a new “screen in porch” is the best solution and perhaps brings it closer to its original program use. The solution would bring the structure into compliance with a coordinated color scheme and Hardie Cement board lap siding at the porches base, Black Aluminum railing, and Trex Flooring.

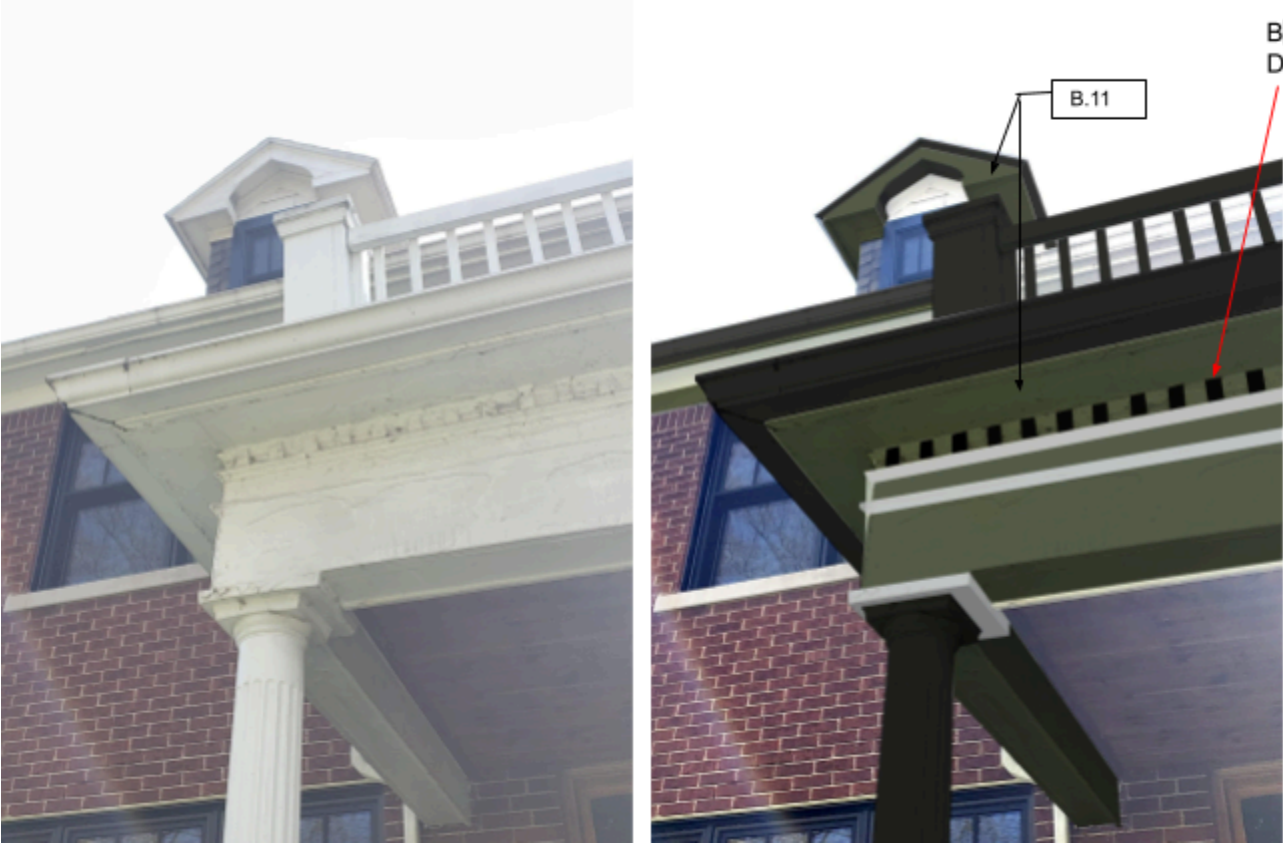
B. Paint Scheme

Fig. 15.0 - Fire severely damaged interior of "office"

See our proposed color scheme per Staff’s Color Chart

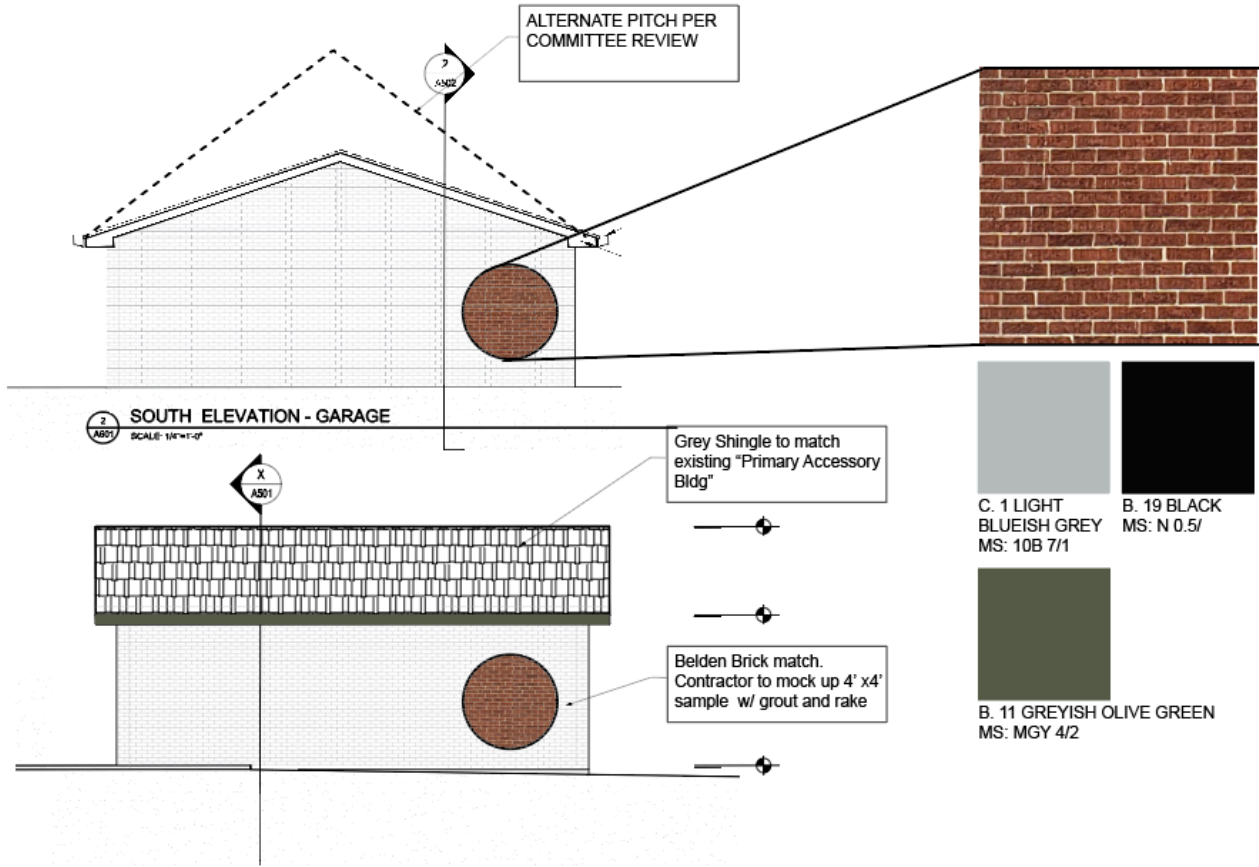
2 SOUTH ELEVATION - GARAGE
 AB01 SCALE: 1/4"=1'-0"

Grey Shingle to match existing "Primary Accessory Bldg"

Due to multiple structural issues identified at our visit we conclude that repair of the garage is not a viable option.

We conclude that demolishing the structure in its entirety and building a new structure is the best solution. The solution would bring the structure into compliance with a matching masonry structure with similar architectural roof style and pitch.
