SCOPE OF EXTERIOR WORK
SINGLE-FAMILY HOUSE AT 1480 SHIPHERD ST., MI 48214

II. SCOPE OF EXTERIOR WORK

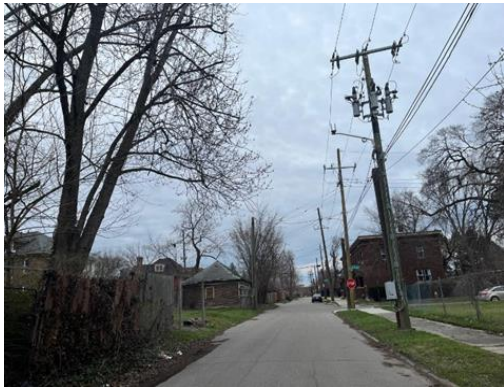
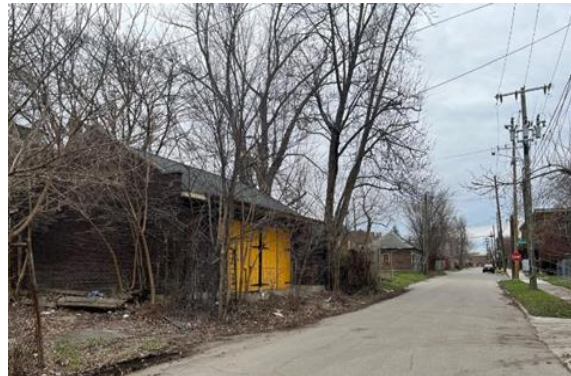
Block where our property is located with large empty areas.

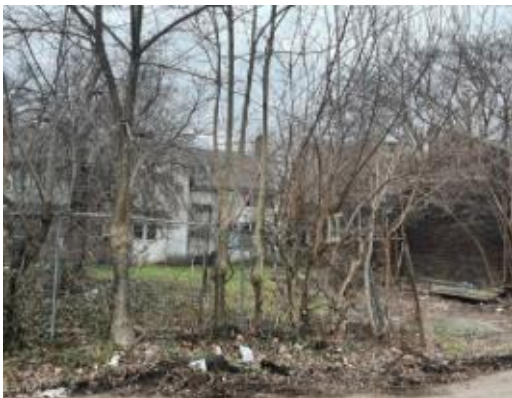
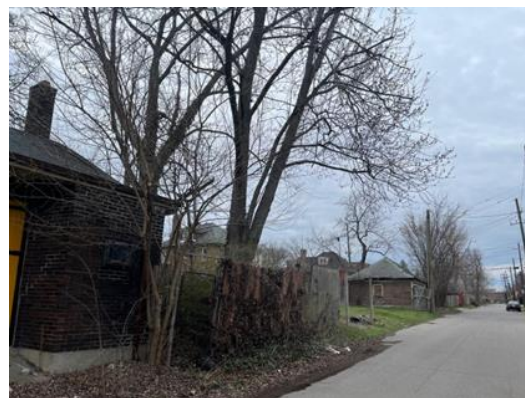
It is important to note that poorly maintained properties as the ones that we can see on the pictures can significantly bring down the value of other homes in the area. Our project will bring a better look to the area.

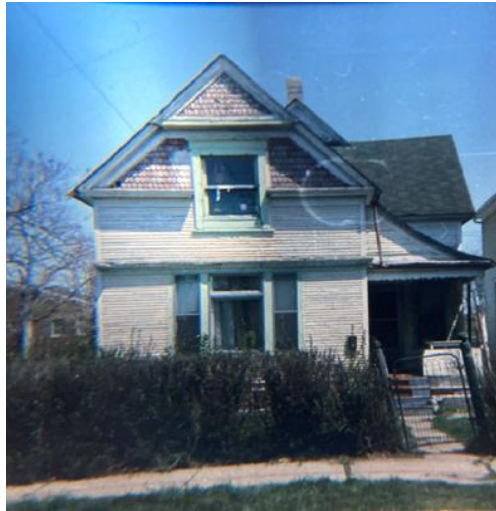
According to the records of the Detroit Historic District Commission this is how the property located in 1480 Shipherd St. MI 48214 looked before.

(Photography obtained from the records of the Detroit Historic District Commission).

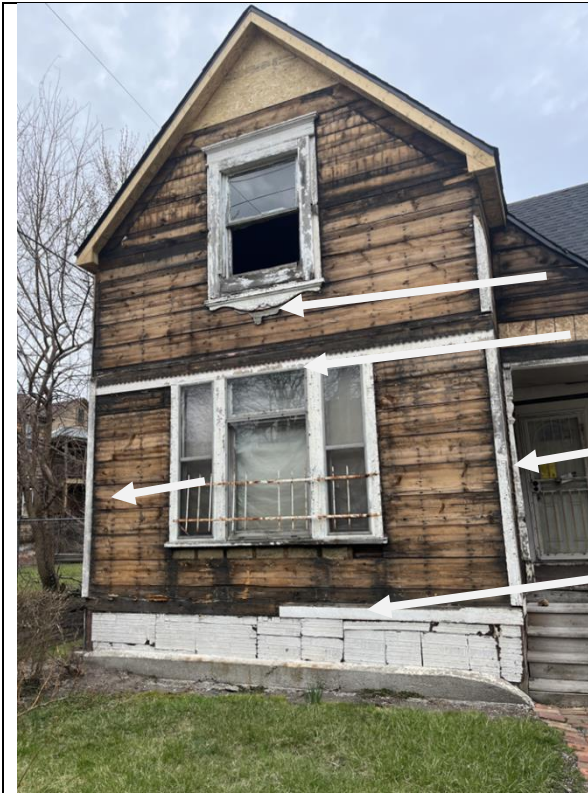
All the white wooden details will be preserved (current condition of the property)
