STAFF REPORT: OCTOBER 11, 2023 MEETING PREPARED BY: A. DYE

APPLICATION NUMBER: HDC2023-00024

ADDRESS: 2244 WABASH

SCOPE: DEMOLISH REAR OF HOUSE* (WORK COMPLETED WITHOUT APPROVAL);

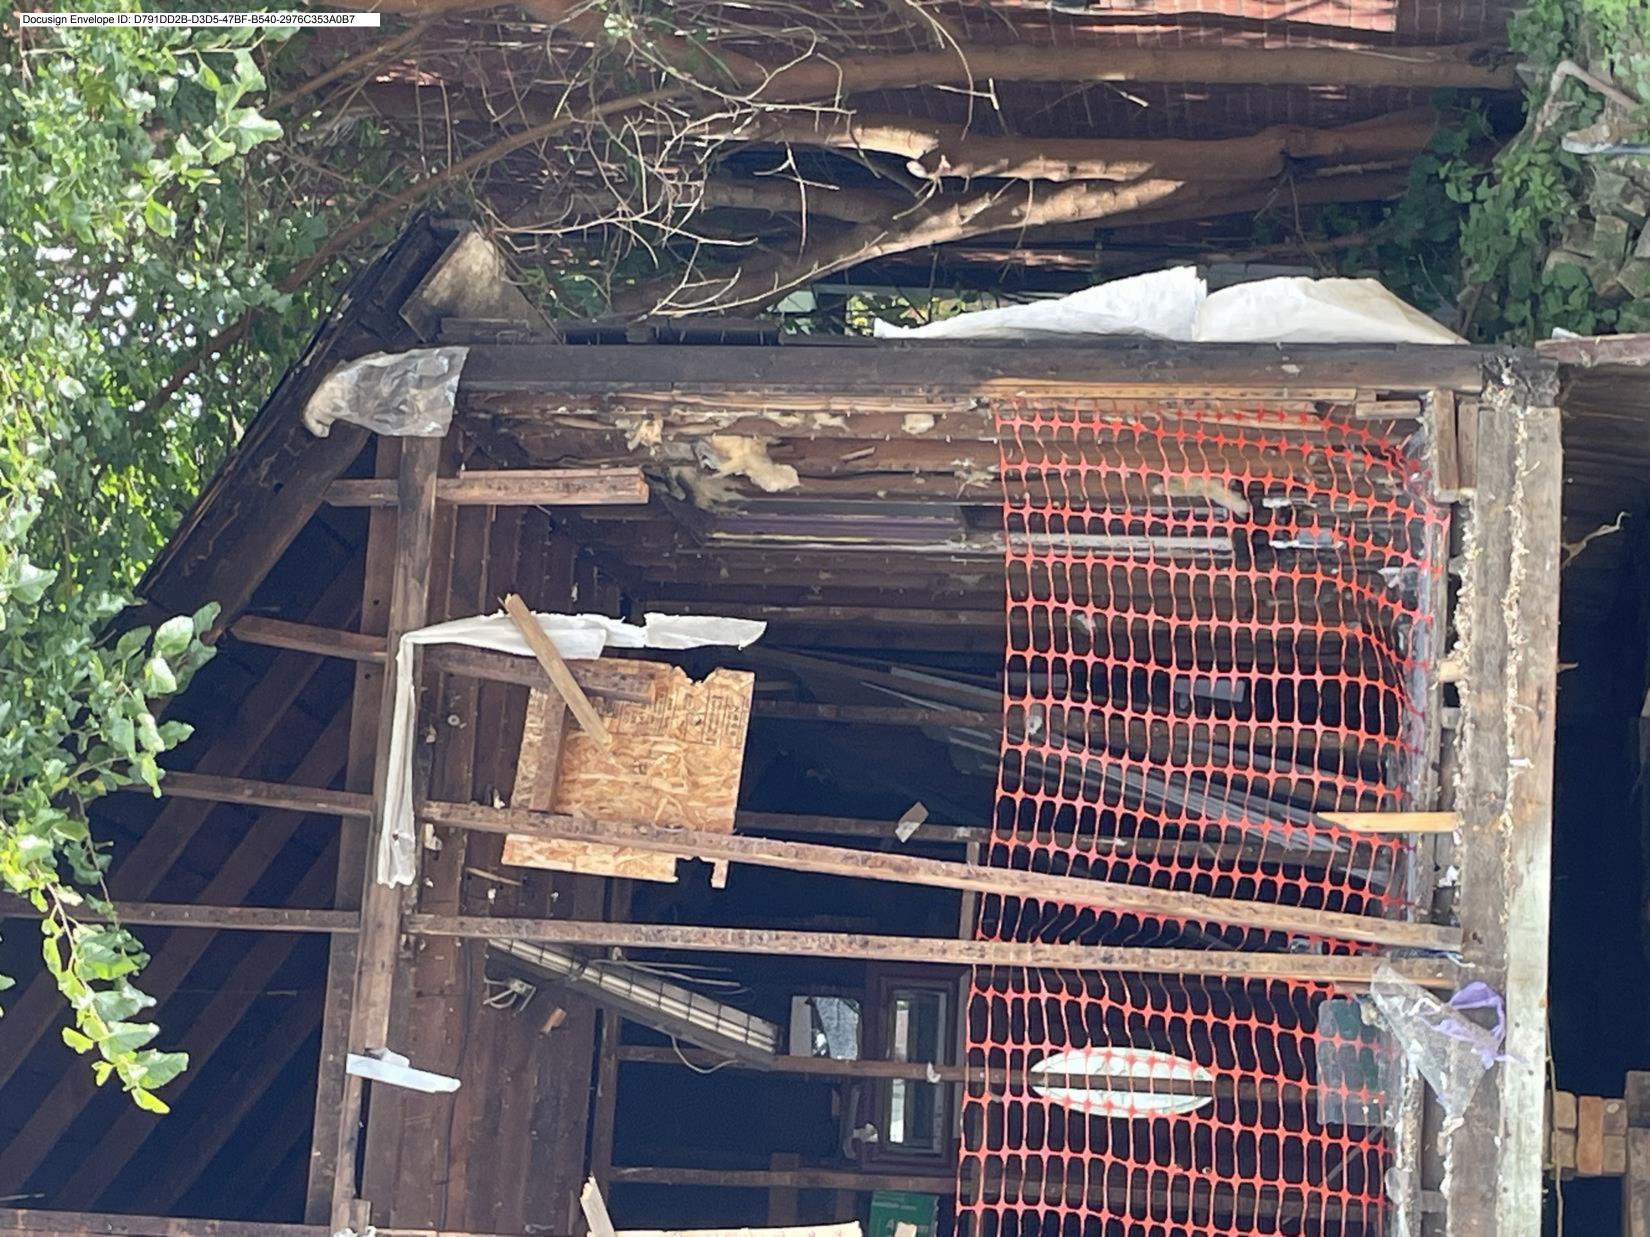
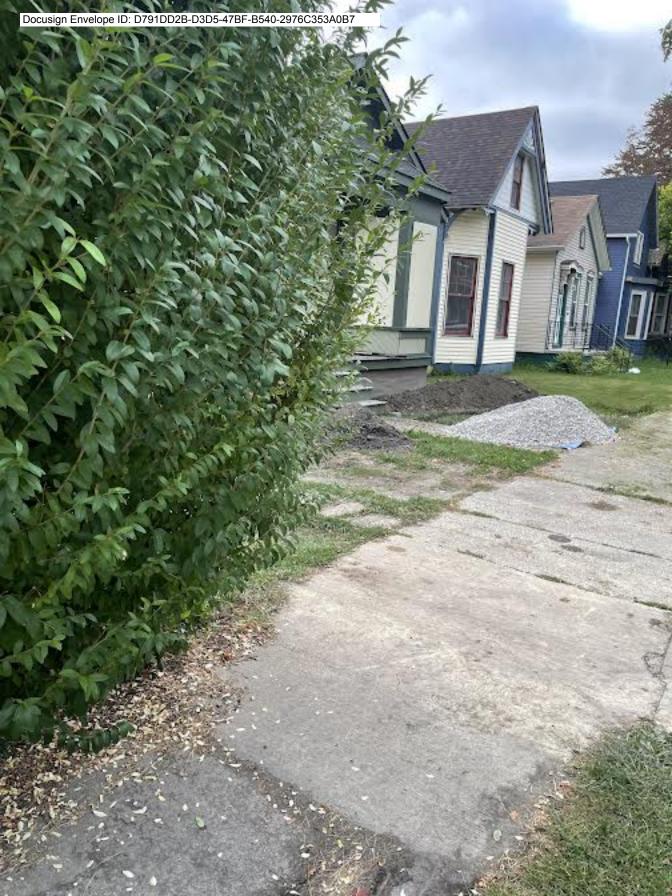
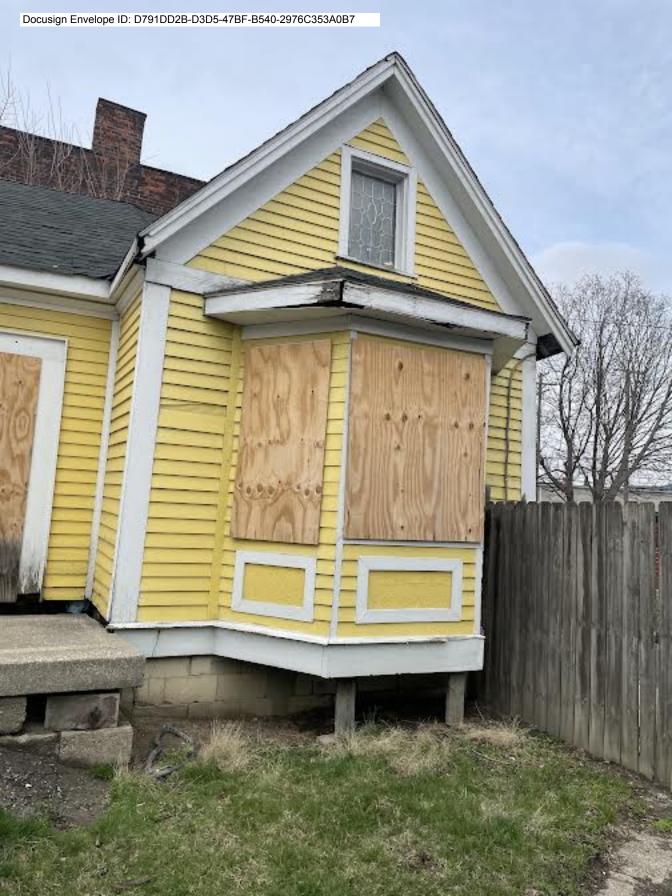
the home was left vacant with the back of the home open and exposed to the elements for more than 10 years according to the neighbors. A large hole showed some
