## 932 edison meeting

**APPLICATION NUMBER:** HDC2024-00609

**ADDRESS:** 932 EDISON

**Scope of Work:** • Replace existing windows • Rebuild the rear porch • Replace siding • Install a new pool  
FRONT SIDE OF HOUSE

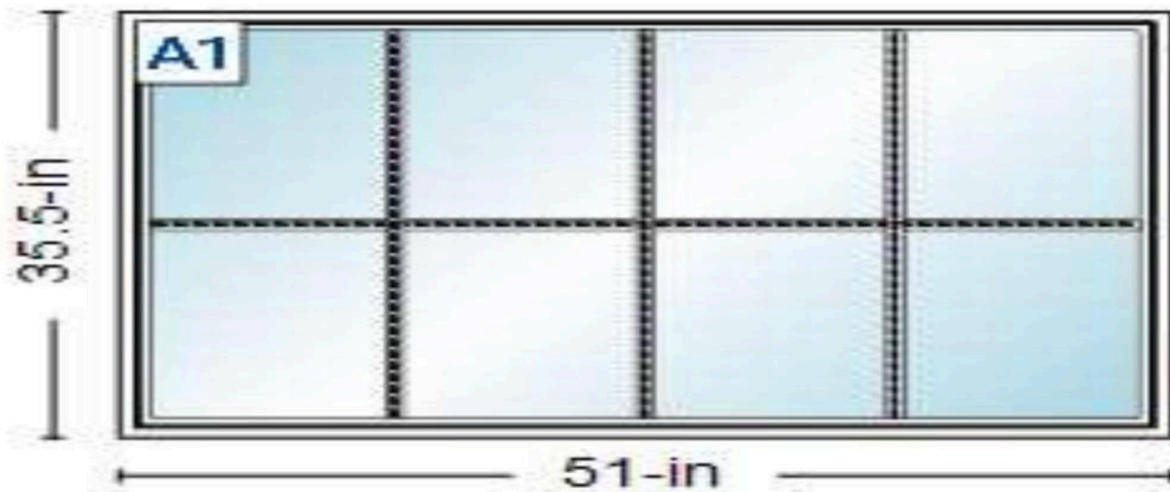
Lifestyle | Direct Set | Fixed Frame| aluminum yellowish white clad pella

- **Total Windows:** 54
- **Condition of Windows:** All 54 windows are damaged
  - **Types of Damage:**
    - Broken glass
    - Missing hardware
    - Deteriorated wood
    - Missing sash
    - Missing frames
    - Damaged sills

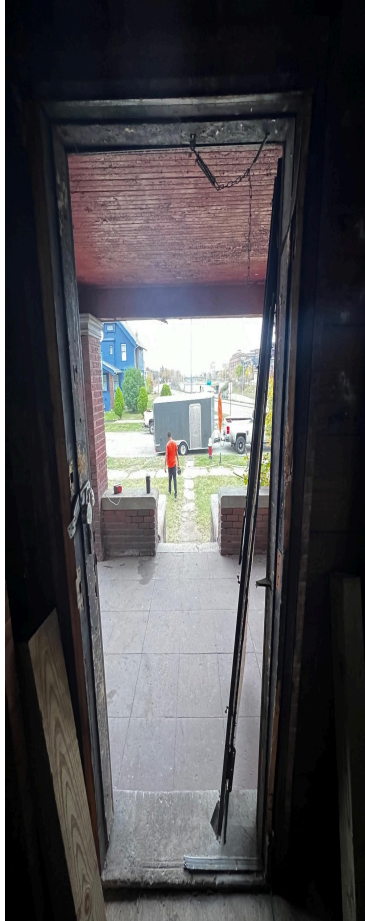
FIRST FLOOR ENTRY DOOR

- **Attic Window:** Missing one lower sash.
  - **Second Floor Windows:** Missing three upper sashes and four lower sashes.
  - **First Floor Window:** Missing one upper sash.
  - **Fascia (Around Balcony and Bay Window):** Completely rotted.
  - **Soffit:** Extensively rotted and falling apart.
  - **Cedar Shake:** Damaged, rotted, missing, and falling down.
  - **Stairs:** Deteriorating and falling apart.
  - **Front Door:** Missing.

I propose replacing the missing exterior front door on the first floor and the balcony door on the second floor. All remaining doors will be retained, repaired, and restored to their original condition.

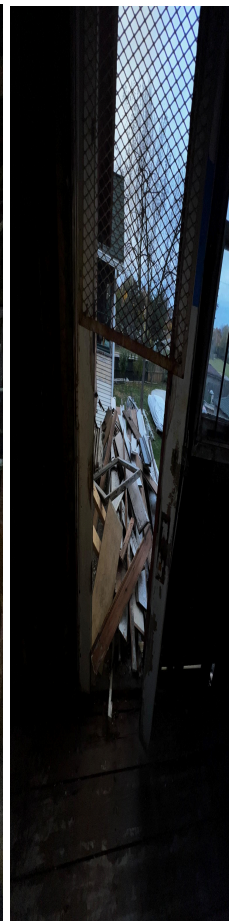
BALCONY DOOR

- Attic Window: Upper and lower sash missing.
- Second Floor Windows: Two lower sashes missing.
- First Floor Window: Upper and lower sash missing.
- Balcony Door: Damaged beyond repair.
- Cedar Shake Siding: Missing, rotted, and deteriorating.
- Second Floor Balcony: Rotted and collapsing.
- Back Porch: Collapsed; wood is rotted beyond repair.
- Basement Window: Missing.
- Gutters: Missing.

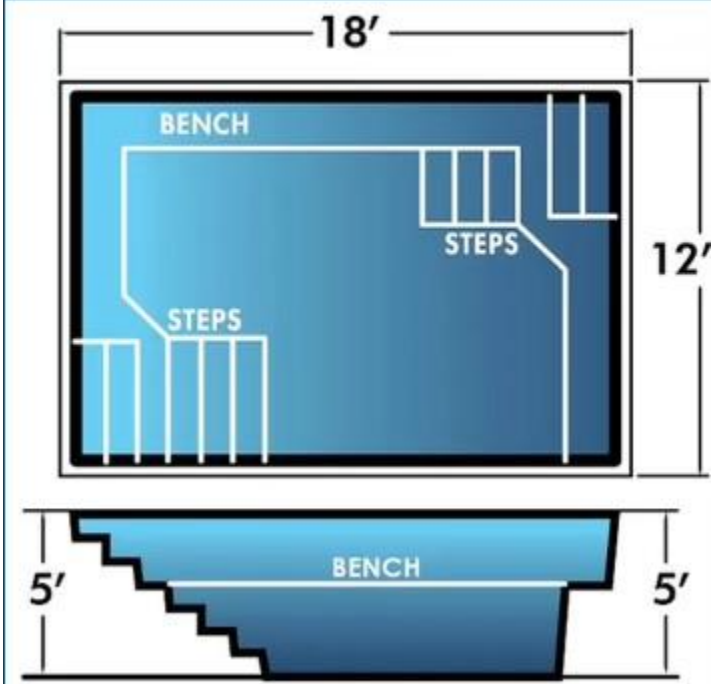
## Installation Schematics

The existing pool is currently inoperable, with its waterline completely gone and concrete walls deteriorating and showing signs of structural failure. We propose reducing the pool size to 12'x18' to allow for a safe and accessible pathway to the garage. This adjustment will enhance both safety and functionality for the property.
