**RE: 19566 Canterbury
Detroit, MI
Formal Proposal**

Based on the inspection at 19566 Canterbury Road in Detroit, MI, more than 65% of the windows at the residence are **not** repairable due to the fact that we are unable to get the parts. My recommendation is to replace the windows with Quaker Historic.

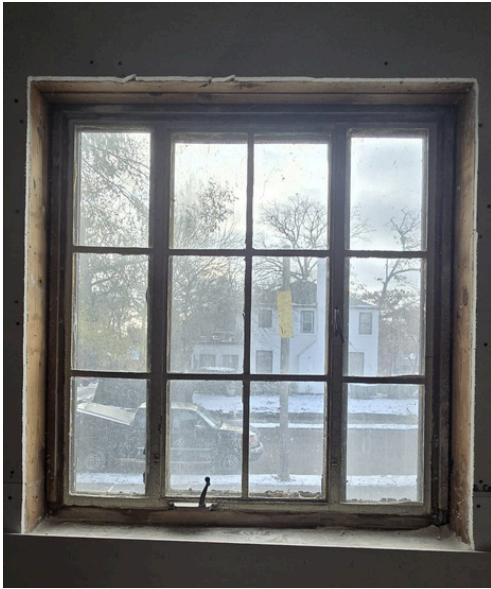
Window Number: 1F

Window Location: Kitchen

Broken Panes: None

Operational: Yes

Hardware Condition: Operable

Notes: Window is functional and hardware is operation.

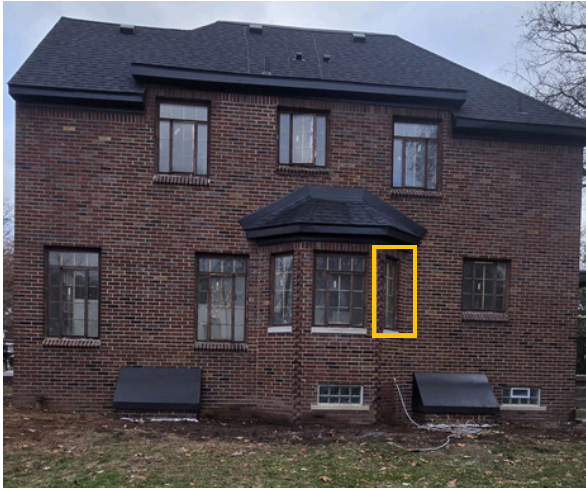
Window Number: 2F

Window Location: Kitchen

Broken Panes: None

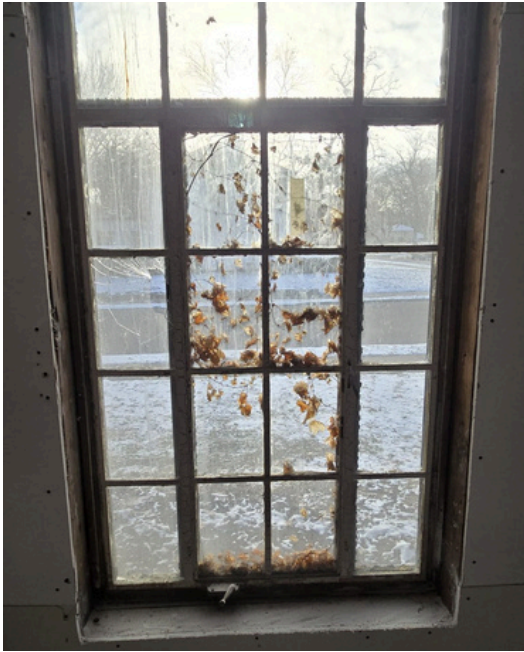
Window Number: 5F

Window Location: Dining Room

Broken Panes: One

Operational: Cannot Latch

Hardware Condition: Fair

Notes: Window frame has a deformation with a span differential of one 1/2 inch between the top and bottom of the frame.

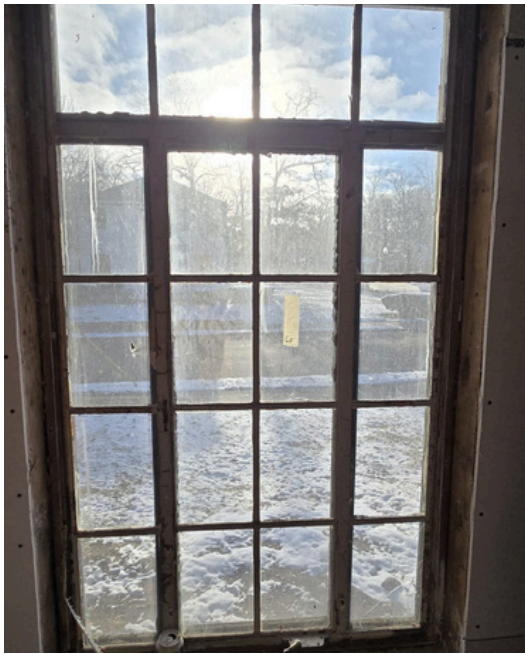
Window Number: 6F

Window Location: Dining Room

Broken Panes: One

Operational: Latch is Bent but Operable

Hardware Condition: Bent

Notes: Window frame has a deformation with a span differential of one 1/4 inch between the top and bottom of the frame.

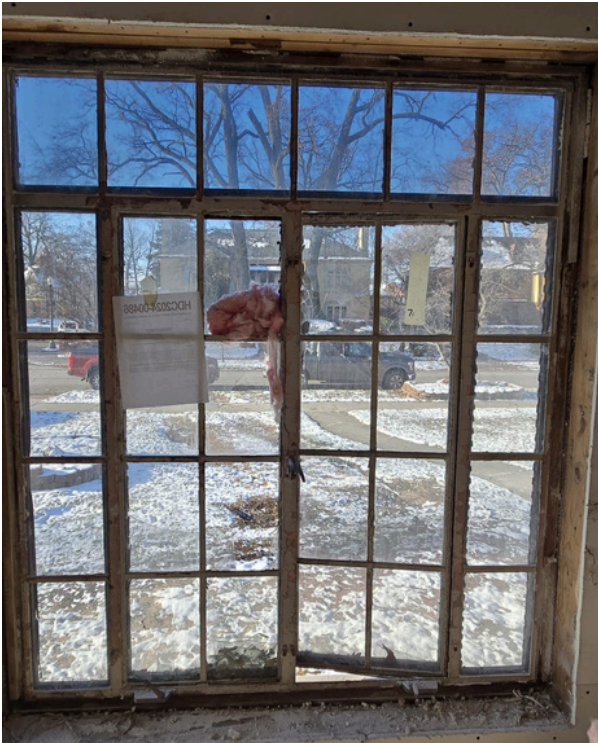
Window Number: 7F

Window Location: Dining Room

Broken Panes: Five

Operational: Left side will close, right side cannot close even with outside pressure.

Hardware Condition: Bent and Not-Operable

Notes: The left side of the window has a deformation with a span differential of one 1/2 inch between the top and bottom.

The right side of the window does not close, even when outside pressure is applied.

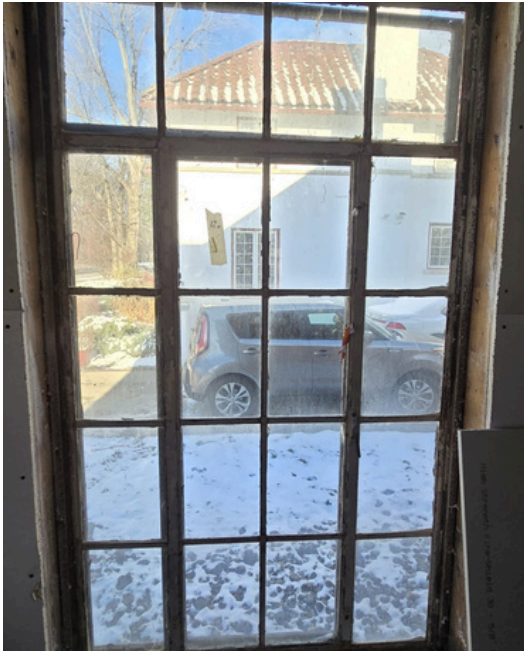
Window Number: 12F

Window Location: Living Room

Broken Panes: None

Operational: Will Latch

Hardware Condition: Operable

Notes: Window frame has a slight deformation of 1/8 inch between the top and bottom.

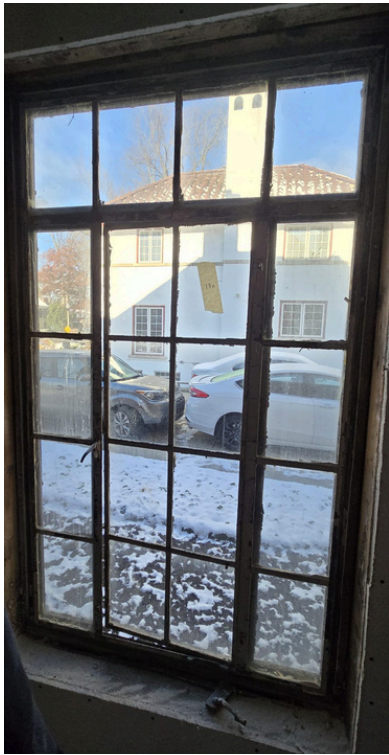
Window Number: 13F

Window Location: Living Room

Broken Panes: None

Operational: Closes only with outside pressure applied

Hardware Condition: Bent and Latches only with extreme force applied

Notes: Window frame has a deformation with a span differential of 1/4 inch between the top and bottom of the frame.

The window frame is also bowed by almost 3/8 of an inch.

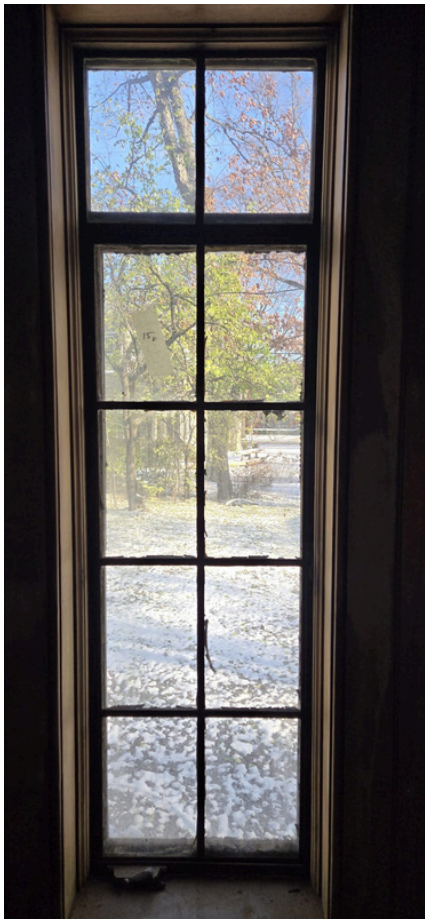
Window Number: 15F

Window Location: Library

Broken Panes: None

Operational: Closes only with outside pressure applied

Hardware Condition: Bent and Latches only with extreme force applied

Notes: Window frame has a deformation with a span differential of $\frac{3}{8}$ inch between the top and bottom of the frame.

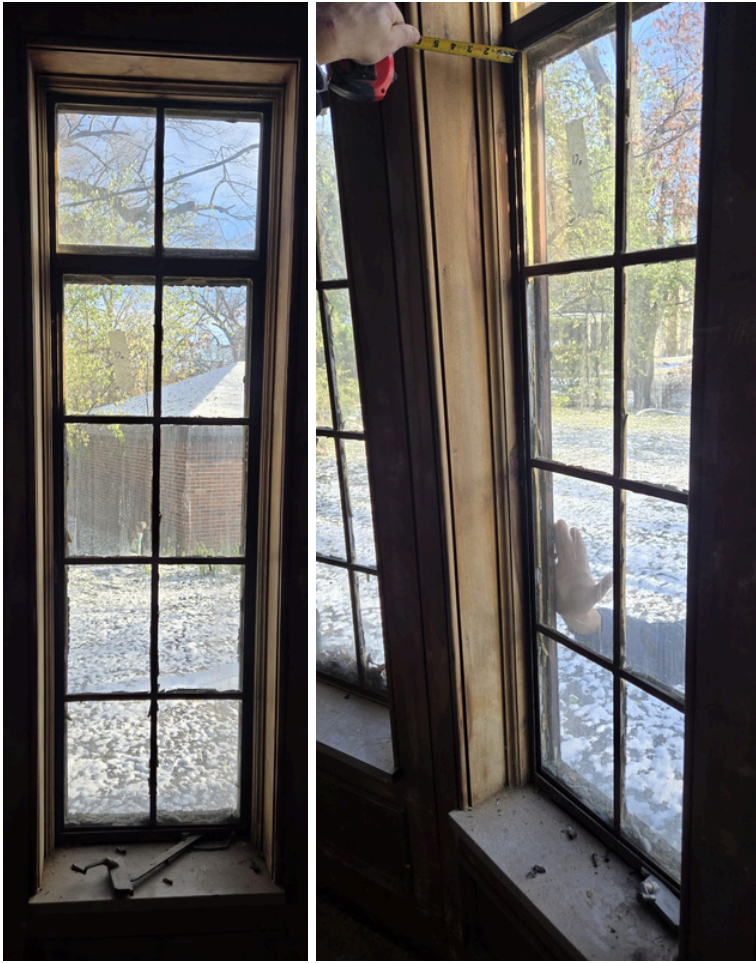
Window Number: 17F

Window Location: Library

Broken Panes: None

Operational: Closes only with outside pressure applied

Hardware Condition: Latch is missing. Hardware is bent and broken.

Notes: Window frame has a deformation with a span differential of over 1/4 inch between the top and bottom of the frame. Gap is present even when pressure is applied from the outside to close the window.

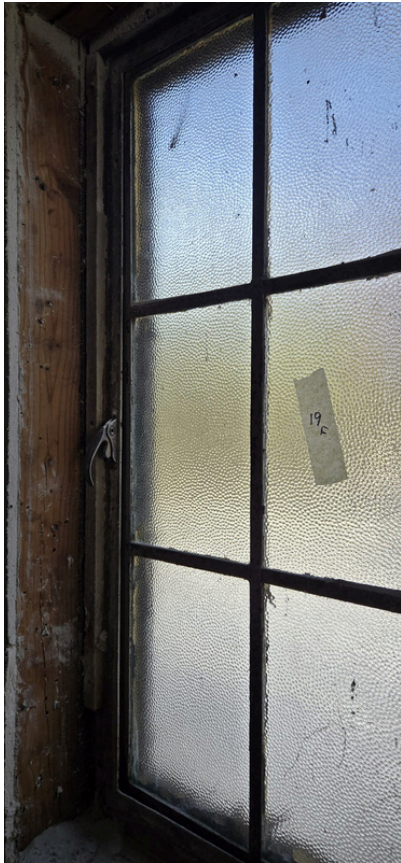
Window Number: 19F

Window Location: Pantry

Broken Panes: None

Operational: Does not latch

Hardware Condition: Broken in multiple places

Notes: Window frame has a deformation with a span differential of one 1/2 inch between the top and bottom of the frame.

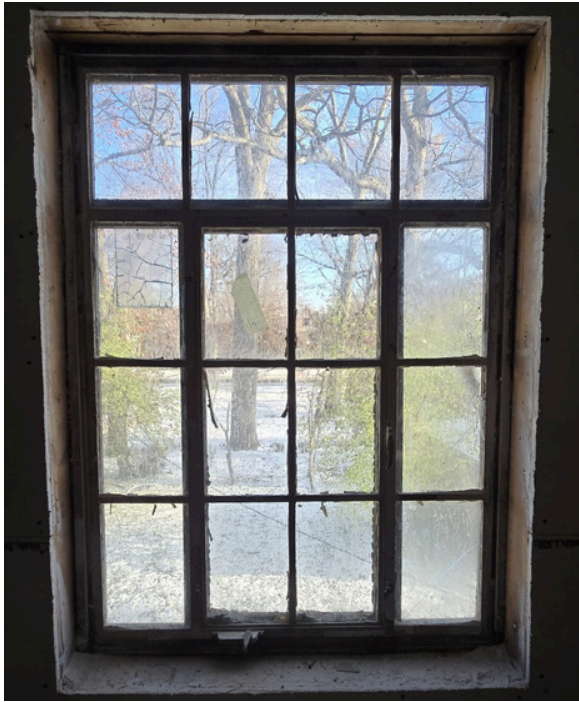
Window Number: 1S

Window Location: Rear Bedroom

Broken Panes: Two

Operational: Window closes and latches as intended

Hardware Condition: Operational

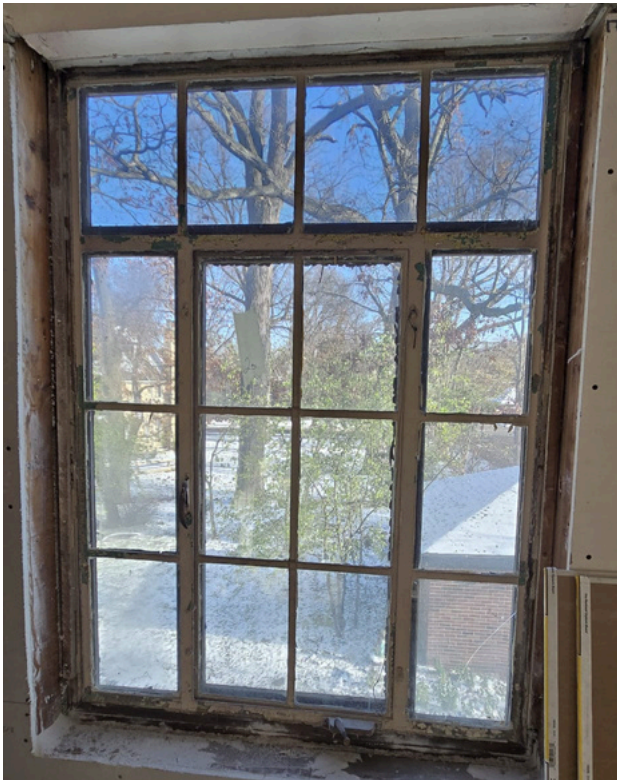
Window Number: 2S

Window Location: Rear Bedroom

Broken Panes: One

Operational: Window does not Latch

Hardware Condition: Operational

Notes: Window frame has a deformation with a span differential of just under 1/4 inch between the top and bottom of the frame.

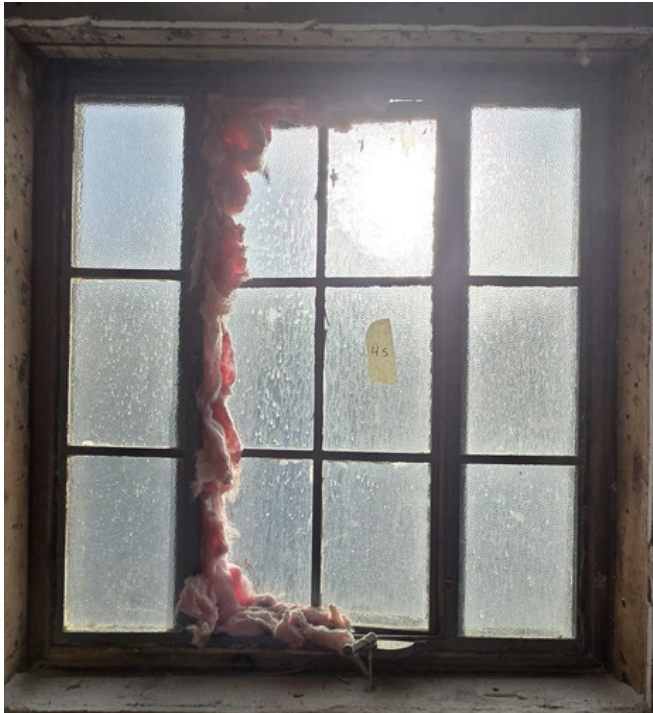
Window Number: 4S

Window Location: Main Bathroom

Broken Panes: None

Hardware Condition: Broken and missing pieces

Notes: Window cannot be secured due to broken hardware.

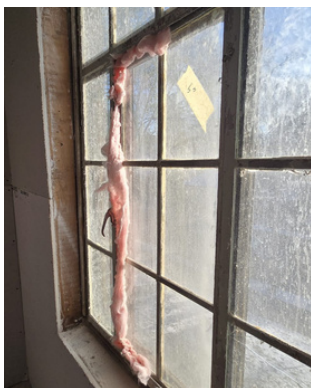
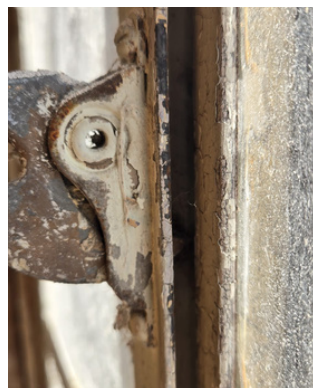
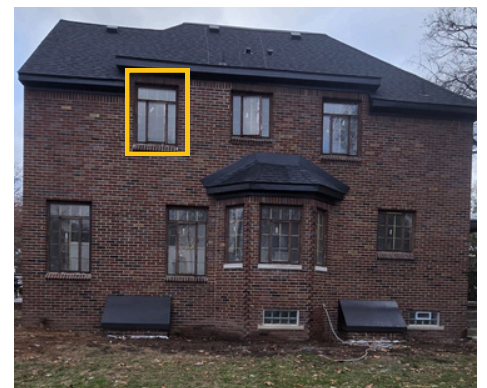
Broken Panes: One

Hardware Condition: Broken, unable to close.

Notes: Window frame has a deformation with a span differential of just under $\frac{3}{8}$ inch between the top and bottom of the frame.

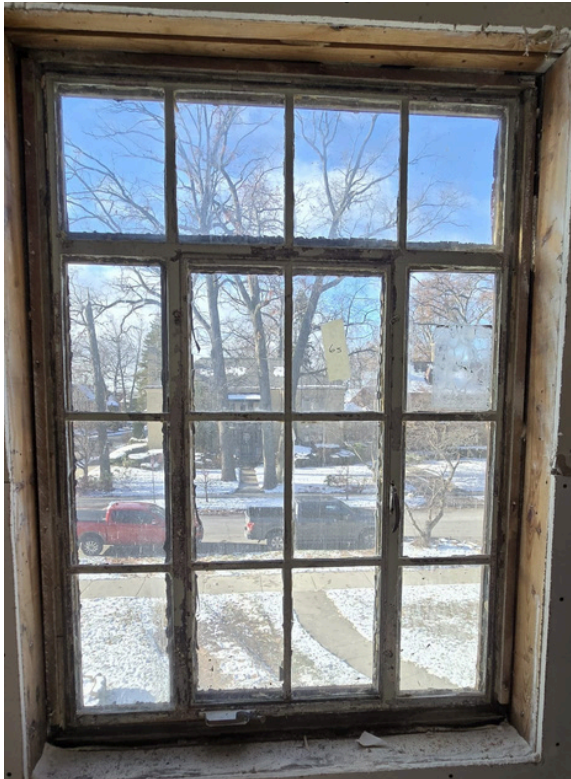
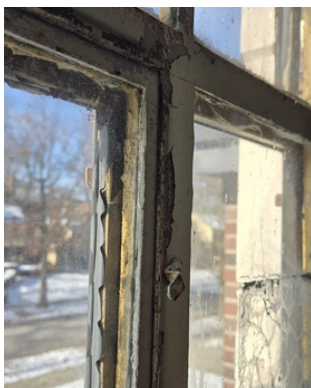
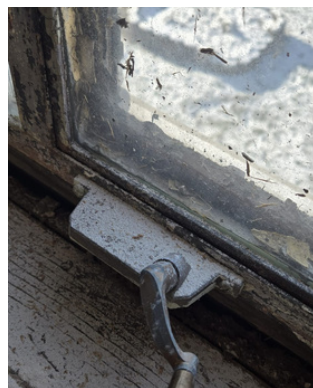
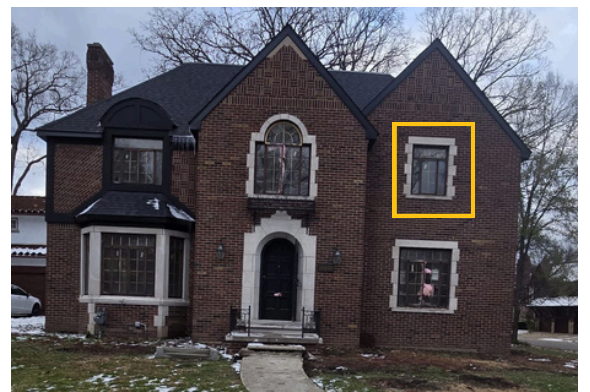
Window Number: 6S

Notes: Even though the window operates as intended, the frame still shows signs of neglect with a larger gap at the bottom than at the top.

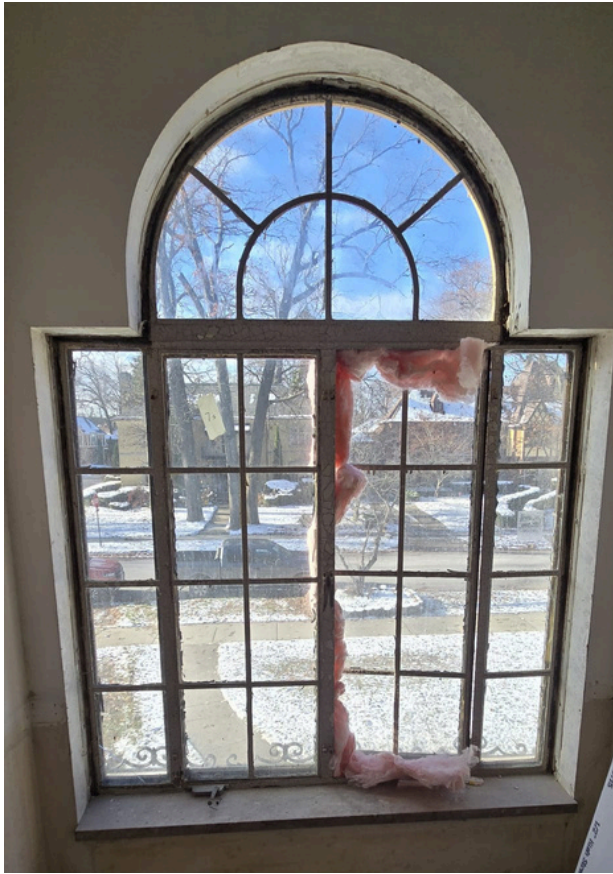
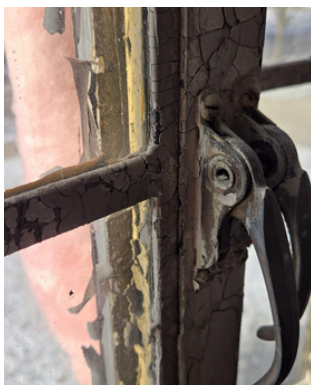
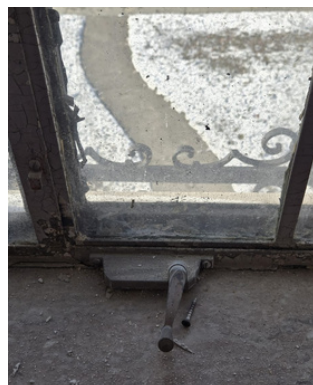
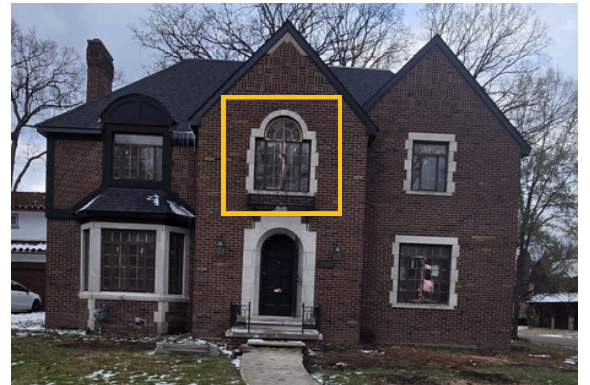
Window Number: 7S

Broken Panes: One

Operational: Left side of window closes and latches as intended. The right side of the window is unable to close completely, even with outside pressure.

Hardware Condition: Left side operational and Right side broken

Notes: Brick Molding on both sides of the window is actively wet and breaking apart.

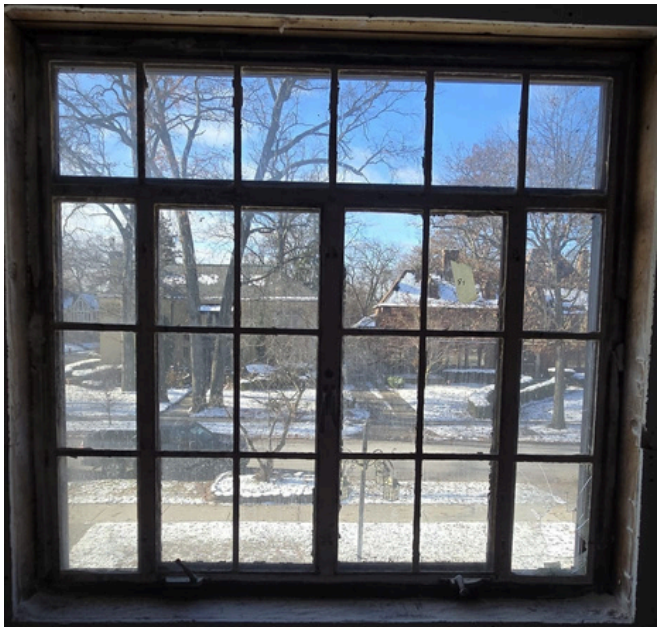
Window Number: 8S

Broken Panes: One

Operational: Left side has a significant gap and the right side closes as intended

Hardware Condition: Left is Broken and the Right side is operational.

Notes: hardware has been replaced and does not match.

Window frame has a deformation with a span differential of just under 3/8 inch between the top and bottom of the frame.

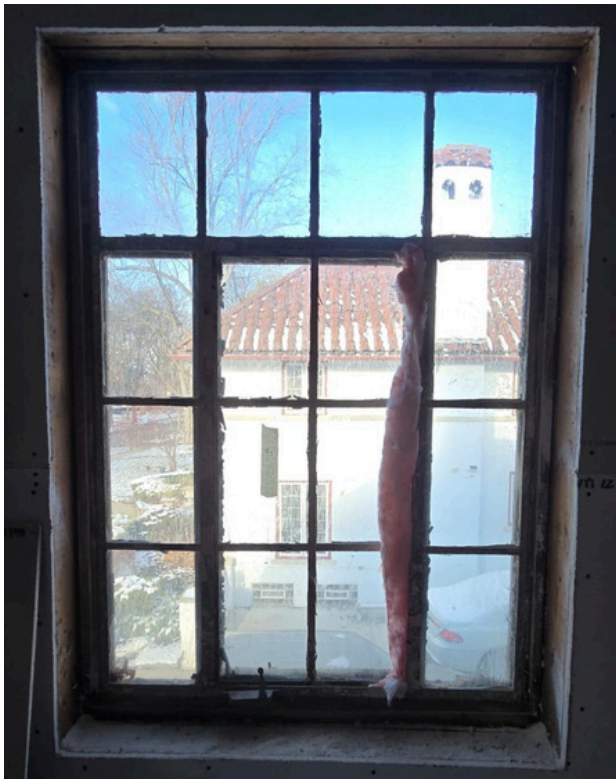
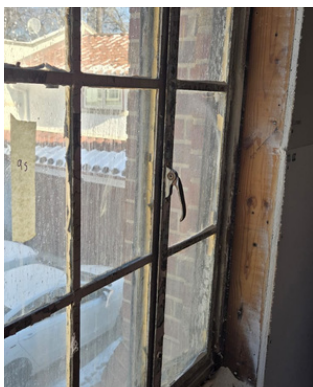
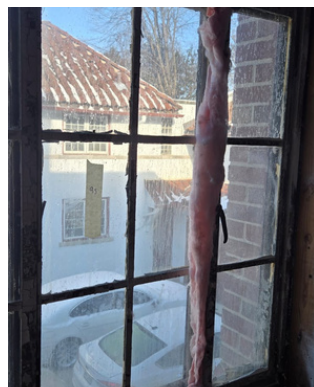
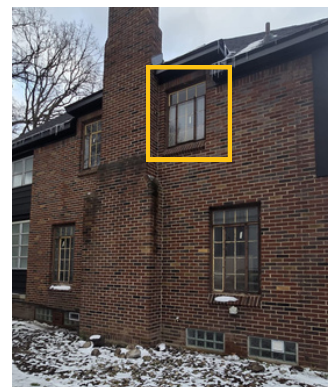
Window Number: 9S

Operational: Will open but will not close without assistance and does not latch

Hardware Condition: Mechanism arm is bent

Notes: Window frame has a deformation with a span differential of just under 1/4 inch between the top and bottom of the frame.
