HISTORIC DISTRICT COMMISSION APPLICATION FOR WORK APPROVAL

APPLICATION ID
HDC2025-00014

ADDRESS(ES): 24293 Telegraph Road
HISTORIC DISTRICT: Russell Woods-Sullivan

Window & Siding Replacement

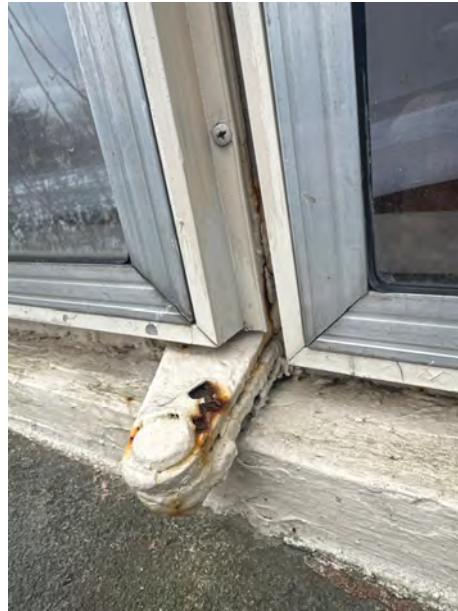
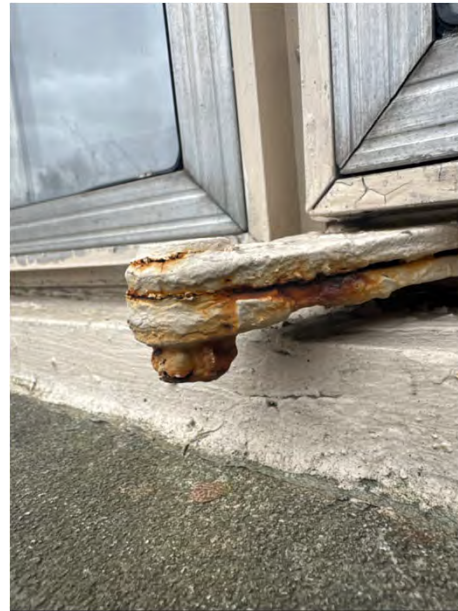
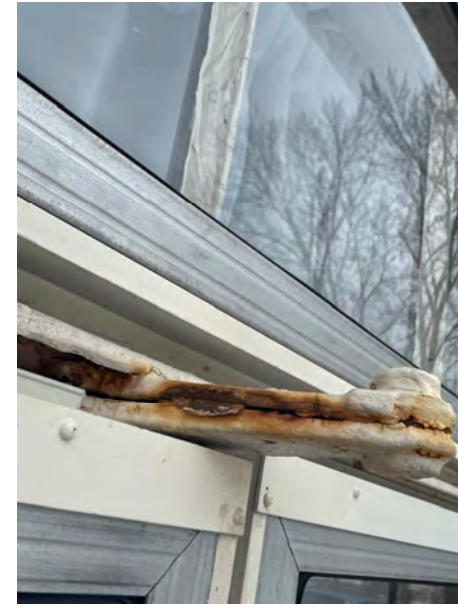
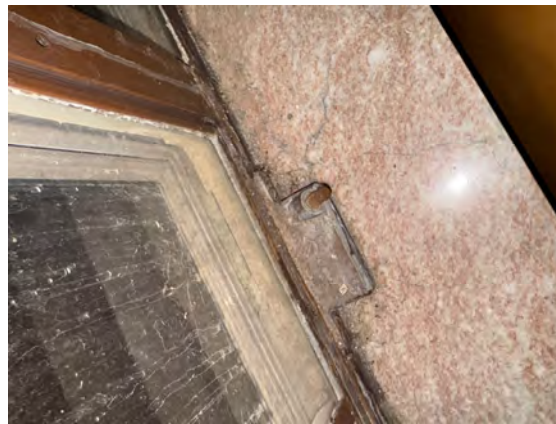
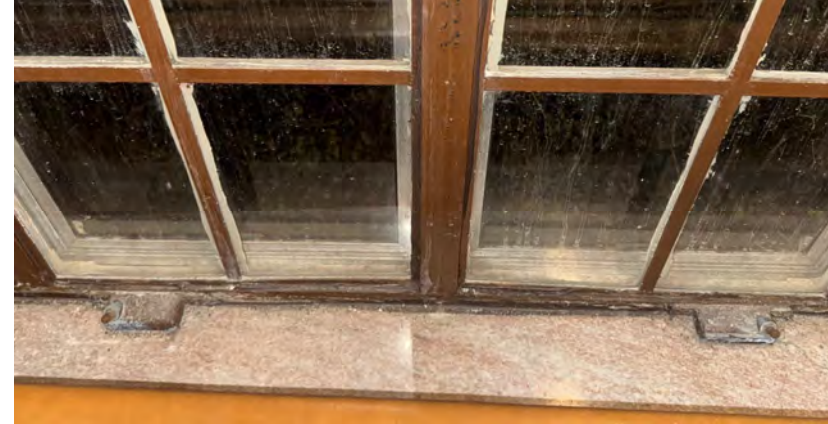
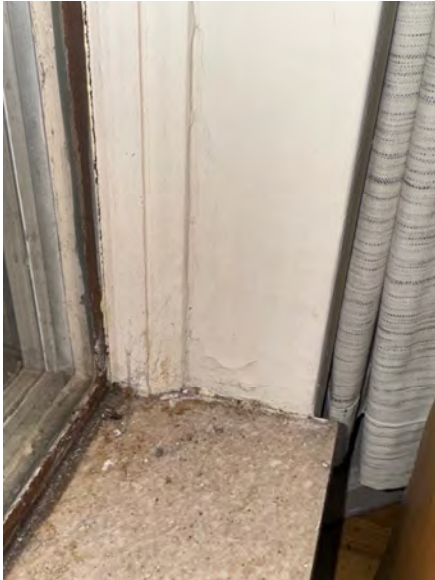
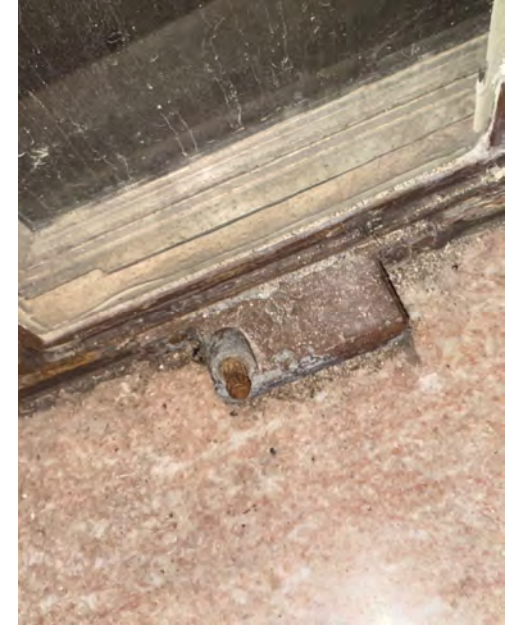
1- hardware and window rusted shut, inoperable. Fails to meet egress/code

- Deteriorated wood in window frame compromising structural integrity
- Rusted gears in casement windows
- Inoperability: Window is sealed shut. Non-functioning windows exacerbate the non-compliance, as they cannot serve as emergency exits or provide adequate ventilation. Repair is not a feasible solution when operability cannot be restored due to structural and mechanical issues.
- Non code compliance: Failure to Meet Egress Standards: The windows do not meet egress requirements, making them unsafe and non-compliant with current building codes. This is particularly problematic for emergency escape routes.

1. Rusted Gear in Casement Window:

•**Functional Obsolescence:** A rusted gear in a casement window has lost its mechanical integrity, preventing smooth or reliable operation. Rust compromises the precise movement required for opening and closing, and repairs (e.g., lubrication or partial component replacement) often fail to restore full functionality due to corrosion spread across interconnected parts.

•**Safety Concerns:** A malfunctioning gear could lead to sudden failure, making the window unsafe for operation. As per guidelines, operability is essential to preserve the historic character of windows

Full Replacement Justification:

- Holistic Solution:** Full replacement with wood windows featuring aluminum cladding ensures compliance with historic guidelines while addressing durability, functionality, and weatherproofing.
- Long-Term Preservation:** The new windows will match the original design while incorporating modern materials that prevent recurrence of these issues. Proper water grading, operability, and protection against further deterioration are integral to preserving the building's structural and historical integrity

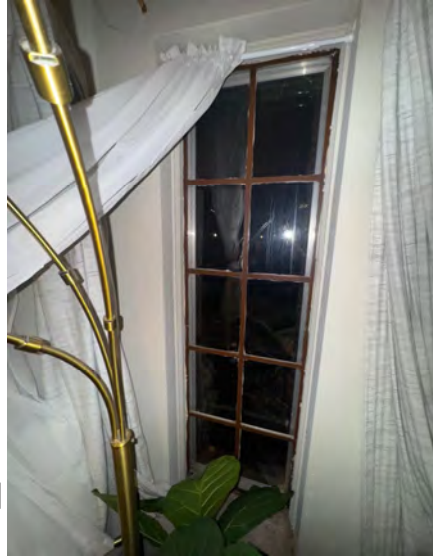
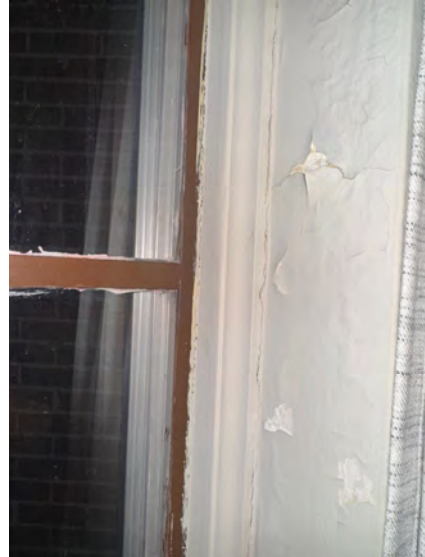
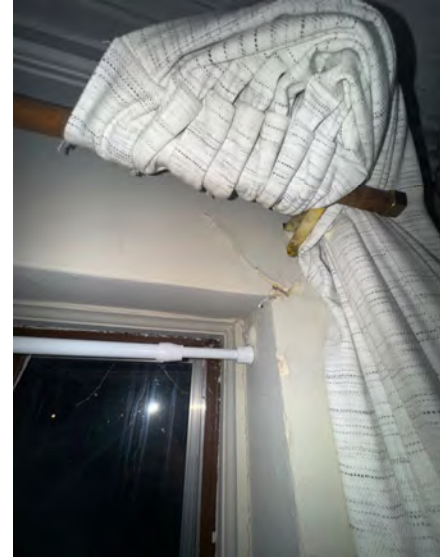
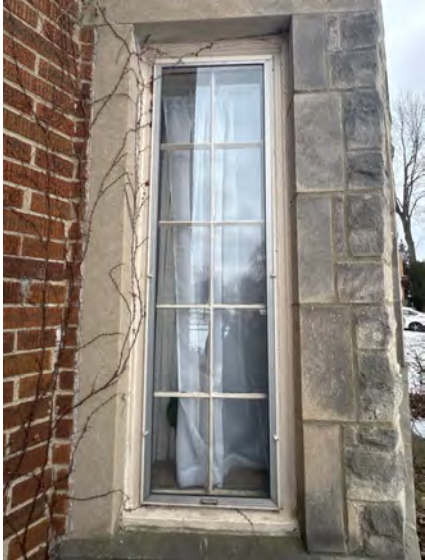
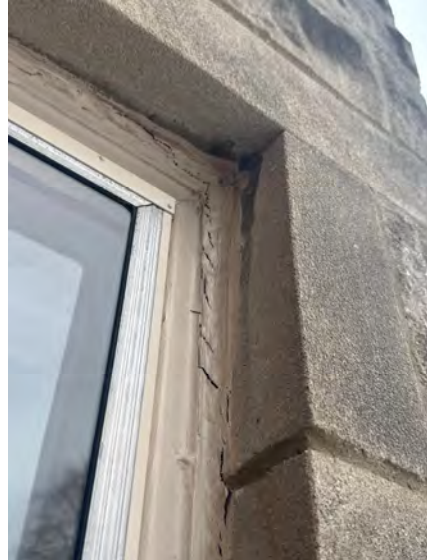
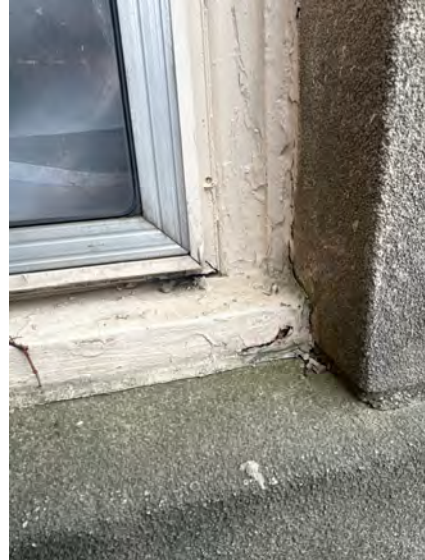
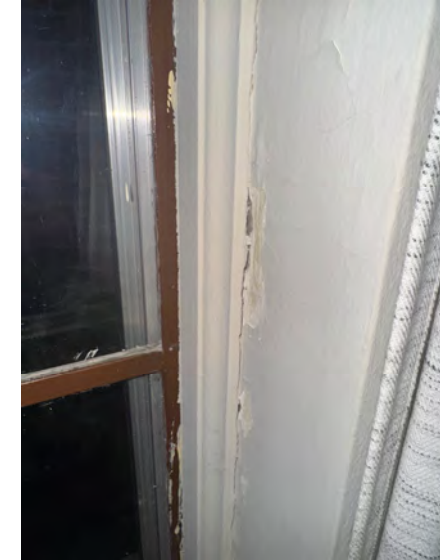
- Deteriorated wood in window frame compromising structural integrity
- Extensive water damage shows extreme deterioration, compromising structural integrity of the window and weatherproofing ability

Window 2: Interior

Water Damage to Interior Walls:

- **Evidence of Intrusion:** Photographs demonstrate water infiltration through the windows, leading to damage such as stained walls, mold growth, and potential weakening of wall structures. This evidence underscores the windows' failure to provide a proper seal against weather.
- **Health and Safety Issues:** Mold and water damage present serious health risks to occupants, violating modern building codes that require healthy and habitable living conditions.

Deteriorated Wood on exterior:

• **Loss of Structural Integrity:** Wood that has deteriorated due to moisture, mold, or rot no longer provides adequate support for the window assembly. This compromises the entire frame's stability and may pose a safety hazard.

Replacement is necessary when repair is not technically feasible or when deterioration affects the window's ability to retain its shape, support glass, and maintain weatherproofing. Aluminum-clad wrapping further ensures long-term durability by protecting against future moisture and weather-related damage

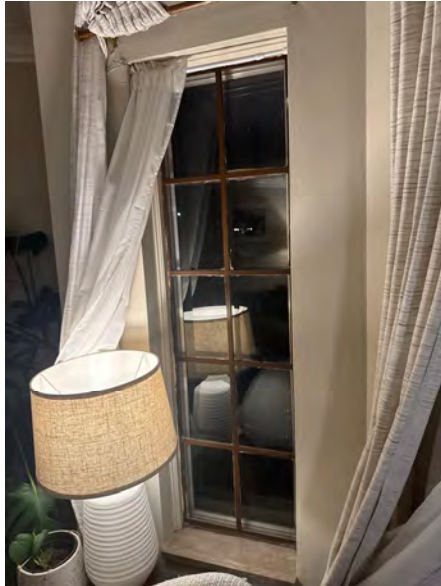
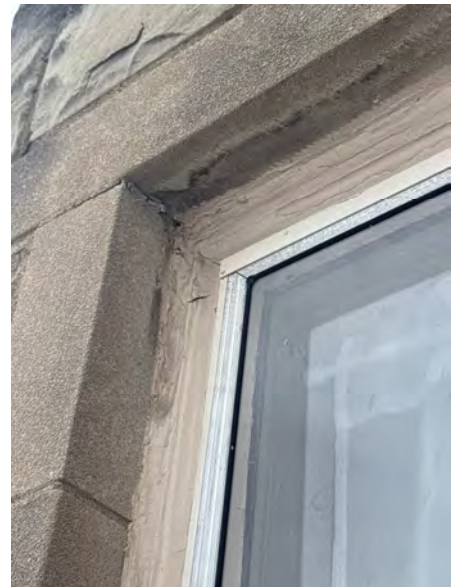
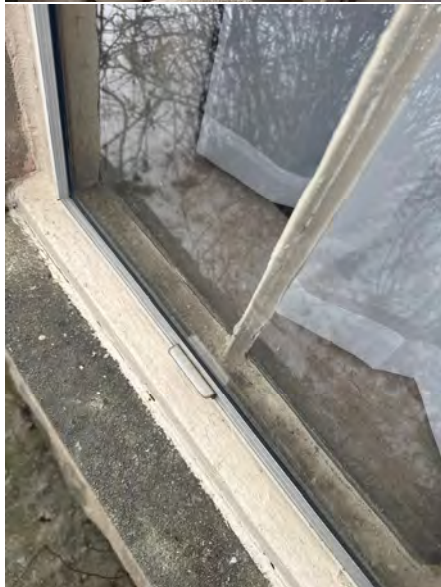
Window 3:

- Evidence of exterior wood frame rot
- Evidence of mold between storm window and original window

- **Deteriorated Wood on exterior:**
- **Loss of Structural Integrity:** Wood that has deteriorated due to moisture, mold, or rot no longer provides adequate support for the window assembly. This compromises the entire frame's stability and may pose a safety hazard.
- **Guideline Requirements:** Replacement is necessary when repair is not technically feasible or when deterioration affects the window's ability to retain its shape, support glass, and maintain weatherproofing. Aluminum-clad wrapping further ensures long-term durability by protecting against future moisture and weather-related damage

- **Compromised Integrity:** Mold indicates prolonged moisture exposure, often leading to weakened or deteriorated materials that cannot be effectively repaired, necessitating full replacement.
- **Health Hazards:** Mold poses significant health risks (e.g., respiratory issues) and can persist in porous materials, making replacement essential to fully eliminate the issue and prevent recurrence.
- **Underlying Moisture Issues:** Mold is often caused by structural defects like improper grading or seals, which require replacement to correct and ensure future moisture resistance.
- **Code and Safety Compliance:** Replacement ensures compliance with modern building codes and health standards, providing a safe, mold-free environment while preventing further damage.

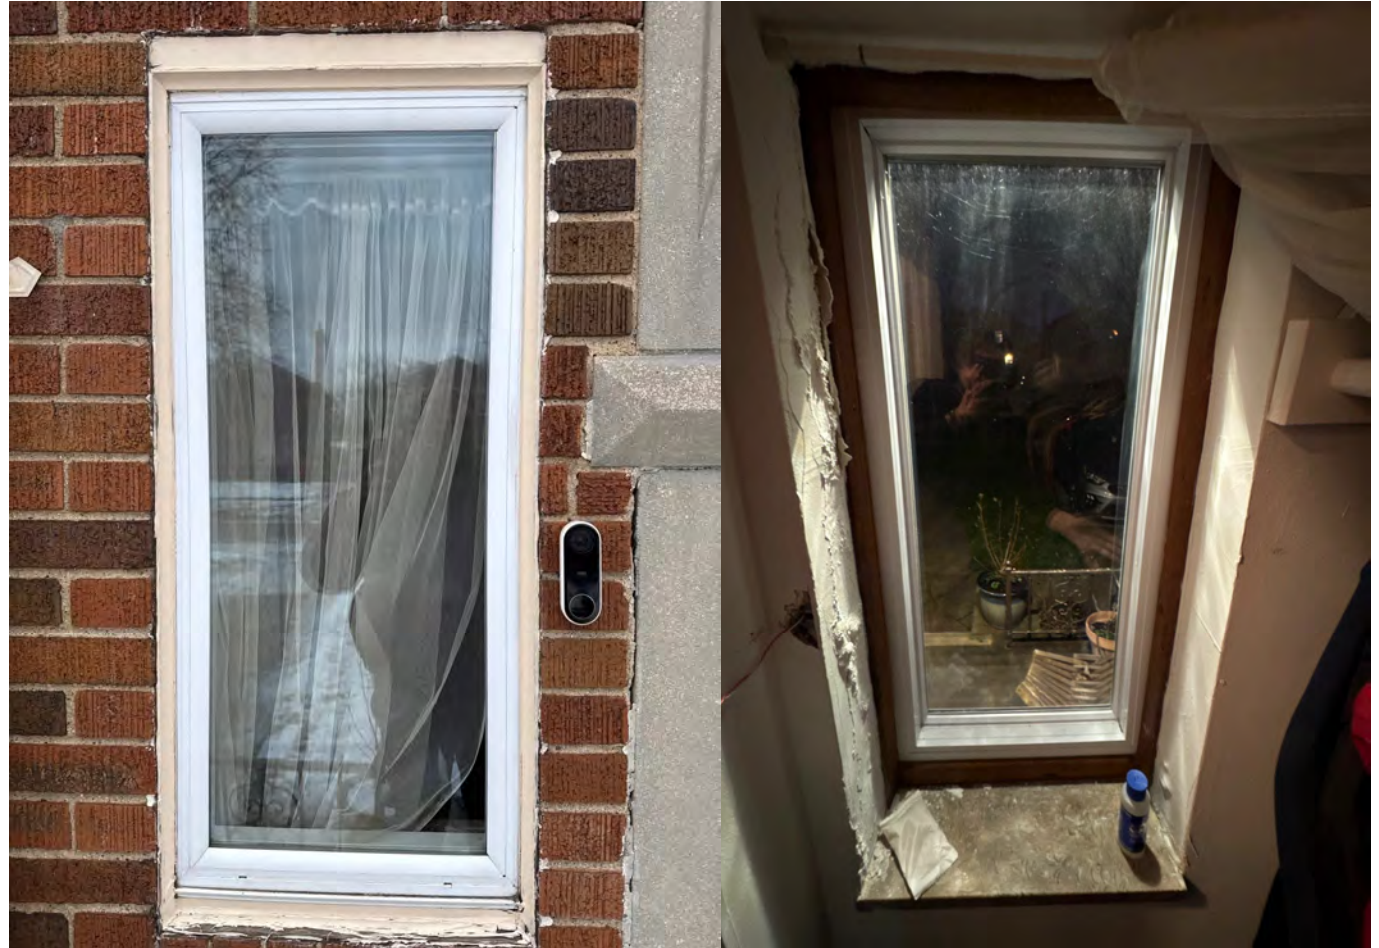
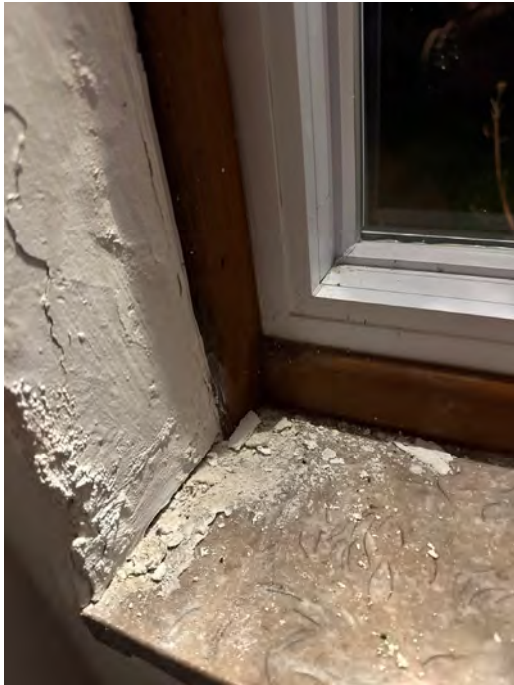
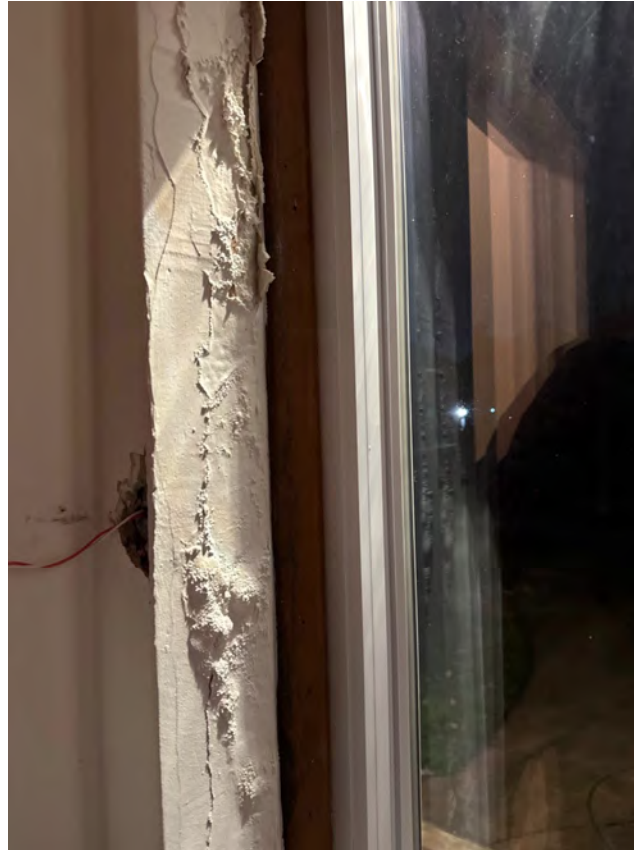
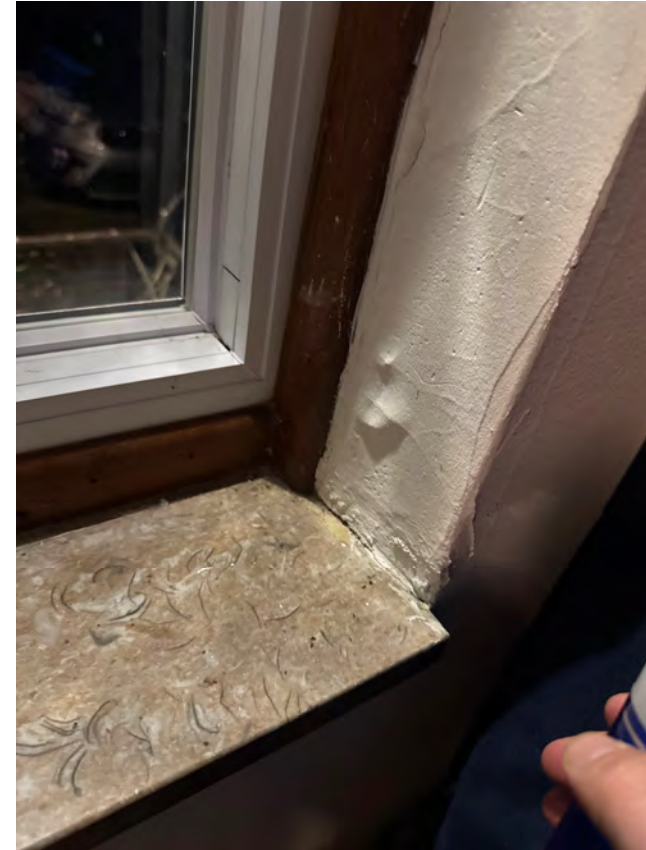
Window 13:

- Vinyl
- Marble sill will be preserved to maintain historical correctness

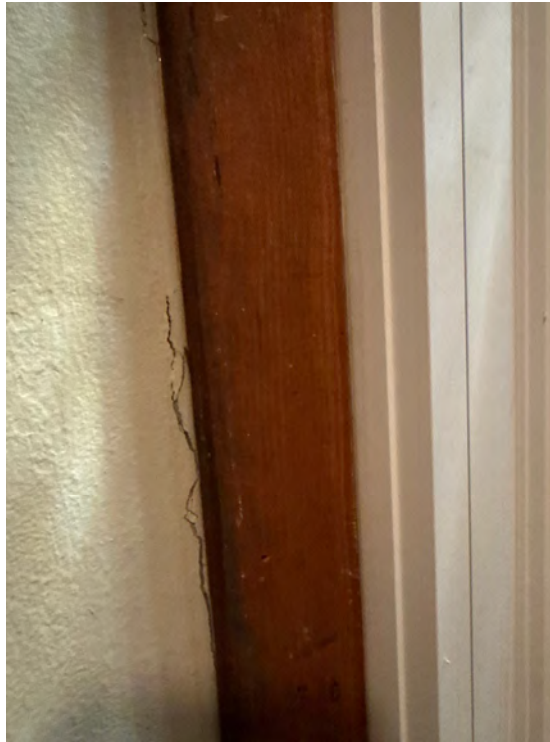
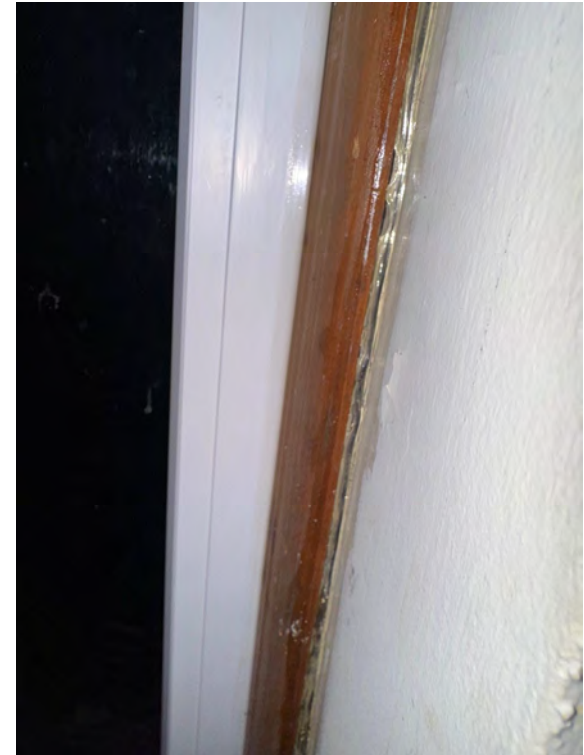
Window 14:

- Vinyl
- Marble sill will be preserved to maintain historical correctness

- Repairs with clear silicone caulk were attempted
- vinyl

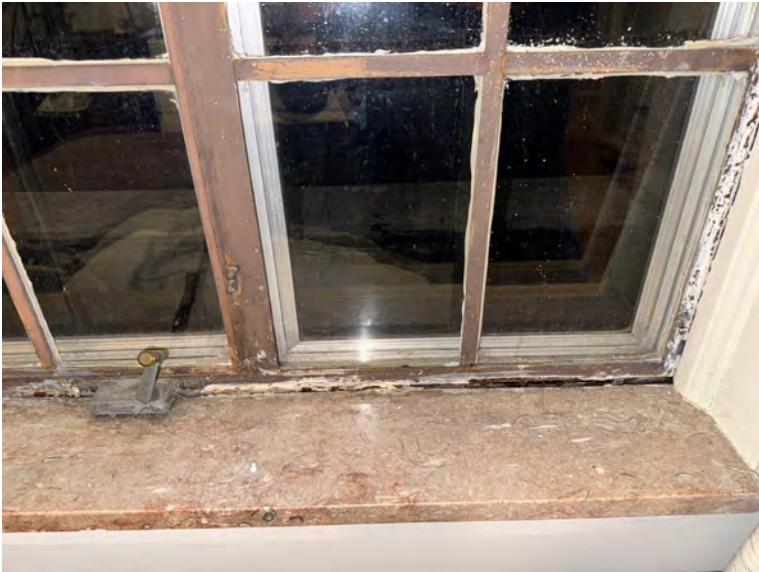
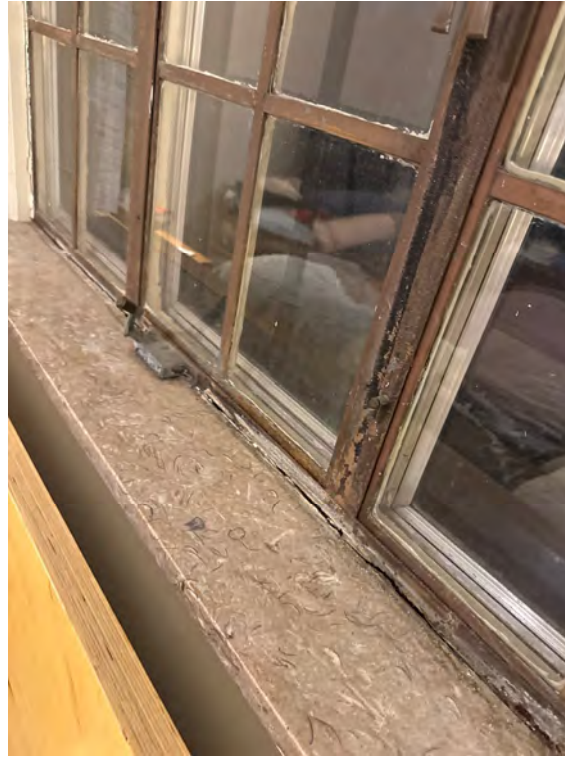
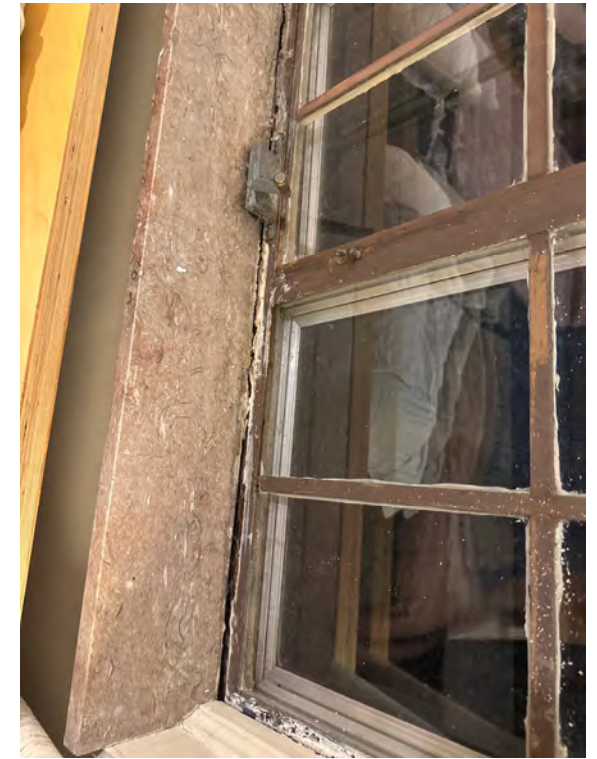
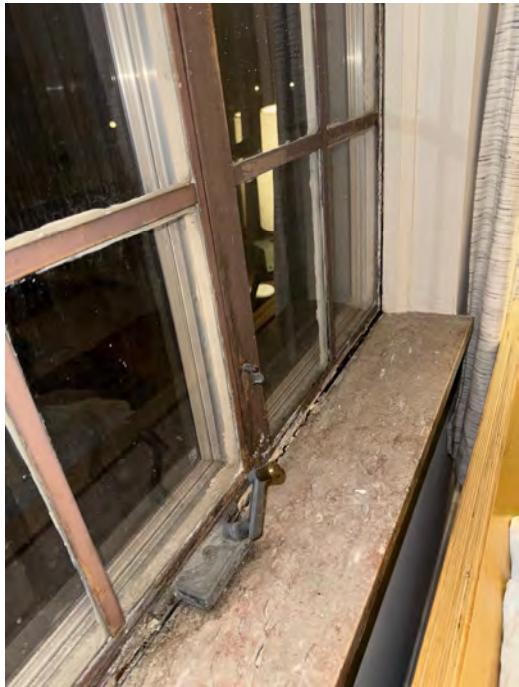
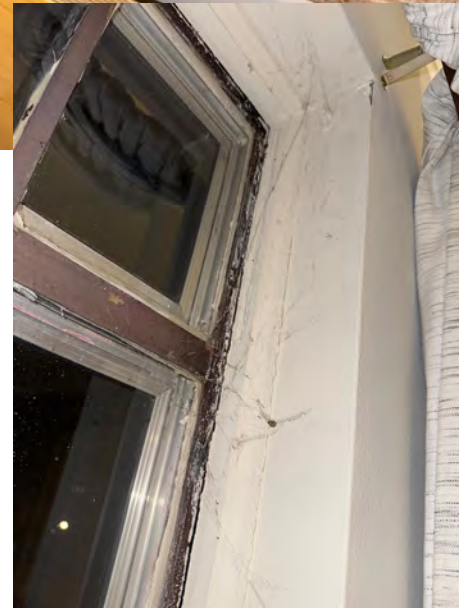
Window 16 (continued)

16- Master bedroom: substantial gaps in weather proofing, only one casement window opens due to hardware rusted shut, fails to meet egress/code

- substantial gaps in weather proofing,
- only one casement window opens due to hardware rusted shut,
- fails to meet egress/code

- Substantial gaps
- Substantial rusting

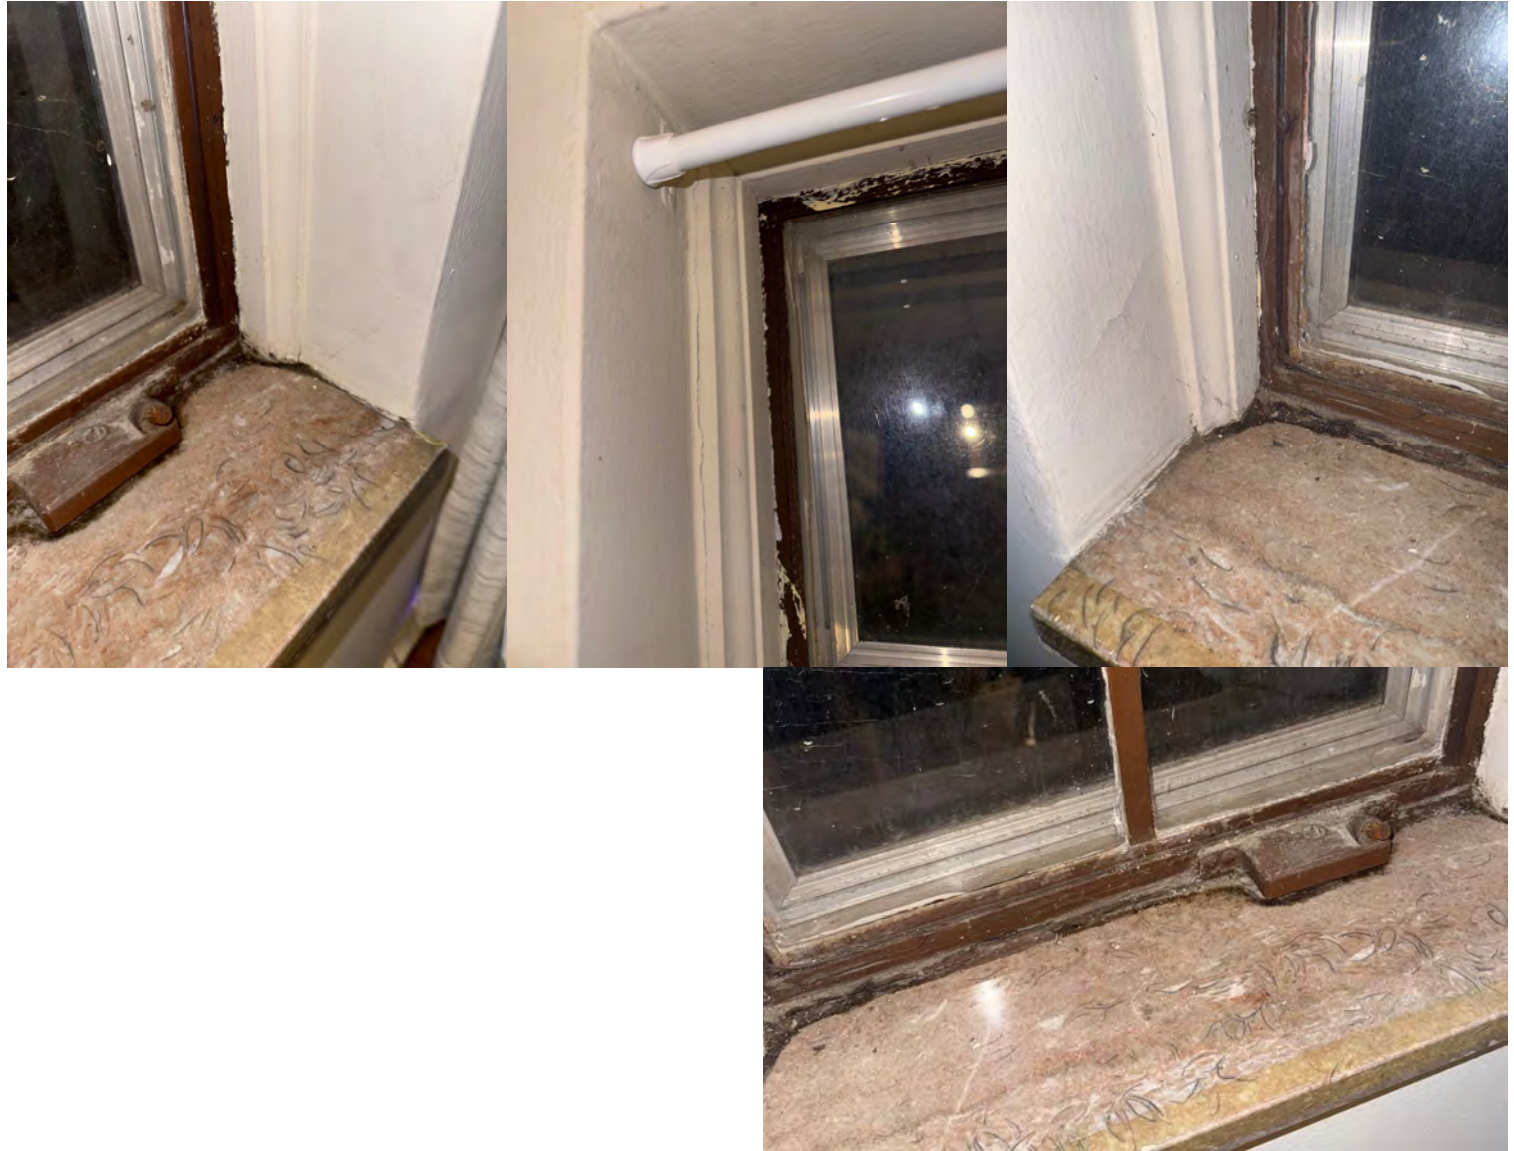
Window 4

- Sealed shut, does not meet egress/code

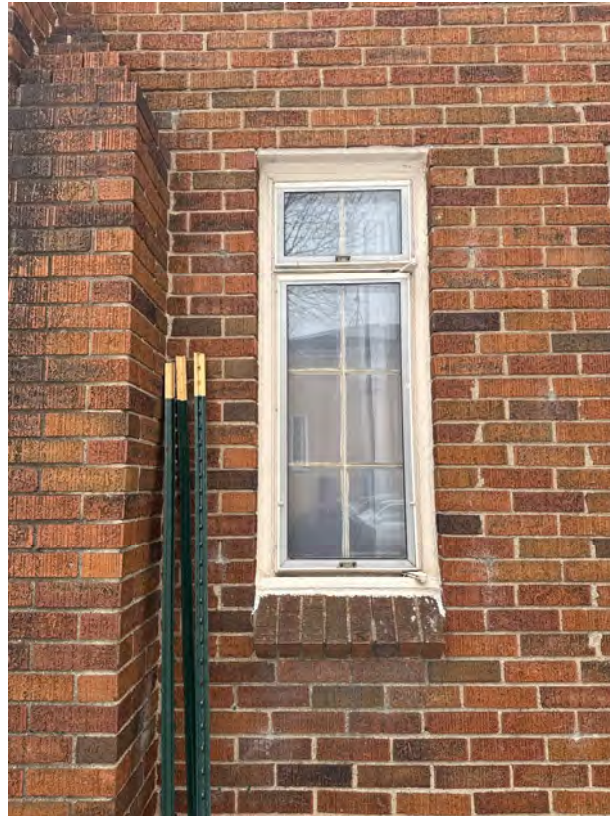
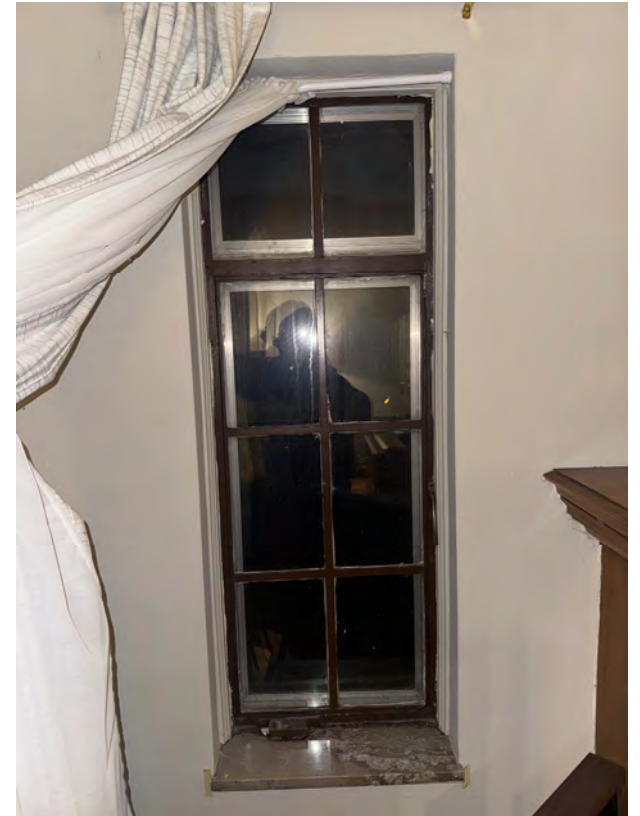
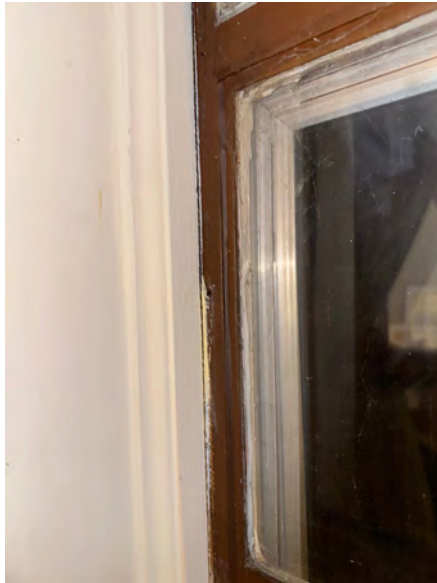
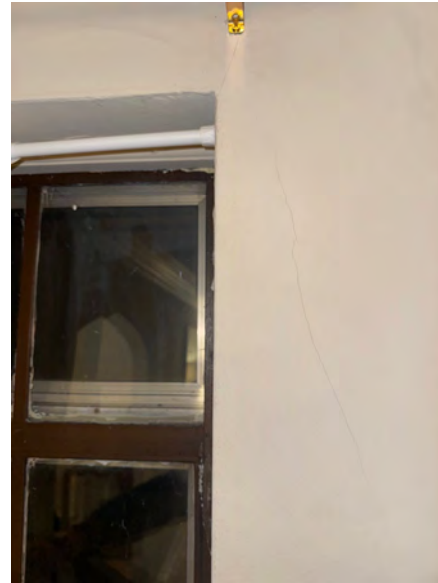
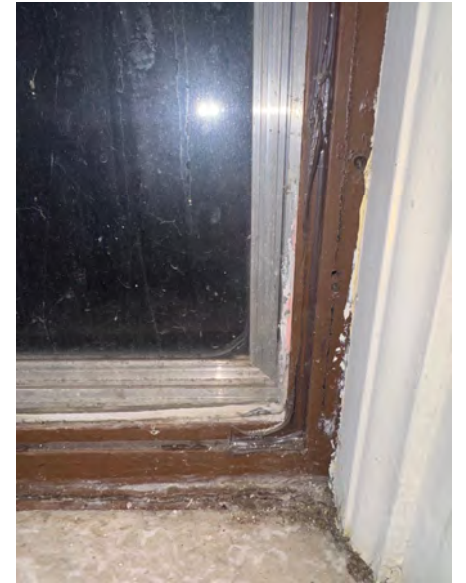
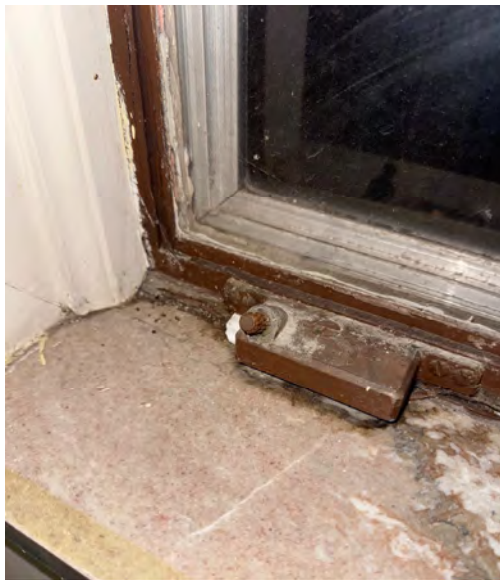
Window 5

- 4- sealed shut
- 5- sealed/rusted shut
- 6- structural rust, evidence of water damage
- 7- sealed/rusted shut
- 17- Worst Condition on entire floor
- 18- sealed/rusted shut
- 19- vinyl; not historically correct

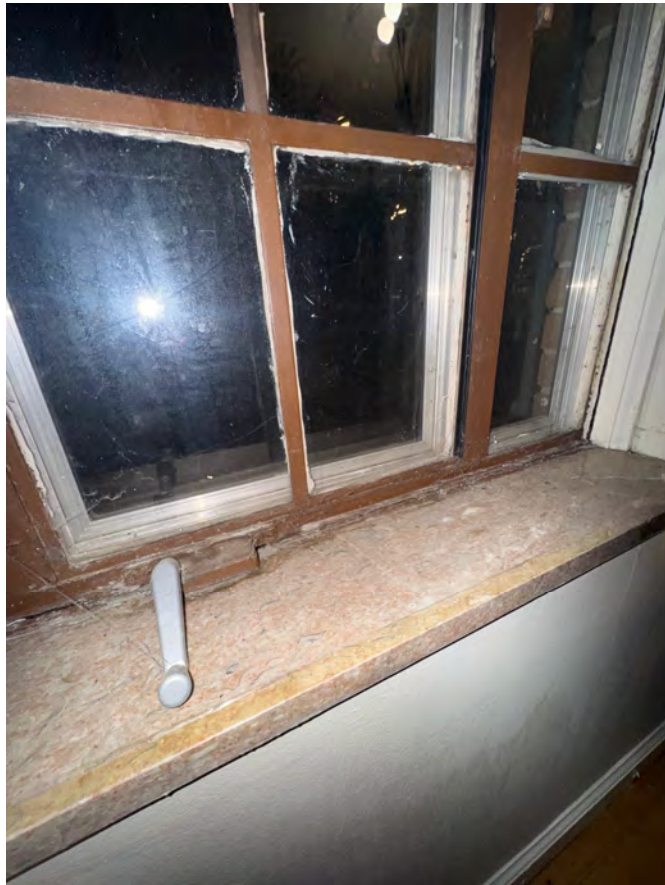
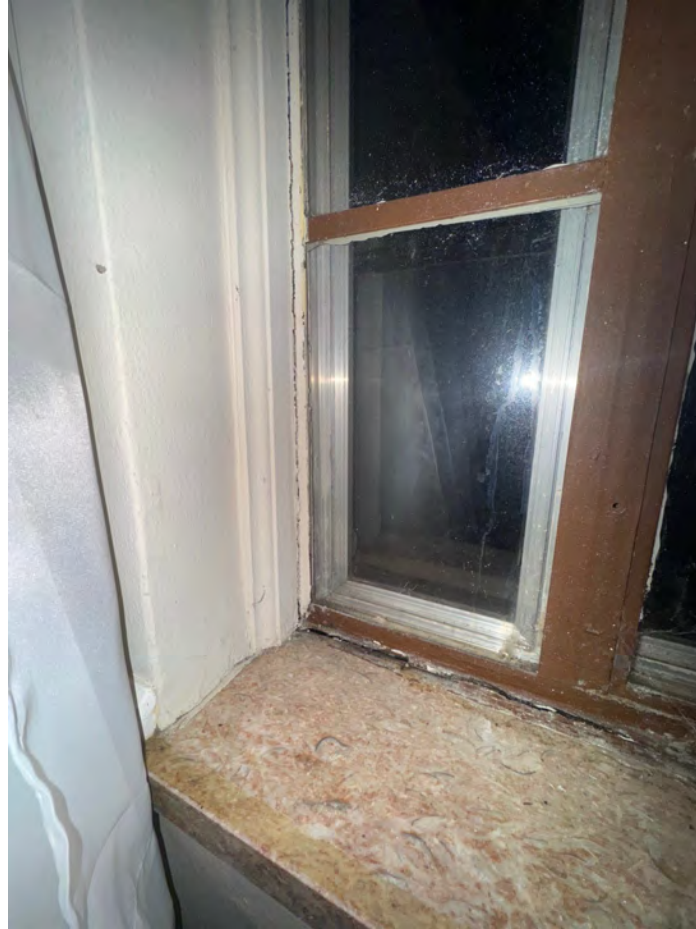
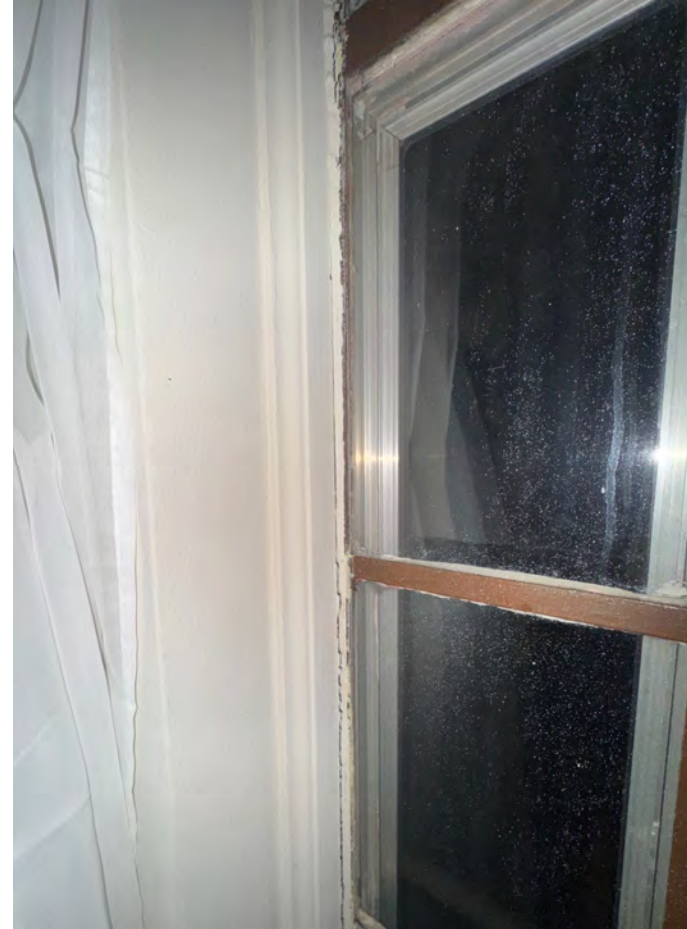
Window 7 (Continued)

- Handle no longer works, gears rusted shut

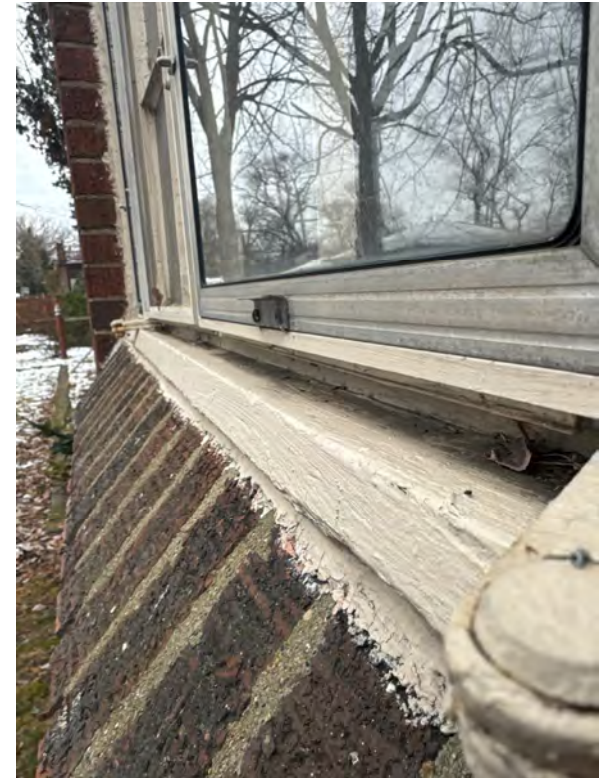
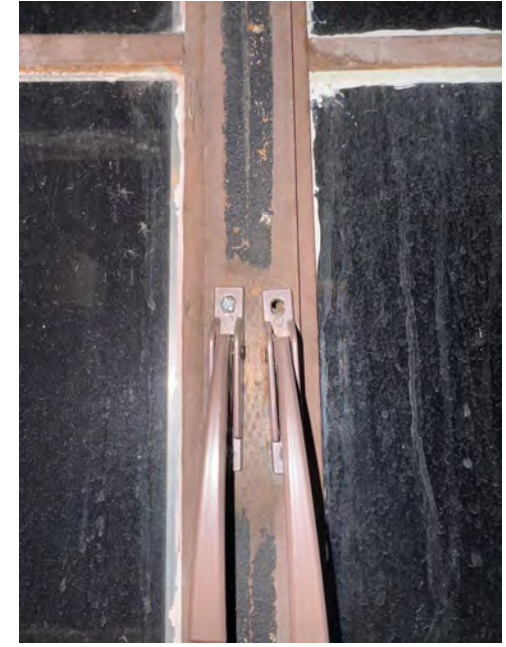
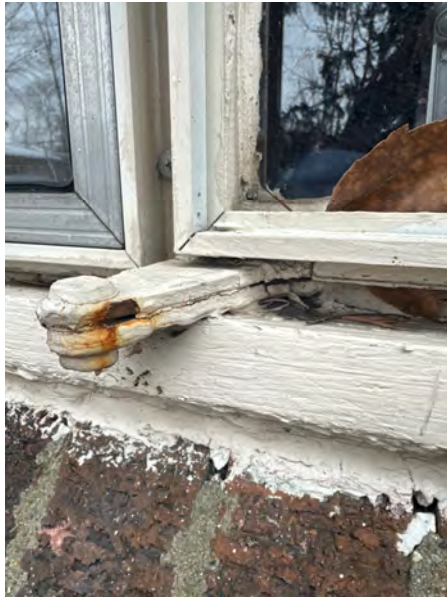
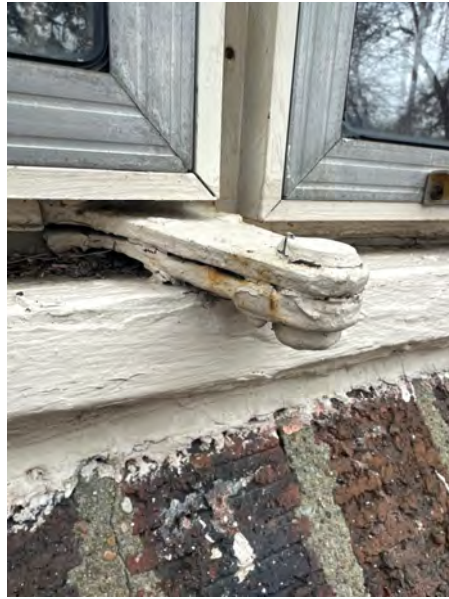
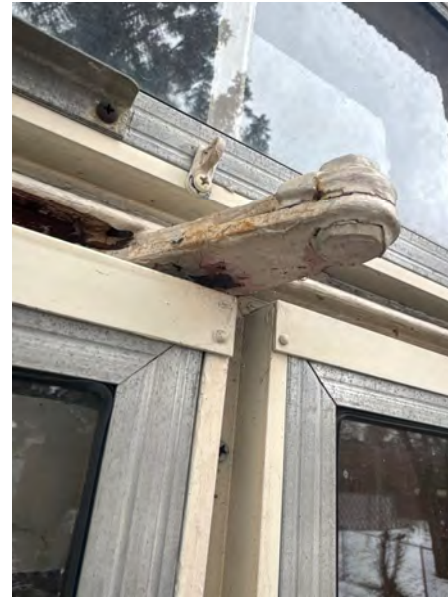
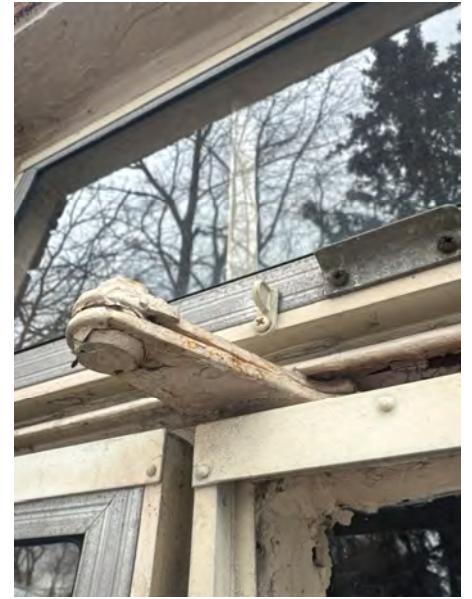
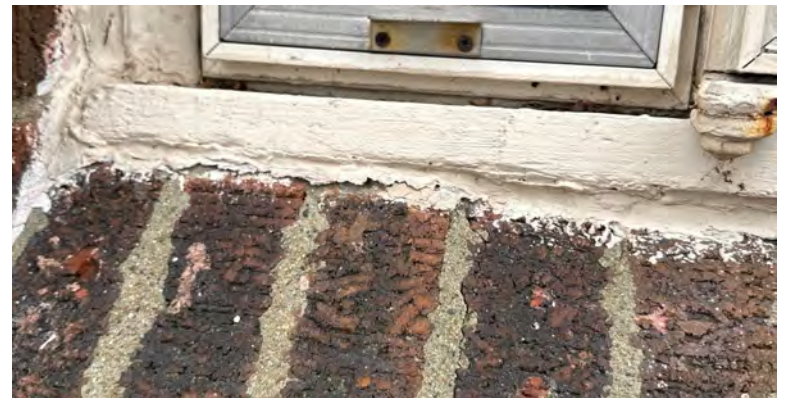
Window 8
(Continued)

8- inward angled deteriorated sill, damaged interior sill, damaged hardware, evidence of mold, exterior hinges rusted out.

- Exterior sill not grading water properly, caused water to damage interior sill
- Hardware receiver rusted out and stripped, repair of handle no longer possible
- Evidence of mold
- Exterior hinges all rusted out, only one casement opens. Does not meet egress/code. Extremely drafty.

Bottom Stud Not Grading Water Properly:

- **Water Pooling and Structural Risk:** The bottom stud is incorrectly angled inward, allowing water to collect rather than drain away from the window. This design flaw exacerbates water retention and encourages wood rot, mold growth, and potential damage to surrounding structures, including the interior walls.
- **Necessity of Replacement:** Adjusting the stud's angle retroactively is not a feasible repair solution due to its integration into the structural frame. Full replacement of the window frame ensures proper water grading and long-term protection against water infiltration

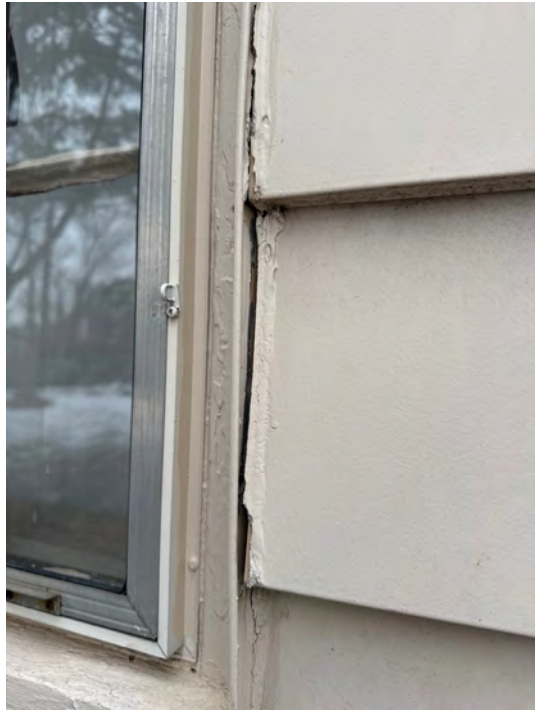
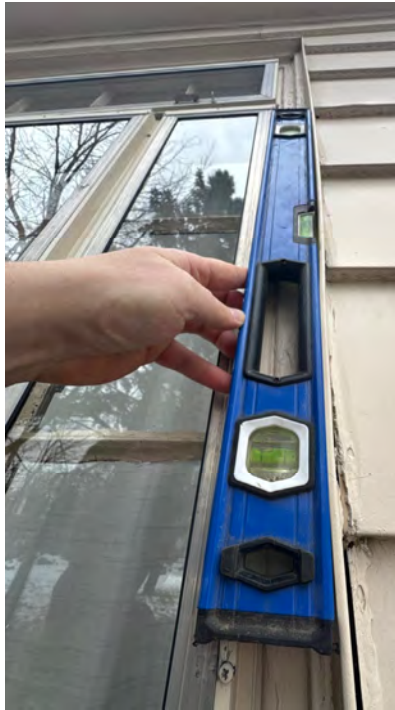
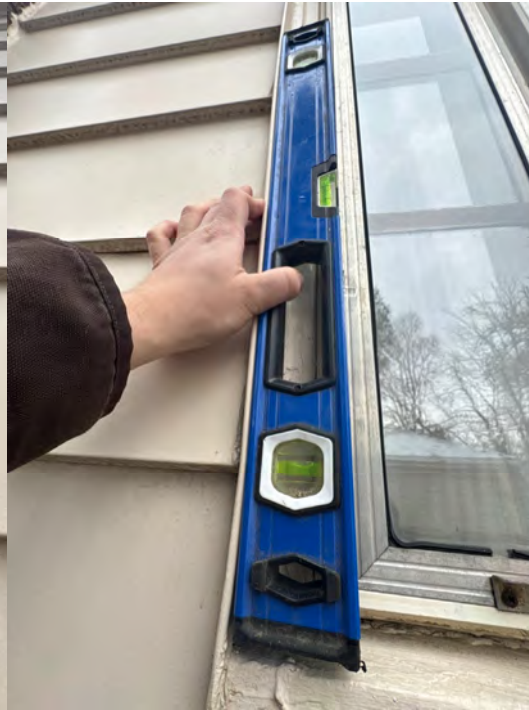
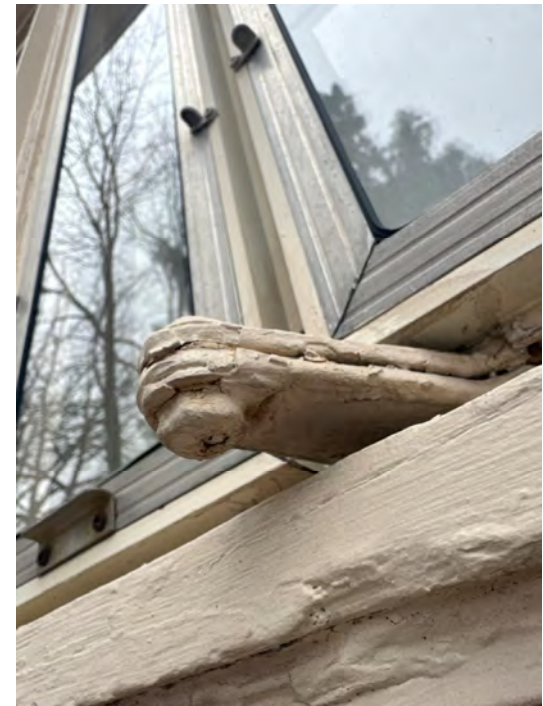
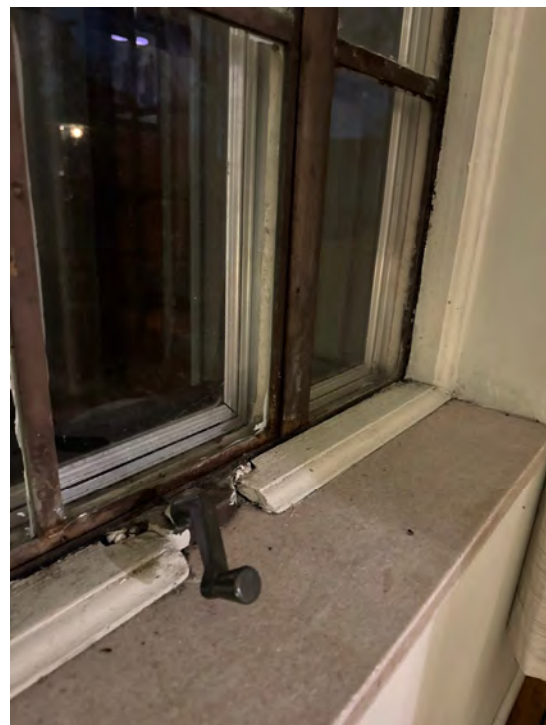
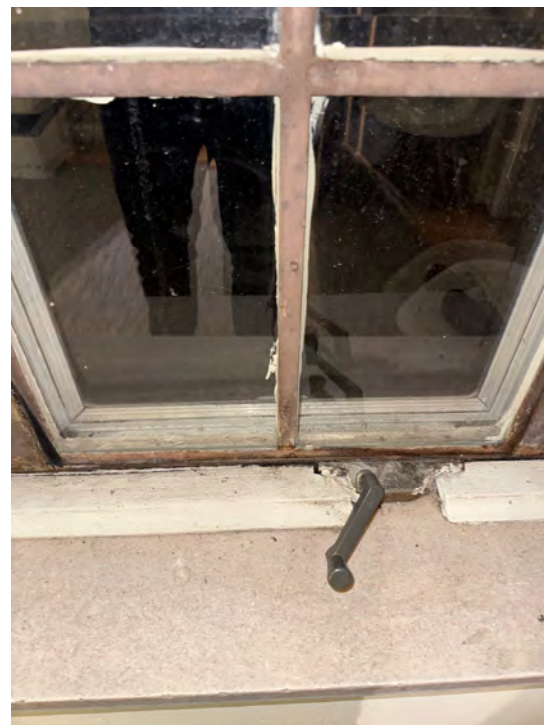
Window 9 Continued

9- evidence of mold, windows not level/flush with rest of home, necessary for proper siding replacement

- Deterioration of bottom exterior sill
- Evidence of mold
- Window not level with home, home has shifted, only remedy is replacement
- Window not flush, needs to be flush for proper siding replacement

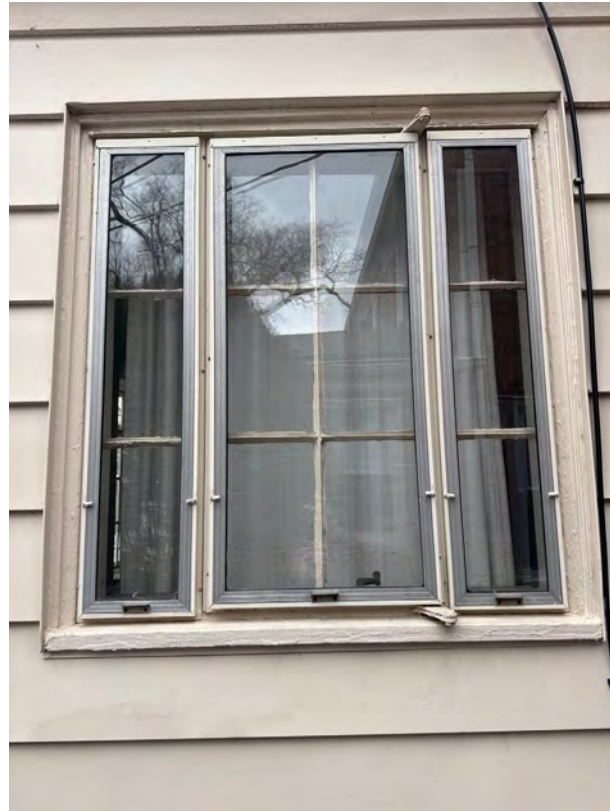
Window 10

10- substantial rust present, substantial gaps in frame, weather stripping was attempted but did not remedy to draft.
