HISTORIC DISTRICT COMMISSION APPLICATION FOR WORK APPROVAL

APPLICATION ID
HDC2025-00014

ADDRESS(ES): 24293 Telegraph Road
HISTORIC DISTRICT: Russell Woods-Sullivan

Window & Siding Replacement

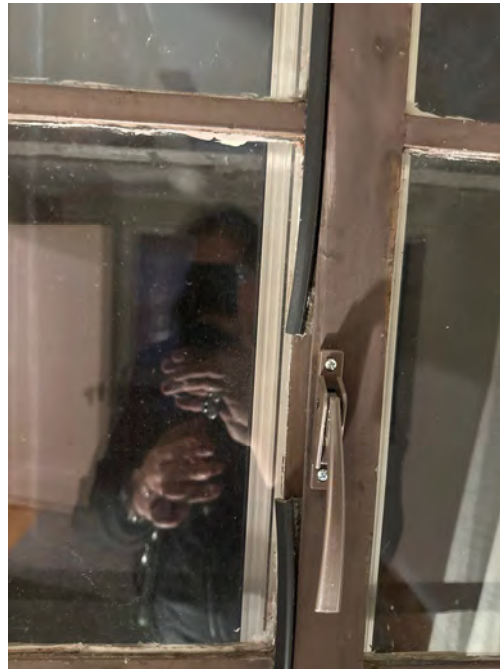
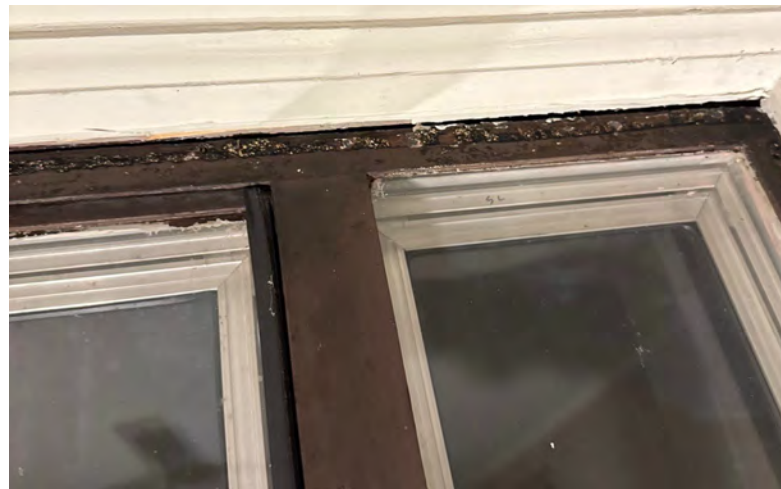
Window 10 (Continued)

- New weather stripping was attempted, did not fix the issue

- Substantial gap above window; not level with home
- Gap in weather stripping
- Very rusted frame

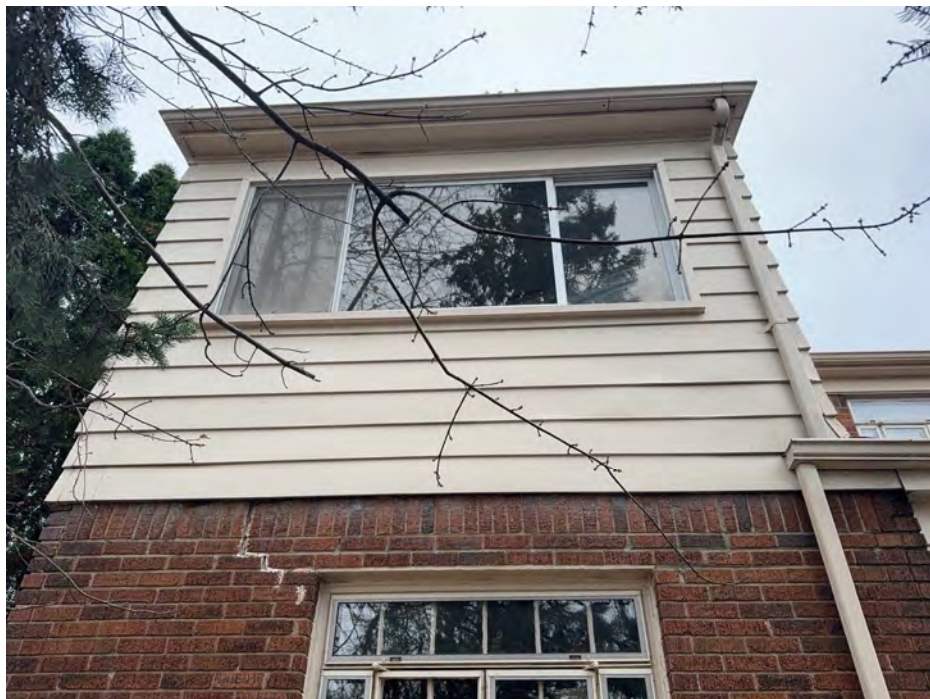
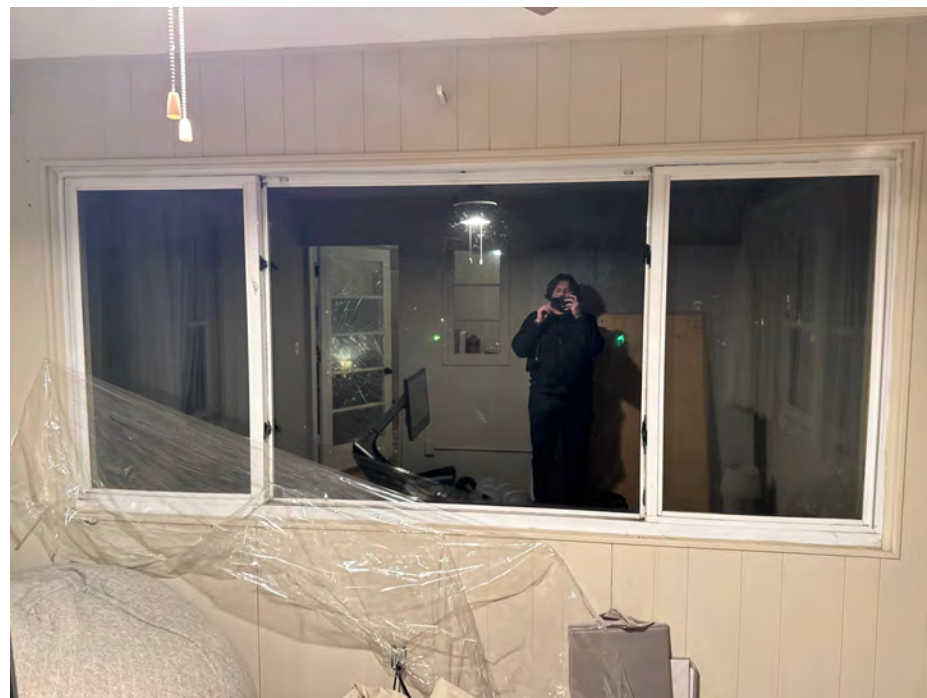
Window 20

- vinyl

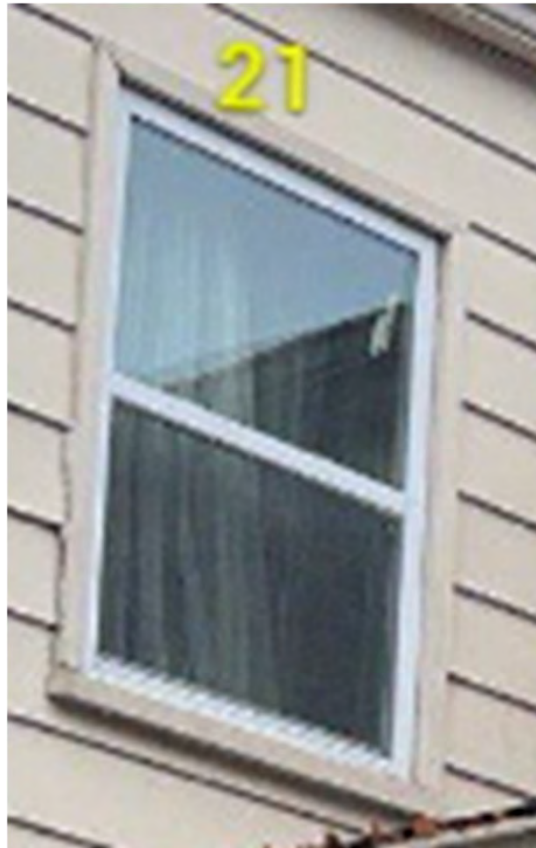
Window 21

- Vinyl; historically incorrect

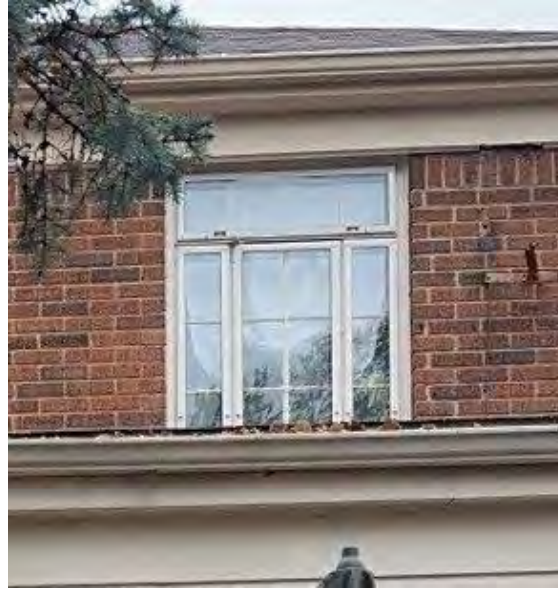
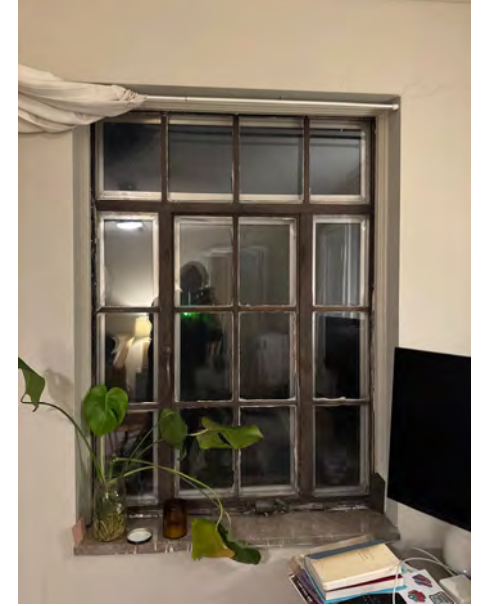
Window 22

22- evidence of water damage, substantial rust is present, broken glass

- evidence of water damage,
- substantial rust is present
- broken glass

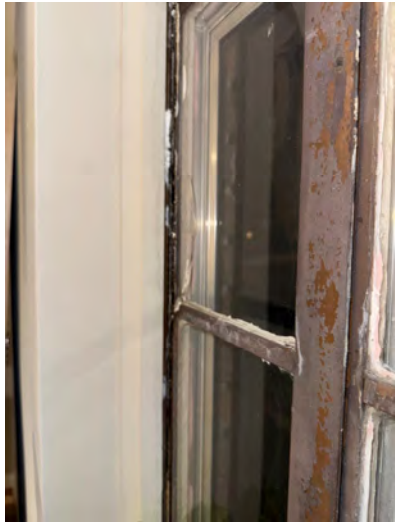
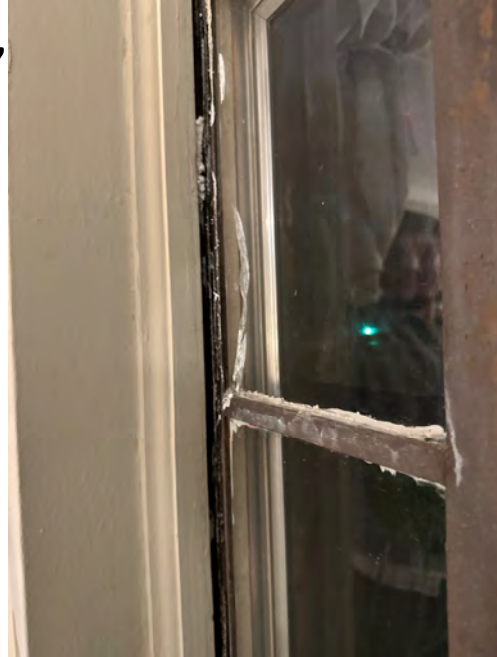
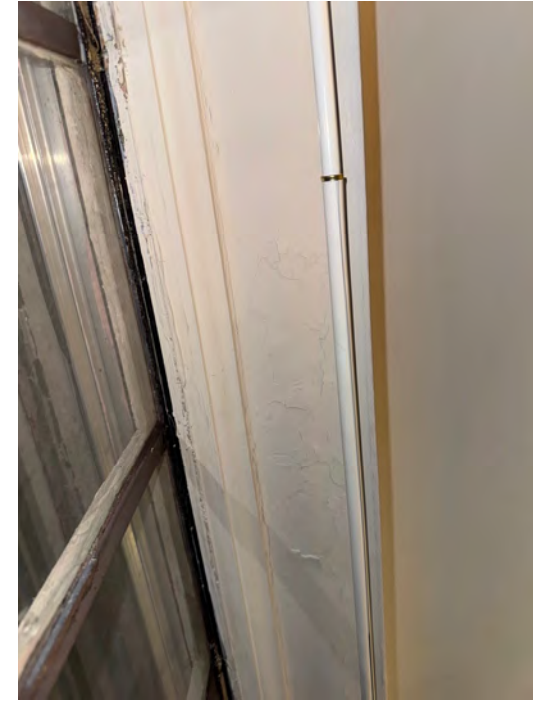
Window 22 (continued)

- Evidence of water damage present,
- Broken glass
- Substantial rust, compromising integrity of the window

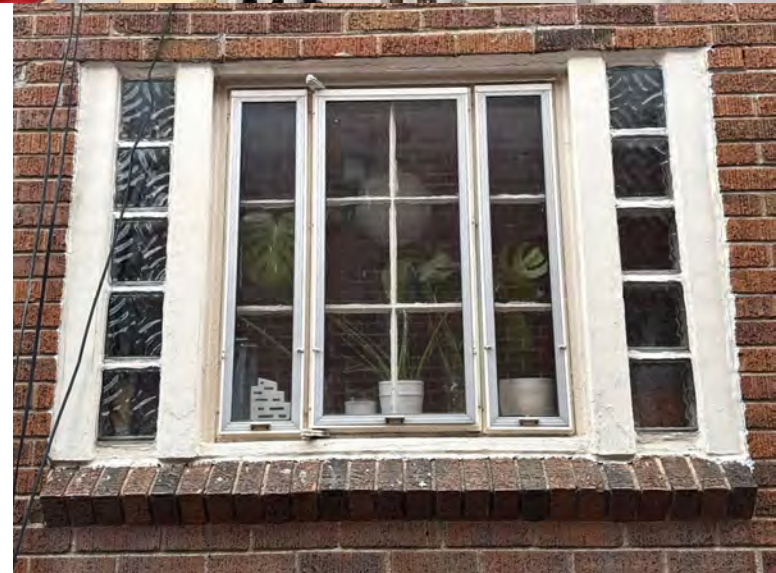
Window 11

11- cant lock, doesn't seal. Draftiest window on first floor. Glass blocks are not original to historical look of the home. Glass blocks were used as an incorrect repair.

- Glass block are not original to home, therefore not historically accurate. Requires replacement of entire opening.

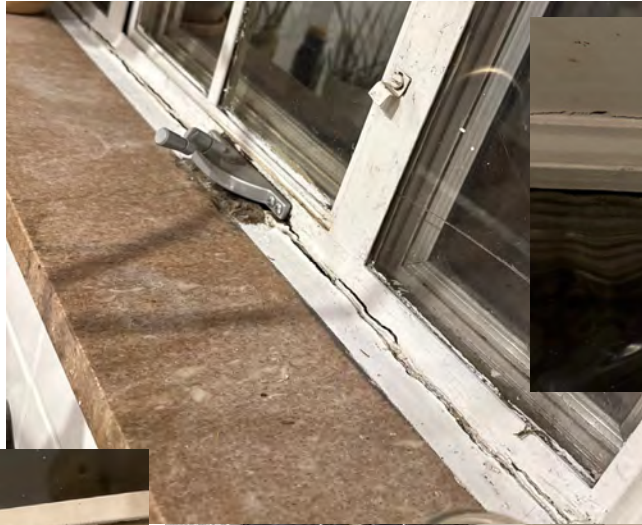
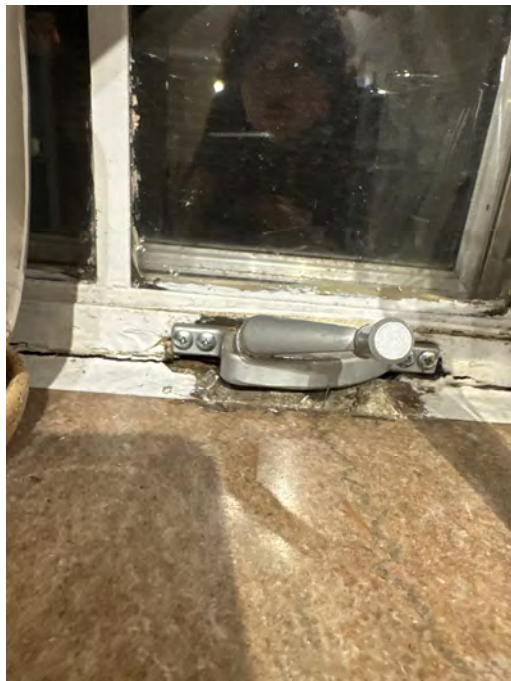
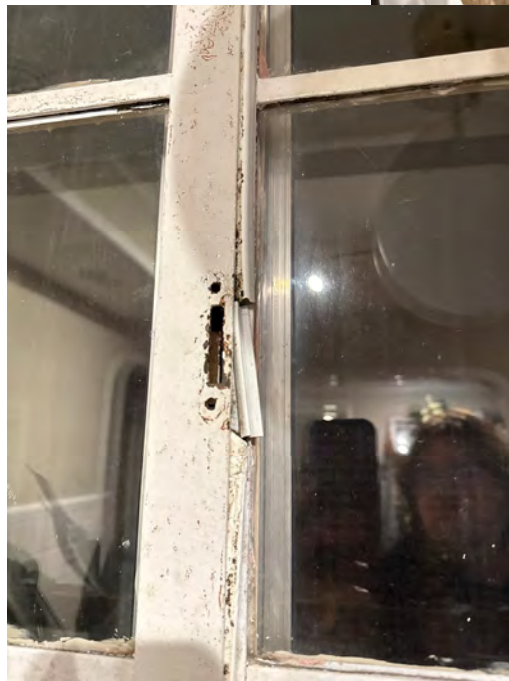
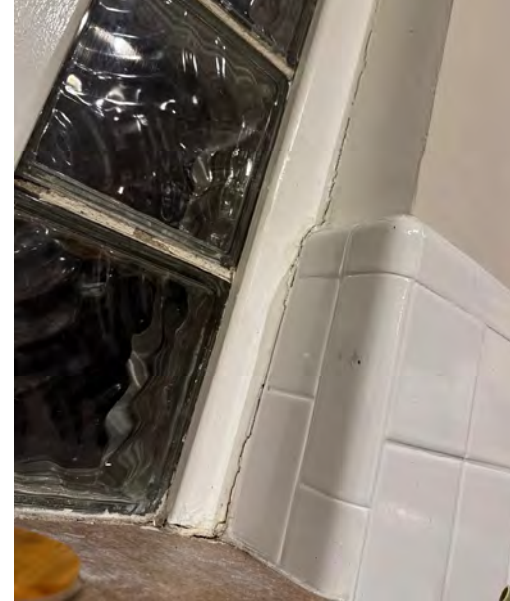
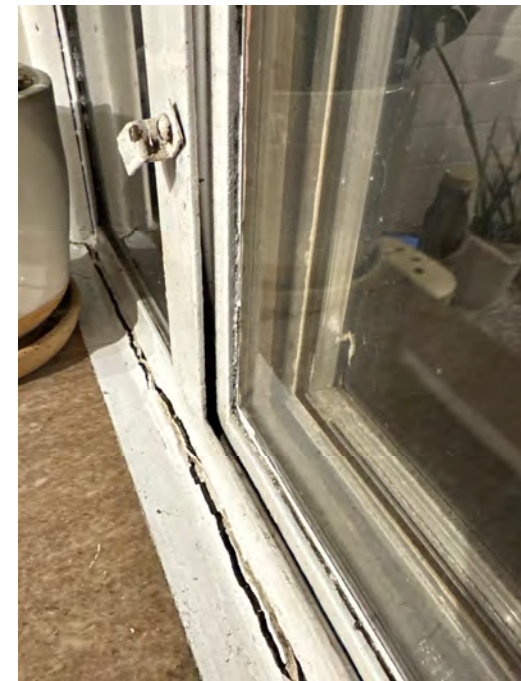
Window 11 (continued)

- Hardware was repaired but can not lock.
- Substantial gaps. Draftiest window on the floor

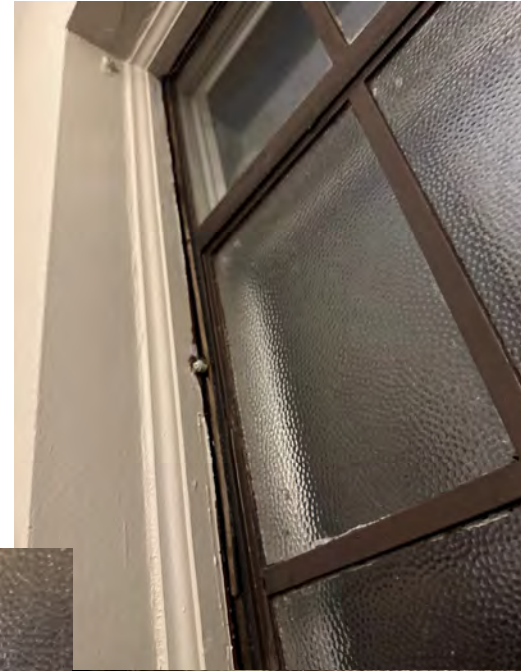
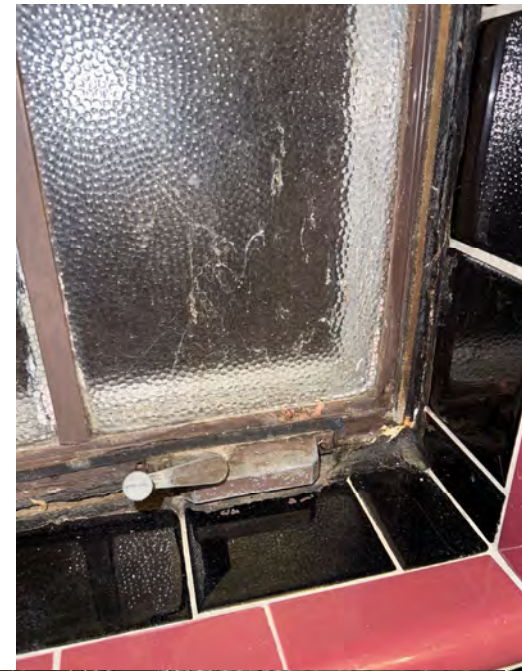
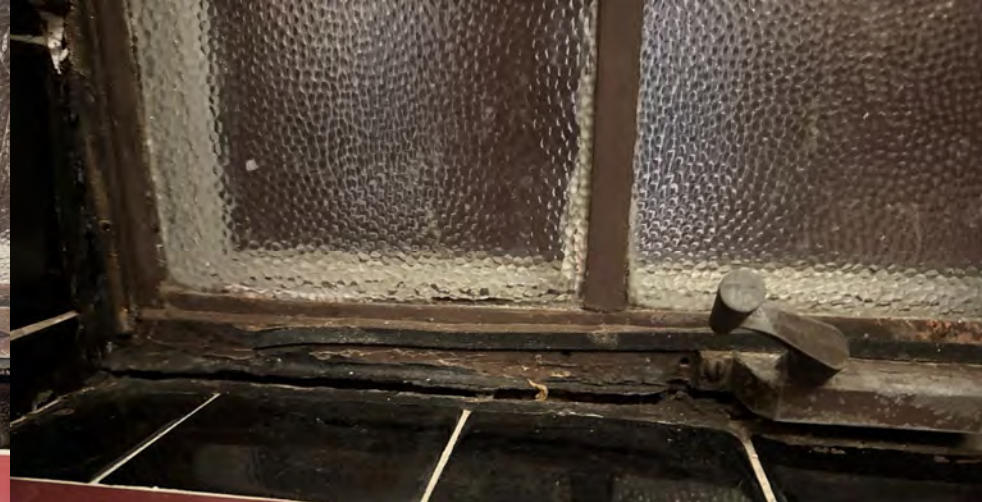
Window 12 (continued)

- Sealed shut, has never been able to be opened
- Substantial gaps, very drafty.
- Severe structural rust

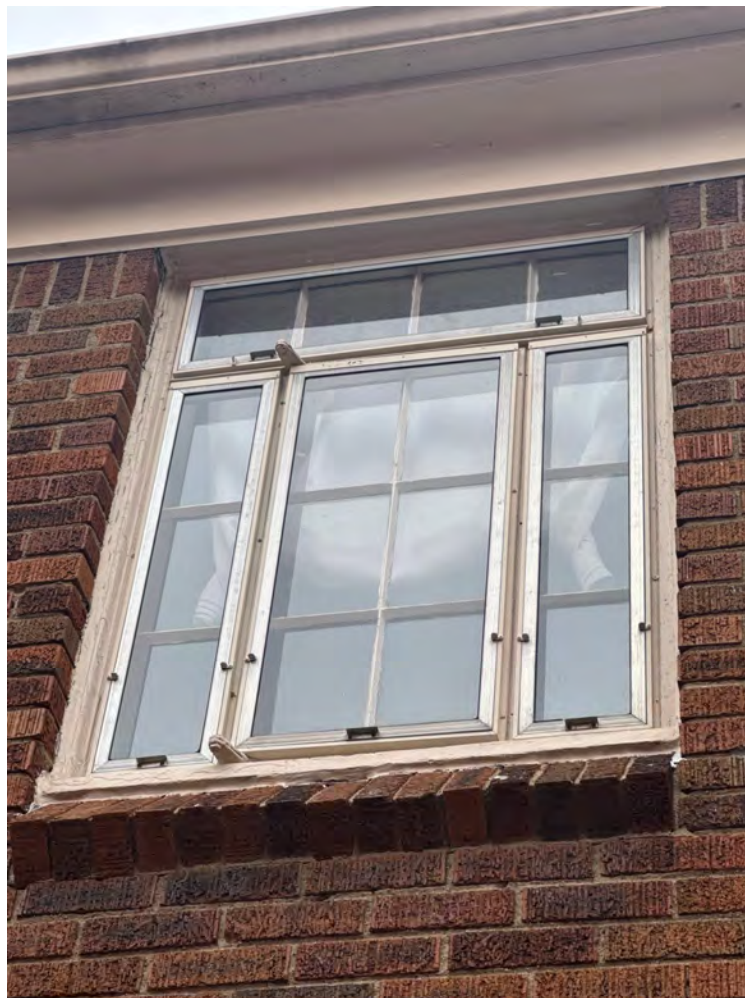
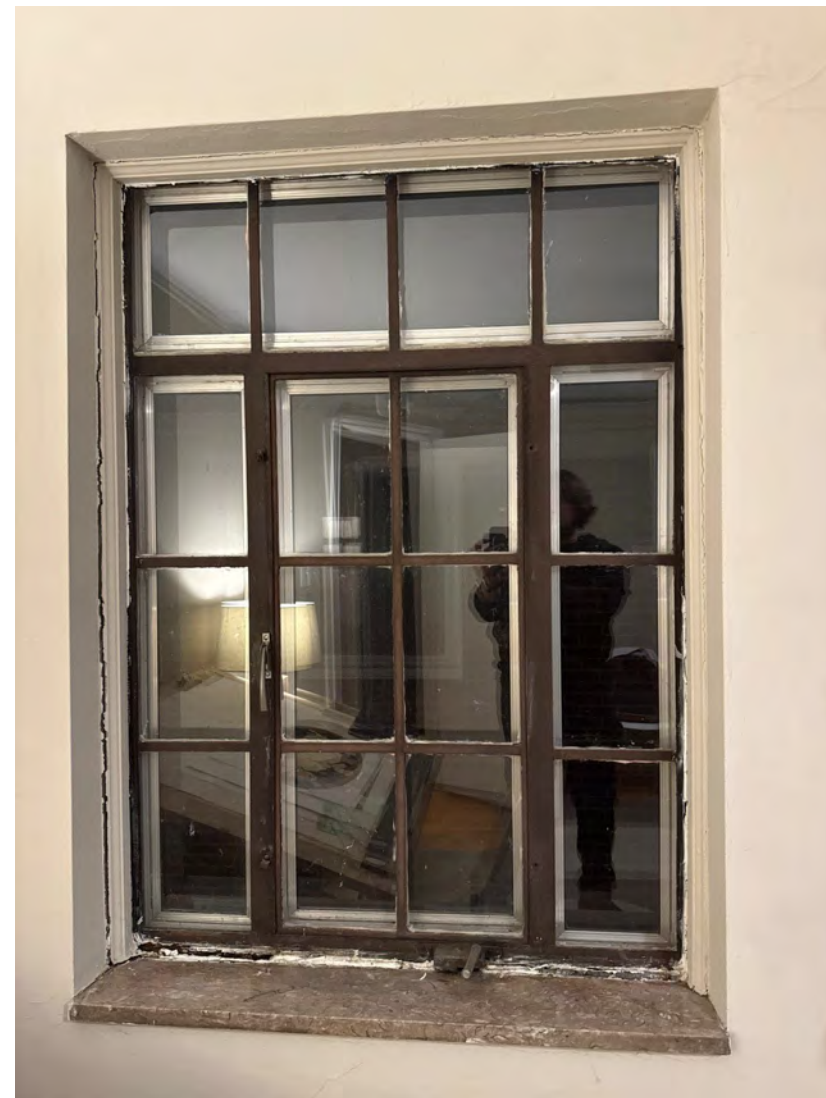
Window 23

- Substantial gaps in window frame. Not flush with home. Very drafty.

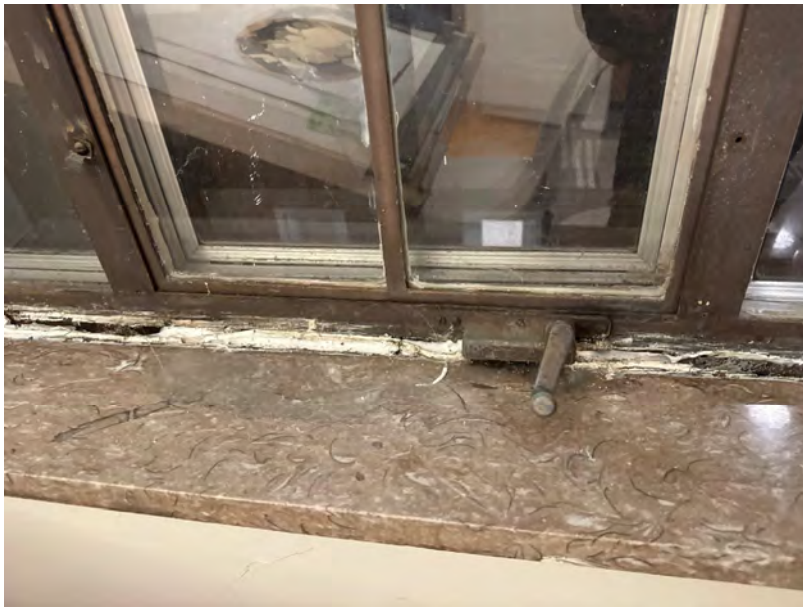
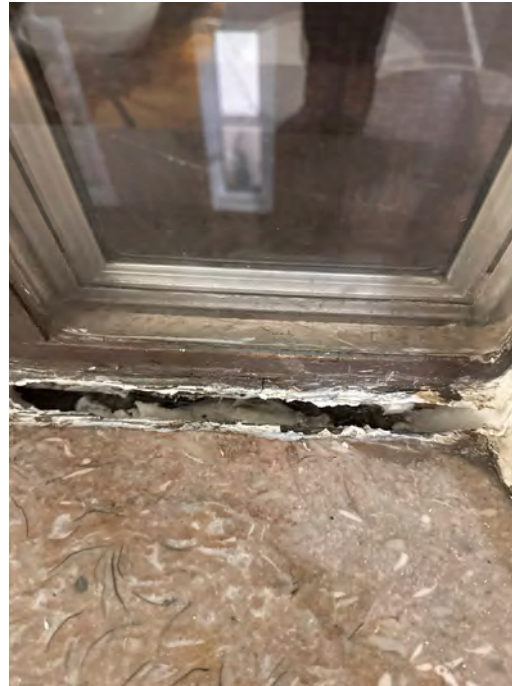
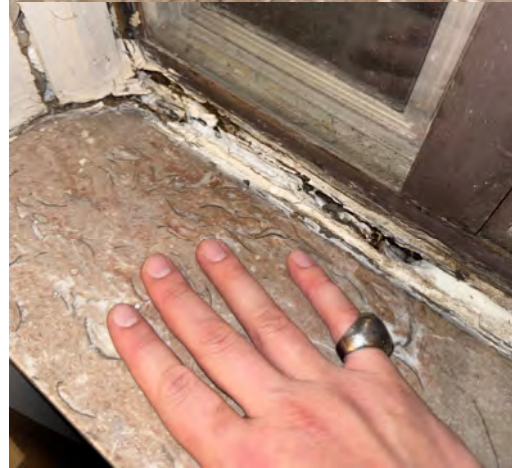
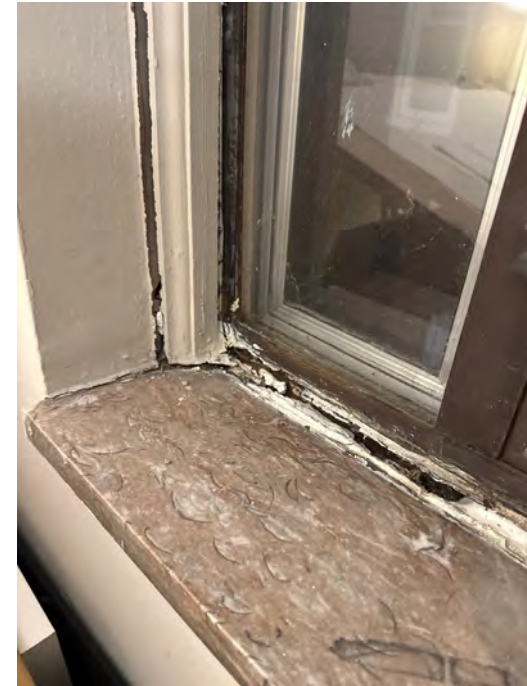
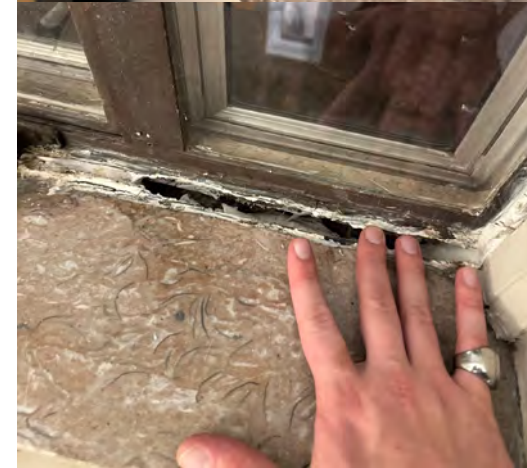
Window 23 (continued)

- Substantial rust contributing to large gaps

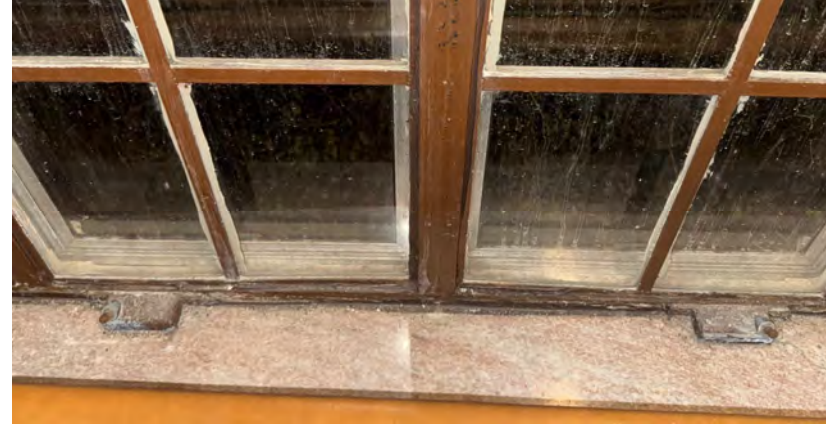
Window 1: (Continued)

1. Rusted Gear in Casement Window:

•**Functional Obsolescence:** A rusted gear in a casement window has lost its mechanical integrity, preventing smooth or reliable operation. Rust compromises the precise movement required for opening and closing, and repairs (e.g., lubrication or partial component replacement) often fail to restore full functionality due to corrosion spread across interconnected parts.

•**Safety Concerns:** A malfunctioning gear could lead to sudden failure, making the window unsafe for operation. As per guidelines, operability is essential to preserve the historic character of windows

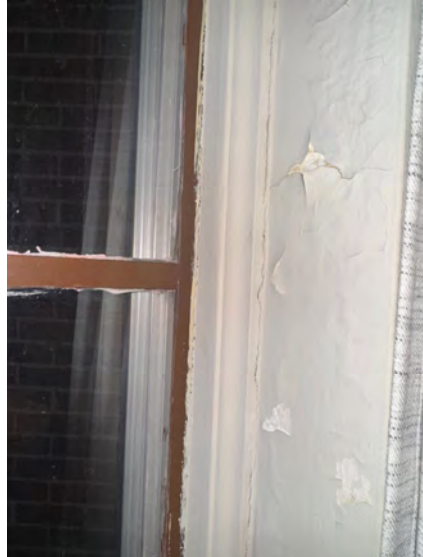
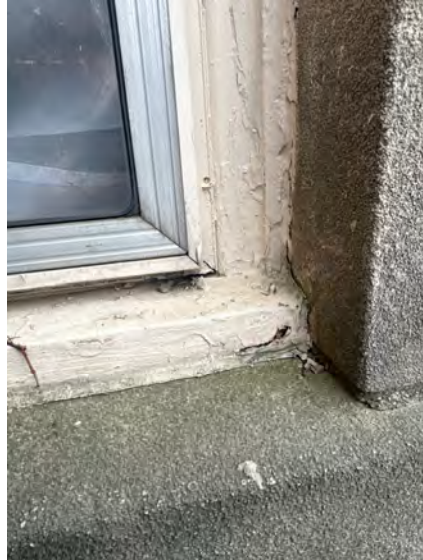
Window 2: Interior

- Deteriorated wood in window frame compromising structural integrity
- Extensive water damage shows extreme deterioration, compromising structural integrity of the window and weatherproofing ability

Water Damage to Interior Walls:

- **Evidence of Intrusion:** Photographs demonstrate water infiltration through the windows, leading to damage such as stained walls, mold growth, and potential weakening of wall structures. This evidence underscores the windows' failure to provide a proper seal against weather.
- **Health and Safety Issues:** Mold and water damage present serious health risks to occupants, violating modern building codes that require healthy and habitable living conditions.

Deteriorated Wood on exterior:

• **Loss of Structural Integrity:** Wood that has deteriorated due to moisture, mold, or rot no longer provides adequate support for the window assembly. This compromises the entire frame's stability and may pose a safety hazard.

Replacement is necessary when repair is not technically feasible or when deterioration affects the window's ability to retain its shape, support glass, and maintain weatherproofing. Aluminum-clad wrapping further ensures long-term durability by protecting against future moisture and weather-related damage

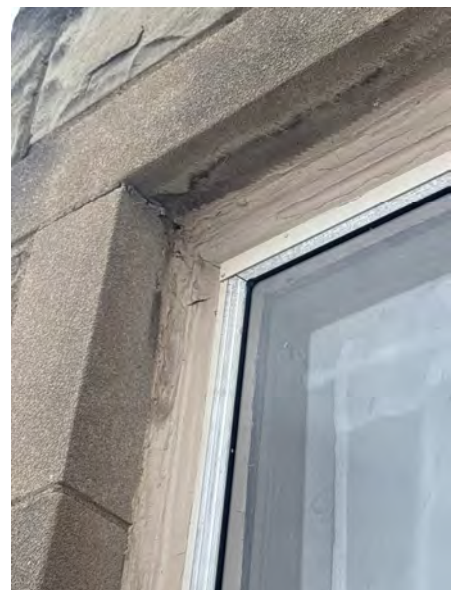
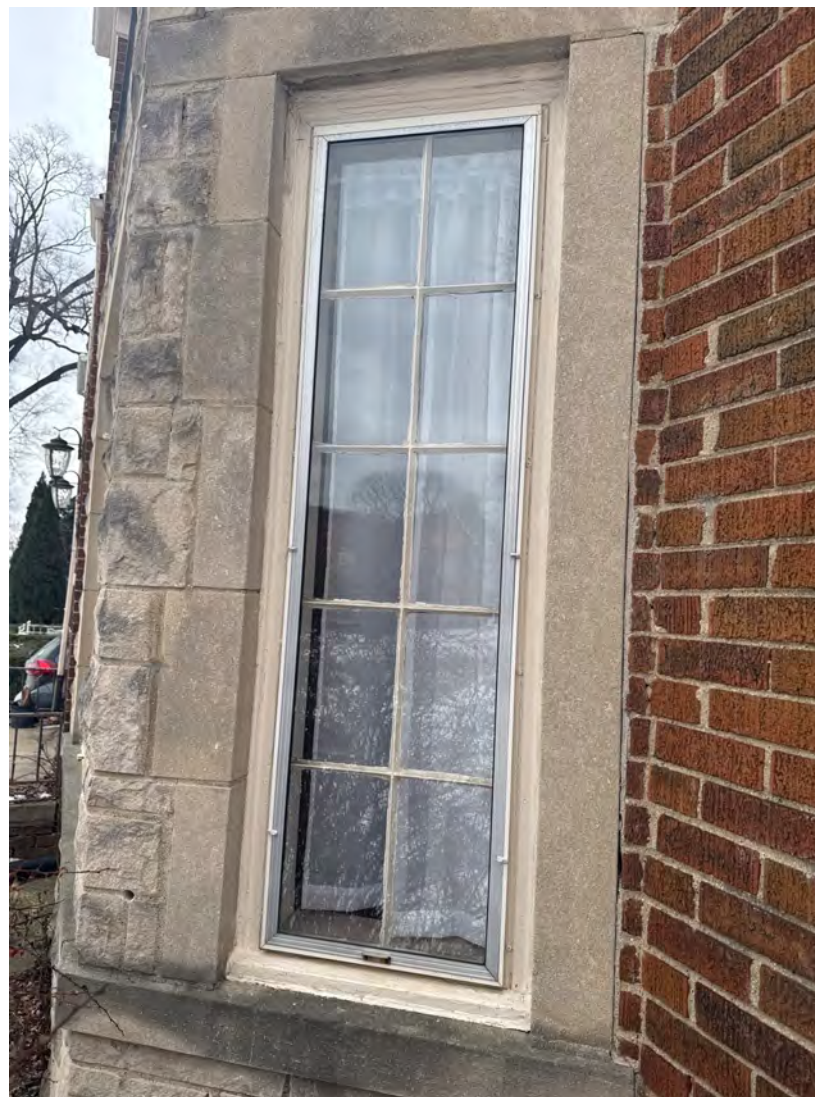
Window 3:

- Evidence of exterior wood frame rot
- Evidence of mold between storm window and original window

- **Deteriorated Wood on exterior:**
- **Loss of Structural Integrity:** Wood that has deteriorated due to moisture, mold, or rot no longer provides adequate support for the window assembly. This compromises the entire frame's stability and may pose a safety hazard.
- **Guideline Requirements:** Replacement is necessary when repair is not technically feasible or when deterioration affects the window's ability to retain its shape, support glass, and maintain weatherproofing. Aluminum-clad wrapping further ensures long-term durability by protecting against future moisture and weather-related damage

Why Mold Warrants Window Replacement Instead of Repair:

- **Compromised Integrity:** Mold indicates prolonged moisture exposure, often leading to weakened or deteriorated materials that cannot be effectively repaired, necessitating full replacement.
- **Health Hazards:** Mold poses significant health risks (e.g., respiratory issues) and can persist in porous materials, making replacement essential to fully eliminate the issue and prevent recurrence.
- **Underlying Moisture Issues:** Mold is often caused by structural defects like improper grading or seals, which require replacement to correct and ensure future moisture resistance.
- **Code and Safety Compliance:** Replacement ensures compliance with modern building codes and health standards, providing a safe, mold-free environment while preventing further damage.

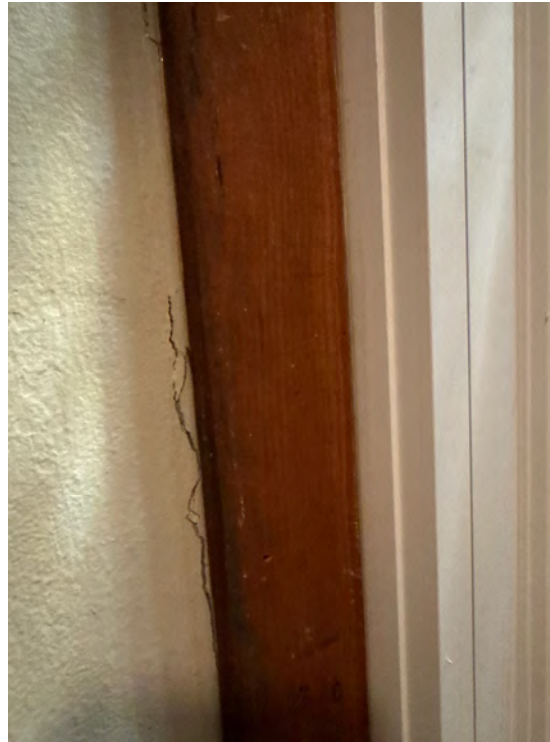
Window 14:

- Repairs with clear silicone caulk were attempted
- vinyl

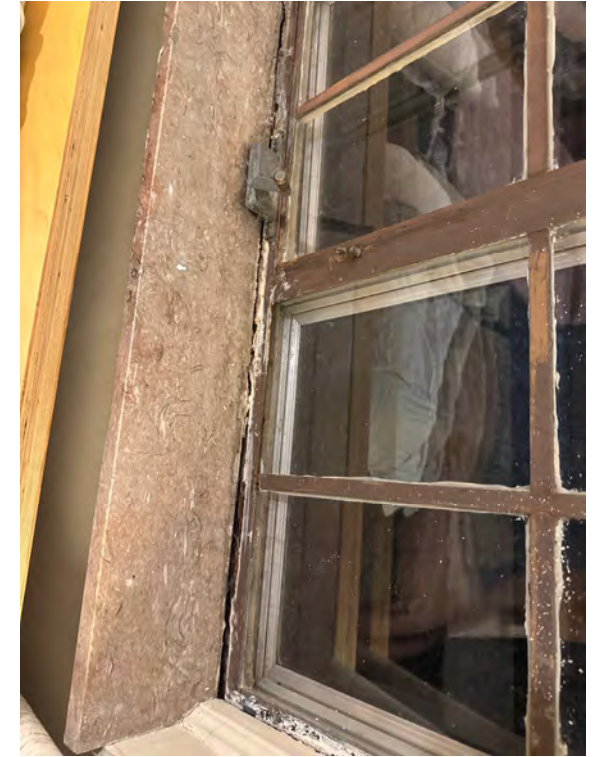
Window 16 (continued)

- substantial gaps in weather proofing,
- only one casement window opens due to hardware rusted shut,
- fails to meet egress/code

- Substantial gaps
- Substantial rusting

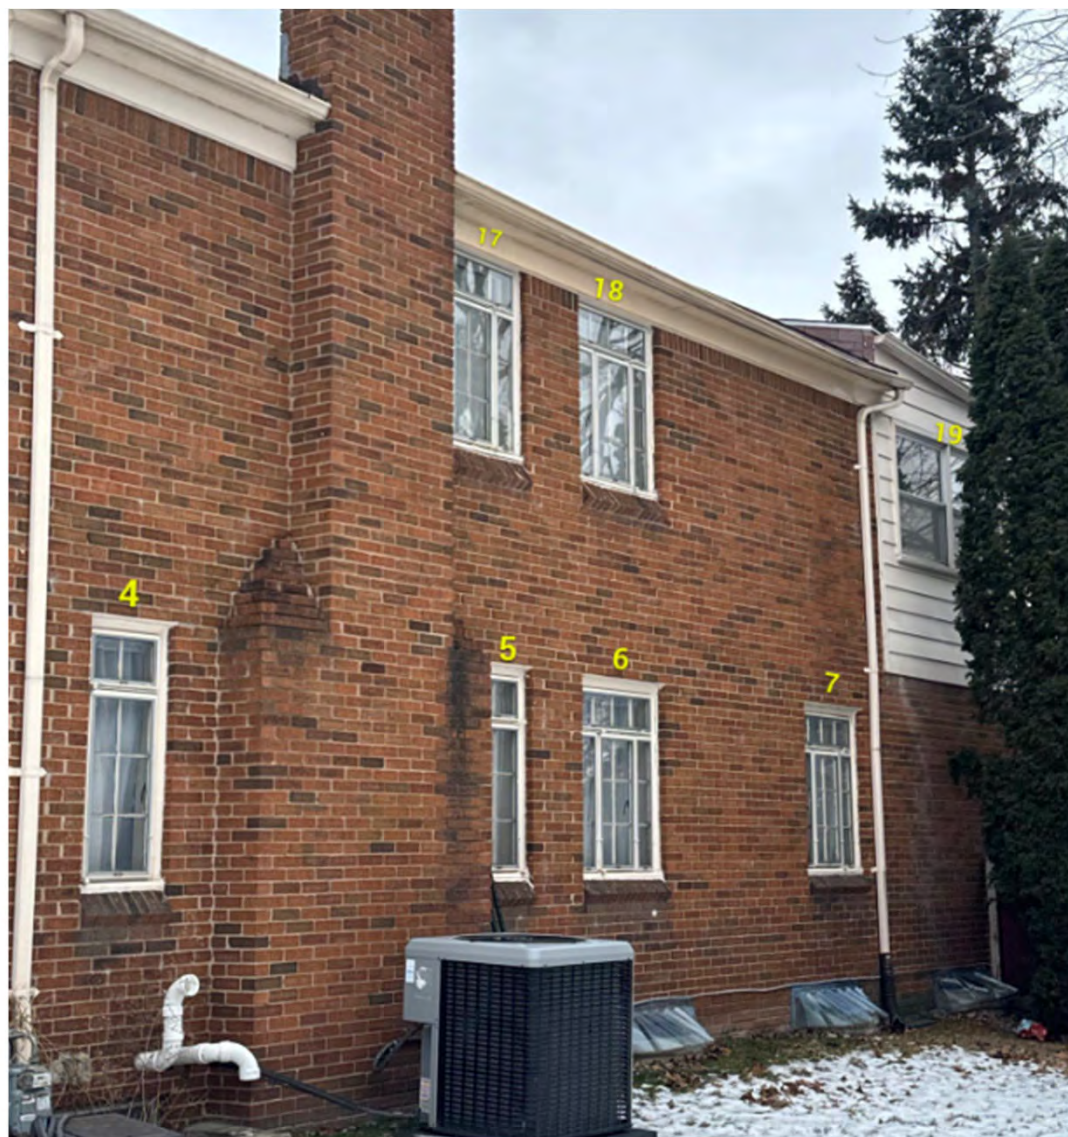
Windows –Left

- 4- sealed shut
- 5- sealed/rusted shut
- 6- structural rust, evidence of water damage
- 7- sealed/rusted shut
- 17- Worst Condition on entire floor
- 18- sealed/rusted shut
- 19- vinyl; not historically correct

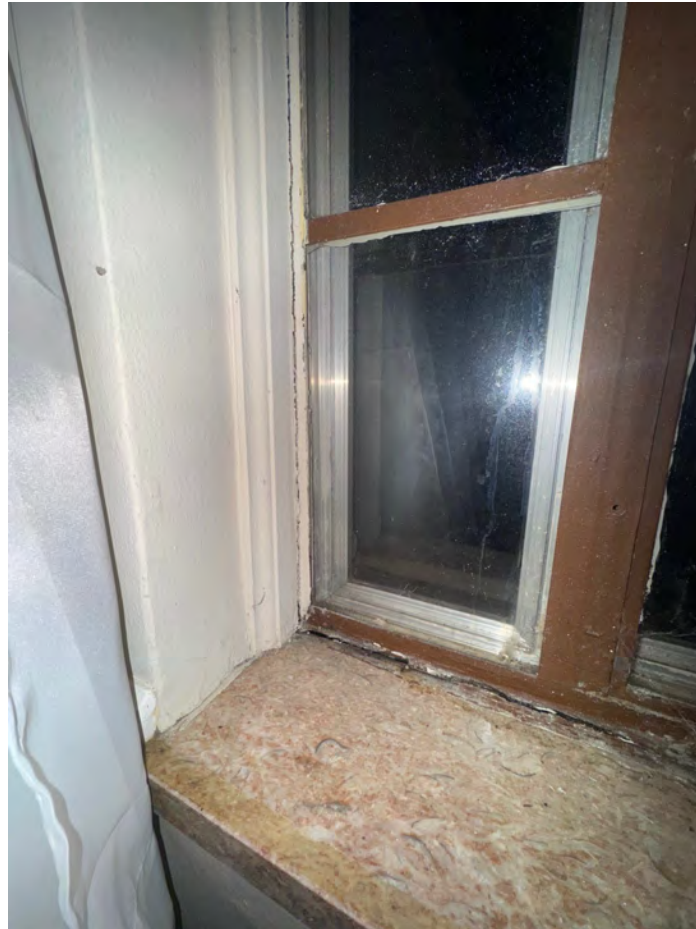
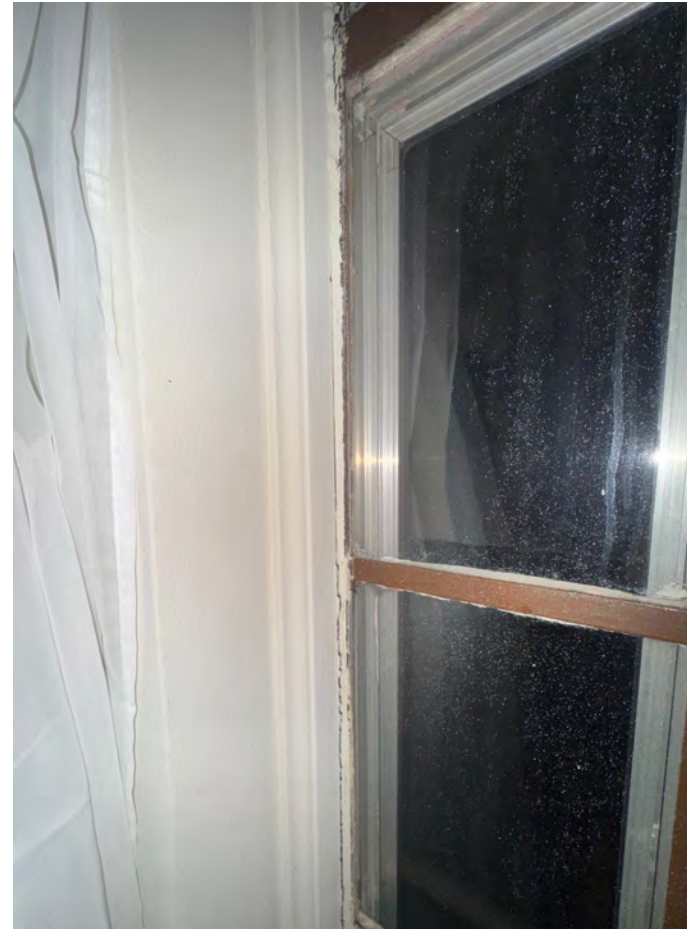
Window 7 (Continued)

- Handle no longer works, gears rusted shut

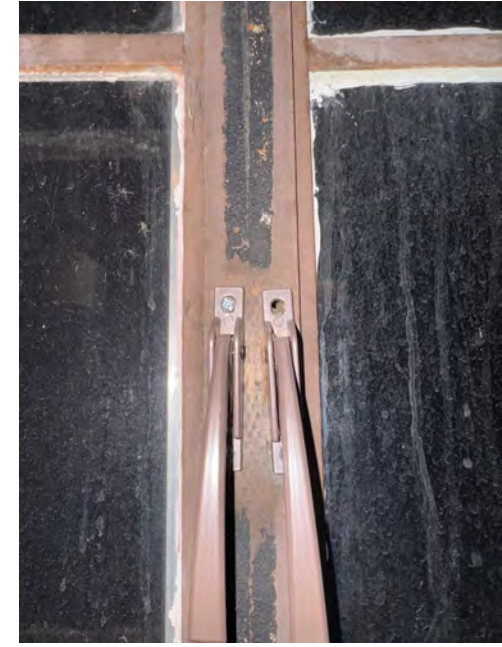
Window 8
(Continued)

- Exterior sill not grading water properly, caused water to damage interior sill
- Hardware receiver rusted out and stripped, repair of handle no longer possible
- Evidence of mold
- Exterior hinges all rusted out, only one casement opens. Does not meet egress/code. Extremely drafty.

- **Water Pooling and Structural Risk:** The bottom stud is incorrectly angled inward, allowing water to collect rather than drain away from the window. This design flaw exacerbates water retention and encourages wood rot, mold growth, and potential damage to surrounding structures, including the interior walls.
- **Necessity of Replacement:** Adjusting the stud's angle retroactively is not a feasible repair solution due to its integration into the structural frame. Full replacement of the window frame ensures proper water grading and long-term protection against water infiltration

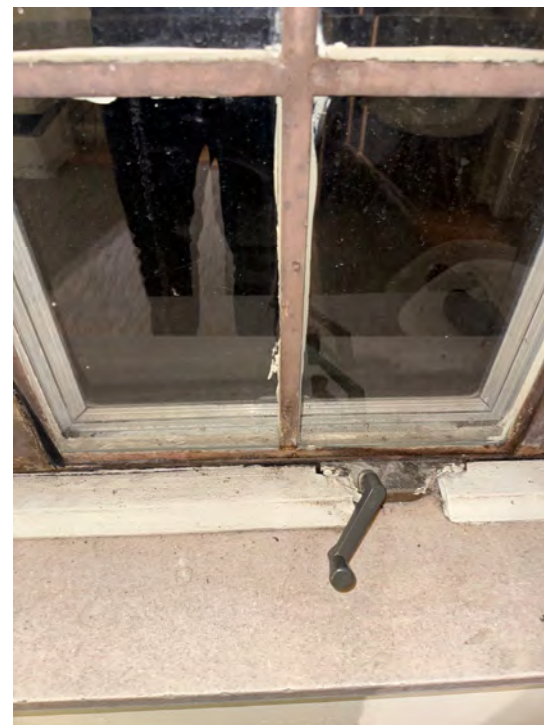
Window 9 (continued)

- Deterioration of bottom exterior sill
- Evidence of mold
- Window not level with home, home has shifted, only remedy is replacement
- Window not flush, needs to be flush for proper siding replacement

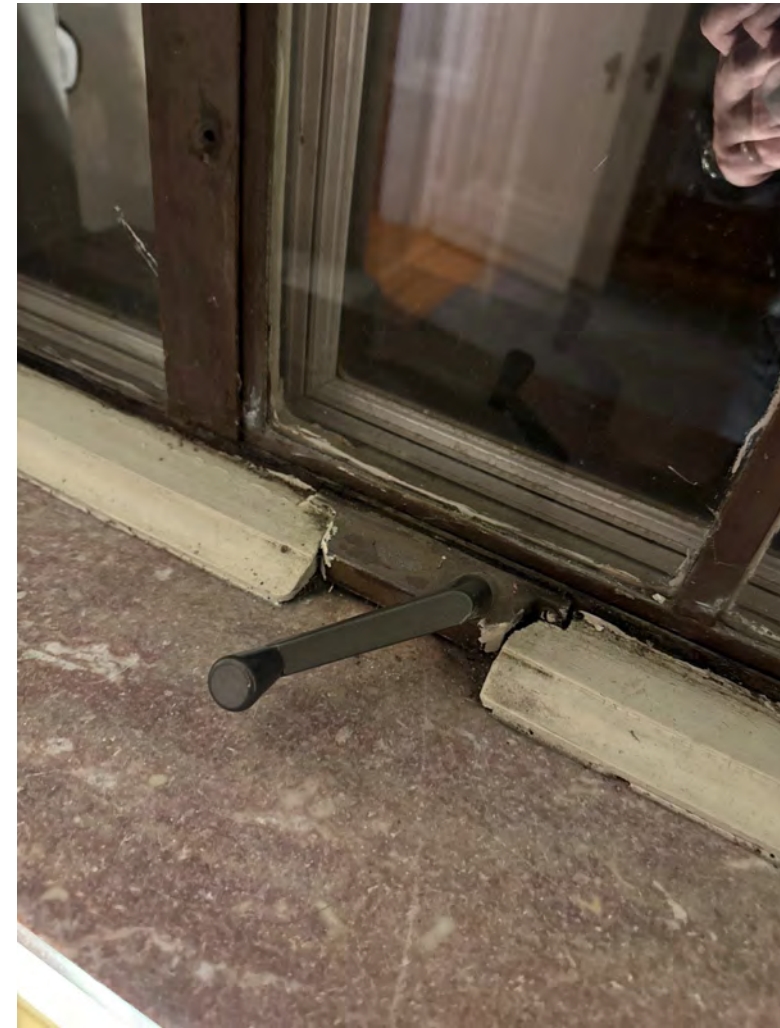
Window 10 (Continued)

- New weather stripping was attempted, did not fix the issue

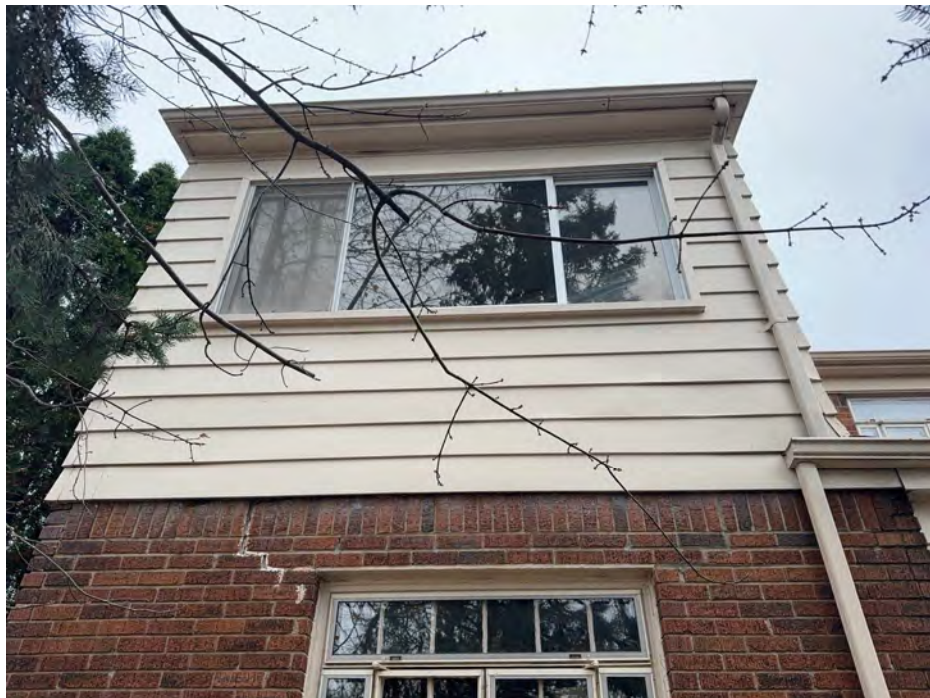
Window 20

- vinyl

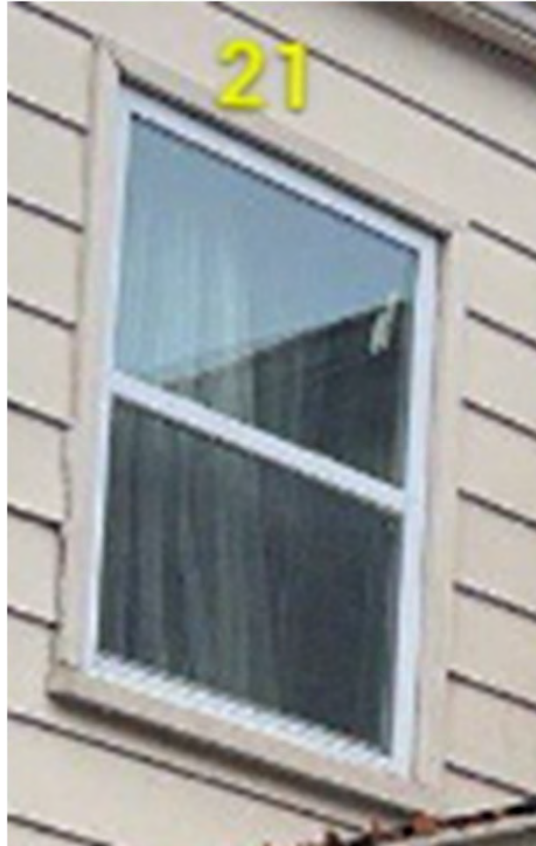
Window 21

- Vinyl; historically incorrect

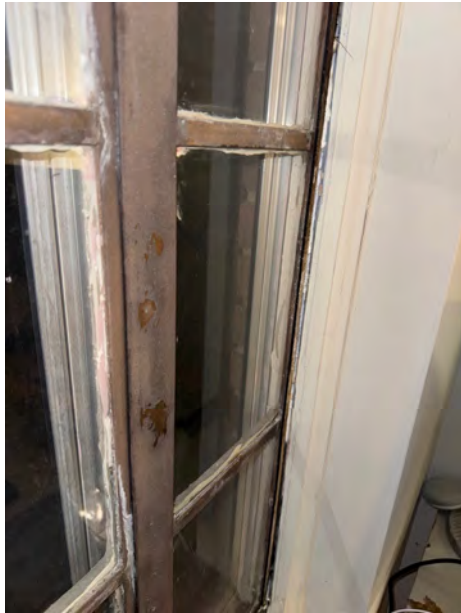
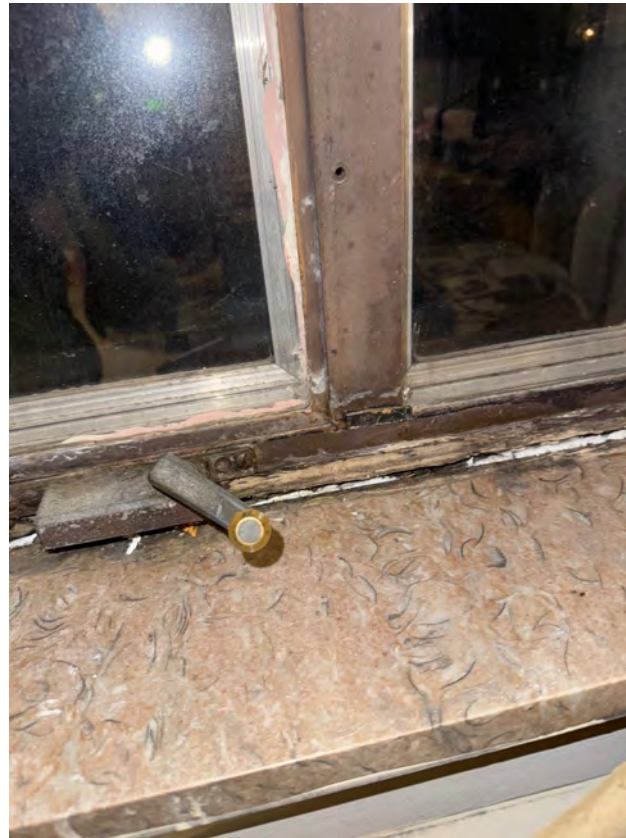
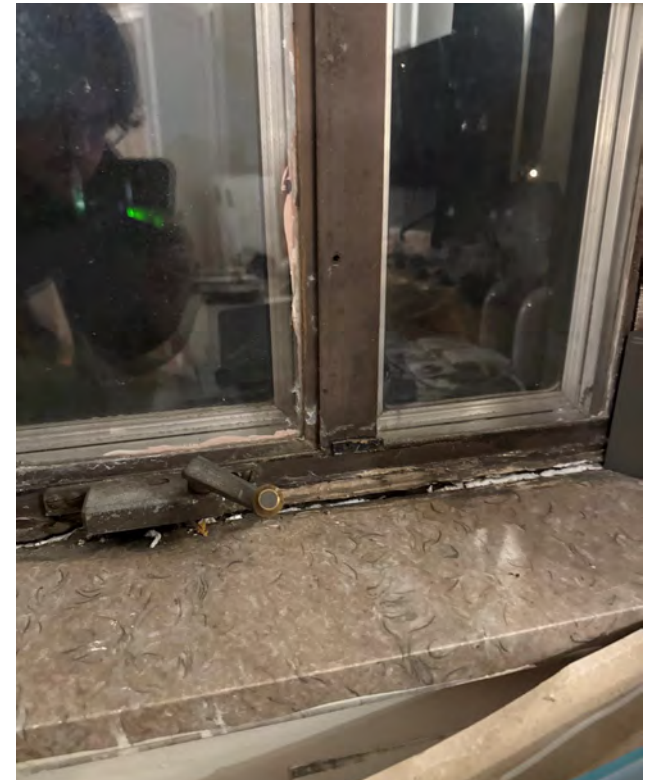
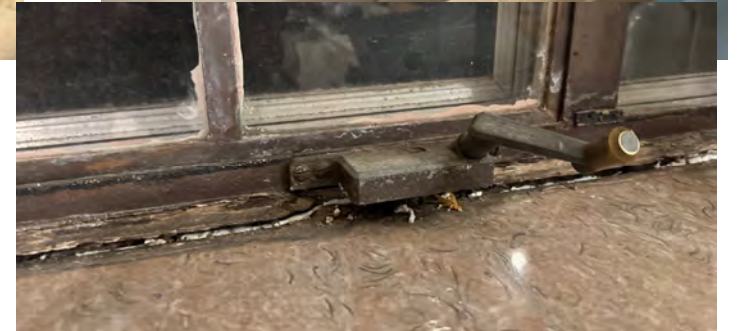
Window 22 (continued)

22- evidence of water damage, substantial rust is present, broken glass

- evidence of water damage,
- substantial rust is present
- broken glass

- Evidence of water damage present,
- Broken glass
- Substantial rust, compromising integrity of the window
