HISTORIC DISTRICT COMMISSION APPLICATION FOR WORK APPROVAL

APPLICATION ID
HDC2025-00014

ADDRESS(ES): 24293 Telegraph Road
HISTORIC DISTRICT: Russell Woods-Sullivan

Window & Siding Replacement

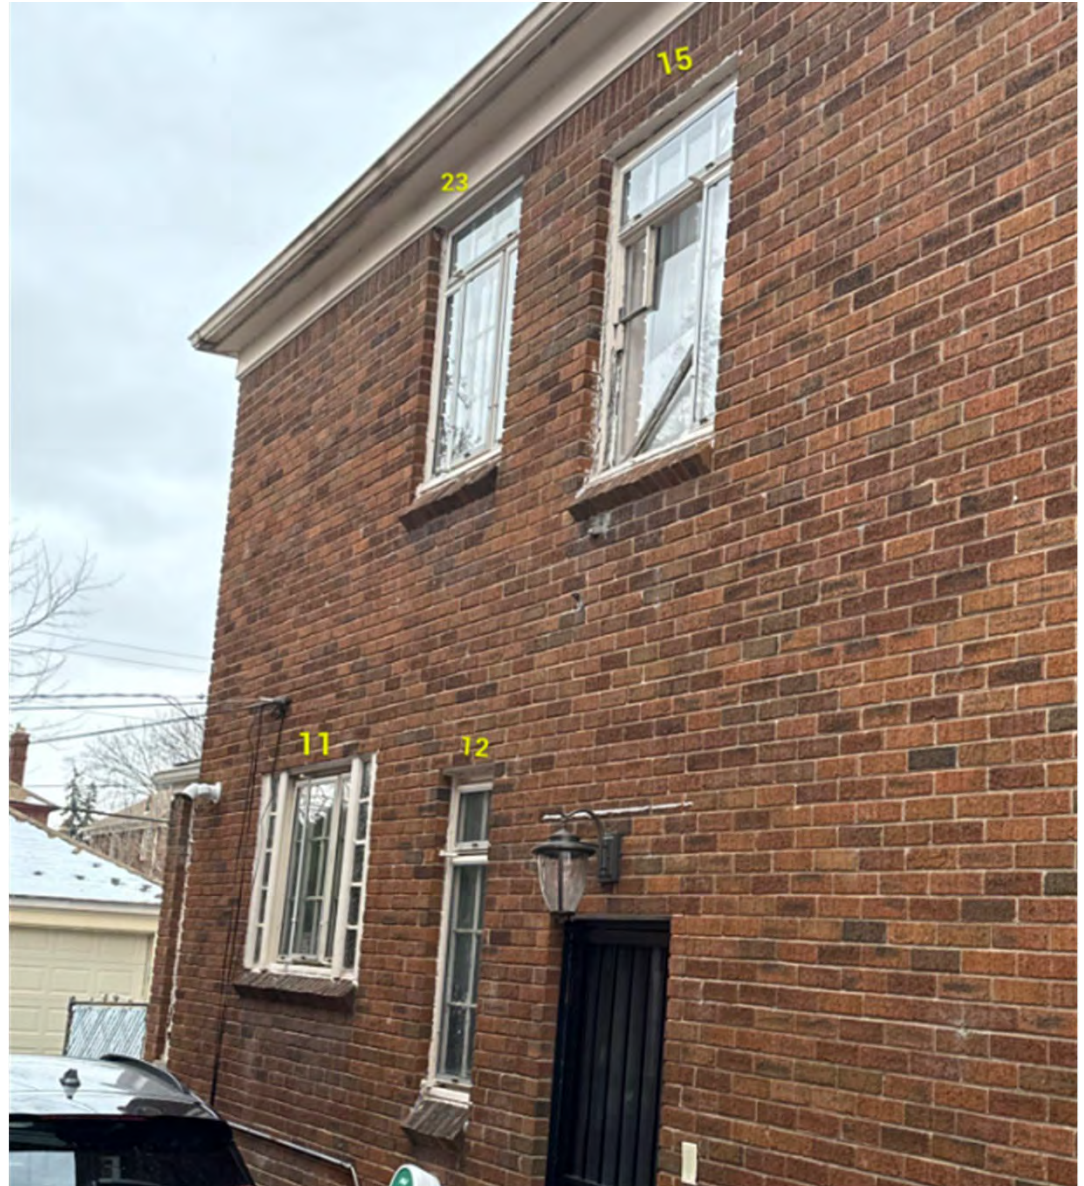
Window 11

11- cant lock, doesn't seal. Draftiest window on first floor. Glass blocks are not original to historical look of the home. Glass blocks were used as an incorrect repair.

- Glass block are not original to home, therefore not historically accurate. Requires replacement of entire opening.

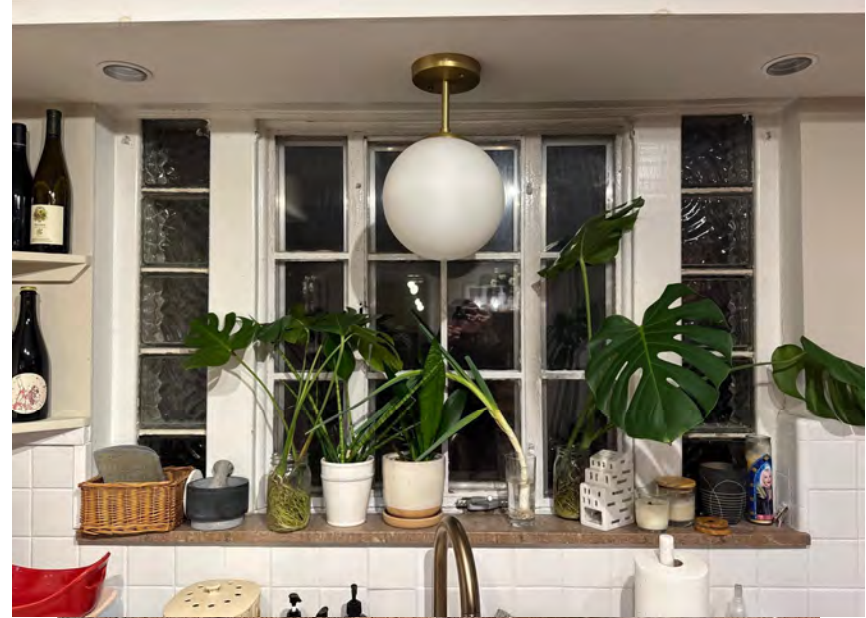
Window 11 (continued)

- Hardware was repaired but can not lock.
- Substantial gaps. Draftiest window on the floor

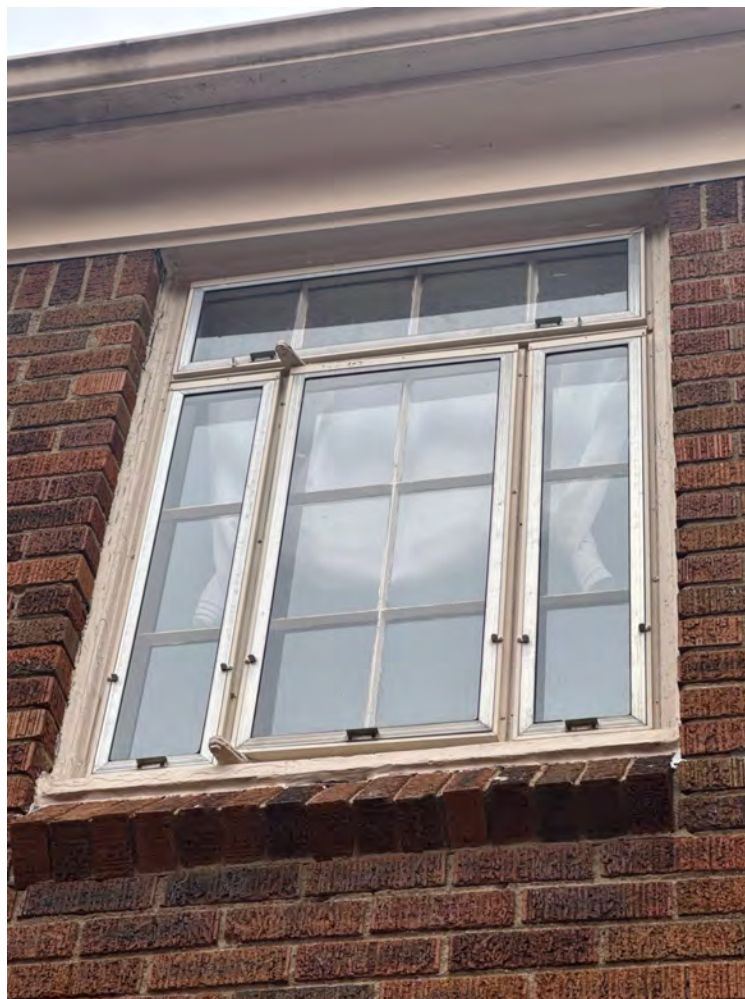
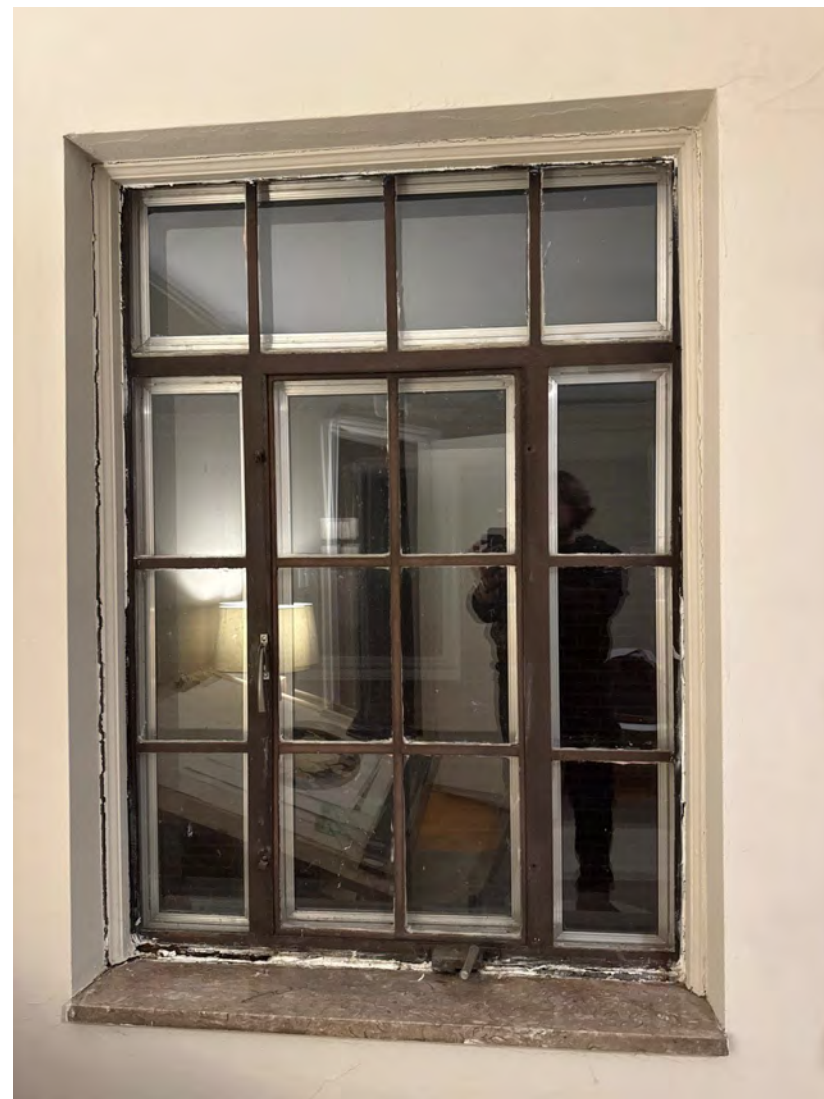
Window 23 (continued)

23- substantial gaps seen from interior of the window frame

- Substantial gaps in window frame. Not flush with home. Very drafty.
