HISTORIC DISTRICT COMMISSION APPLICATION FOR WORK APPROVAL

HDC2026-00001

ADDRESS(ES): 1806 Leverette St

Window Condition Report

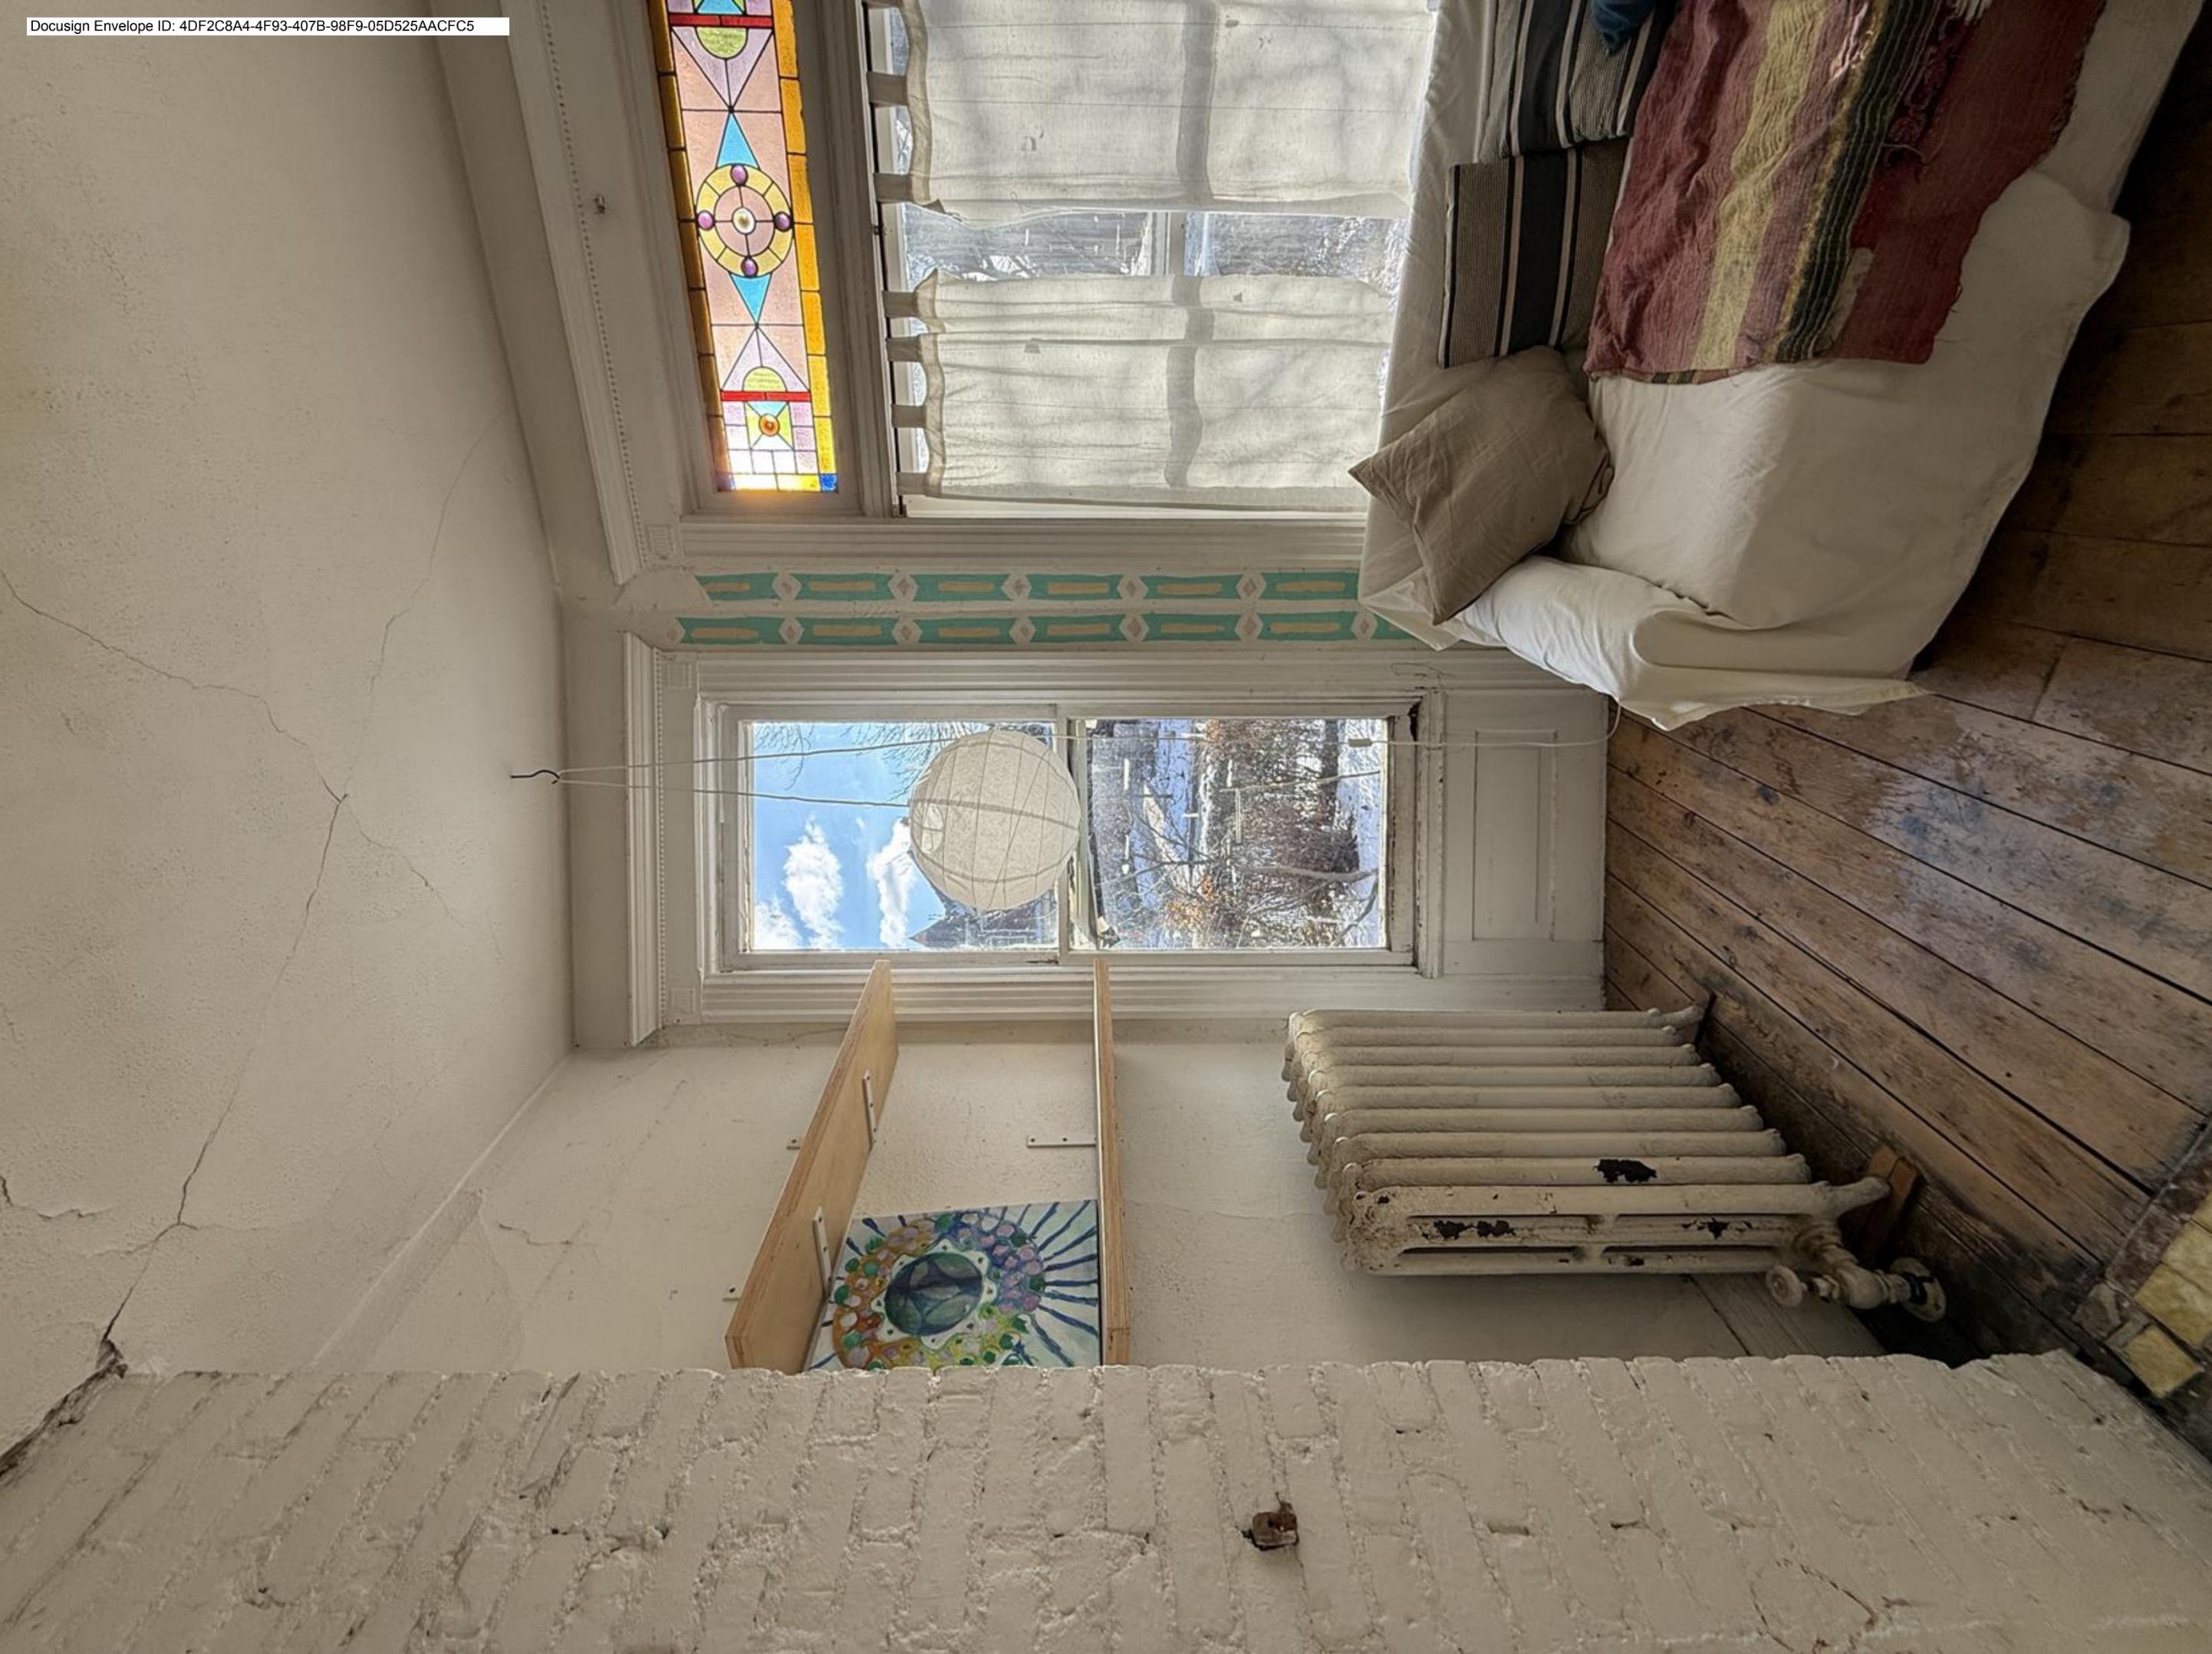
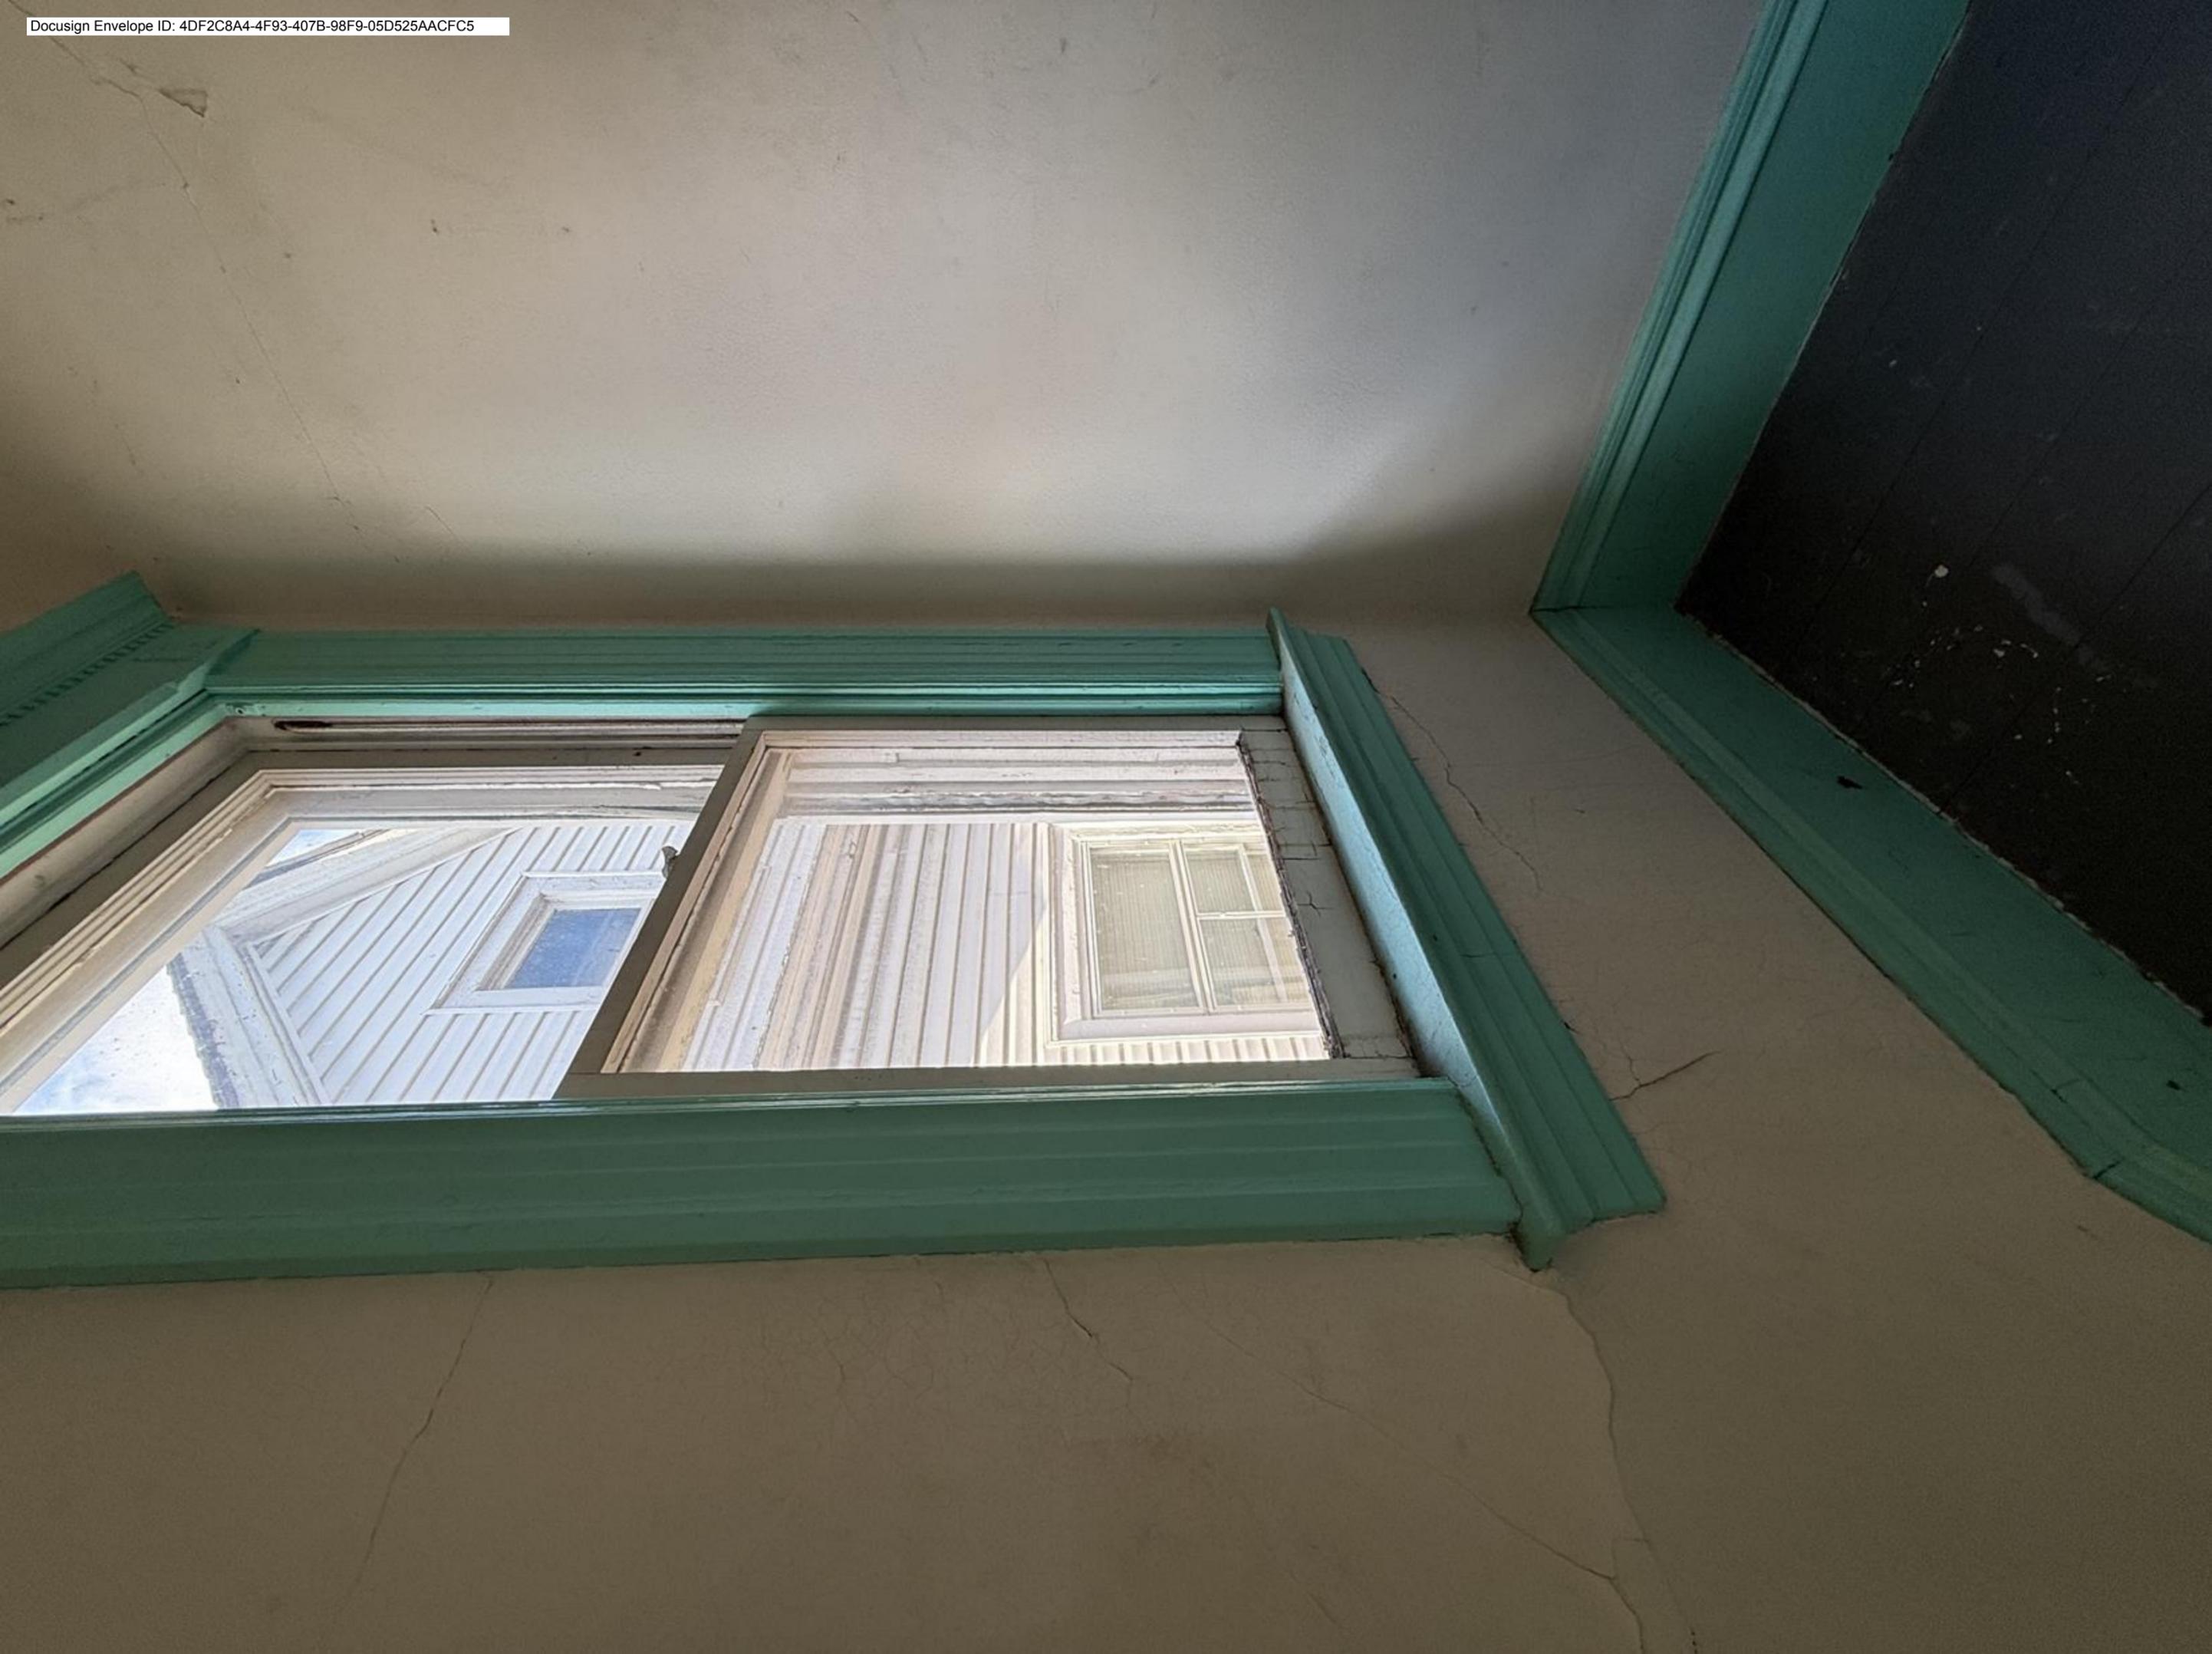
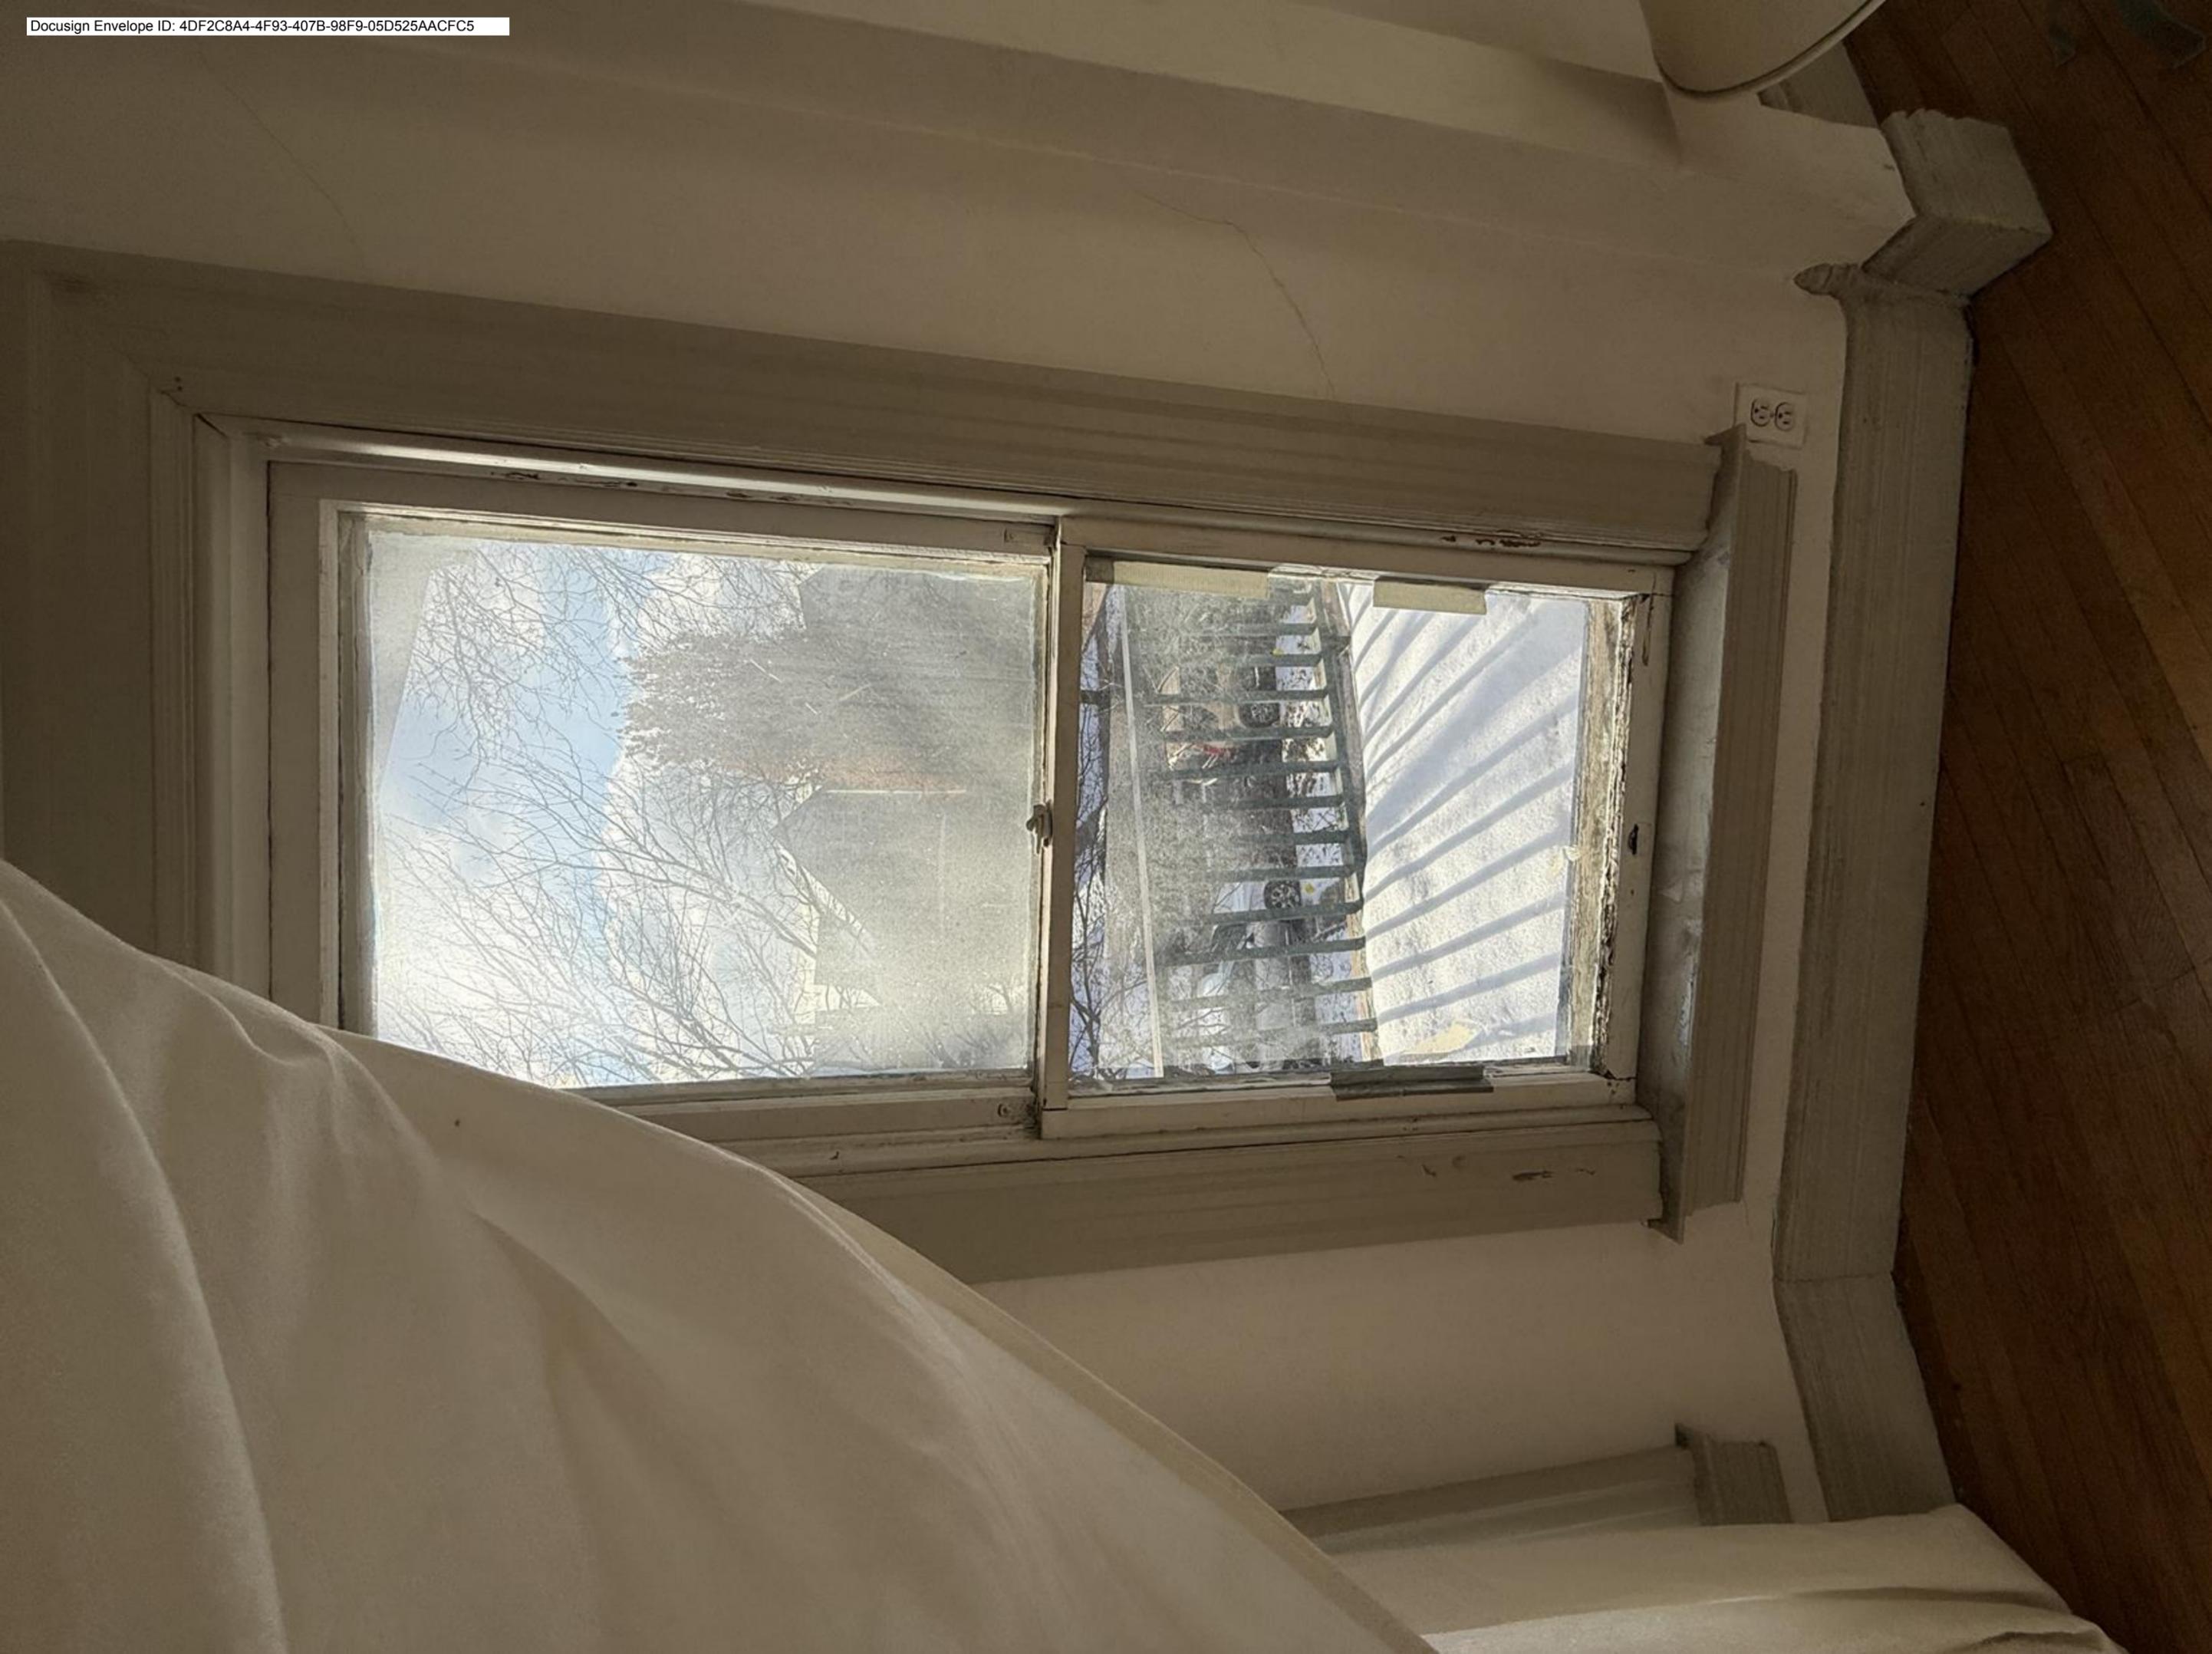
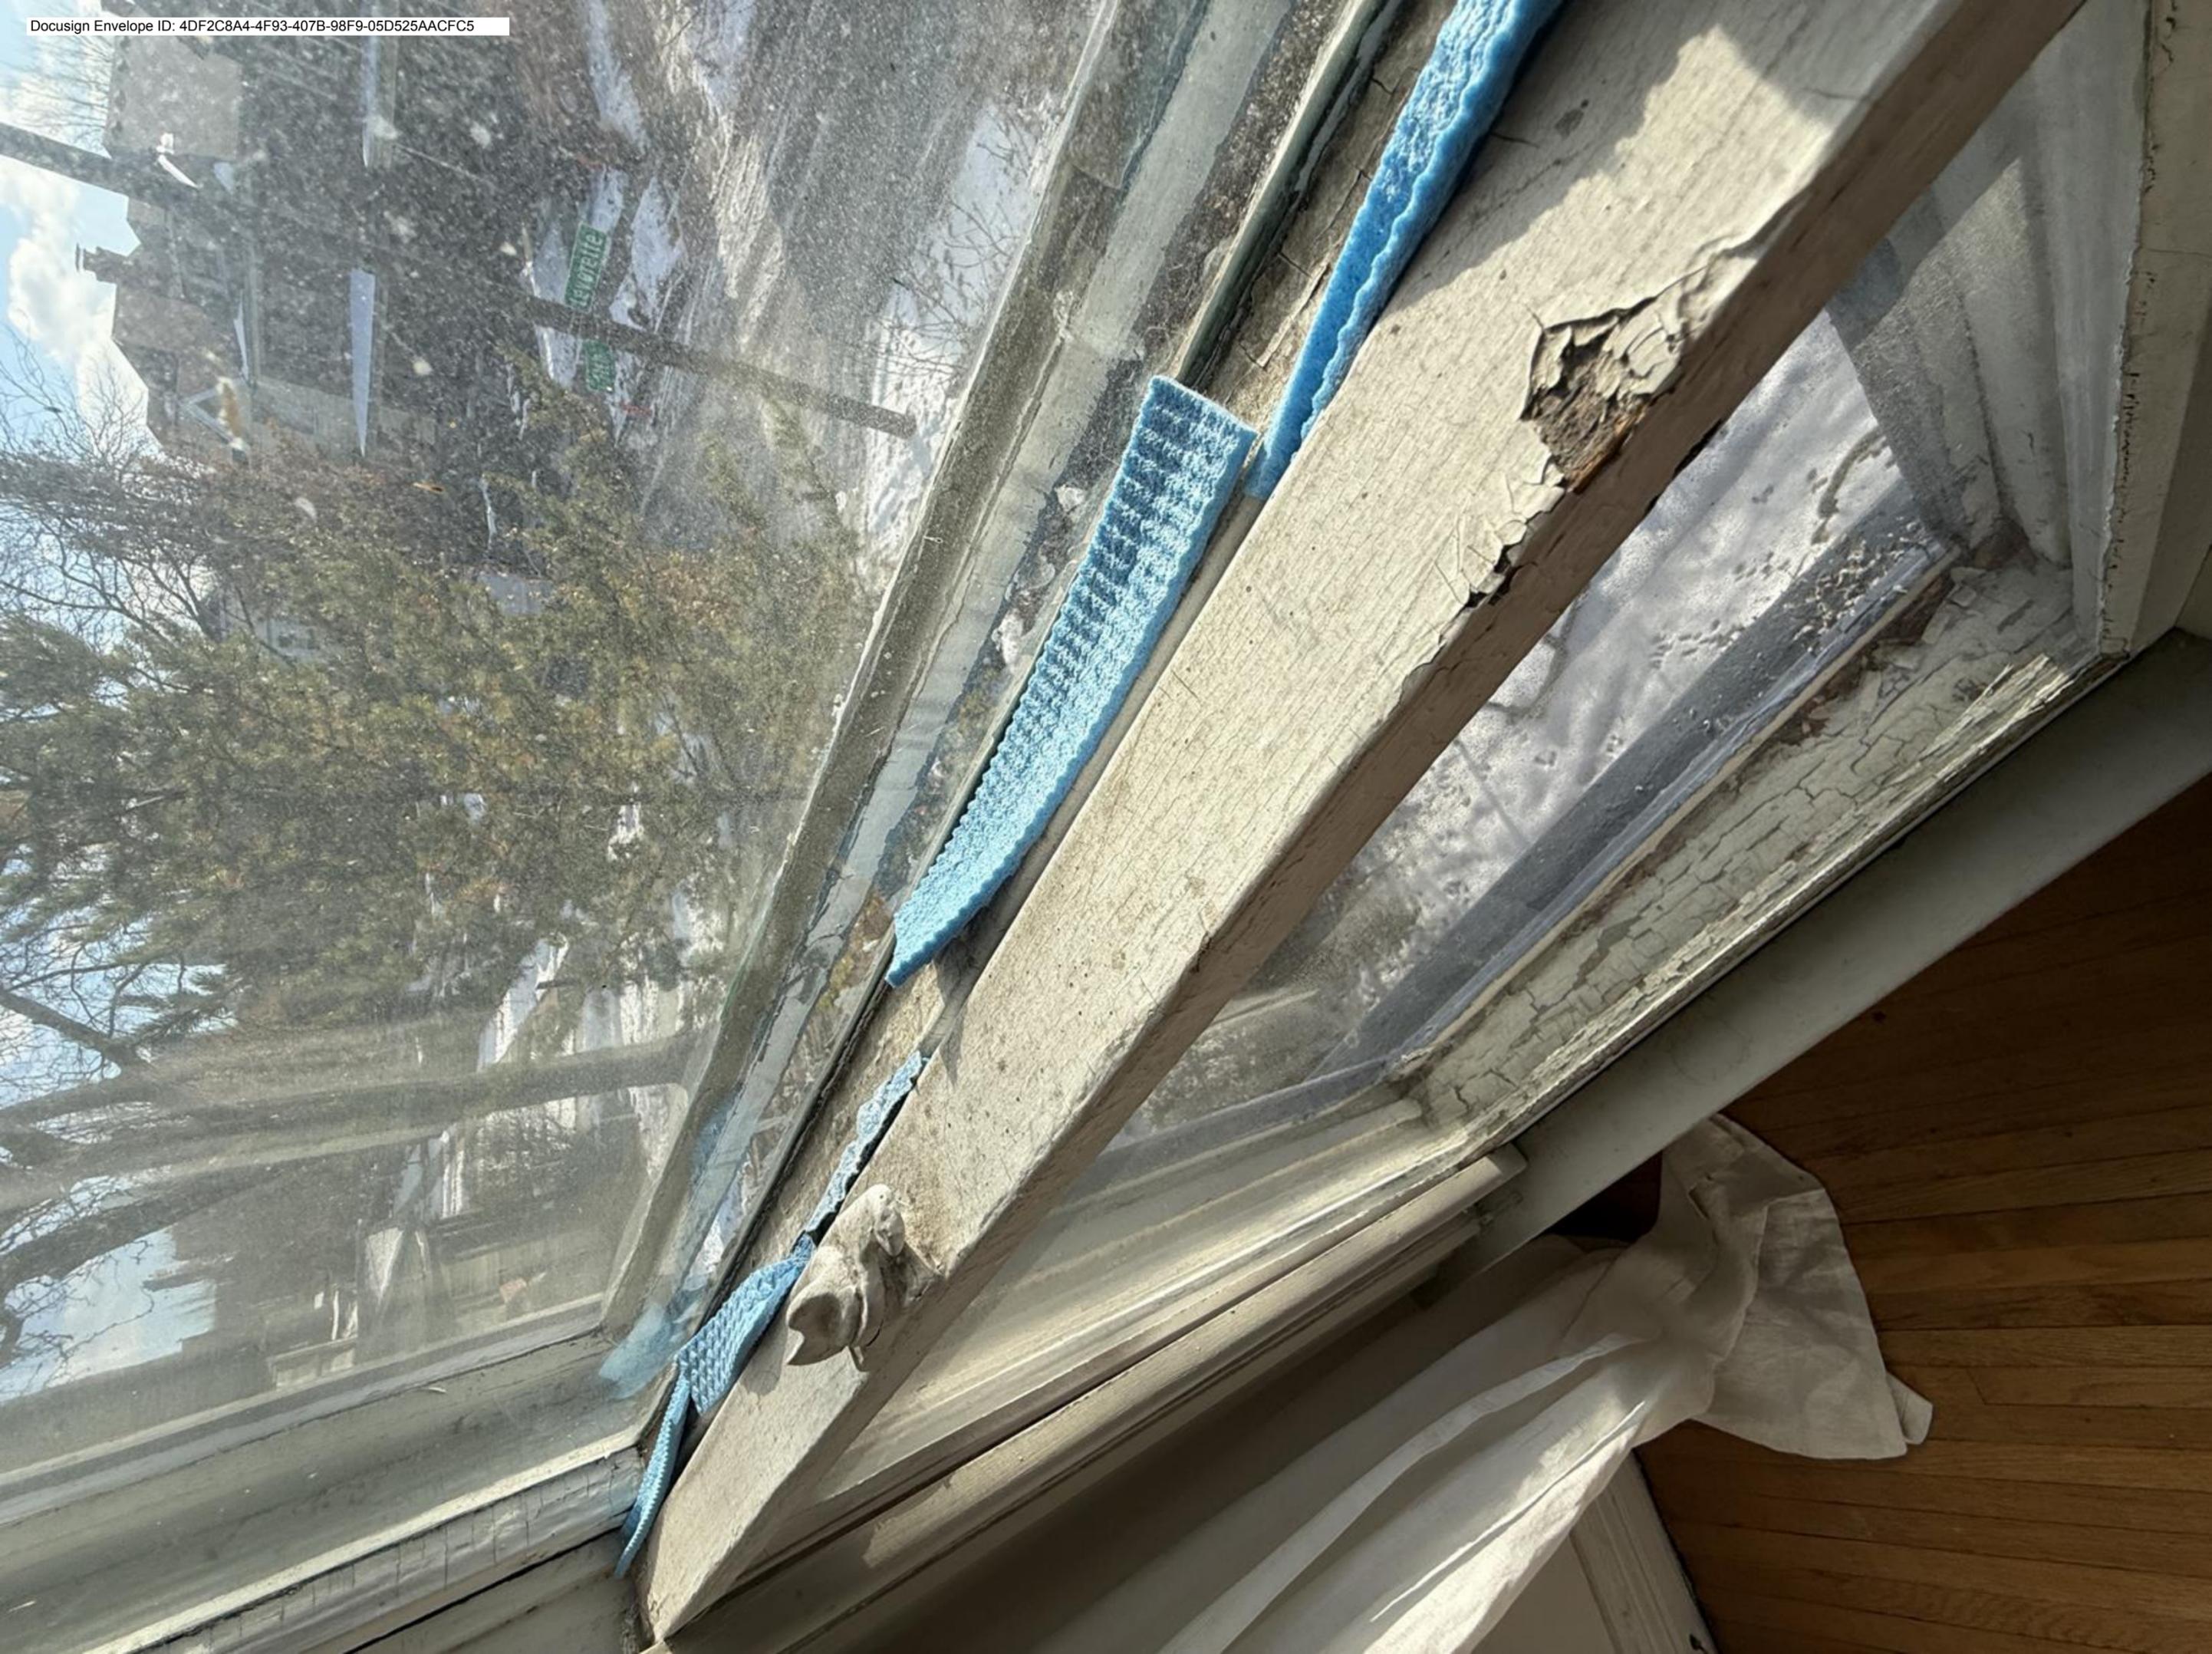
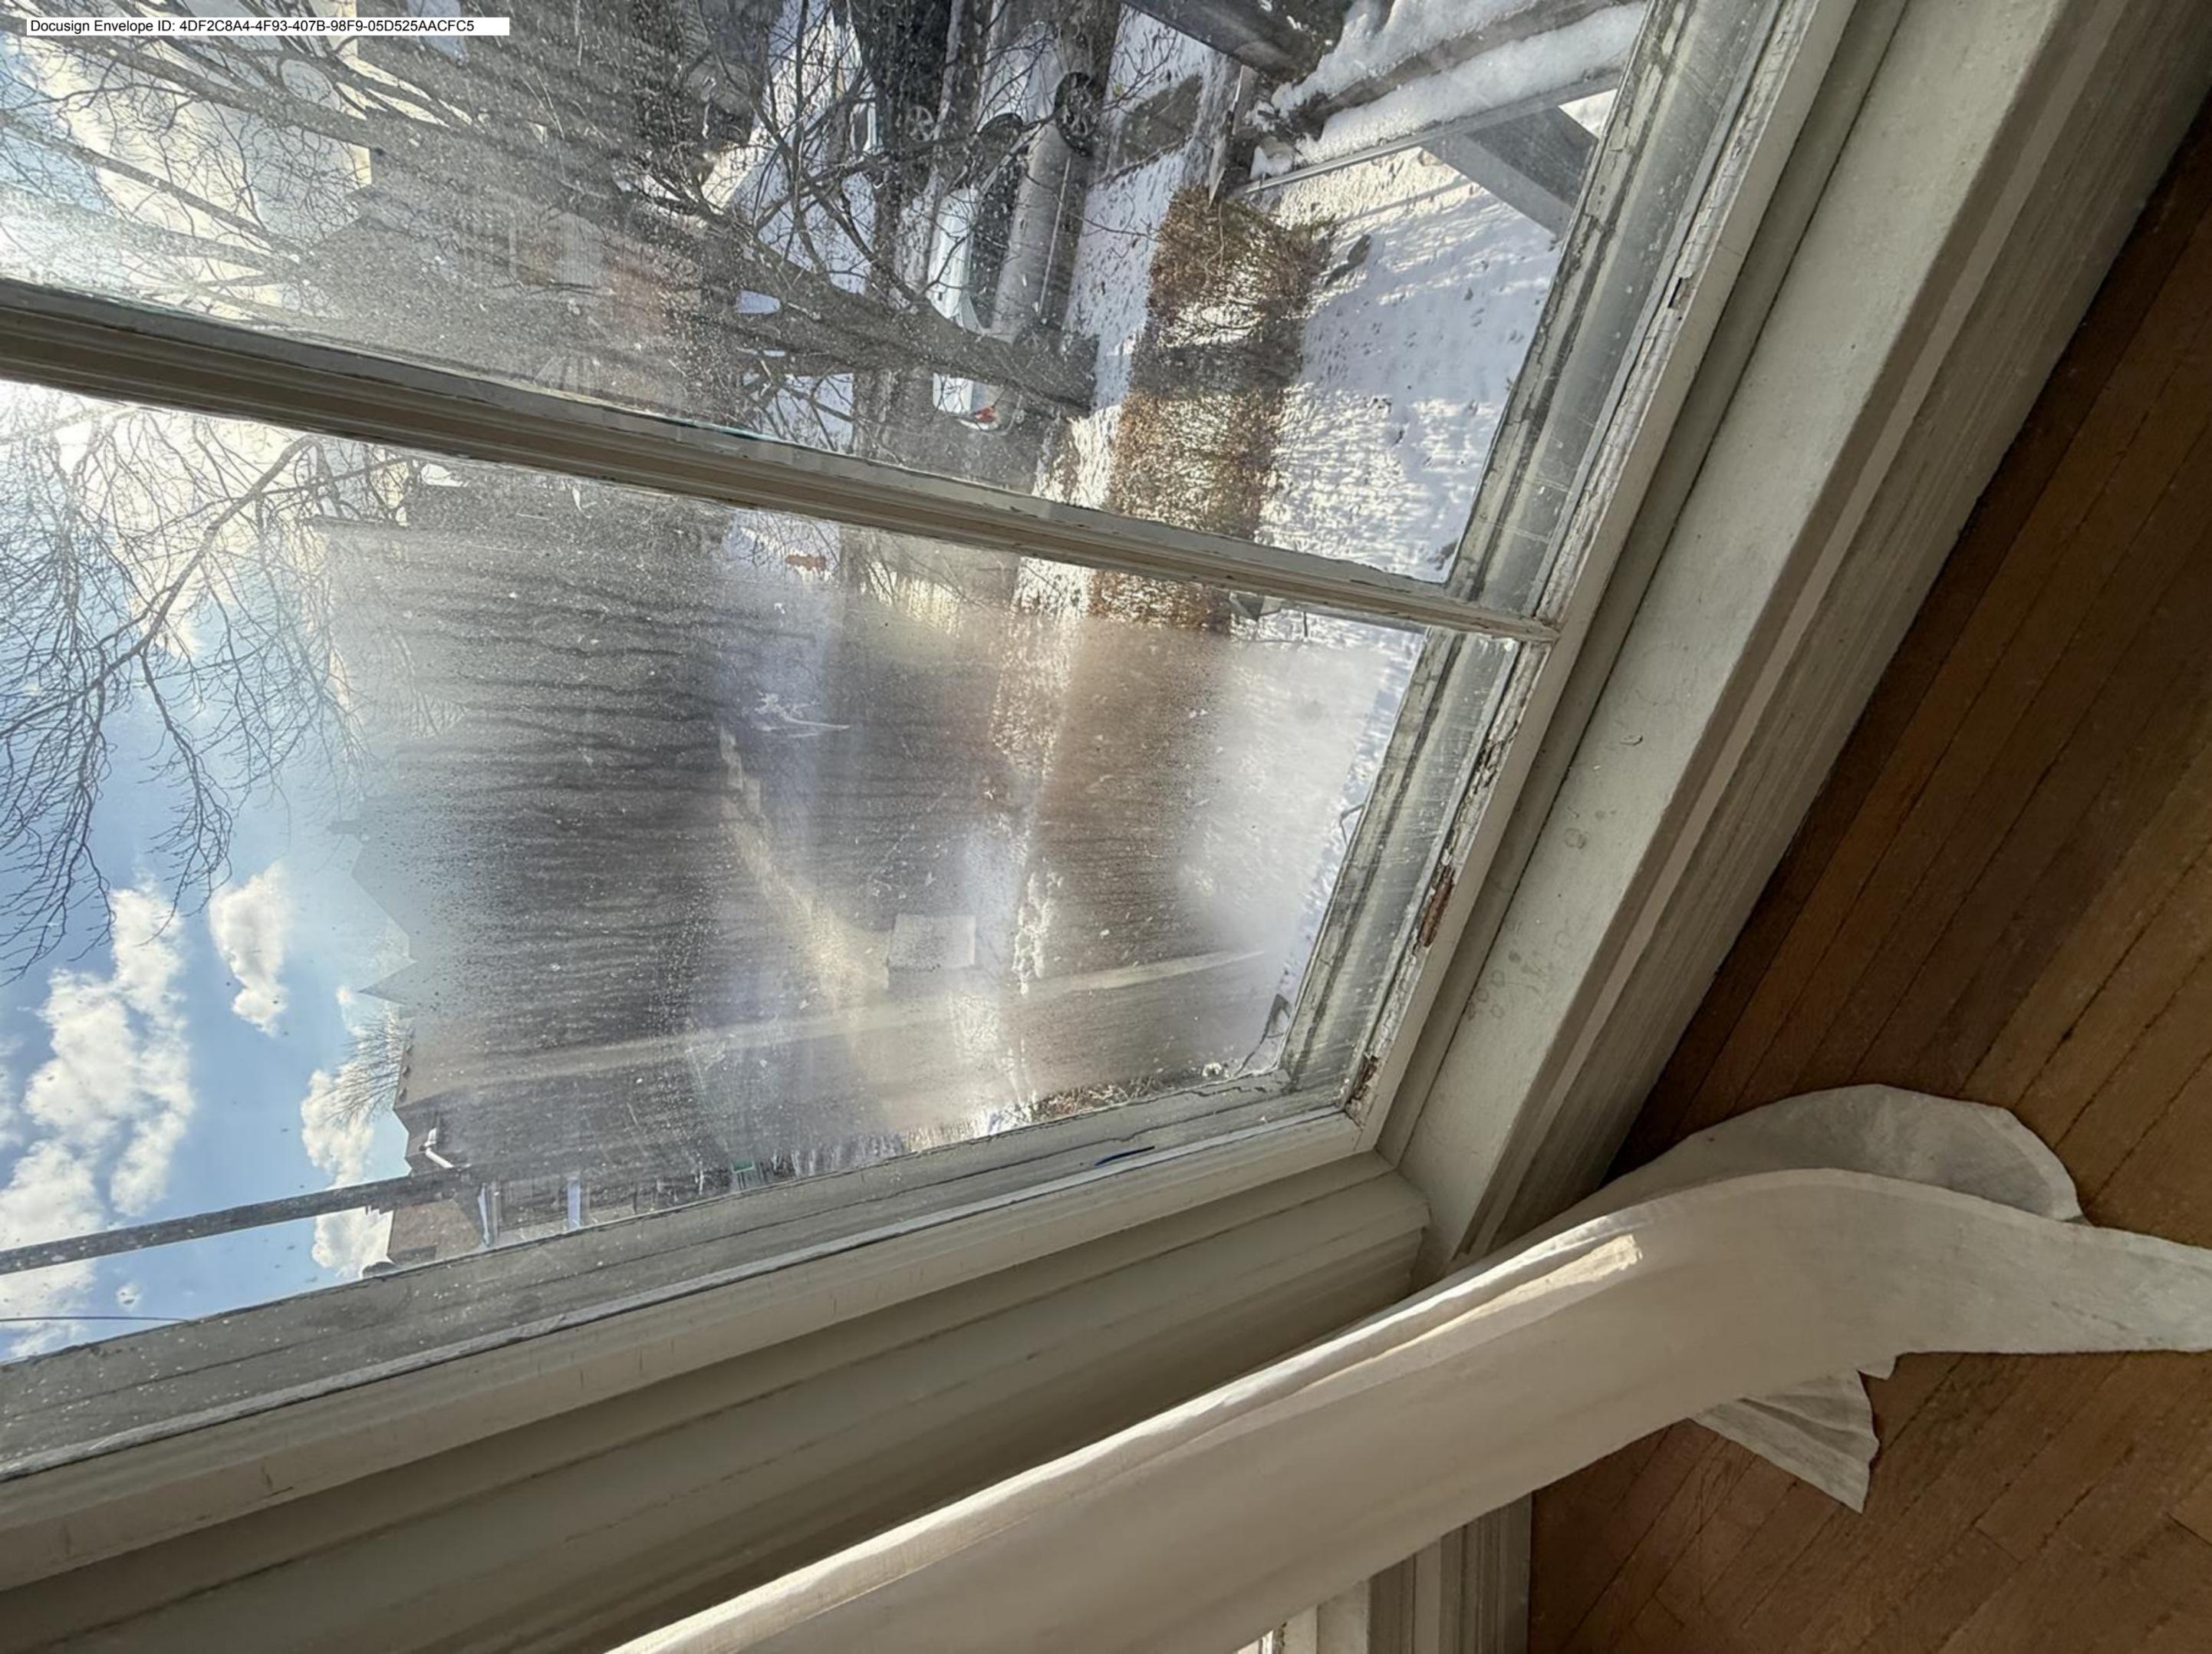
All windows show advanced deterioration beyond repairable condition. The original rope-and-pulley balance systems are largely nonfunctional or missing, and many frames have decayed to the point of structural compromise. Multiple sashes fail to lock, creating safety hazards and allowing significant air and moisture intrusion.

Due to the extent of rot, misalignment, and mechanical failure, restoration would not restore functionality or energy performance to an acceptable level. Full replacement with historically appropriate windows is recommended to maintain architectural integrity while ensuring safety, efficiency, and durability.
