RE: Ste. Anne de Detroit: Exterior Restoration and Rehabilitation  
1000 St Anne St  
Detroit, MI 48216  
Local Historic District: Ste. Anne's Parish Complex

Subject: HDC Application for Ste. Anne de Detroit: Exterior Restoration - Request for COA revision, Historic Wood Windows, Replacement Windows, and Basement Masonry Openings

### EXISTING HISTORIC WINDOWS ASSESSMENT AND PROPOSED TREATMENTS:

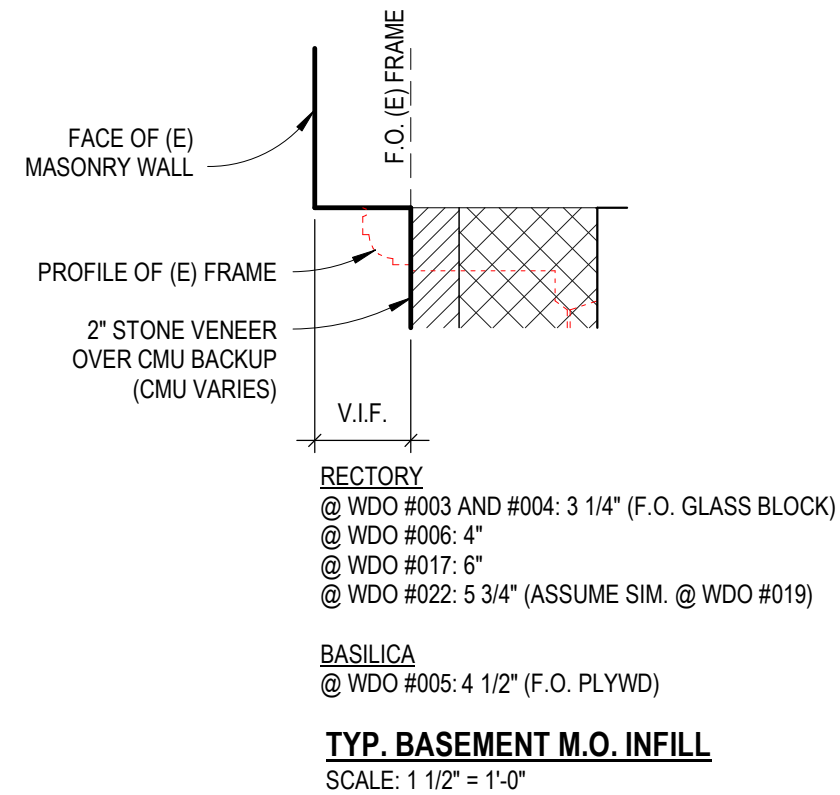
View of existing historic masonry opening #003 at Rectory, south elevation.
