HISTORIC DISTRICT COMMISSION APPLICATION FOR WORK APPROVAL

APPLICATION ID
HDC2026-00170

ADDRESS(ES): 4291 Cortland
HISTORIC DISTRICT: Russell Woods-Sullivan

4291 Cortland - Description of Existing Condition

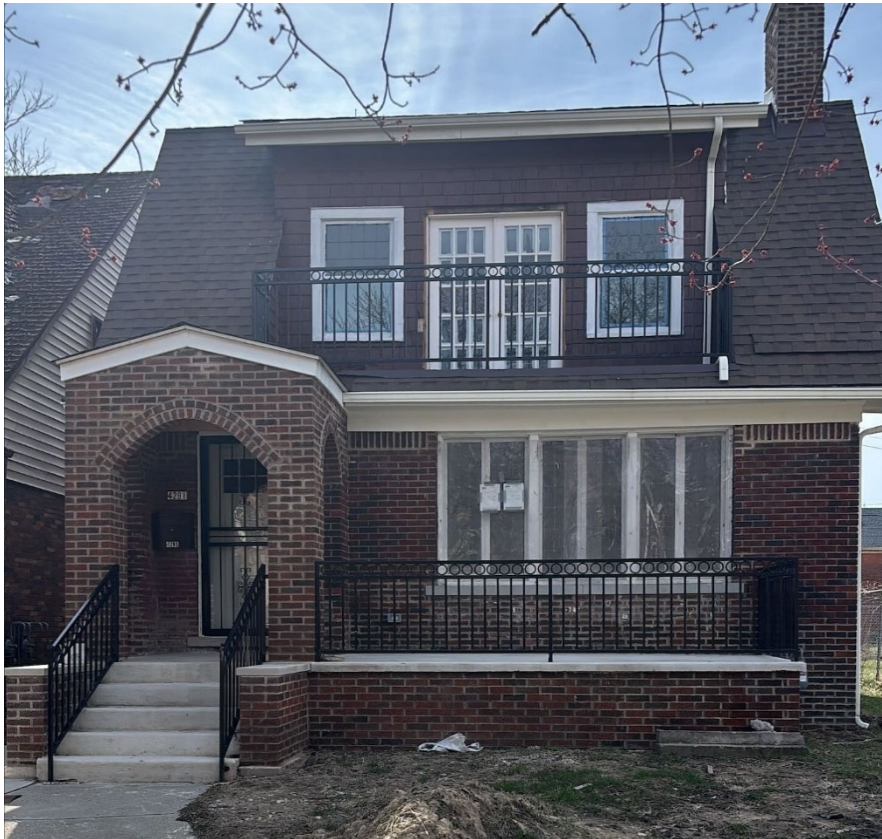
2026 – Window and Door restoration complete on front facade
