# HISTORIC DISTRICT COMMISSION APPLICATION FOR WORK APPROVAL

<b>APPLICATION ID</b>
HDC2026-00193

<b>ADDRESS(ES):</b> 892 W. Boston Boulevard
<b>HISTORIC DISTRICT:</b> Boston-Edison

EDWARD F. FISHER MANSION

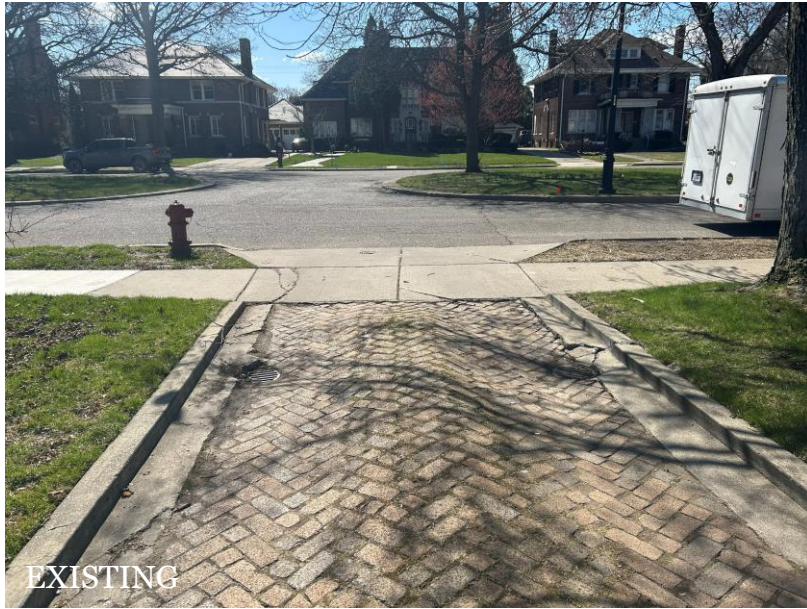
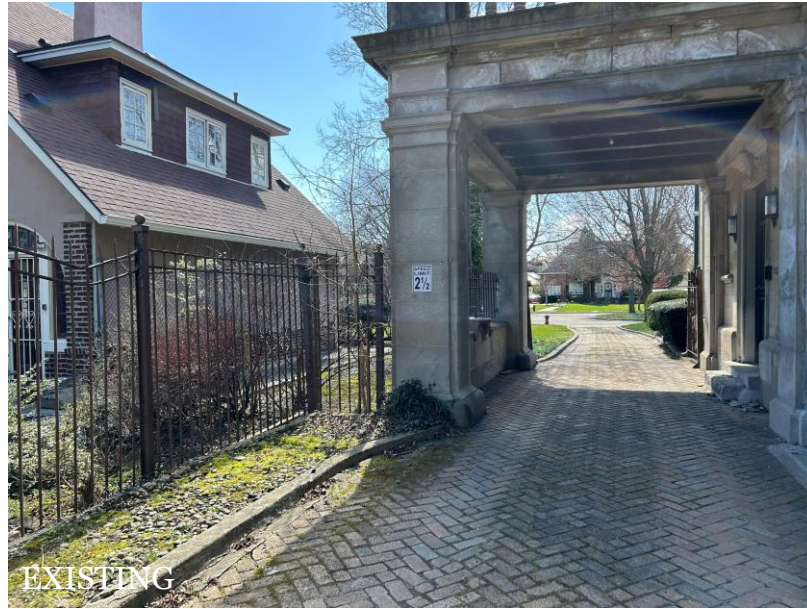
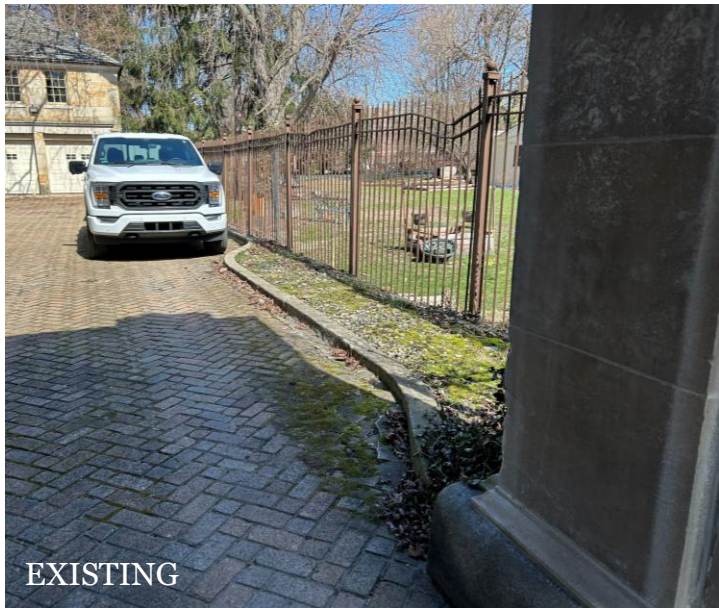
## Driveway

Existing driveway has cracked/broken pieces. The driveway subbase is failing due to compaction from vehicles over the years creating rutting.

Utilize existing brick and install on compacted aggregate base to address compaction issues. Widen to accept modern vehicles.

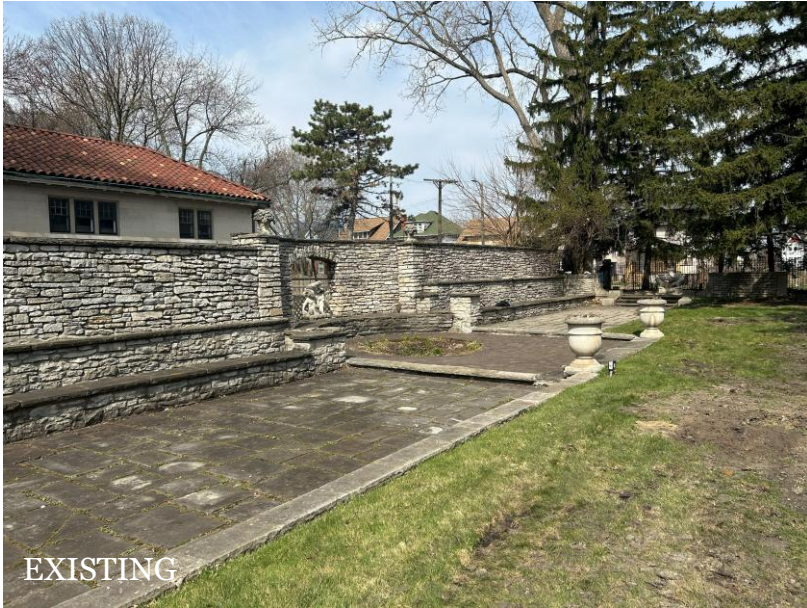
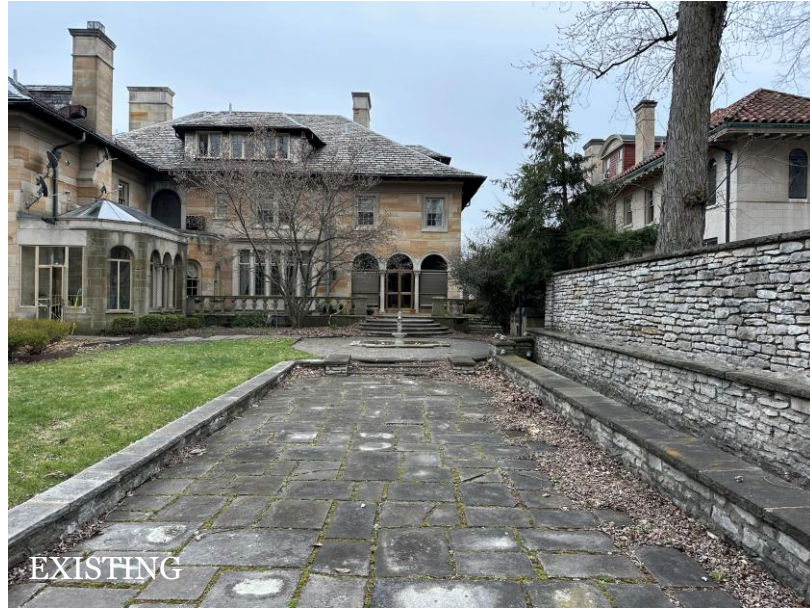
## Entertainment/Dining Terrace

Transition Terrace is not original and replaced with concrete unit pavers in the 90's. The non-historic flatwork is failing.

Remove failing concrete unit pavers. Install Buff Tayko natural stone in historic corridor.

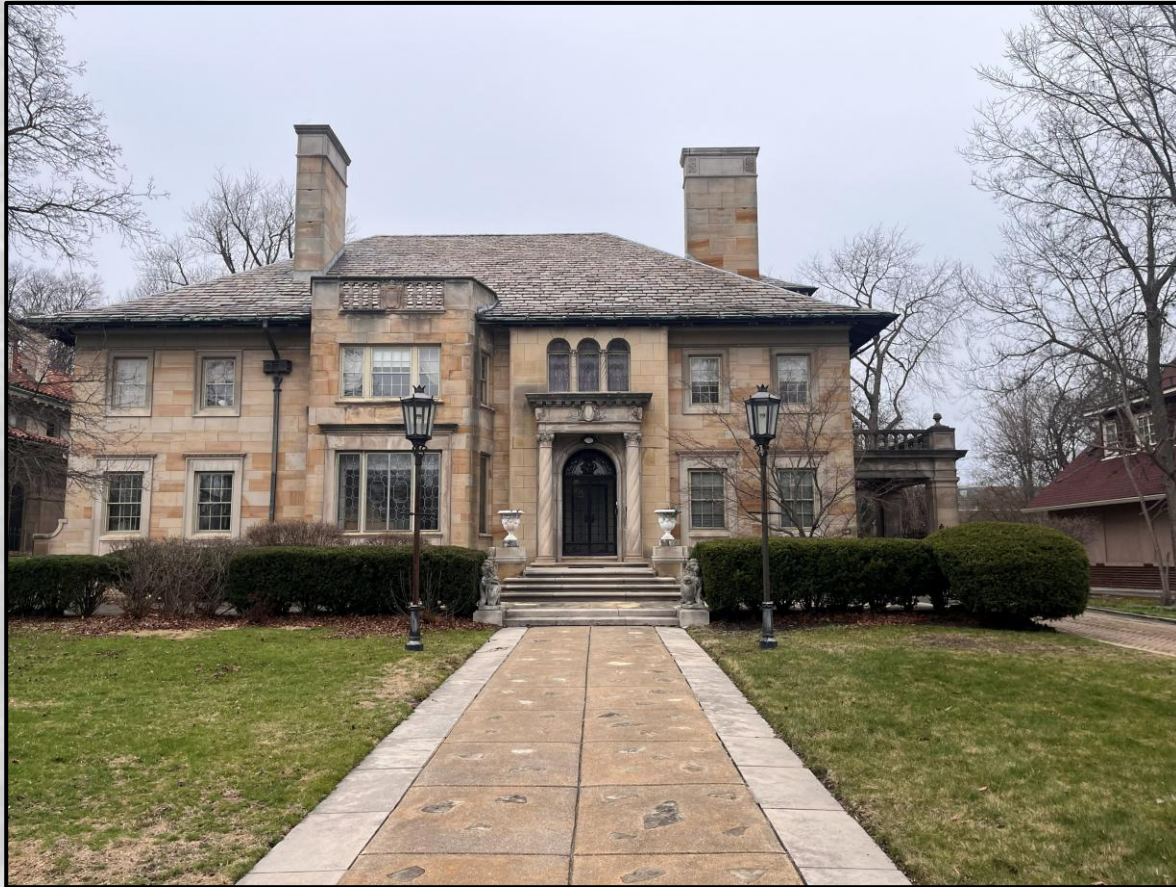
## Entry walk

Entry walk is not historic. Work done in the 90's included removing the original concrete walk and installing a died concrete with pieces of natural stone integrated into the flatwork. According to historical images, the width is the same.

Remove existing concrete entry walk and replace with new exposed aggregate concrete. Existing walkway footprint remains.

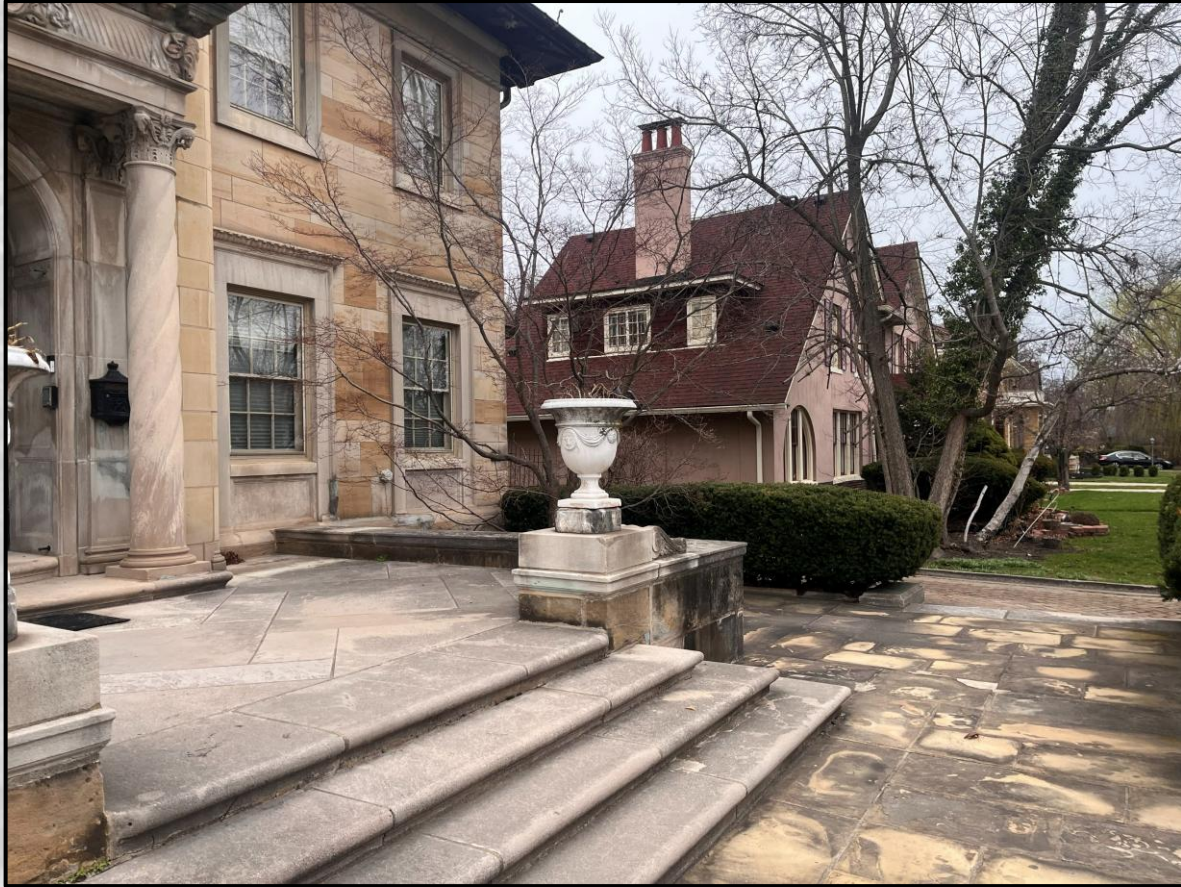
## Entry Porch

Entry Porch contains original natural stone paving with concrete patches.

Existing entry porch flatwork and walls to remain. Wash, tuckpoint, and replace missing pieces. Match with Buff Tayko natural stone.

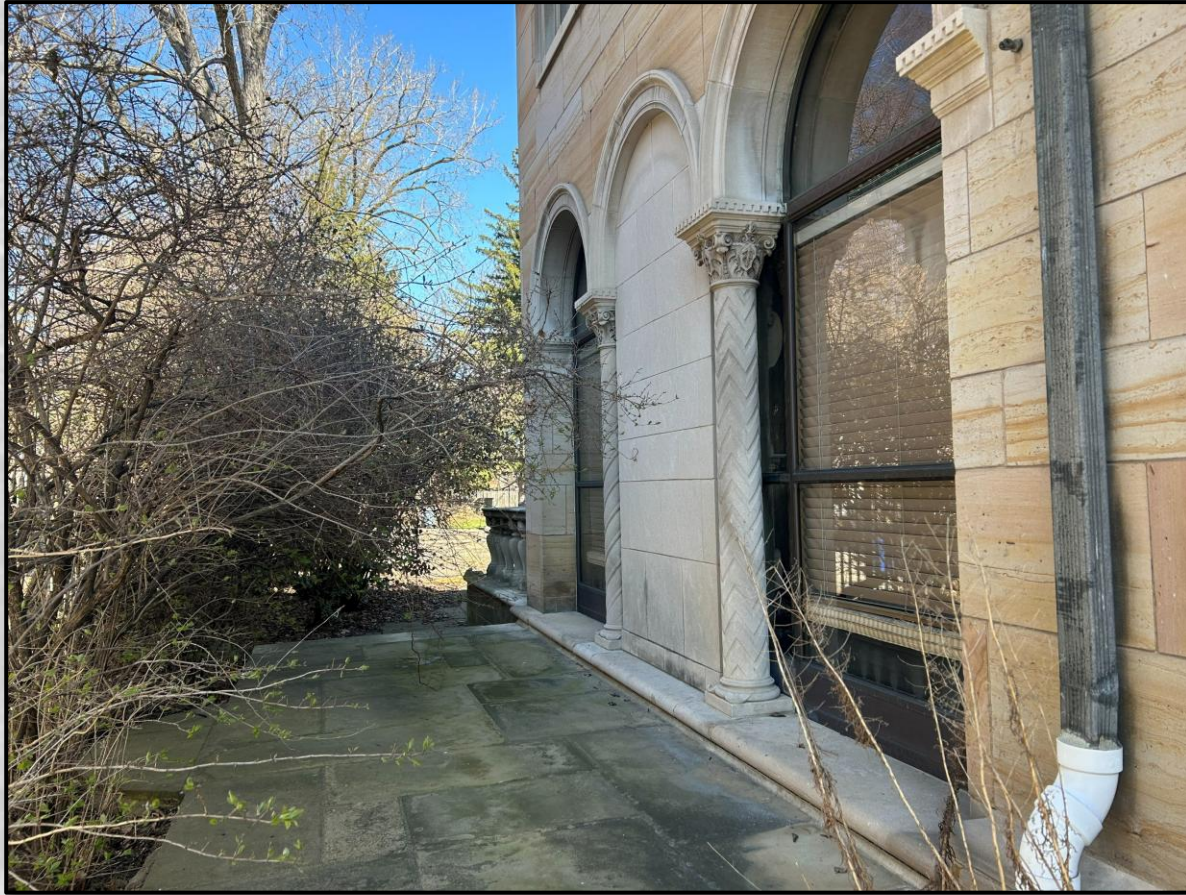
# West Side

West side is completely original.

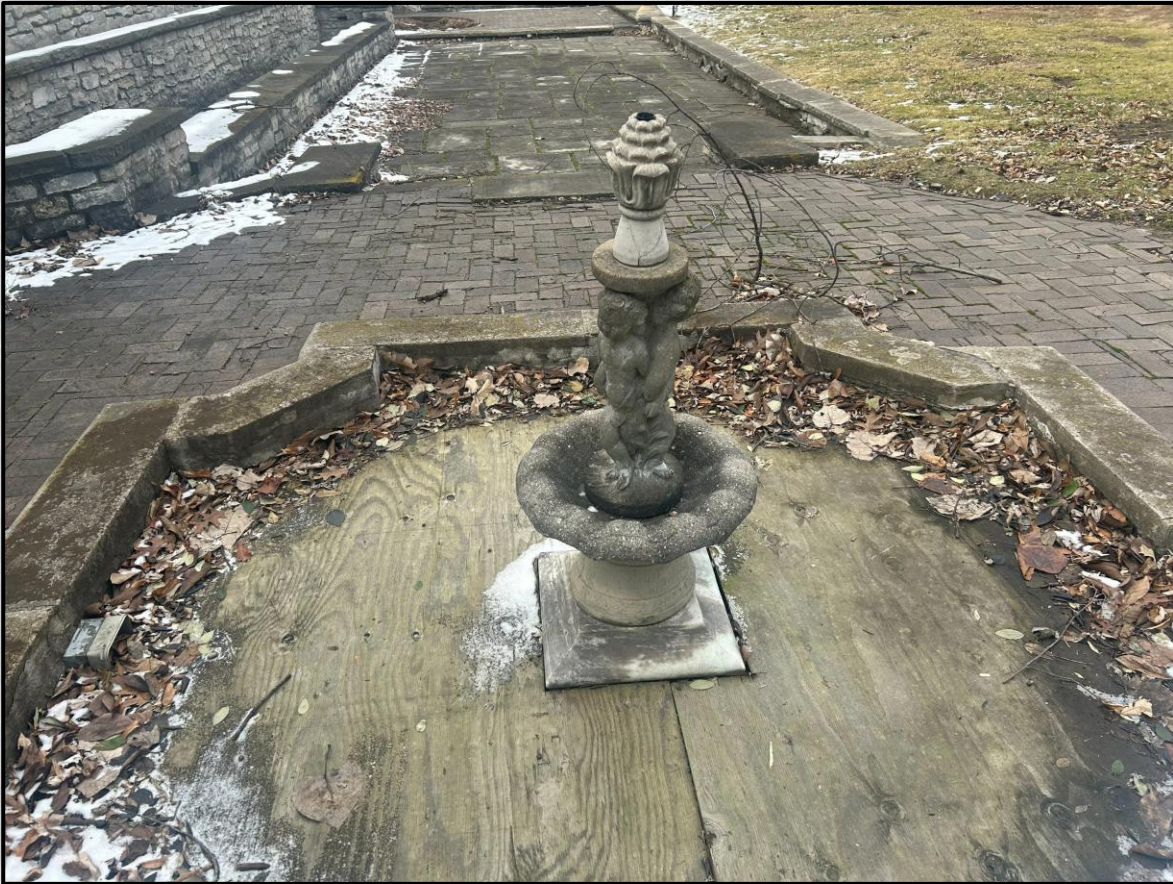
## South Fountain

South Fountain feature is not original, and existing basin is in disrepair.

Historic water feature to be  
replicated with limestone for  
South end water feature.

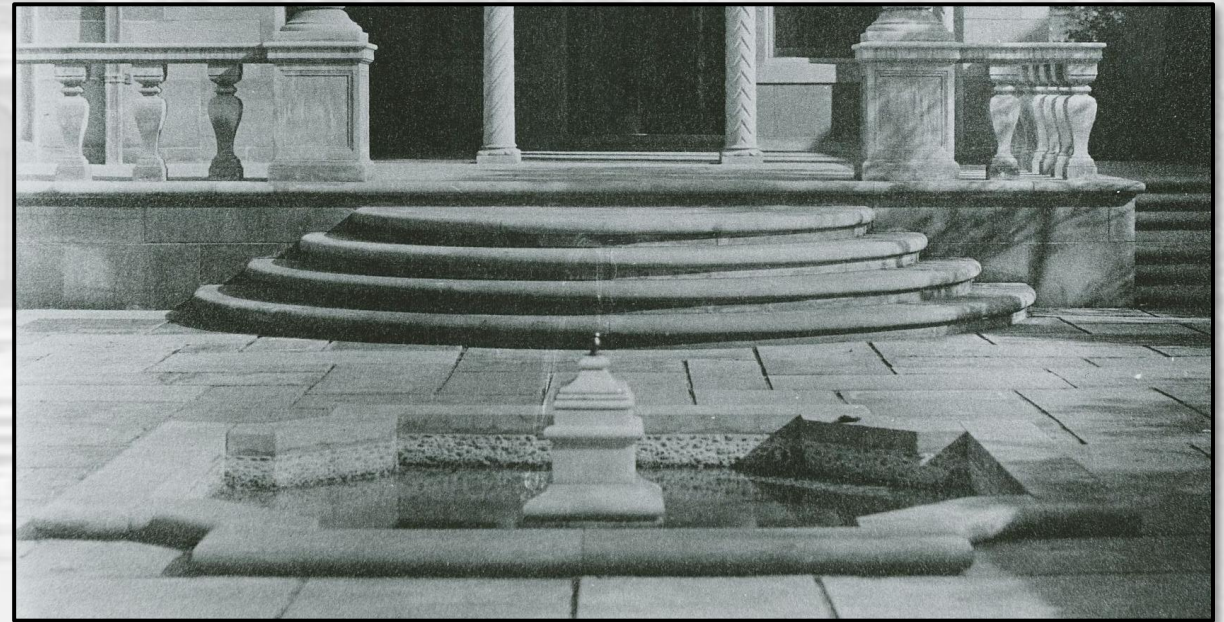
The existing fountains are concrete basins with non-historic water features controlled by a submersible pump. Deficiencies include cracked basin wall/floor, aged/non-functional submersible pump, deteriorated sealant at select joints and penetrations, failing non-historic water features.

The proposed repair will be completed by routing/widening cracks to create a clean bonding surface, fill with a polymer-modified cement mortar repair NSF-rated for submerged conditions, apply crystalline waterproofing system rated for constant water immersion (coating applied per manufacturer's thickness and curing requirements), install proposed water feature and submersible pump, pump connection to be performed by licensed electrician with watertight conduit fittings and junction boxes.

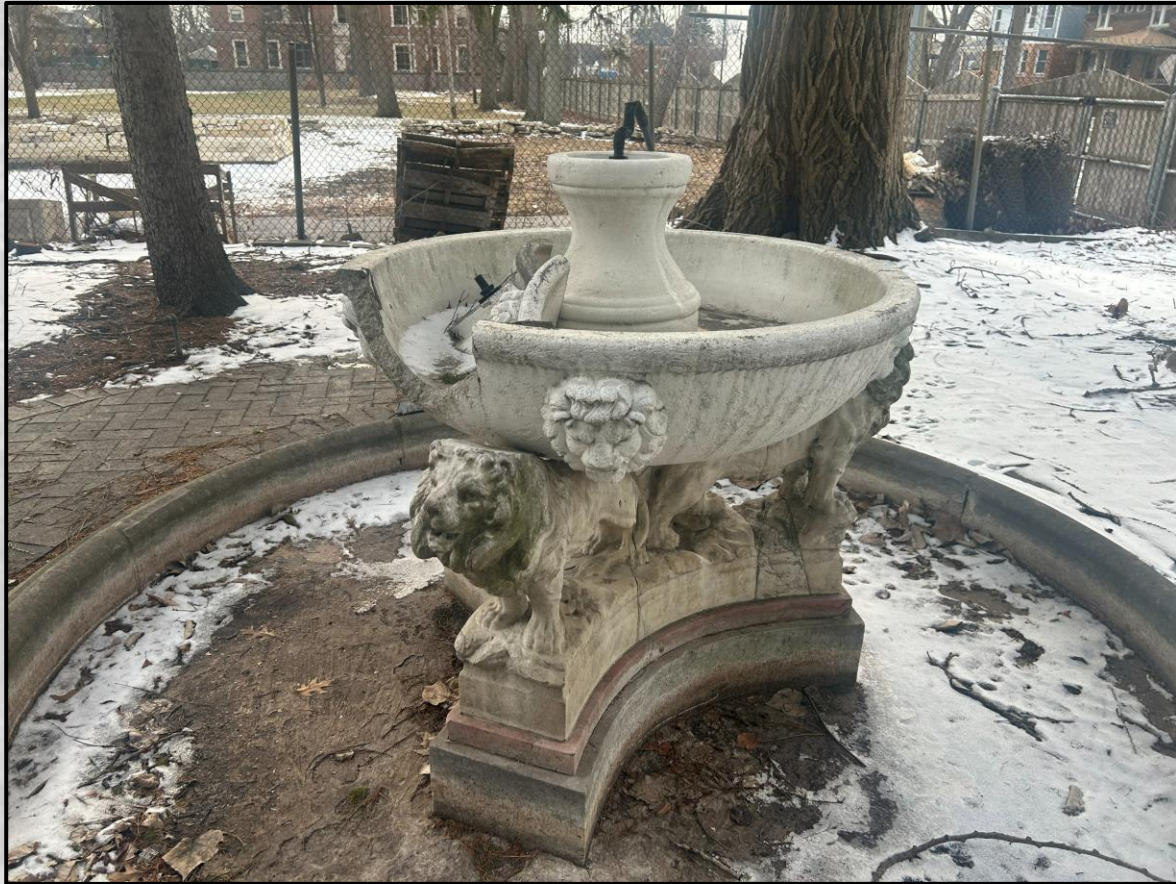
# North Fountain

North Fountain base is historic. The bowl is not historic. The basin is in disrepair.
