HISTORIC DISTRICT COMMISSION APPLICATION FOR WORK APPROVAL

APPLICATION ID
HDC2026-00195

ADDRESS(ES): 1000 St Anne Street
HISTORIC DISTRICT: Ste. Anne's Parish Complex

Subject: HDC Application for Ste. Anne de Detroit: Exterior Restoration - Request for COA revision, Historic Wood Windows, Replacement Windows, and Basement Masonry Openings

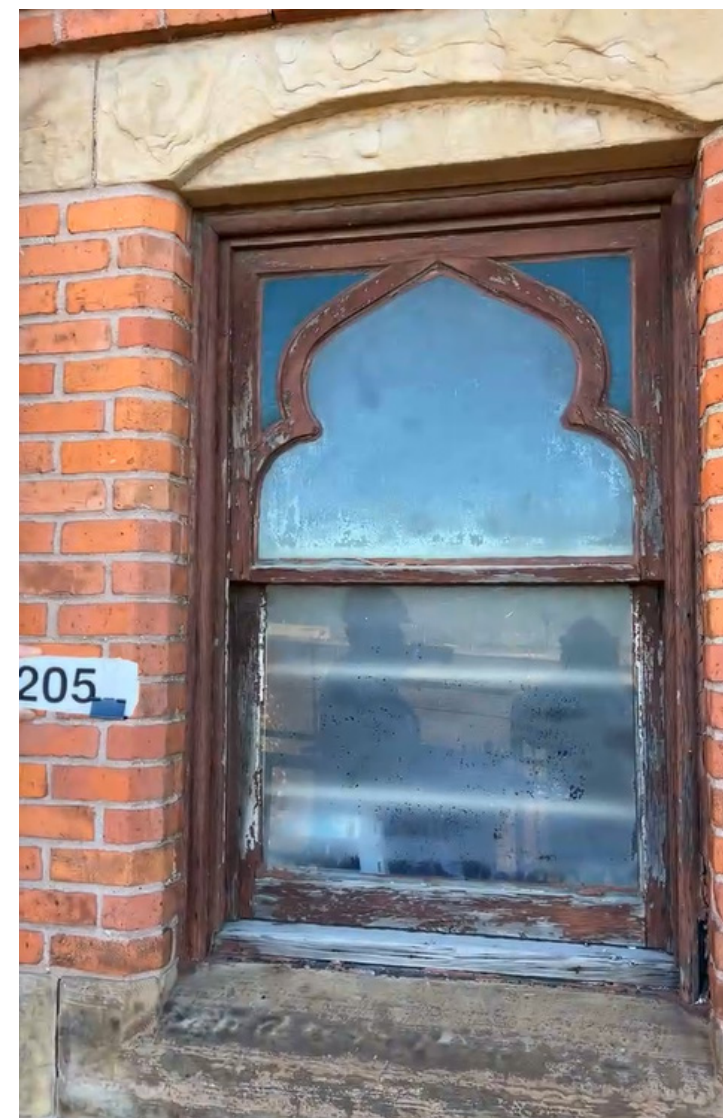
View of existing historic wood window #205 at Basilica (sacristy), 2nd floor, west elevation.

Three historic wood double-hung windows (#203, #204, and #205) at 2nd floor, west elevation. Custom in-kind wood windows proposed for replacement.

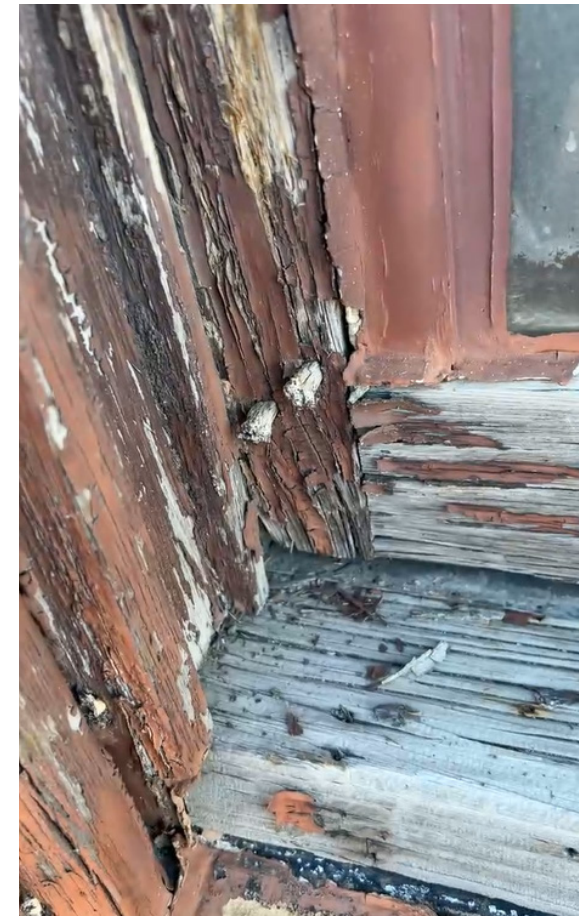
Detail view of existing historic wood sill, frame, and lower sash components, typical condition.
