# HISTORIC DISTRICT COMMISSION APPLICATION FOR WORK APPROVAL

HDC2026-00439

**ADDRESS(ES):** 1459 Atkinson Street

**Siding & Windows Replacement**

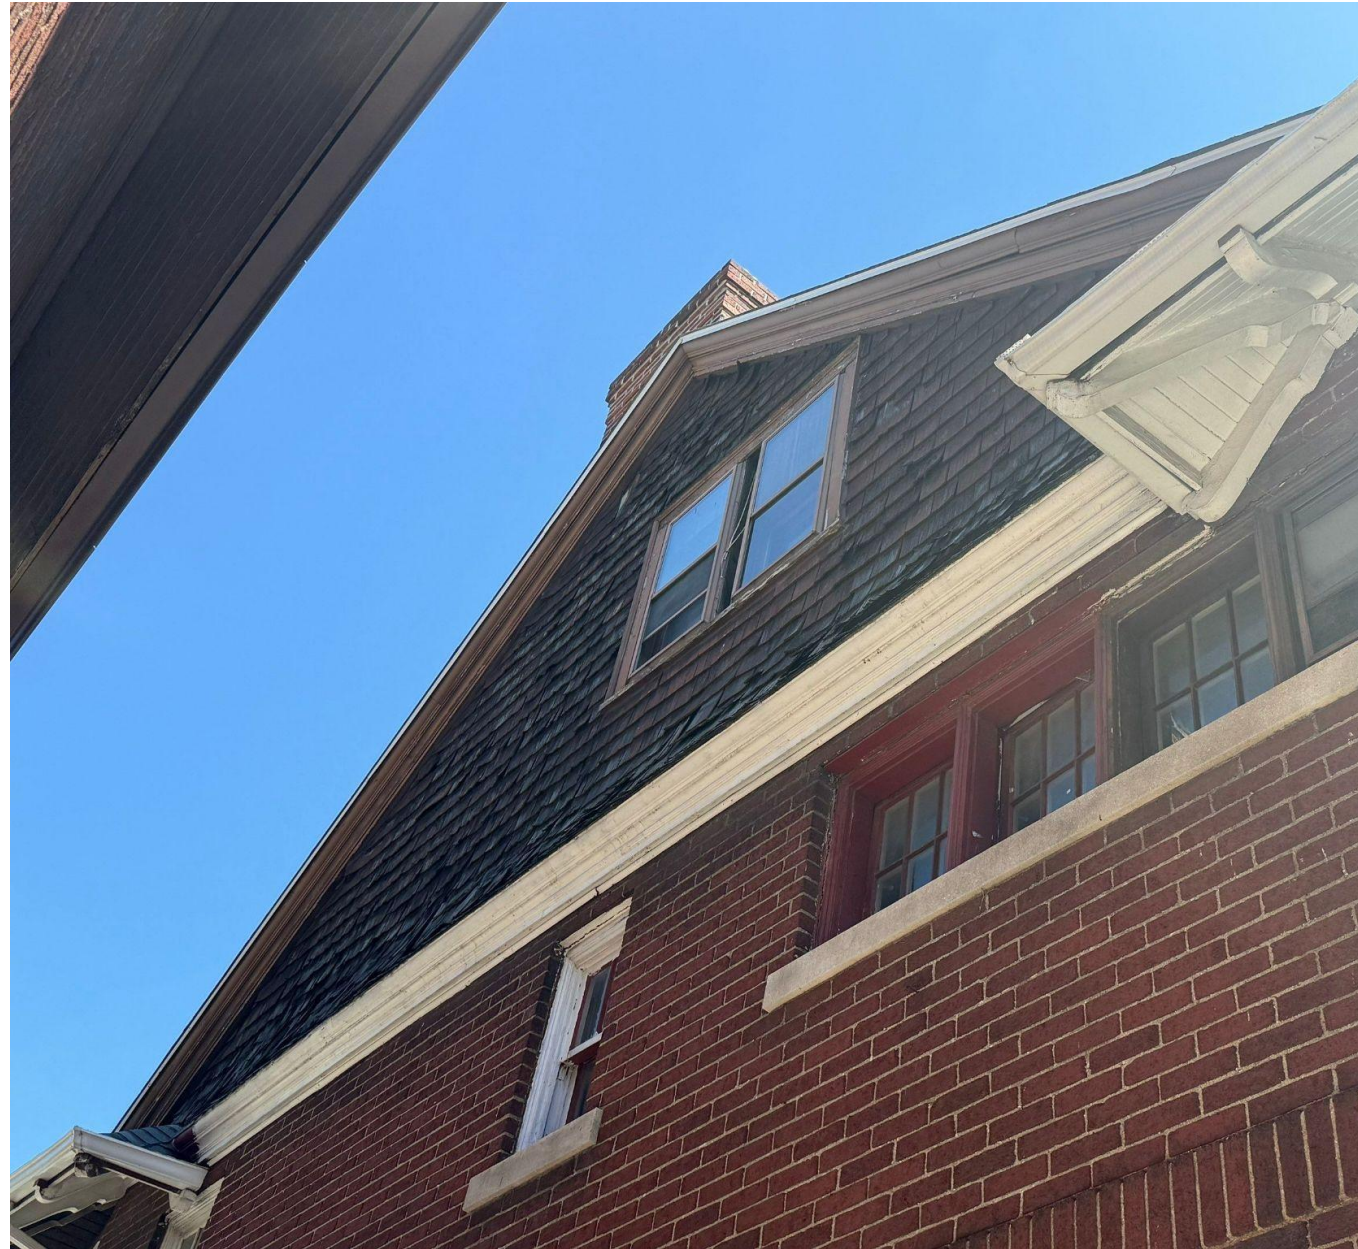
# Right Side Gable

- Rotting siding
- Missing pieces of siding
- Severe splitting
- Severe cupping

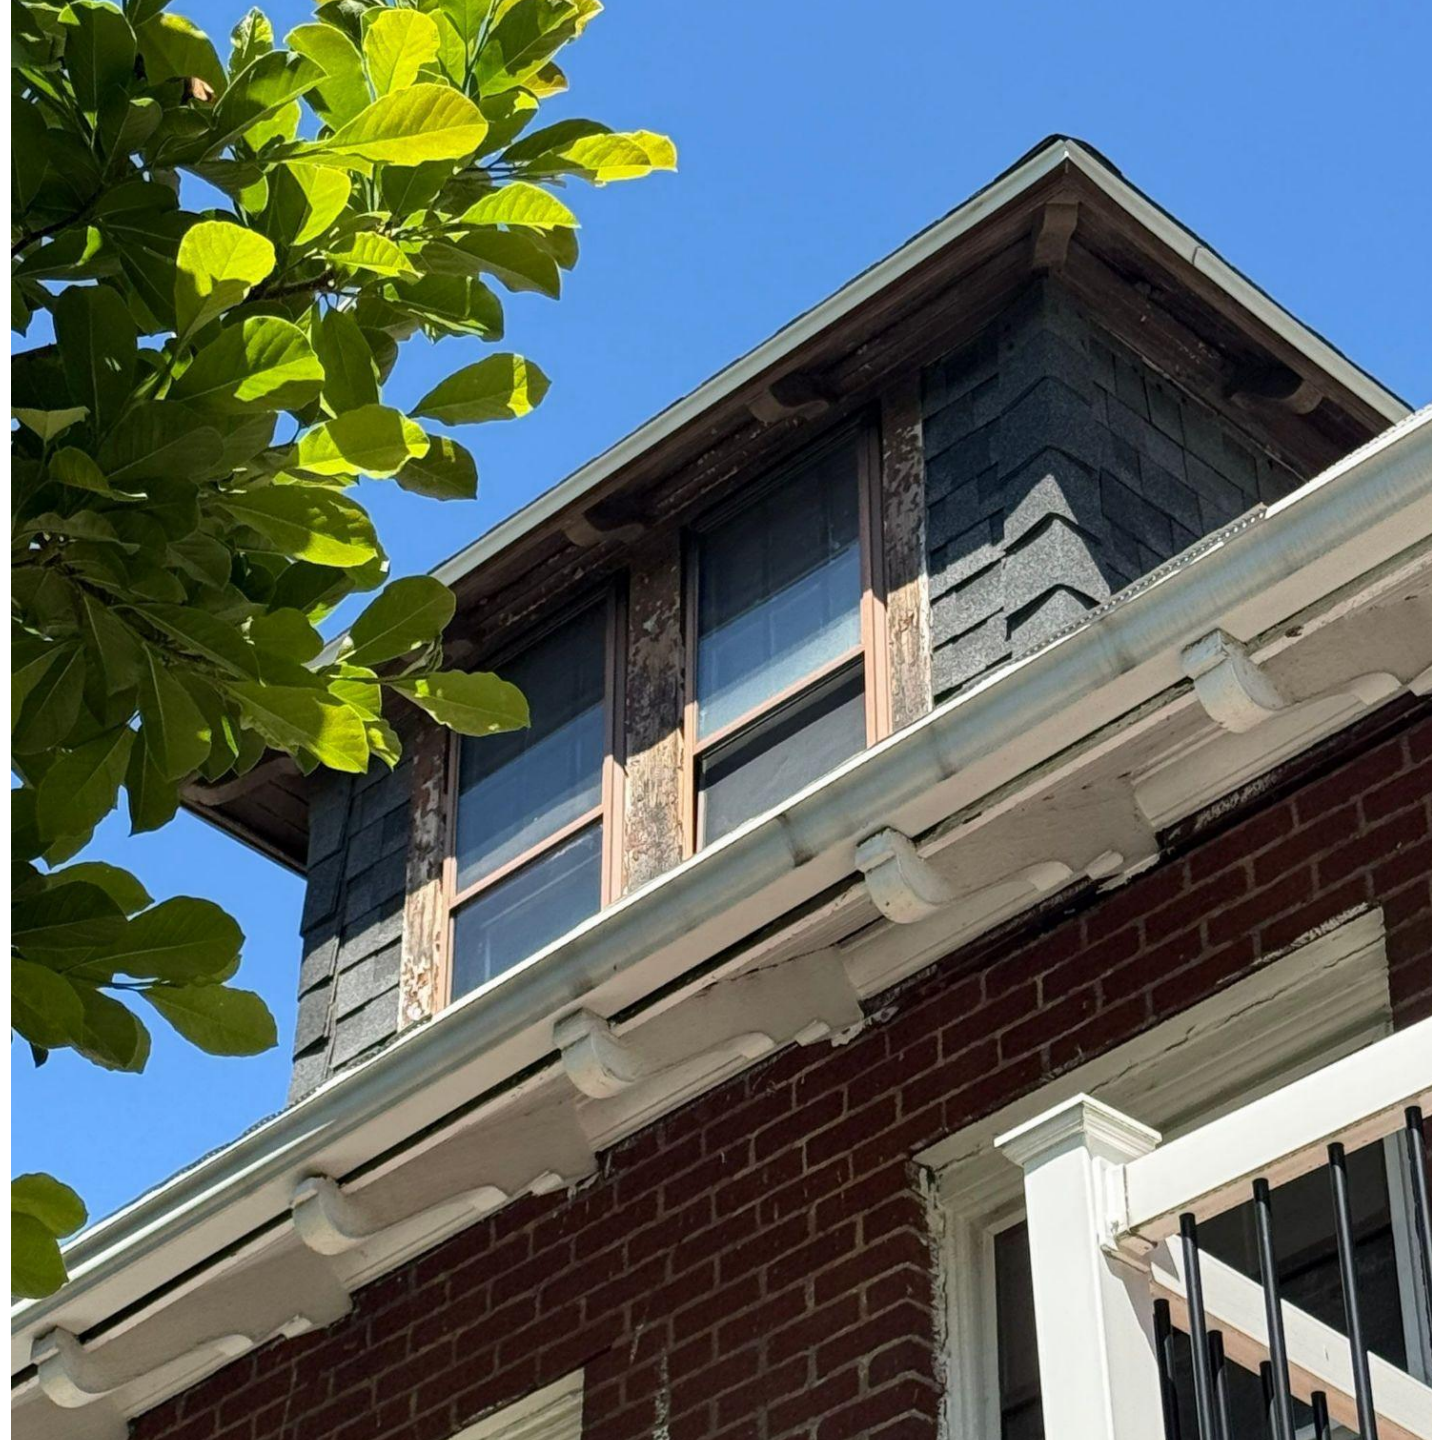
Existing dormer wall surfaces do not comply with HDC guidelines regarding appropriate historic siding materials.

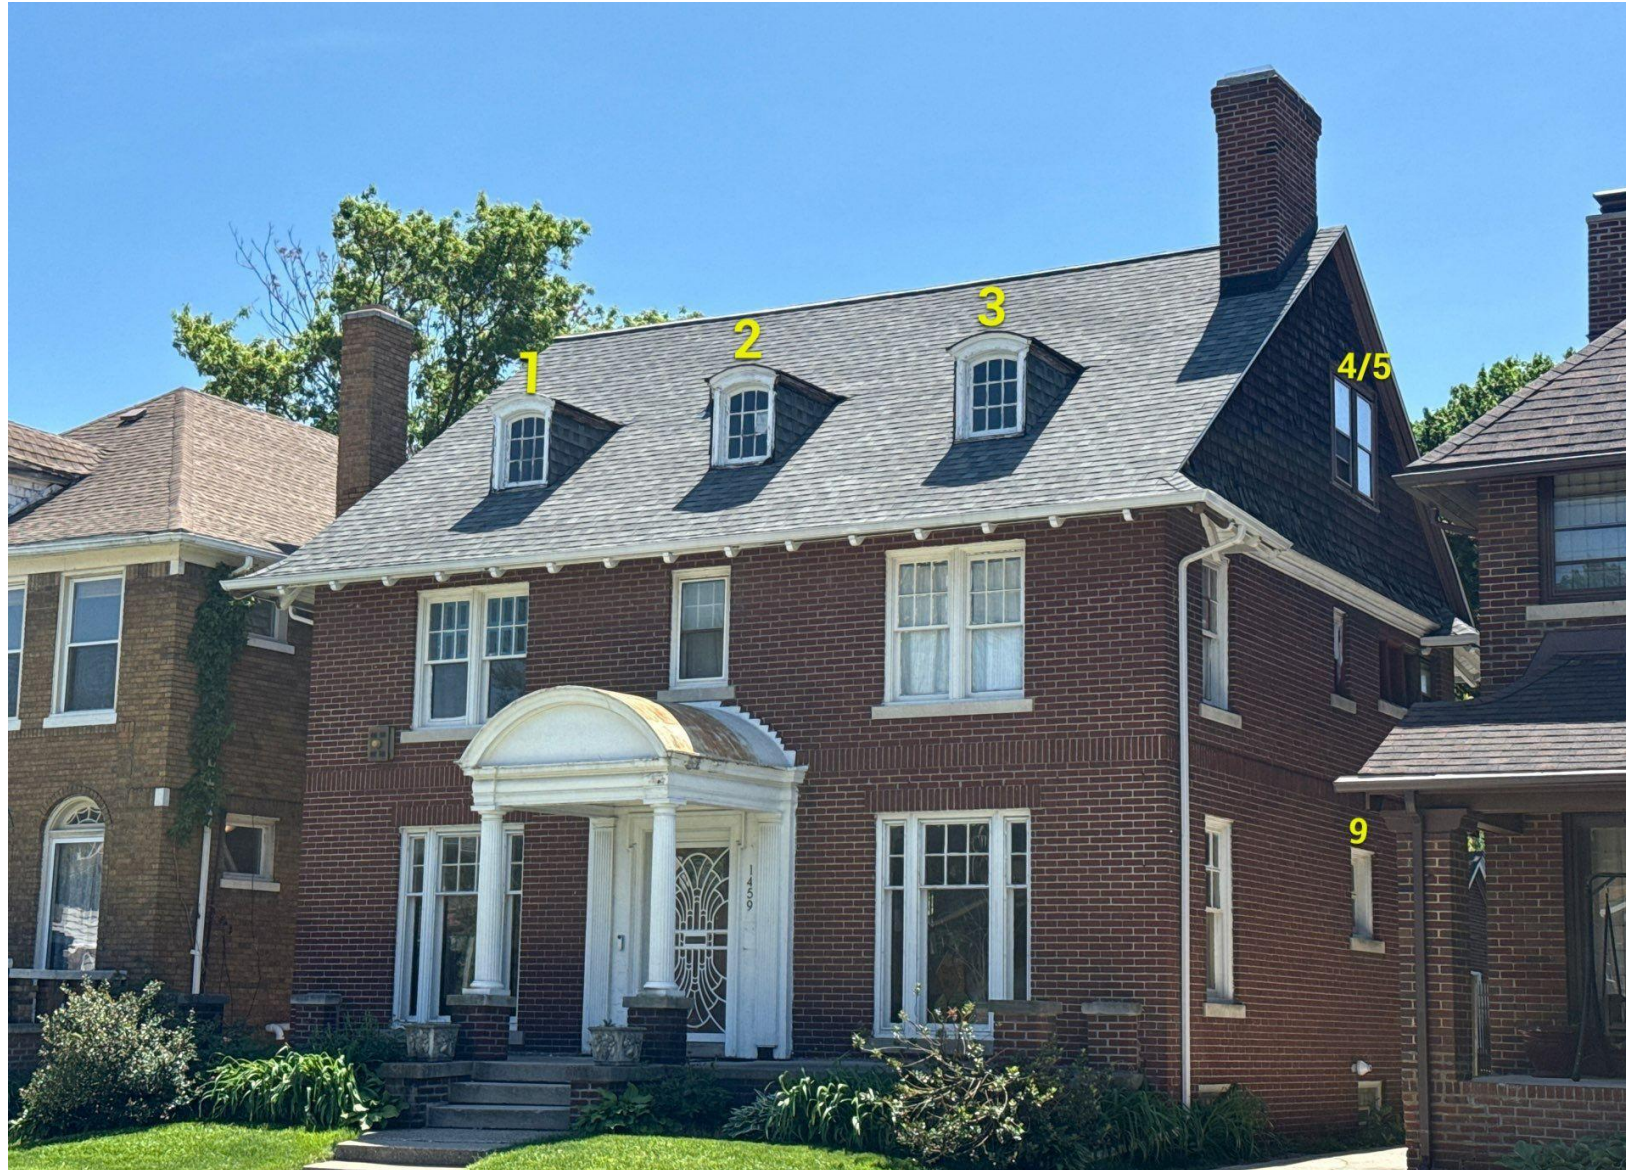
# Windows 1-3 (exterior)

Severe Structural Frame Deflection & Sagging Head Rails: High elevation exposure has caused significant downward deflection across all three arched heads, distorting the radii and creating visible perimeter air gaps along the dormer cheek intersections.

Widespread Paint Coating & Substrate Failure: Severe cracking, flaking paint, and bare, weathered timber across the curved head trim, casings, and sill assemblies expose critical joinery to uninhibited water entry.

Temporary Emergency Sealant Interventions (Center Unit): The center dormer shows clear interior/exterior emergency patching (plastic sheeting and tape visible through the lites) due to active envelope failure and shattered/separated glazing.

Technical Infeasibility of Restoration: High-elevation structural frame warping combined with deep substrate rot along the complex curved joinery renders spot repairs, scraping, or epoxy fills non-viable under Secretary of the Interior Standard 6.

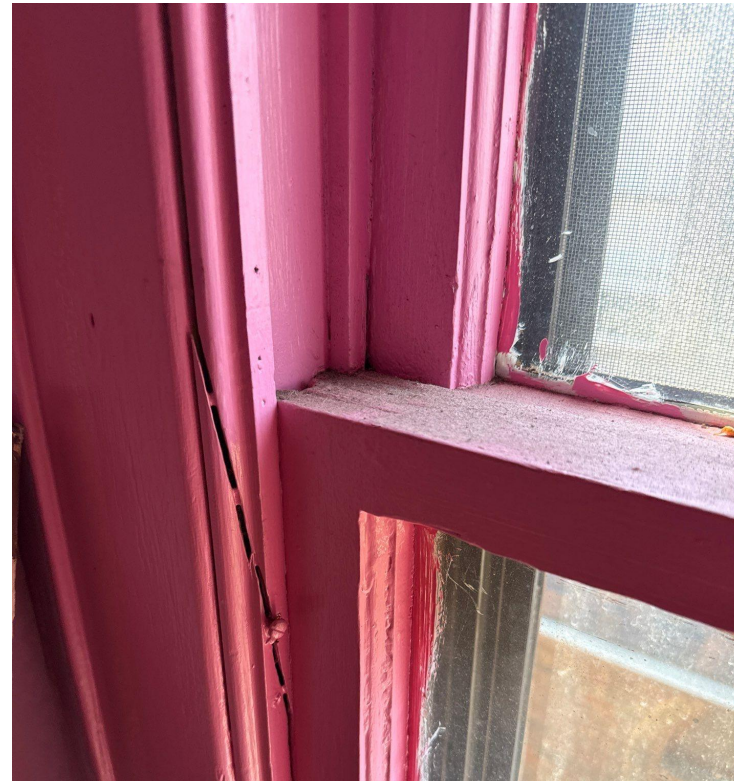
# Window 4/5

Material Failure & Separation: Original exterior window casing/trim has completely detached from the building facade due to fastener corrosion and substrate rot.

Loss of Weather Barrier: Complete absence of exterior trim leaves the window frame perimeter fully exposed to driving rain and bulk water infiltration into the wall assembly.

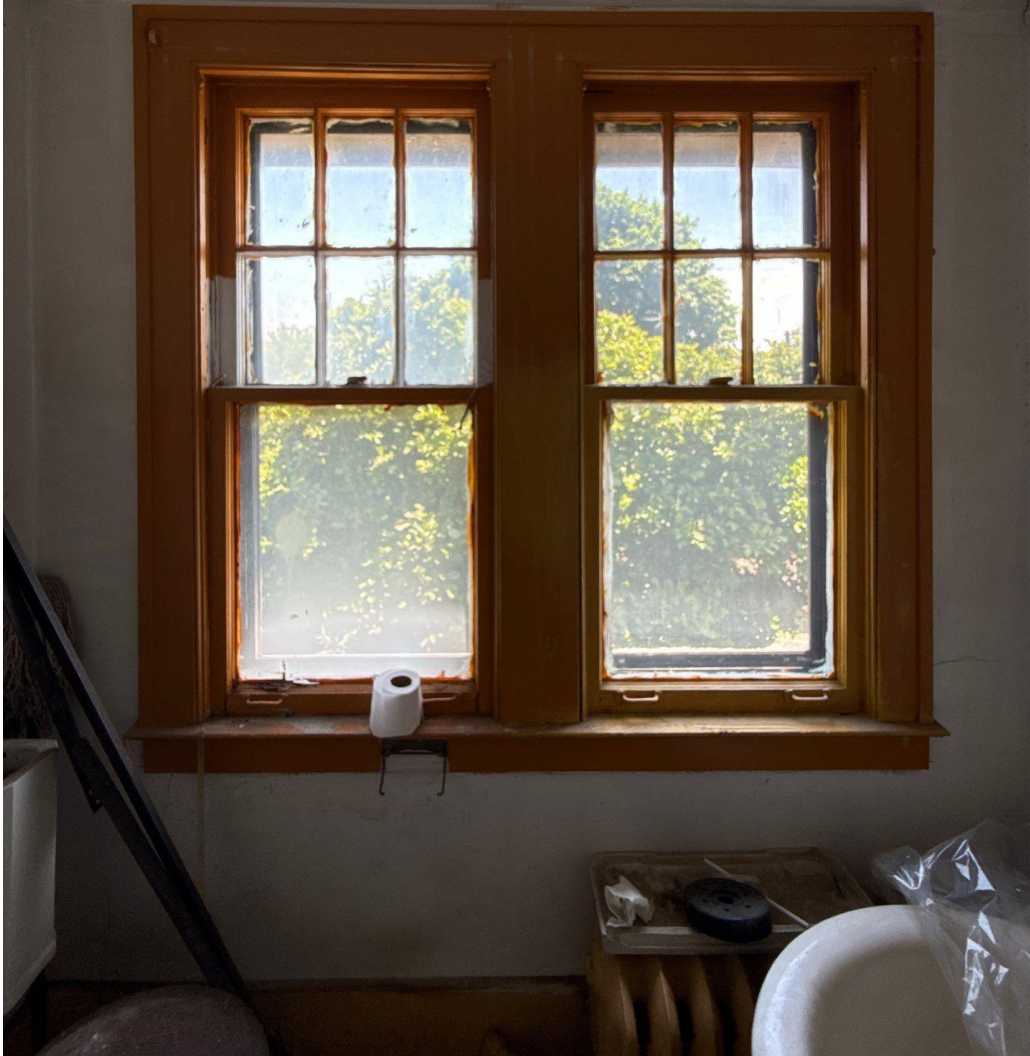
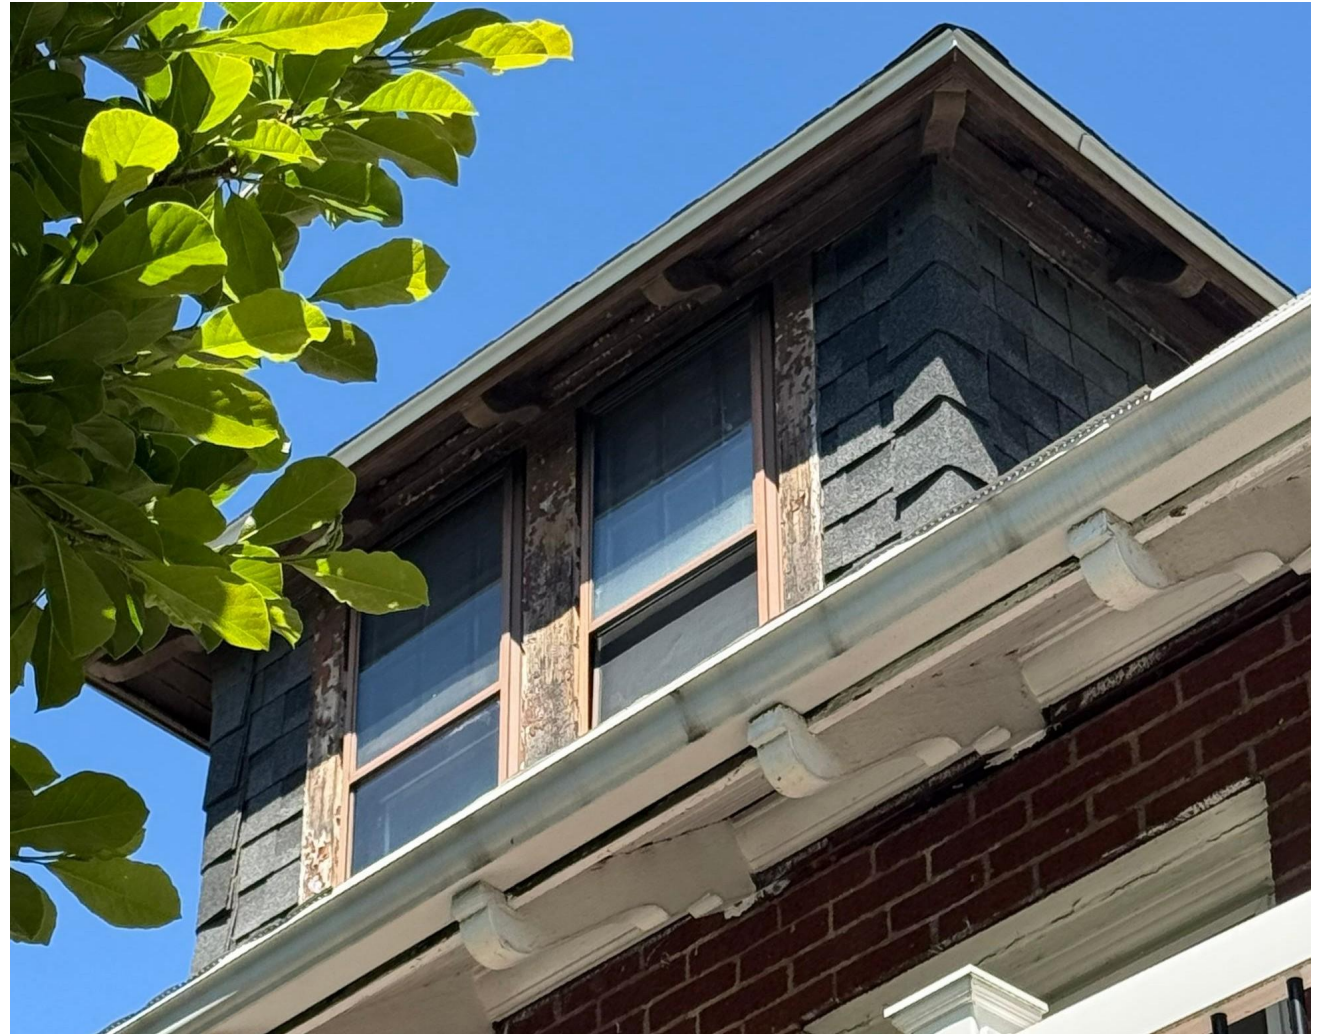
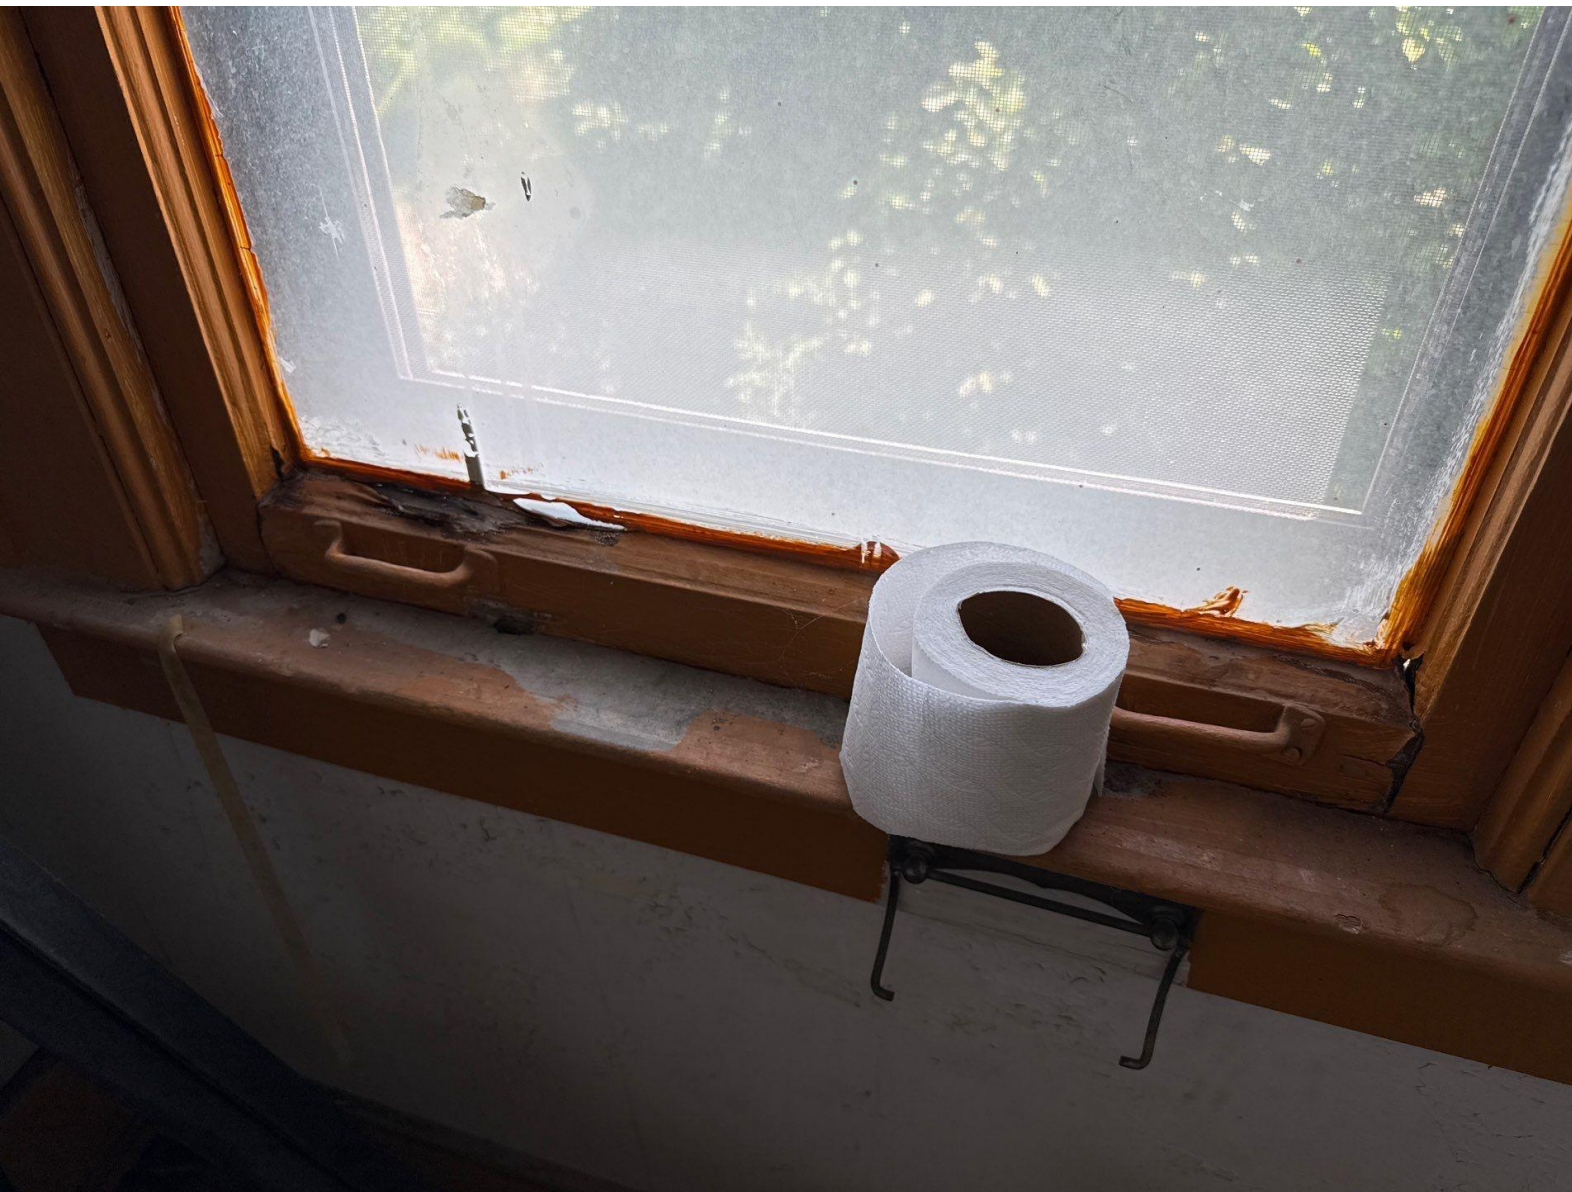
# Window 6/7

Severe Structural Wood Rot: Advanced rot, timber delamination, and dark decay along the lower bottom rail, stile joinery, and inner sill demonstrate complete material breakdown.

Operability & Egress Failure: The upper and lower sashes are permanently bound and seized shut due to severe structural frame racking and severe wood rot, eliminating required natural ventilation and emergency egress capability under local building safety codes.

Glazing Bed & Putty Failure: Complete failure and deterioration of original glazing putty around the bottom glass perimeter, exposing bare wood channels to continuous water trapping.

Ad-Hoc Weather Seal Interventions: Presence of makeshift sealant highlights active bulk water infiltration and severe envelope failure.

Infeasibility of Restoration: Extensive organic decay at critical structural joints renders epoxy consolidation non-viable under Secretary of the Interior Standard 6.

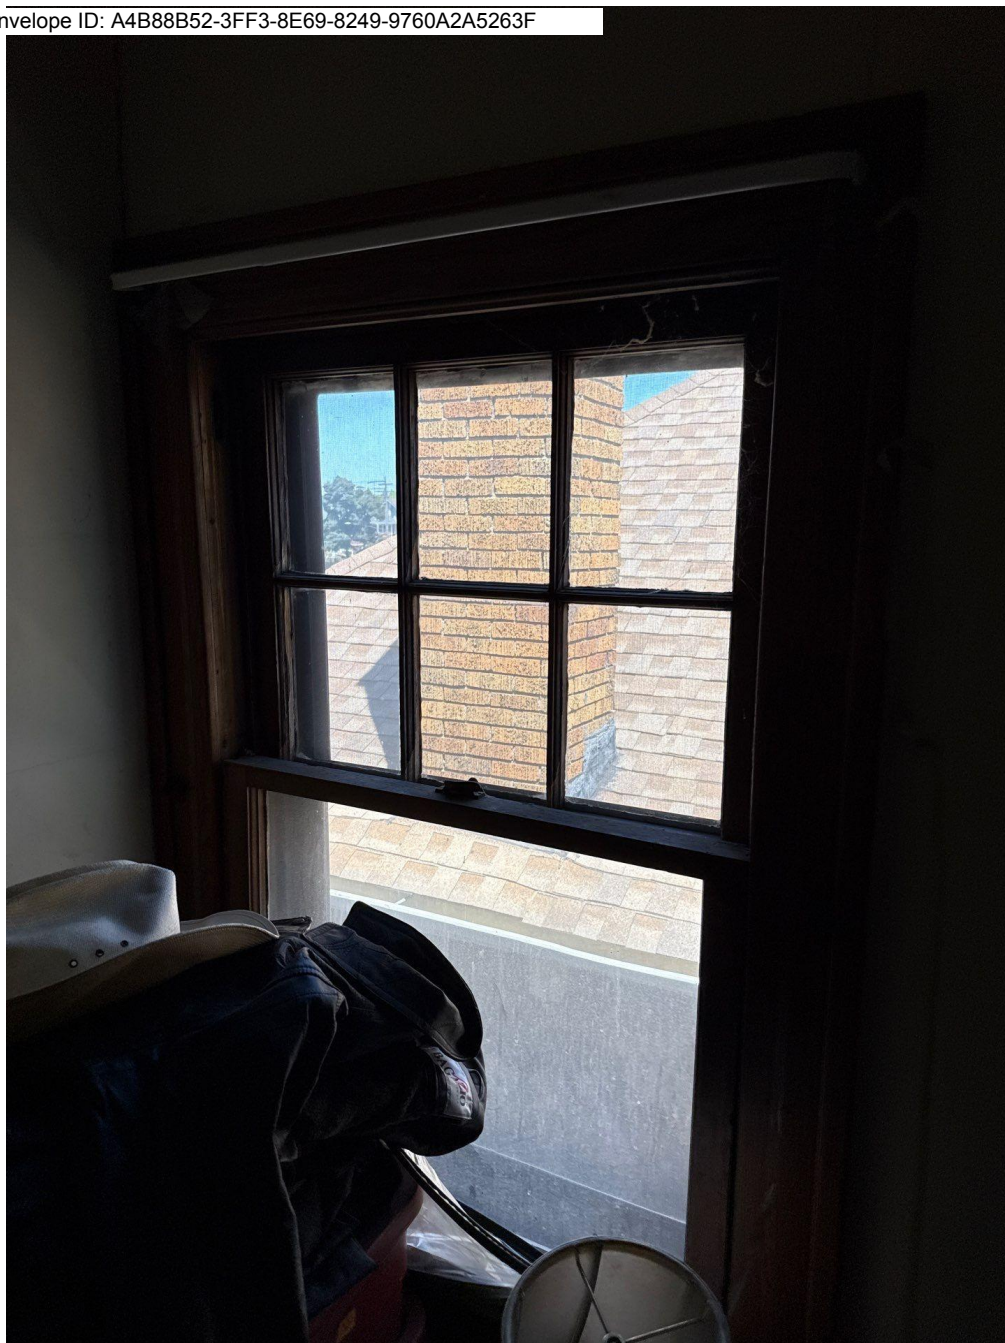
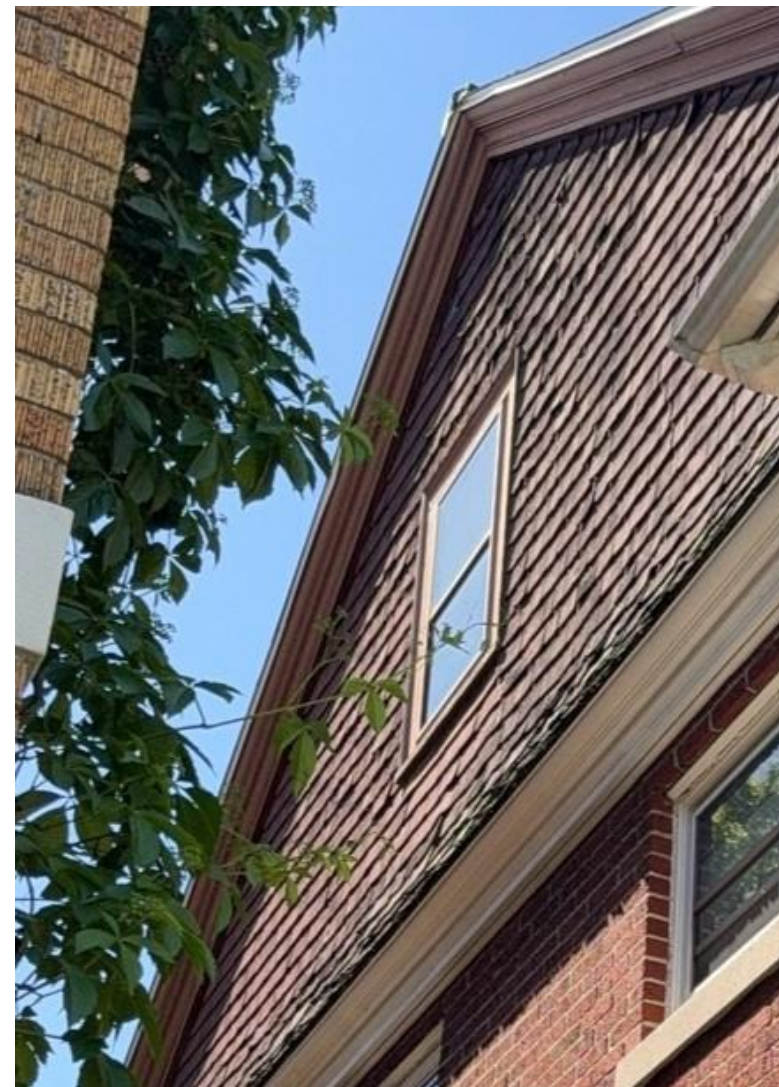
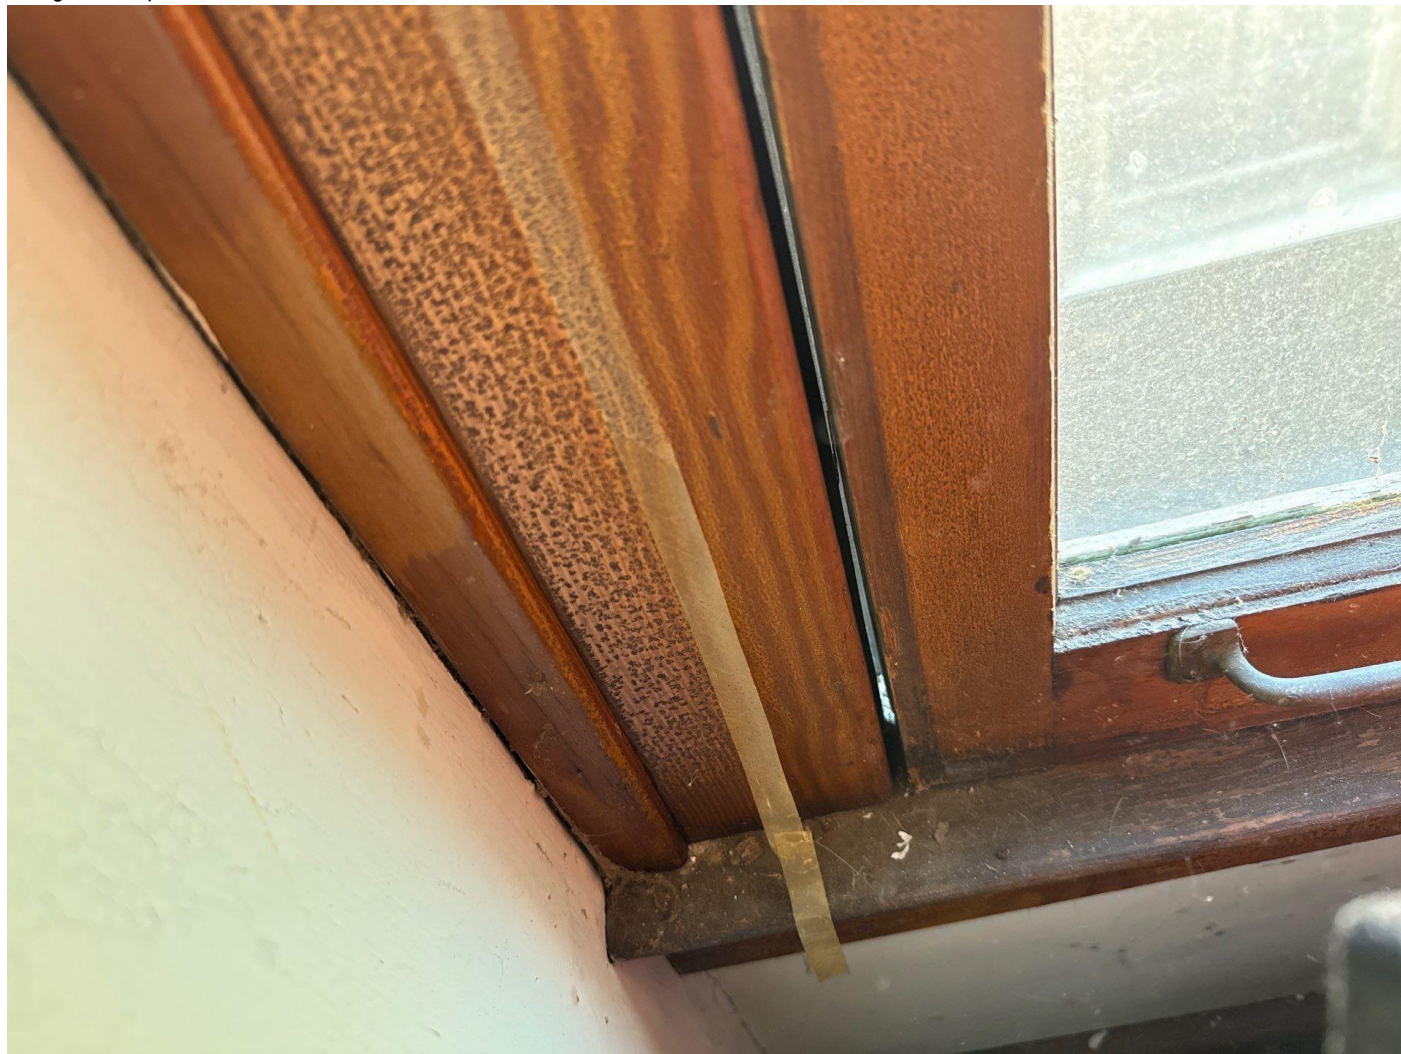
# Window 8

Complete Structural Fracture Due to Rot: Advanced timber decay has completely rotted through and fractured the bottom sash rail, severing the structural frame component and making sash alignment impossible.

Frame Deflection & Perimeter Air Gap: Severe frame out-of-square and sash deflection create a continuous vertical gap along the side jamb (held with tape), allowing direct draft and bulk water infiltration into the wall cavity.

Sash Stile Splitting & Wood Decay: Deep vertical grain checking and wood fiber loss along the sash stile compromise the structural integrity required to hold glass safely.

Sash Lock Alignment Failure: Because the rotted bottom rail can no longer support the sash structure, the meeting rail sweep lock cannot align or engage to secure the window shut.

Technical Infeasibility of Repair: Complete loss of structural wood density from rot renders epoxy consolidation or splicing non-viable under Secretary of the Interior Standard 6.

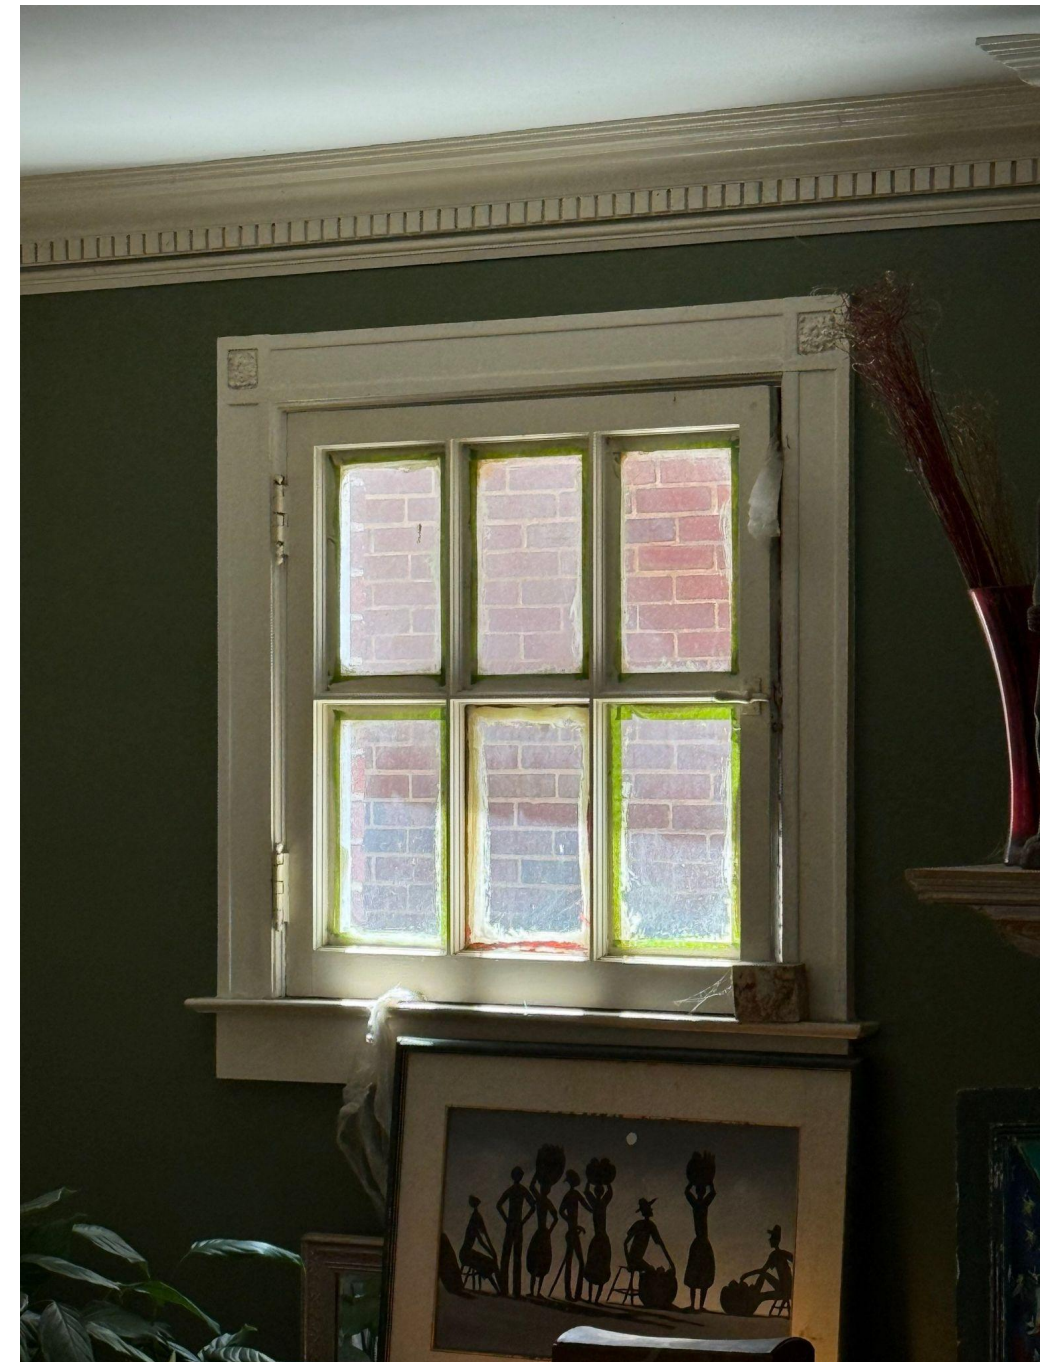
# Window 9

- Severe Degradation: Existing single-pane, inswinging wood casement sash exhibits severe frame warping, joint separation, and air/water infiltration.
- Frame Warping: unable to functionally close due to swelling of rotted wood.
- Temporary Weatherization Failure: The unit currently requires plastic sheeting/temporary sealing to prevent active weather elements from entering the interior living space.
- Technical Infeasibility of Repair: Due to severe frame distortion and wood compromise, repairing or retrofitting weatherstripping to the historic sash is technically infeasible and economically unreasonable under Standard 6 guidelines.
- Proposed solution: to replace with a fixed or inswing casement window unit to match to the existing 6-lite configuration (Grids: 2V1H)
