# HISTORIC DISTRICT COMMISSION APPLICATION FOR WORK APPROVAL

HDC2026-00448

**ADDRESS(ES):** 105 Delaware Street

**HISTORIC DISTRICT:** New Center Area

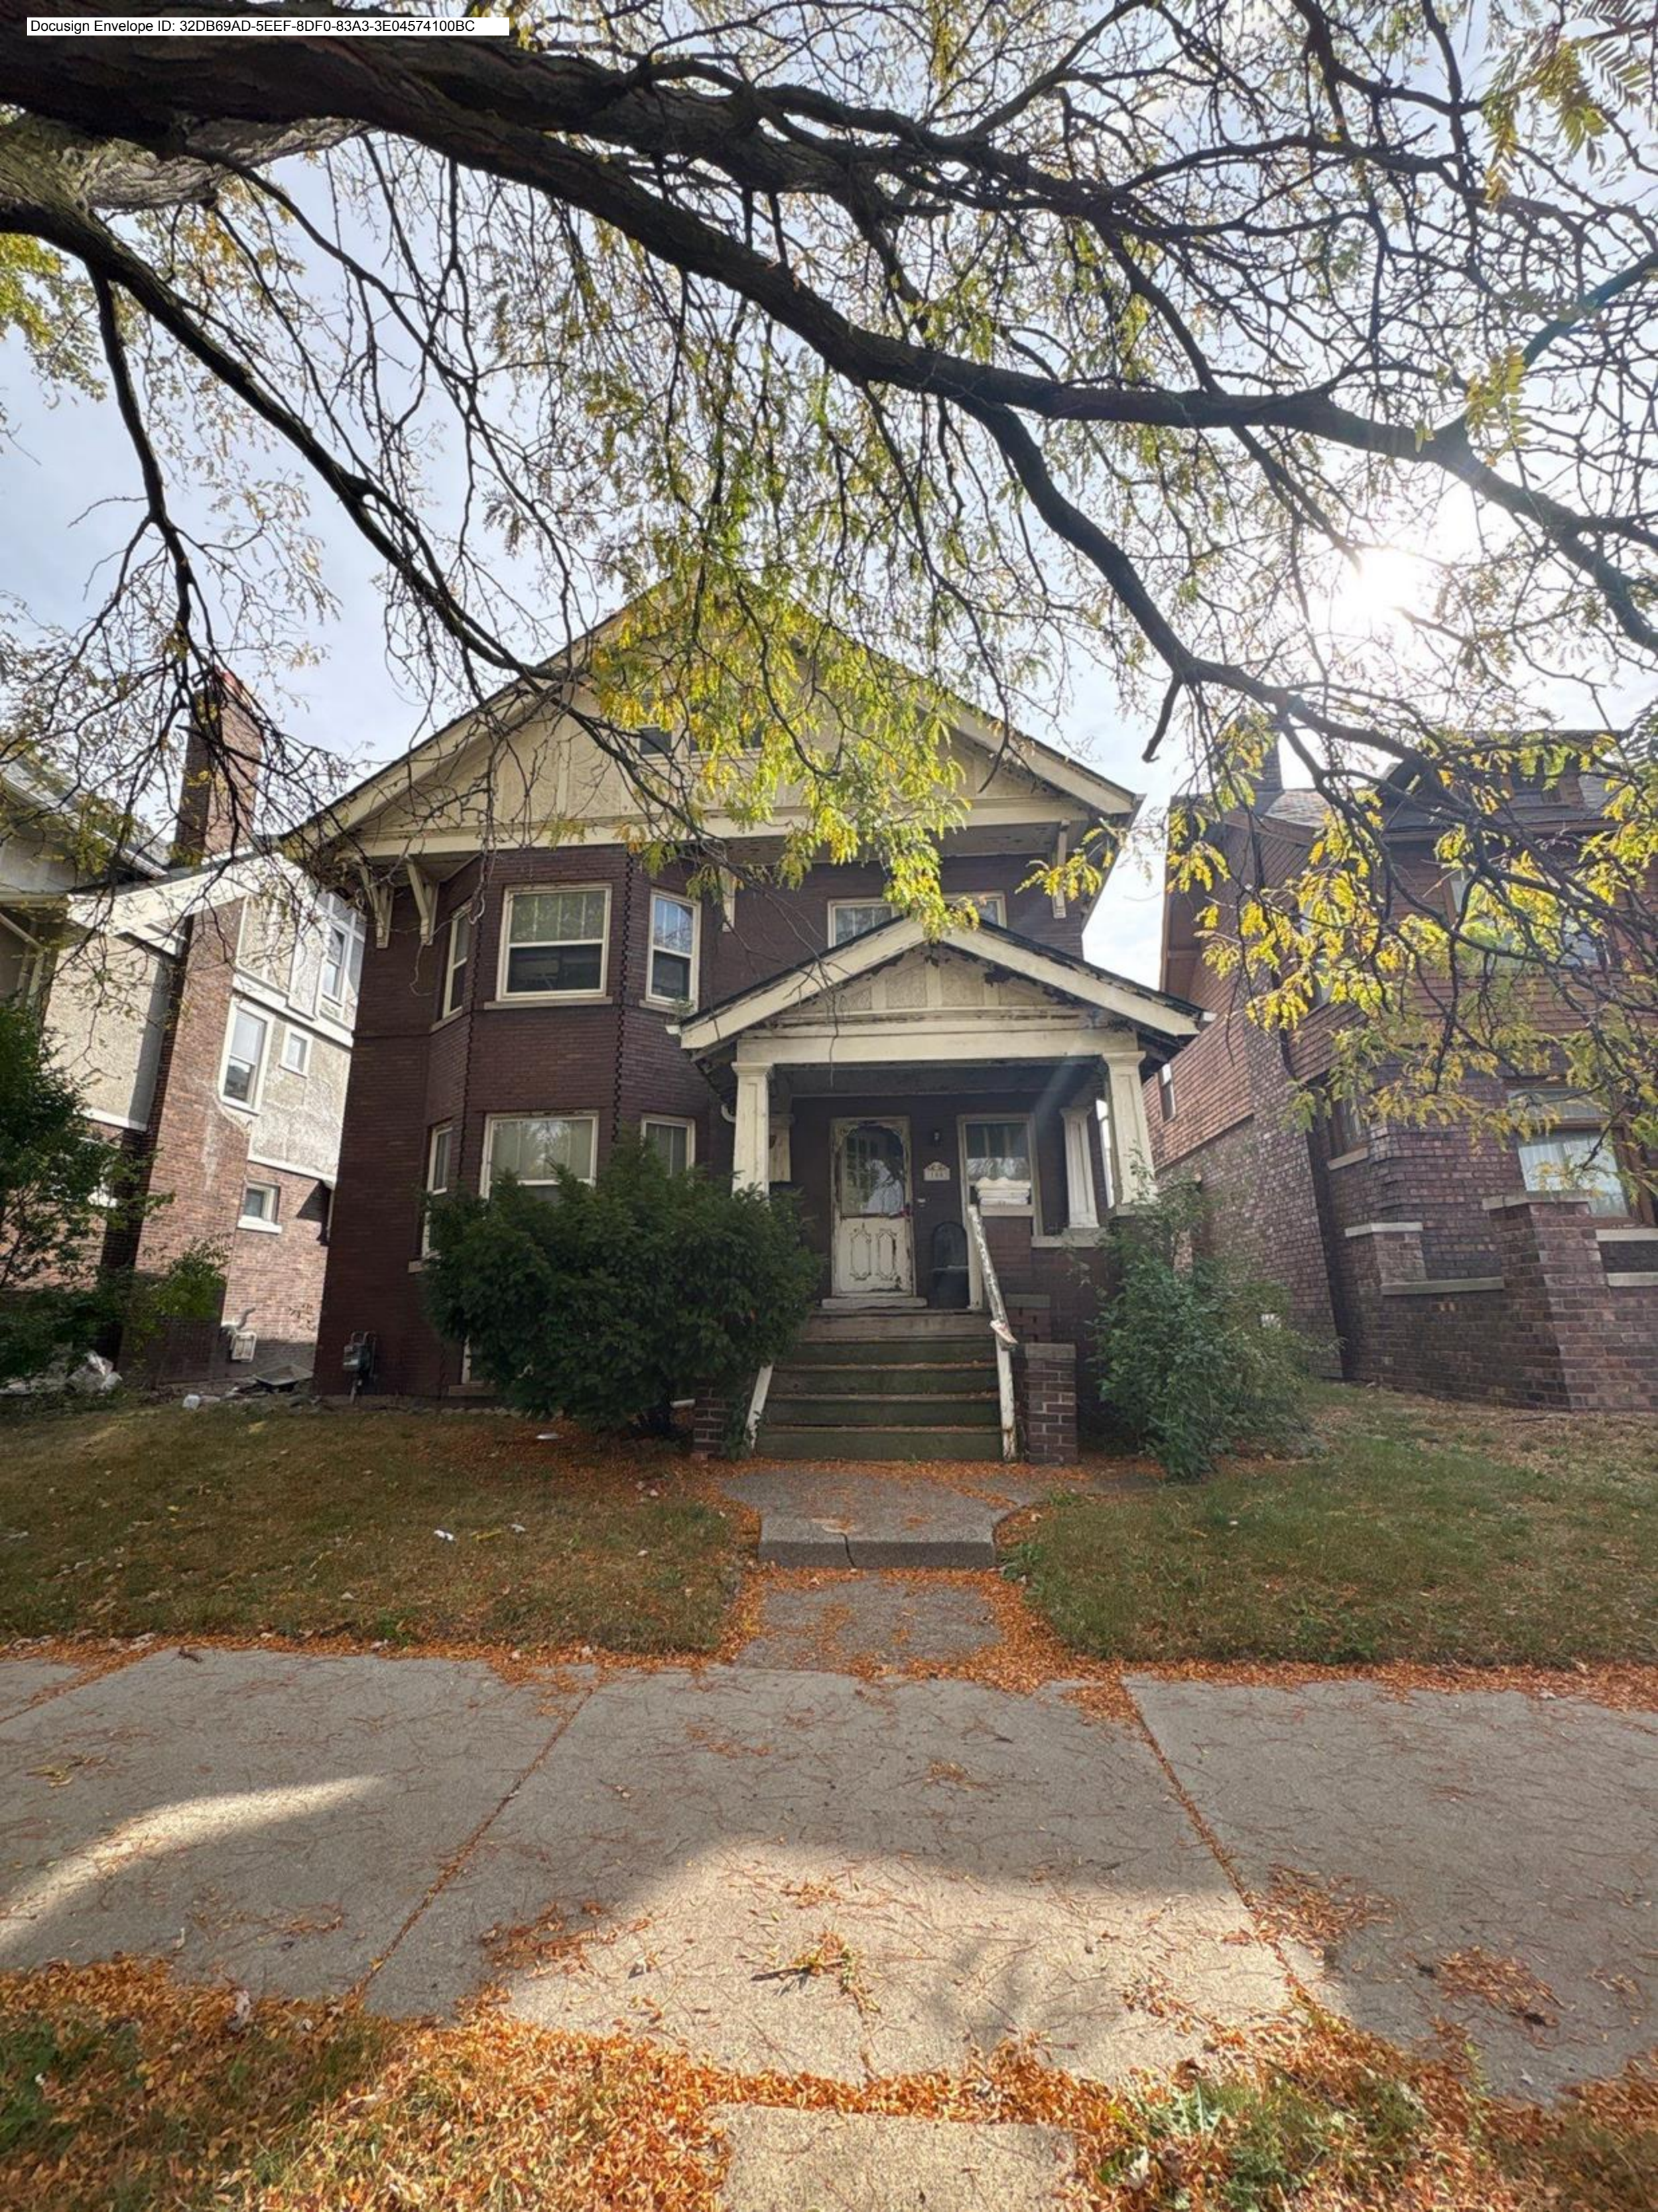
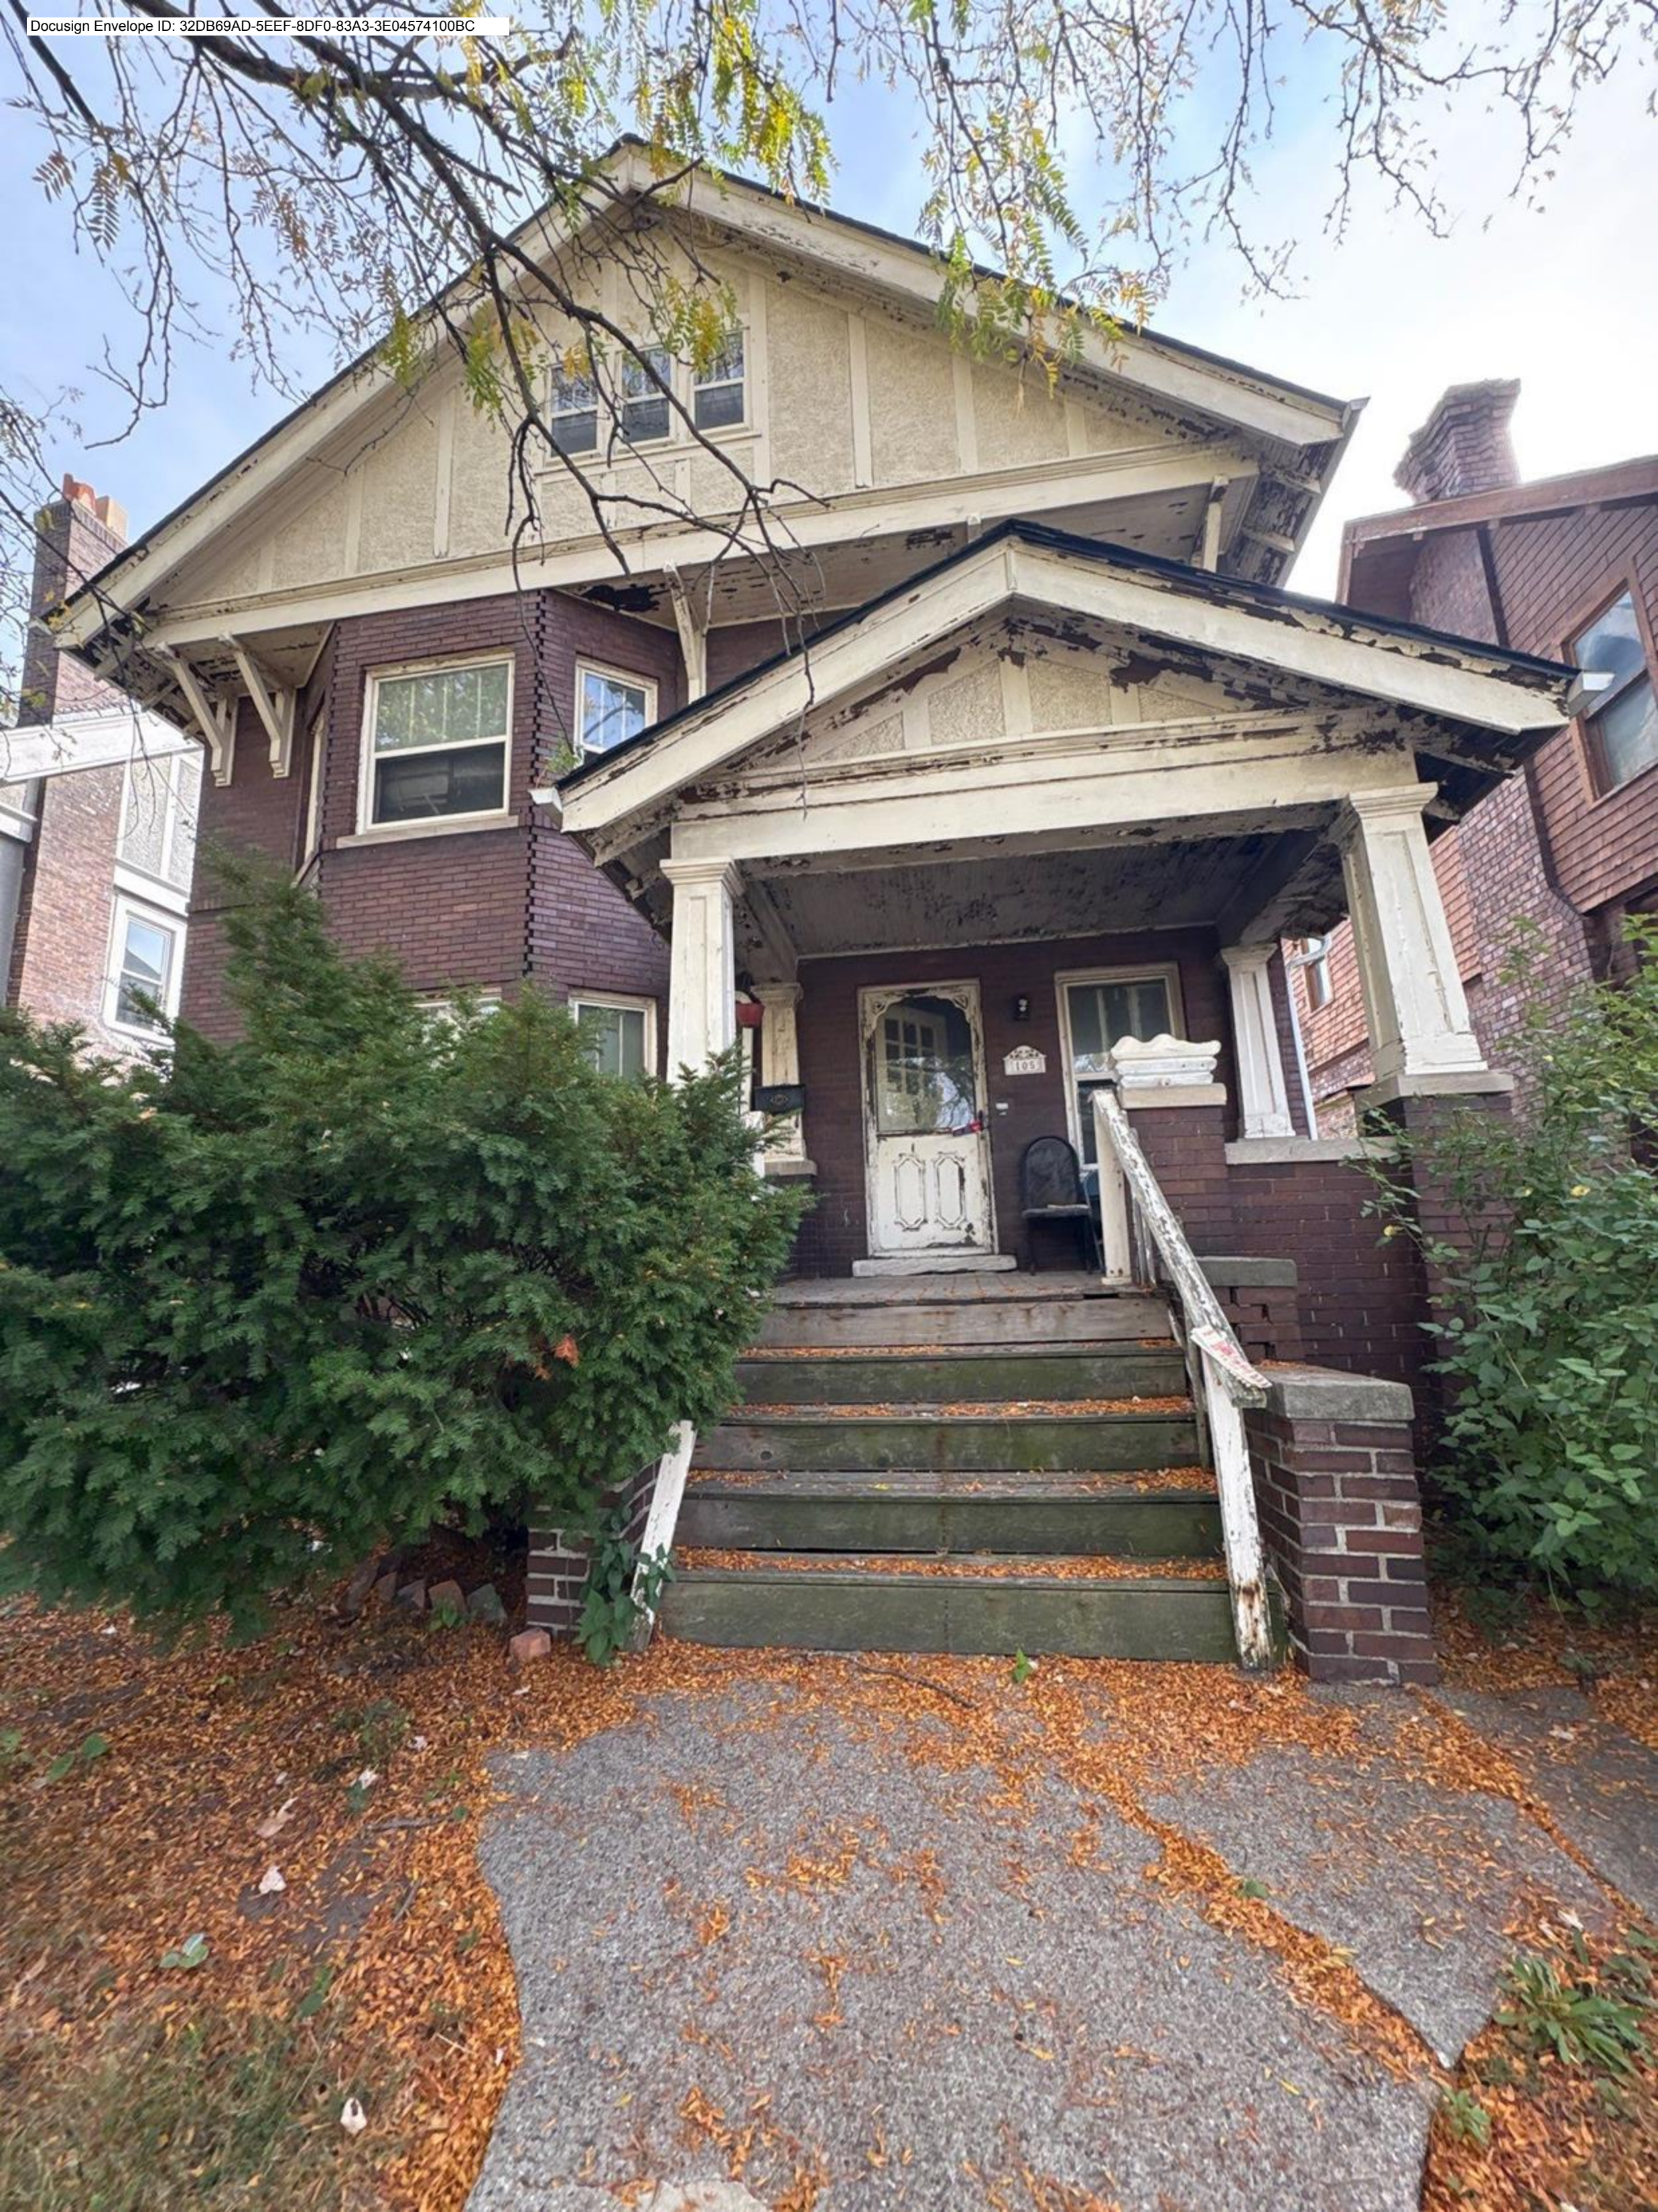
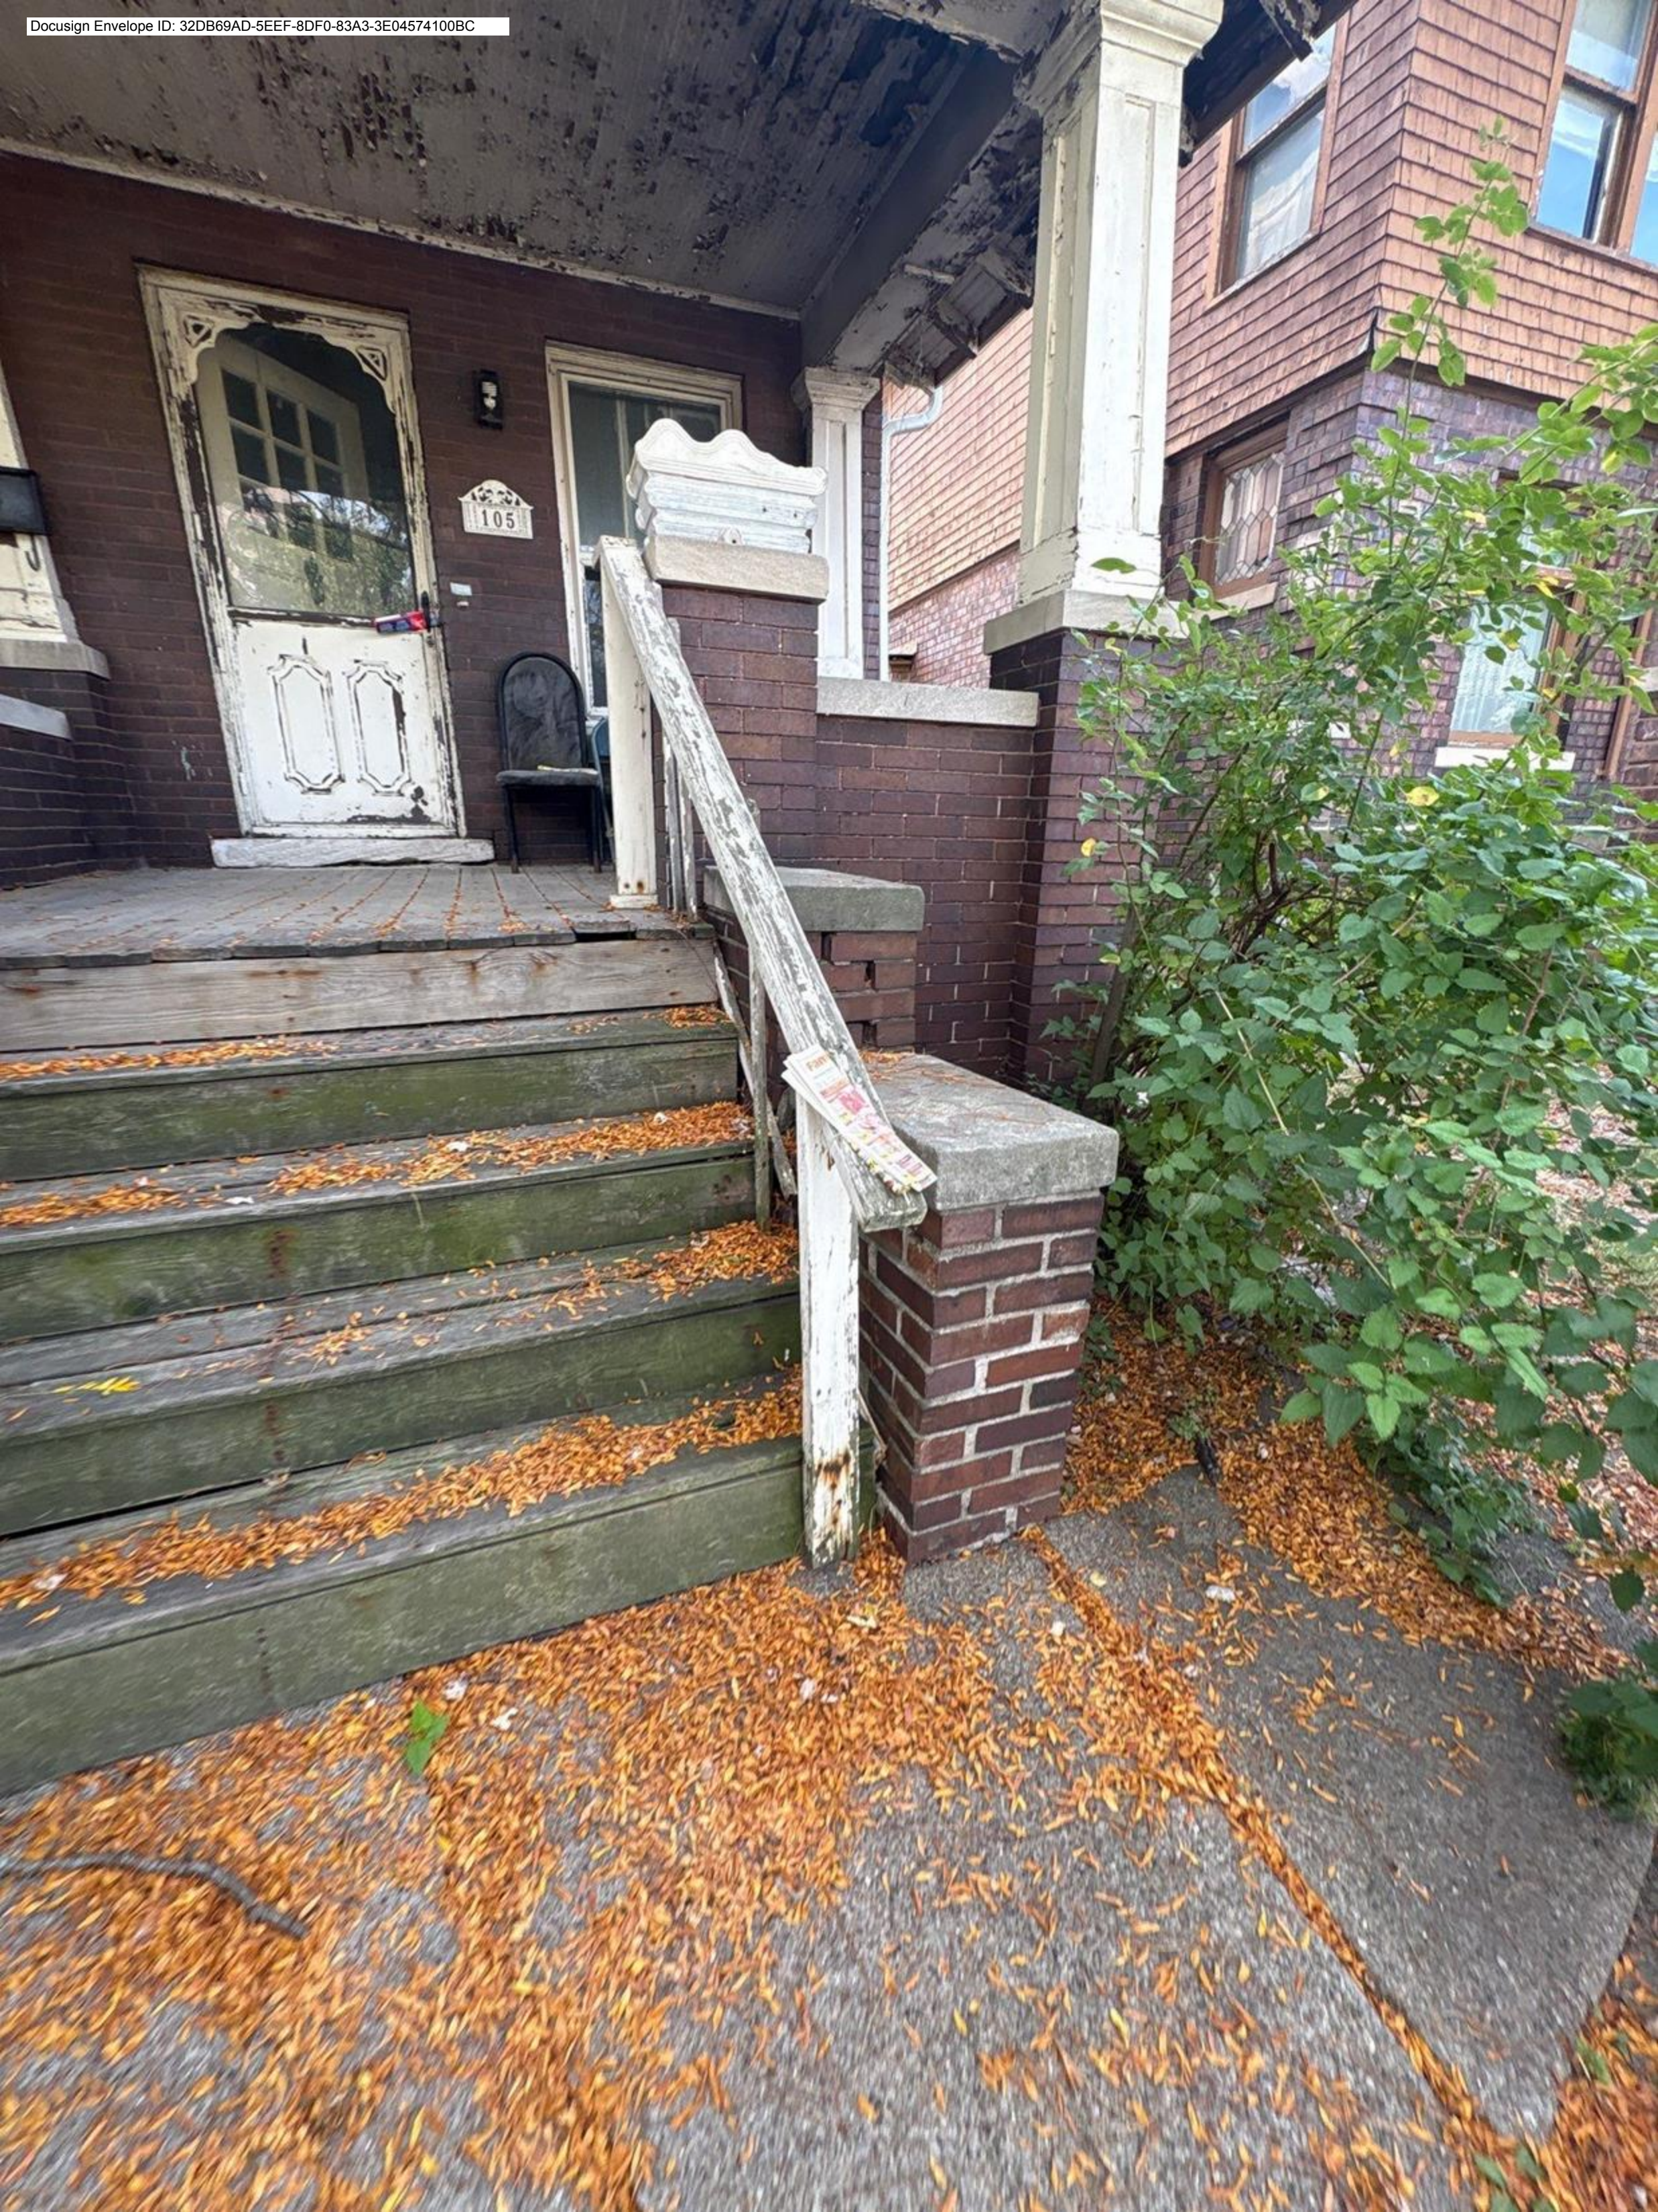
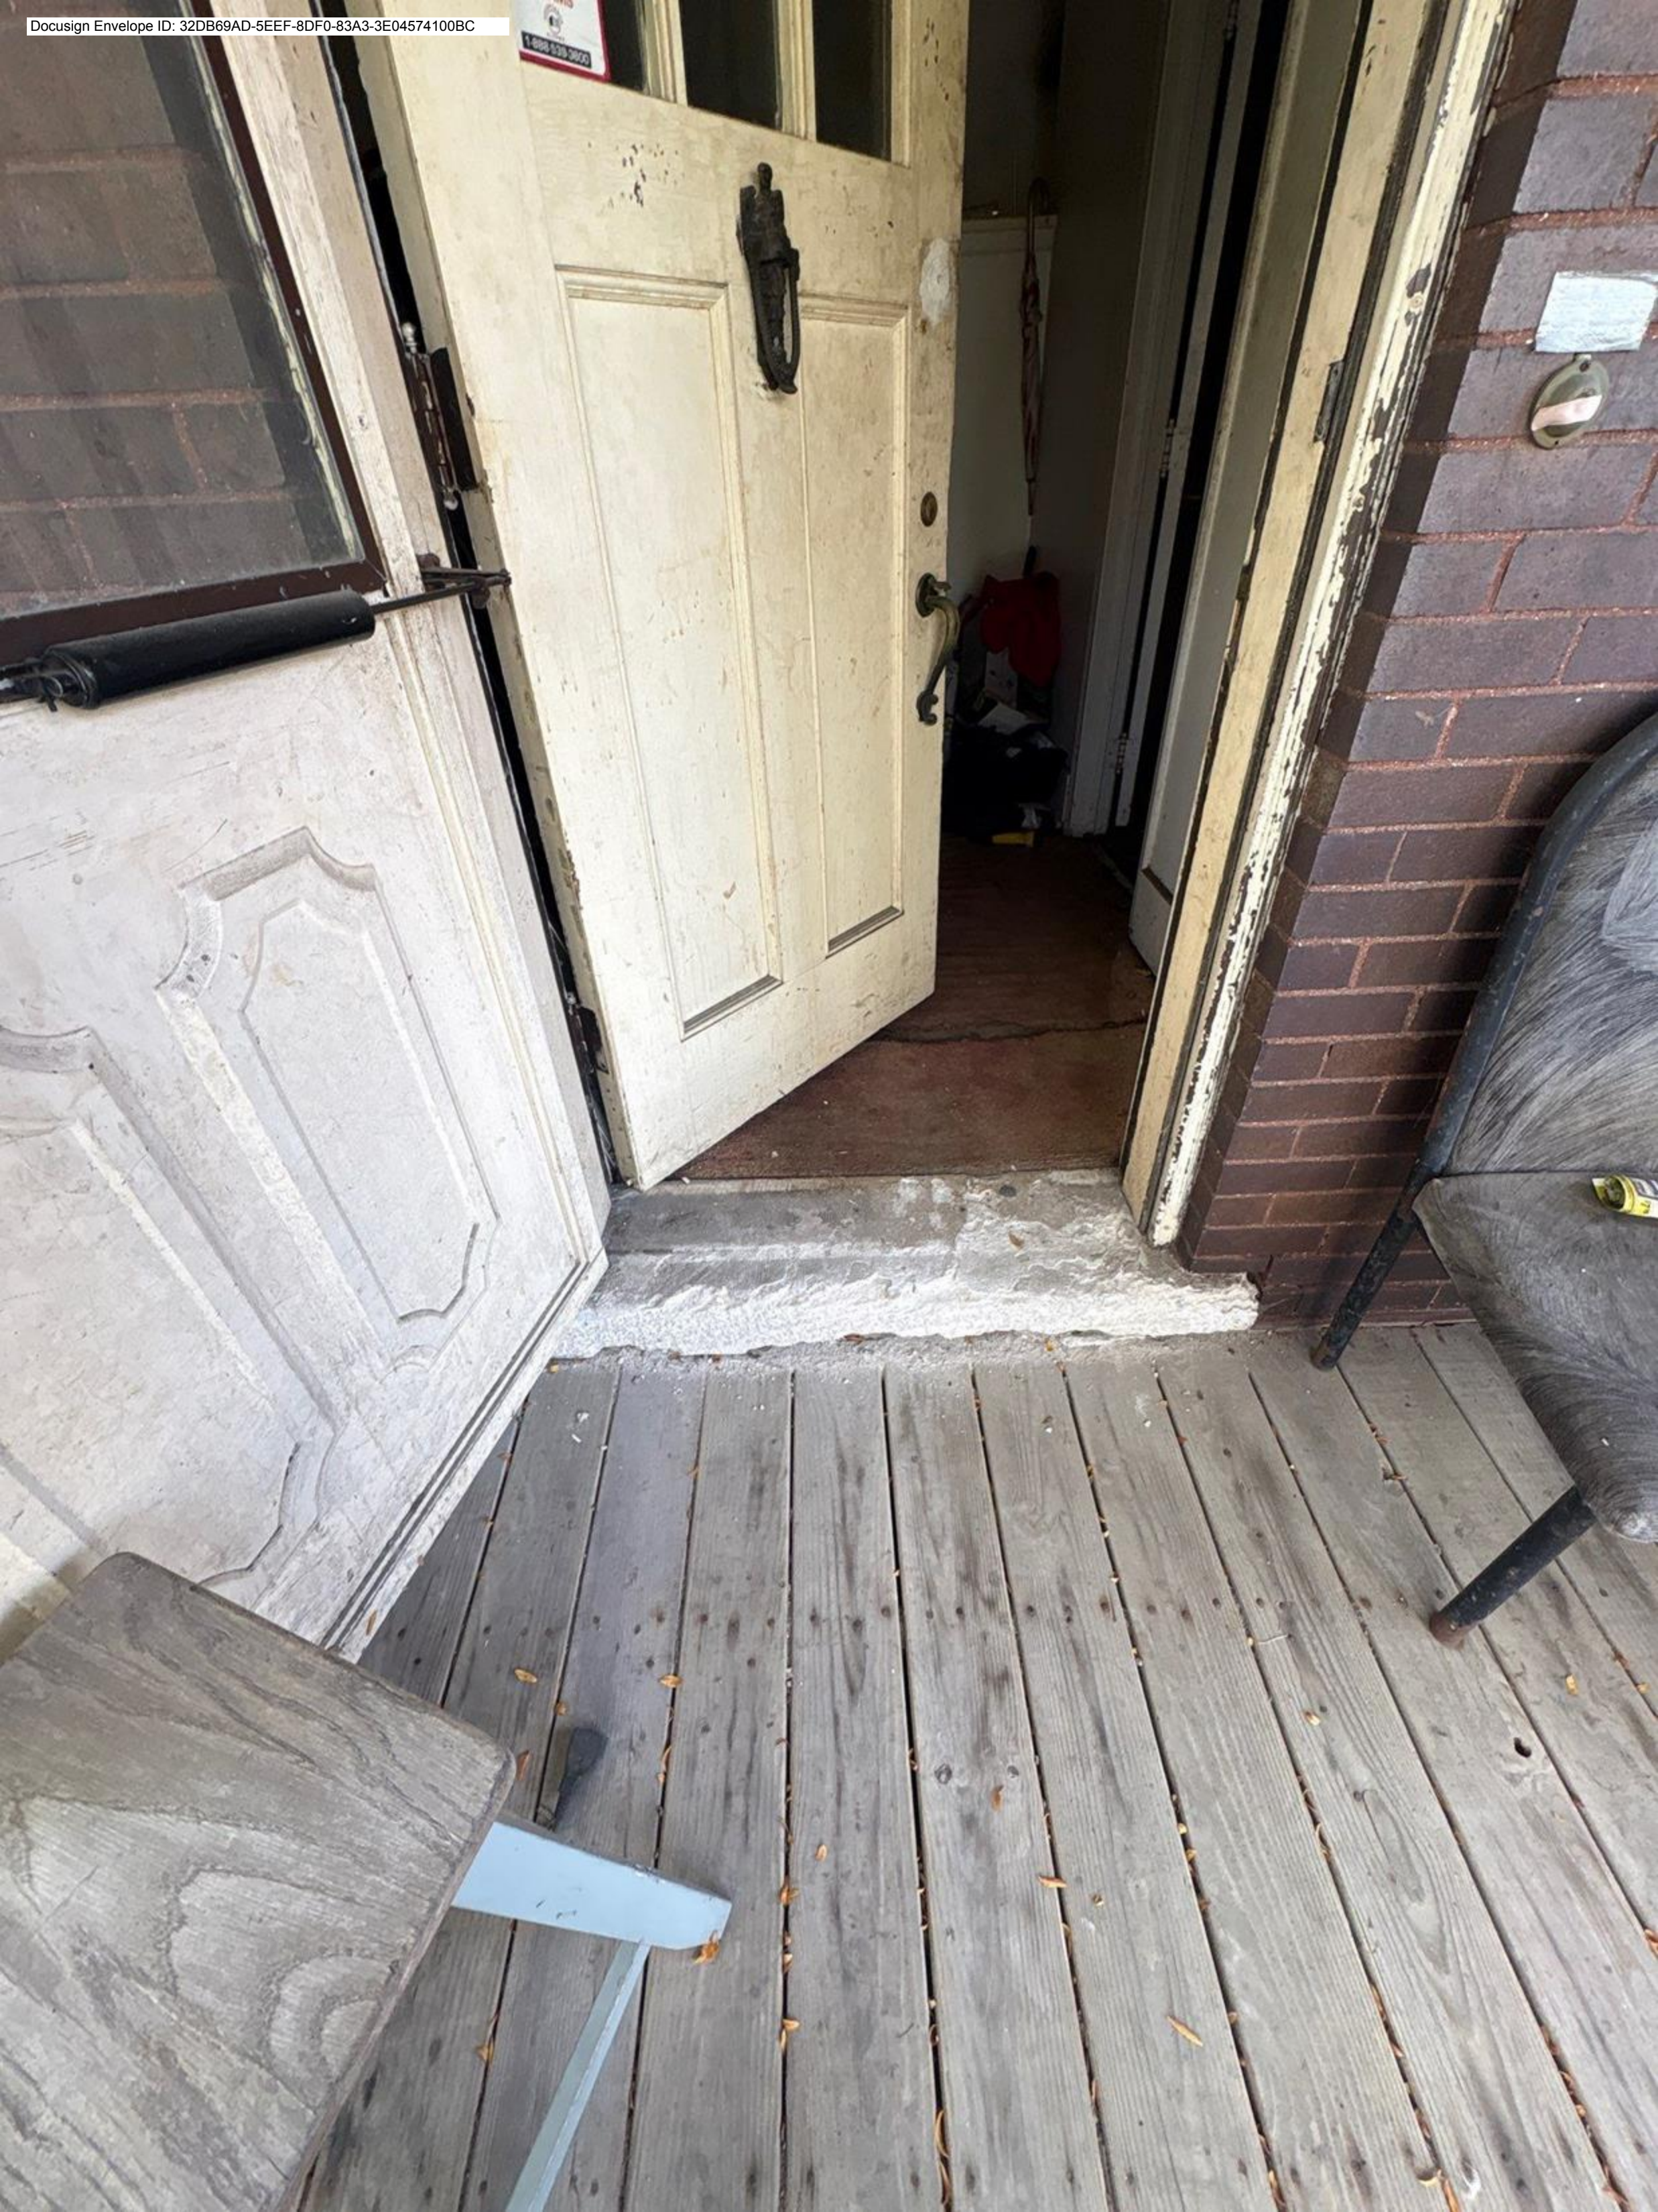
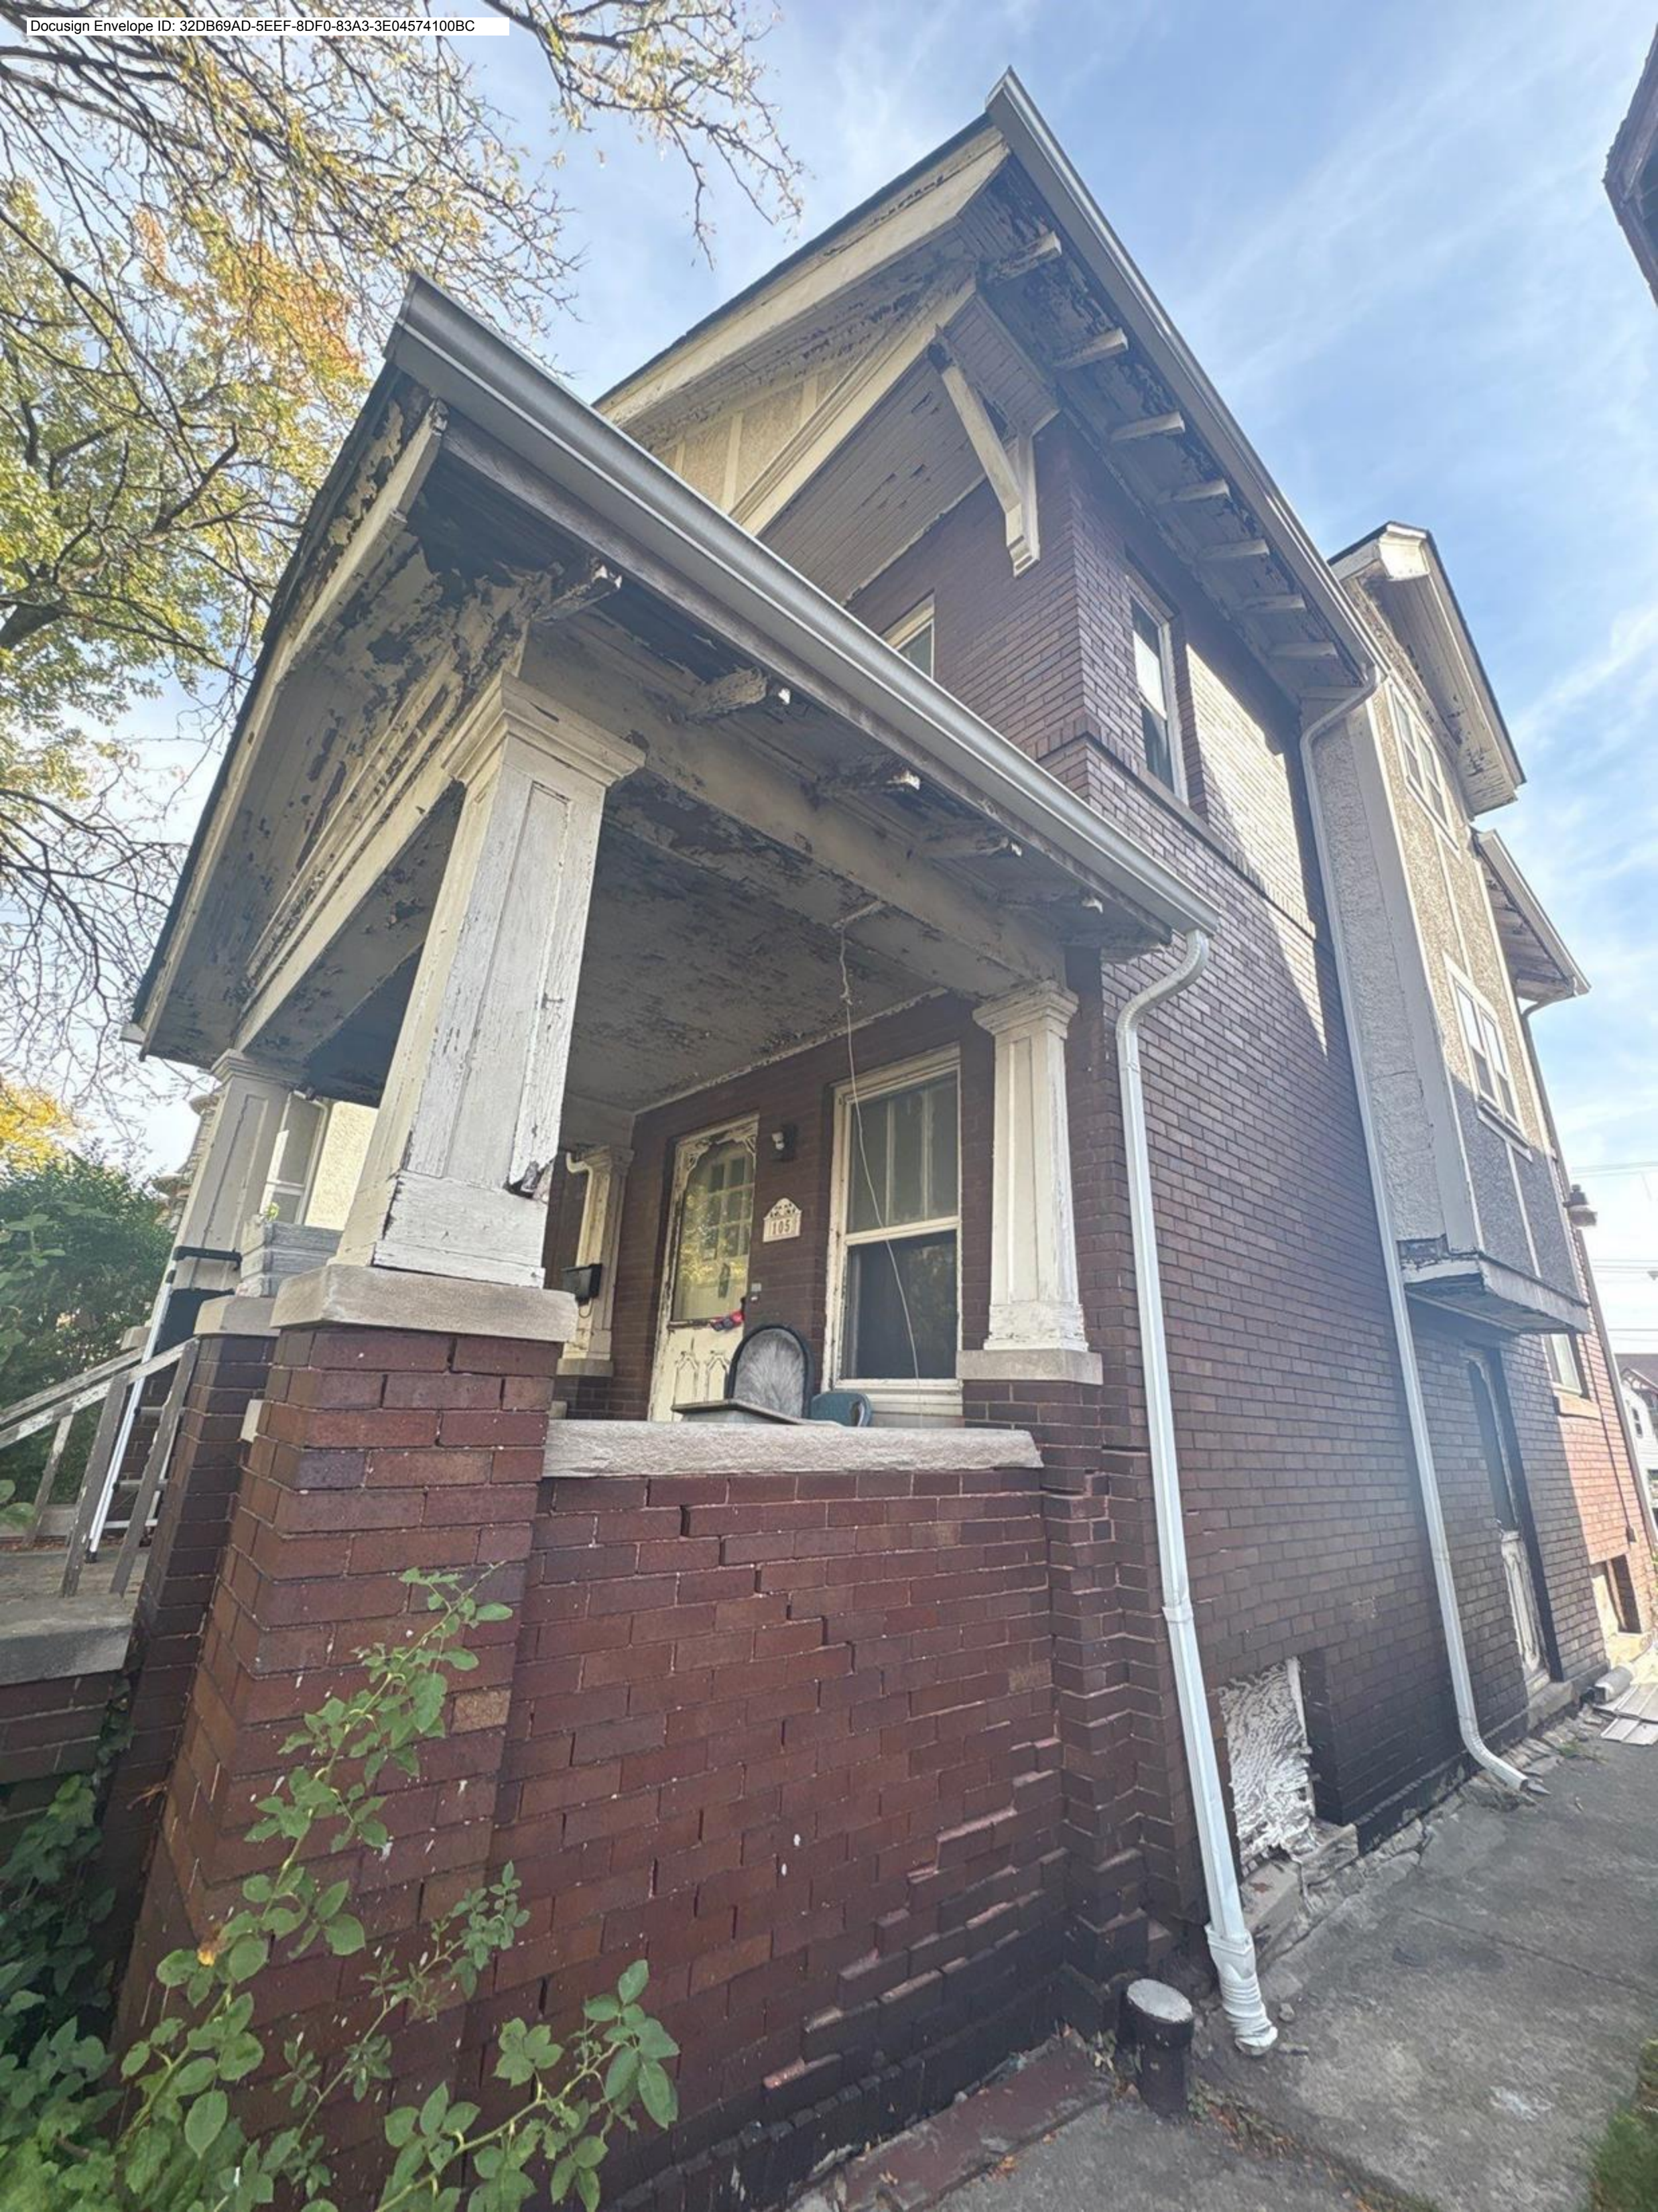
The subject property is a three-story single-family home with brick masonry exterior walls constructed circa 1910, located within the New Center Area Historic District. The property exhibits deterioration typical of its age: Masonry: Brick exterior walls on all four elevations are largely intact but show mortar joint erosion, efflorescence, and isolated cracked/spalled brick units, particularly at the east elevation chimney base and along the south foundation line. Chimney: The original masonry chimney on the east elevation shows deteriorated mortar at the cap, minor displaced bricks, and compromised flashing at the roof penetration allowing water infiltration. Front Porch: The full-width front porch retains its original wood columns on brick piers, tongue-and-groove decking, and wood balustrade. Decking is extensively rotted, several balusters are missing or cracked, and columns show paint failure and minor checking. Brick piers have minor mortar deterioration. Windows: Original double-hung wood sash windows on all elevations show paint failure, glazing compound failure, and air infiltration. Some sill ends show minor rot from prolonged moisture exposure. Roof: Existing asphalt shingles are at end of service life — curling, missing tabs, and exposed underlayment in areas. Gutters and downspouts are deteriorated. Soffit and fascia show paint failure and isolated rot.

- Clean all exterior masonry surfaces with low-pressure water washing (no sandblasting or harsh chemicals)
- Remove deteriorated mortar to a depth of 3/4" using hand tools only (no saw-cutting)
- Repoint with lime-based mortar matching existing in color, composition, texture, and joint profile (mix softer than brick per Secretary's Standards)
- Repair cracked or spalled brick units in-kind; match and reset using salvaged or closely matched brick where units cannot be repaired
- No new openings or alterations to masonry

- Repoint all deteriorated mortar joints on chimney stack using lime-based mortar
- Reset any displaced brick units in-kind
- Repair chimney cap; install new pre-formed stainless-steel cap where existing cap is deteriorated beyond repair
- Repair damaged flashing at roof line; patch or reset in-kind to match existing profile
- No change to chimney height, massing, or profile

- Repair porch decking; remove only rotted boards and reinstall in-kind (#1 grade tongue-and-groove fir, matching existing profile and thickness)
- Repair and restore balustrade; match and reinstall missing or deteriorated balusters in-kind (wood, matching existing dimensions and spacing)
- Consolidate minor checks on wood columns with epoxy consolidant; strip and repaint columns, balustrade, and fascia with exterior-grade paint
- Repoint brick piers at deteriorated mortar joint locations
- No change to porch configuration, column placement, footprint, or railing height

- Retain all existing window frames and sashes
- Repair broken glazing with single-strength glass in-kind
- Re-glaze all sashes with traditional oil-based glazing compound
- Repair rotted sill ends with Dutchman repairs using matching wood species in-kind
- Strip and repaint all sash, frame, and sill elements
- No window unit removal or replacement

- Repair roof covering: remove deteriorated shingles, repair sheathing as needed, reinstall roofing material in-kind (same profile, composition, and color)
- Repair deteriorated gutters and downspouts in-kind
- Repair rotted soffit and fascia sections in-kind (wood, matching existing profile)
- Retain existing roof form, pitch, and dormer configuration without alteration

- Remove non-original exterior stair structure at rear of property
- Structure is not original to the circa 1910 construction and is not identified in historic documentation
- Removal will not affect any original historic fabric
- Resulting opening/foundation to be patched in-kind to match adjacent materials
