STAFF REPORT: MAY 8, 2024 MEETING
APPLICATION NUMBER: HDC2024-00181
ADDRESS: 441 W. WILLIS

SCOPE: ERECT MULTI-FAMILY BUILDING

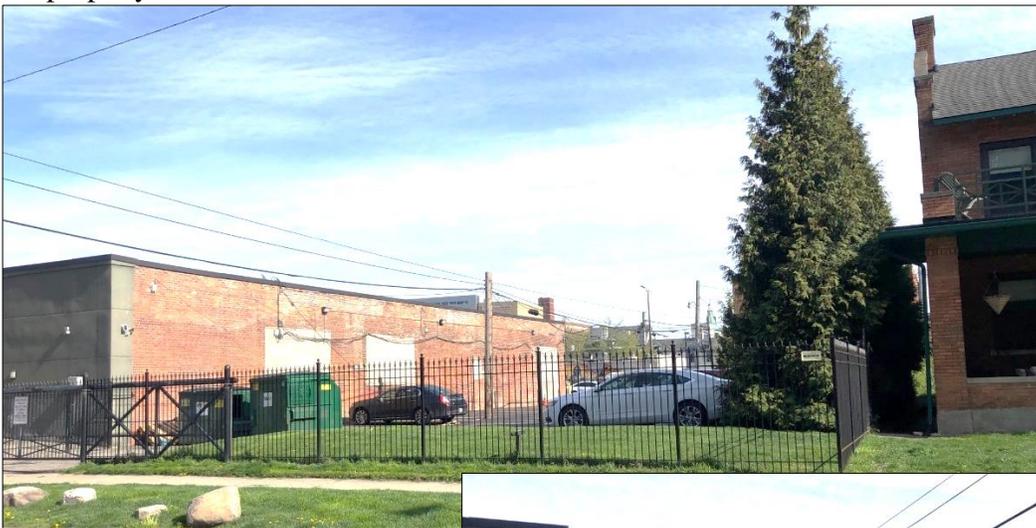
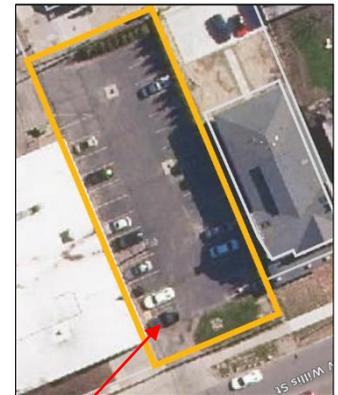
The parcel at 441 W. Willis is currently a paved, gated surface parking lot. A vacated alley falls within the property lines.

*Above: Looking southeast from Willis.
Right: Looking southwest from Willis.
Staff photos, April 19, 2024.*

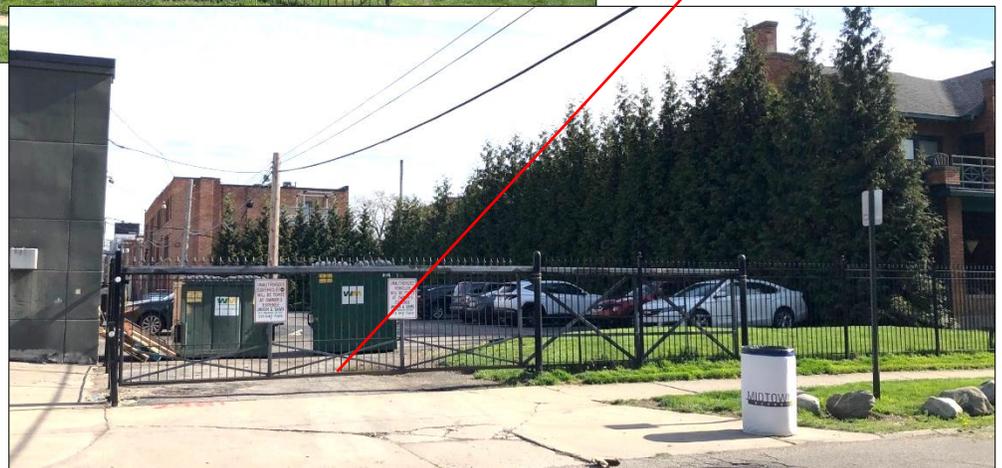
*Top Right: Detroit Parcel Viewer.
Arrow points to vacated alley.*

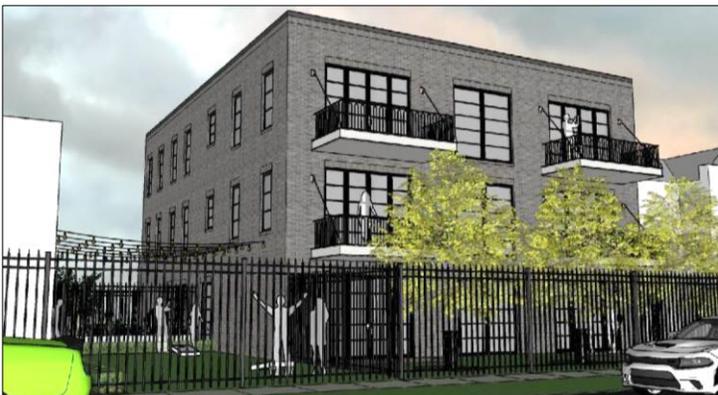
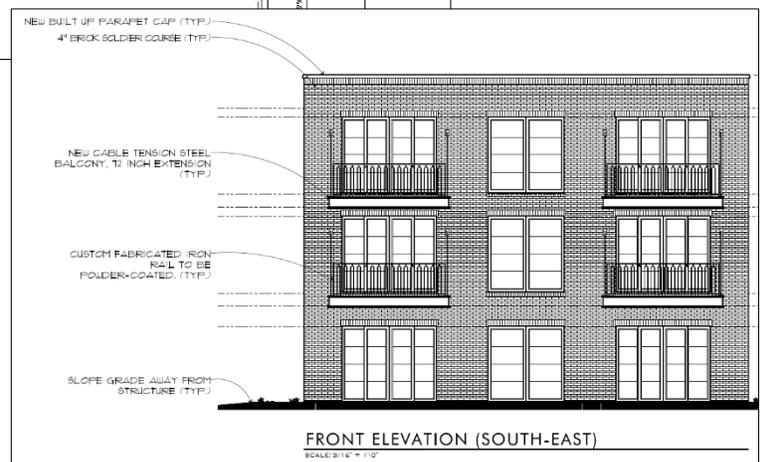
- At the March 11, 2020 meeting, the Commission reviewed and issued a COA for a new construction application for the below three-story building and surface parking lot. Things to note in this application: the location/setback of 449 W. Willis (★) is drawn correctly (denoted by the vertical red line - the front edge of the porch is almost in line with the front wall of the proposed structure at 441 W. Willis) and the dumpster enclosure is located at the rear of the lot, facing the alley.

The site plan submitted with the 2020 application for a new building (shown on page 2) is drawn correctly; staff recommends the site plan be revised accordingly.

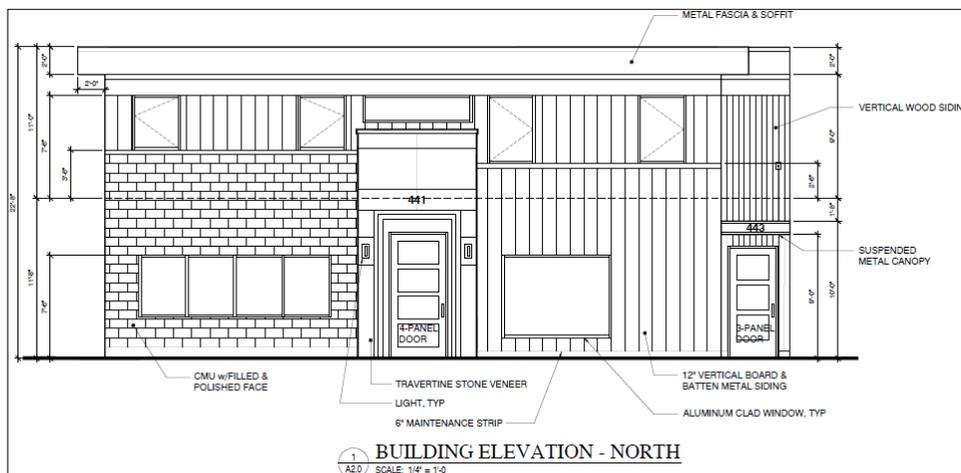
The proposed building has asymmetrically placed window and door openings, coupled with different sized windows and sill heights. The use of vertical and horizontal wall materials separated by different transition heights doesn’t create a vertically or horizontally arranged façade.

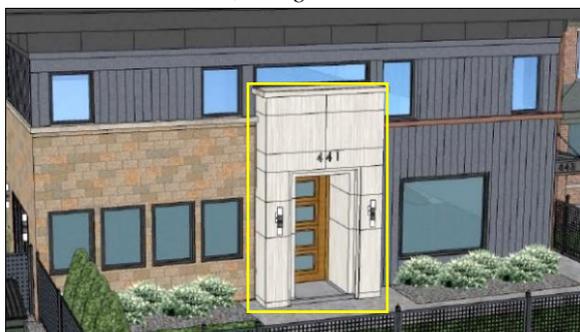
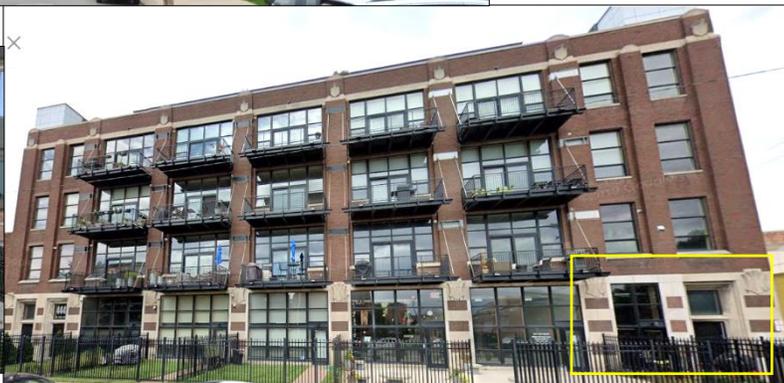
Applicant rendering. Google street view photos.

The tall, narrow, rectangular limestone entrance at 441 W. Willis mimics the proportions of the stone cladding that frames the first floor window and door openings of the industrial building to the north.

It is staff’s opinion that the front entrance design merges the shape, massing, and materiality of the industrial building across the street to the north, and the recessed entry doors of the apartment buildings on the south side of Willis.

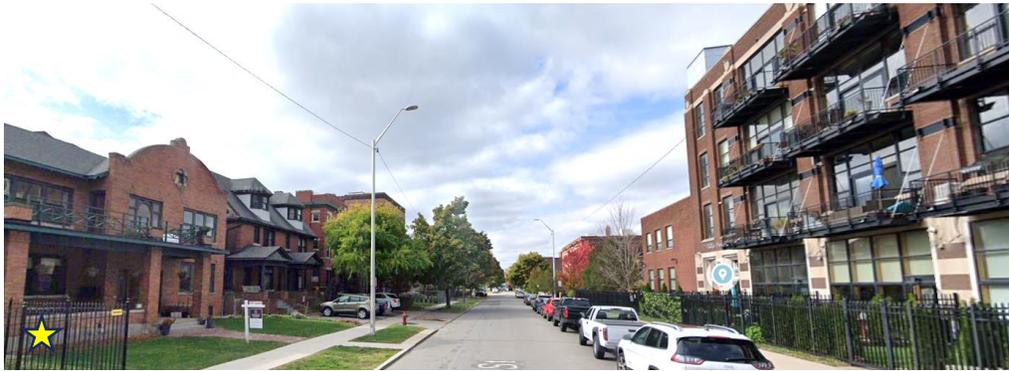
Streetscape view, looking west on W. Willis. Subject property is denoted by the metal fence at bottom left (★). There are two dominant wall materials for each building: brick and stone.

Staff's concern is how the multiple cladding materials relate to the district as well as to each other. In contrast to the above streetscape photo, which shows two dominate materials and colors per building, the subject property has five wall materials and eight colors.

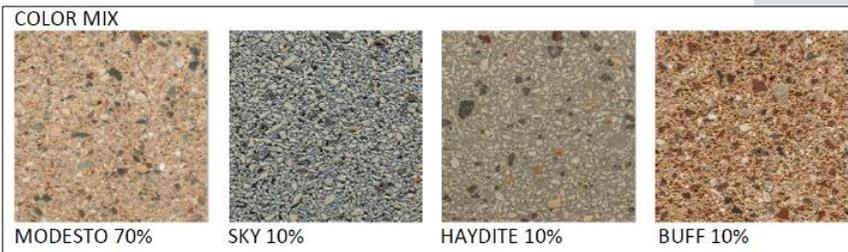
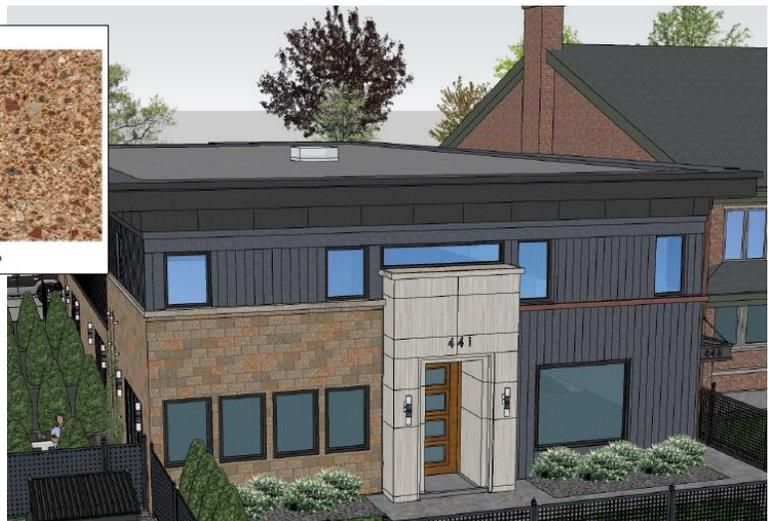
Above: Selected colors of CMU blocks copied from applicant documents. Staff agrees the colors fall within the district's dominate colors.

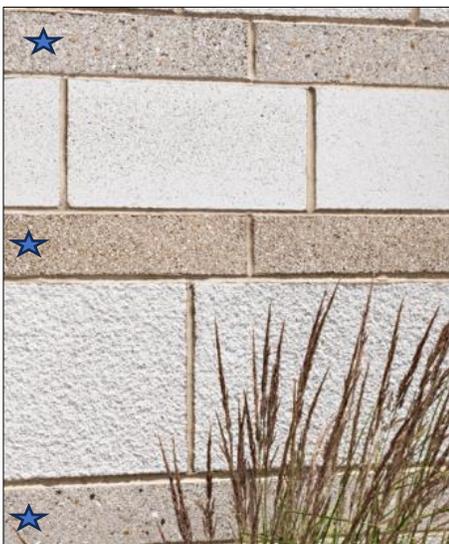
Left: Photo from Echelon Masonry’s Facebook page.

Rows of Trendstone Plus units are identified with blue stars. This example shows the product in a different size; illustrating staff’s comment about the availability of sizes that are more compatible with the district’s dominant use of brick.

Trendstone Plus – architectural CMU – which, according to the company’s website, is an integrated color product that’s polished to a smooth terrazzo-like finish. It appears the company offers different dimensions of blocks, which may offer a more compatible pattern to a district that has brick as its dominant cladding material. The below example shows the surface pattern of the product. Staff is interested to see the level of sheen that accompanies the “terrazzo-like” finish to the “Trendstone Plus” product, as well as a full-size CMU unit.

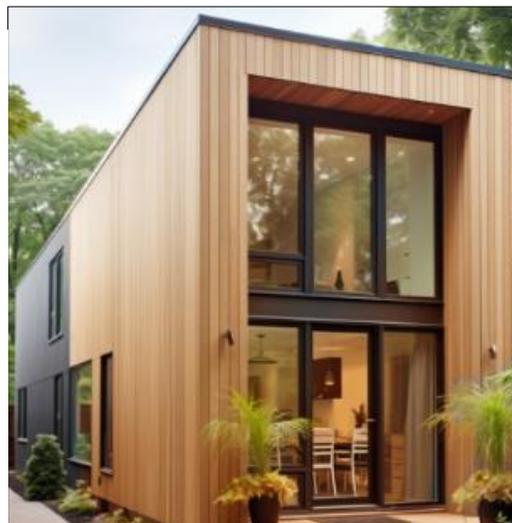
Right: Photo from www.woodtechpanels.com website.

Wood Tech exterior wall panels - a composite product made of wood fibers and thermoplastics. Staff is concerned about the visual appearance of the “wood-like” wall panels as well as the sheen that typically comes with a composite product that includes plastic.

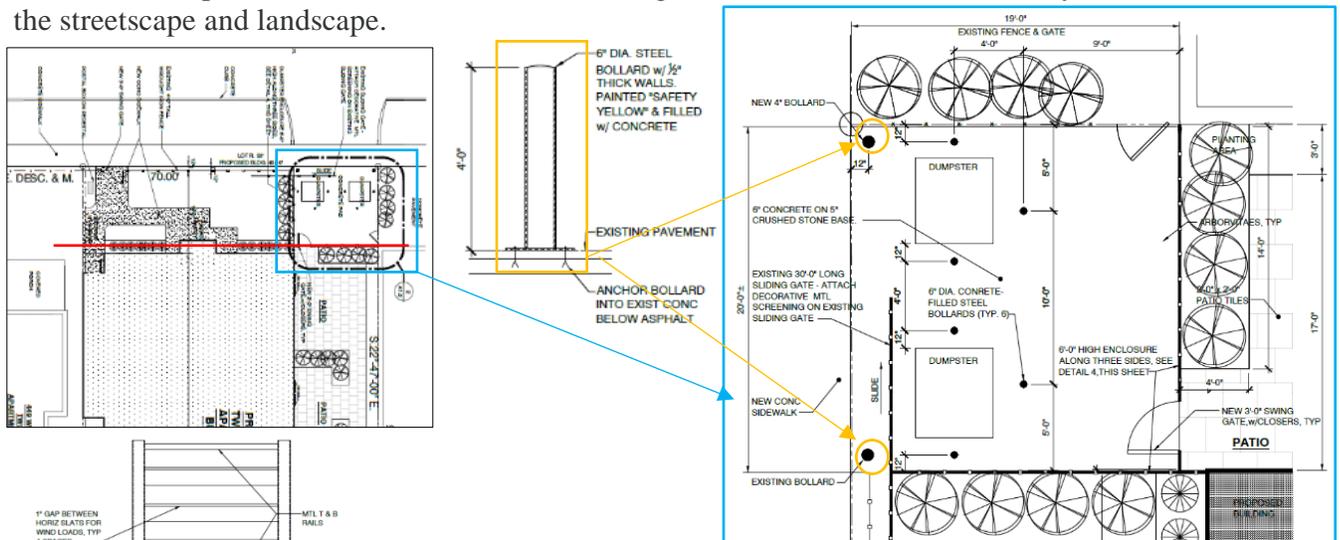
Above left: Site plan – red line identifies front walls of buildings.

Above: Plan of trash enclosure and bollards.

Left and below left: Elevation and cut sheet for enclosure fence “walls”.

Bottom right: Applicant rendering showing trash enclosure and front yard fencing. Staff added orange circles to denote location of bollards, based on the site plan.

The site plan shows the front of the new building in line with the commercial building to the east, but conversely, the trash enclosure sits forward of both buildings. It is located in the front yard space of 441 W. Willis and is enclosed with a fence constructed of solid, plastic panels. The shine and flatness of the manufactured material does not adequately match the profile, dimensionality, and appearance of wood or metal, the most common materials used in fencing and is incompatible for use in the historic district (and is in conflict with *Element 7 – Relationship of Materials* and *Element 8 – Relationship of Textures*). The placement of this enclosure is incongruous to this district and destroys the site line of the streetscape and landscape.

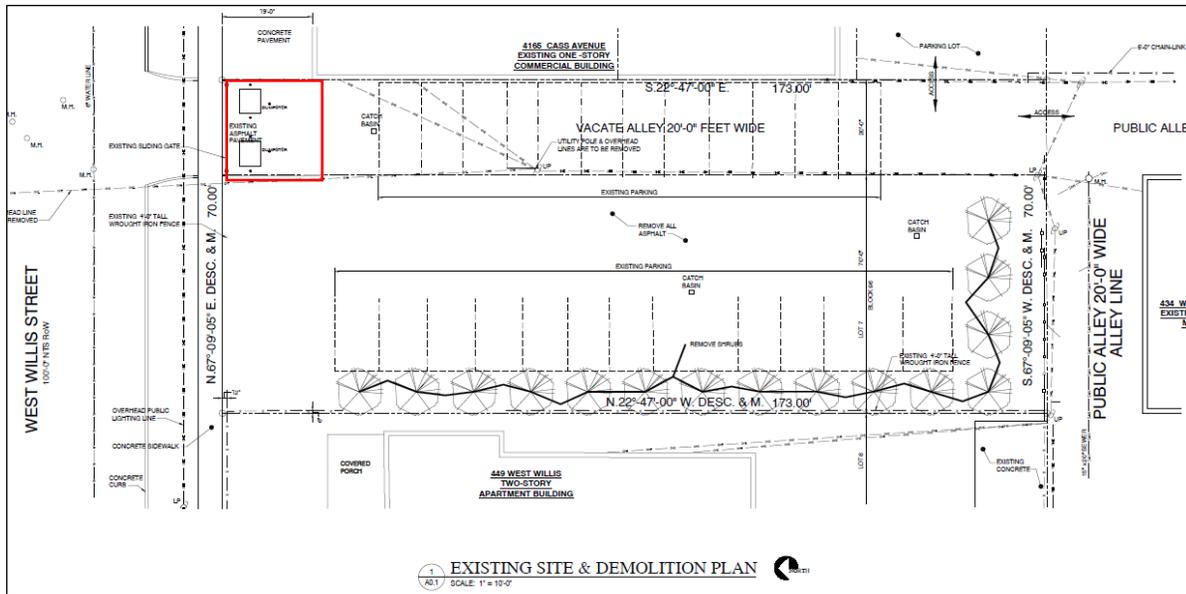
Applicant site plan.

The reason for the trash enclosure being proposed in the front yard is due to the entire rear yard being used for surface parking, and the remaining side yard (the former alley) being dedicated to outdoor space for building residents. Note: While the existing site plan identifies the trash bins being in the front yard now, Google street views shows the bins being located mid-block through October 2020. Staff's site visit photos taken in April 2024 show them closer to Willis but still behind the façade of the commercial building.

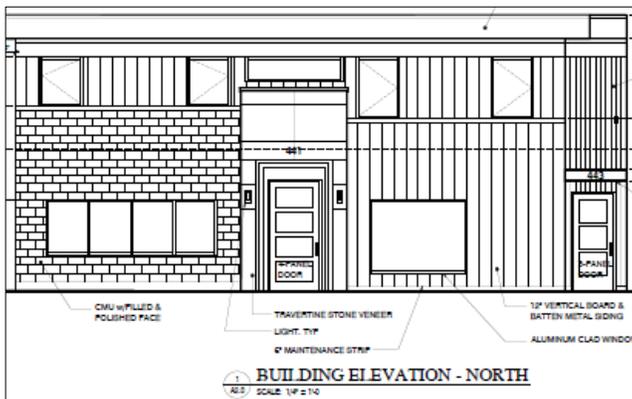
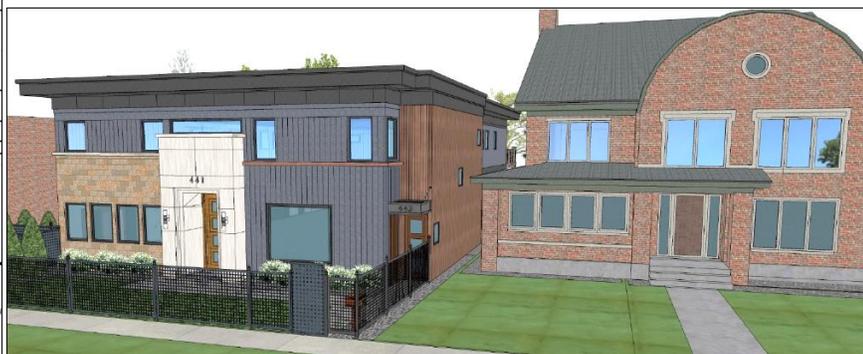
Applicant elevation and rendering. The windows at 449 W. Willis are depicted as casements, but they are 1-over-1 double-hung units.

The 3-1/2- and 5-1/2- story apartment buildings (469 and 479 W. Willis) offer highly symmetrical designs, as does the 2-1/2 story dwelling (455 W. Willis). The balanced massing and consistent window/door openings are emphasized by singular contrasting window trim. At 449 W. Willis, the building next door to the subject property, the asymmetrical massing of the house is balanced by the vertical and horizontal alignment of the window and door openings.

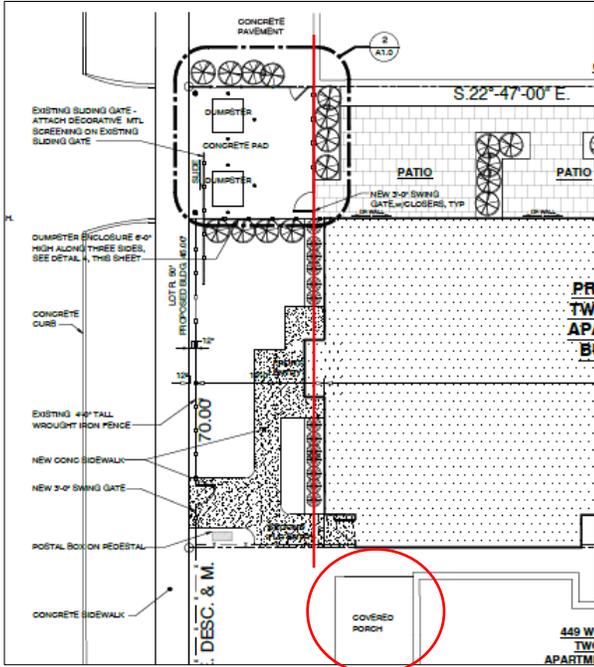
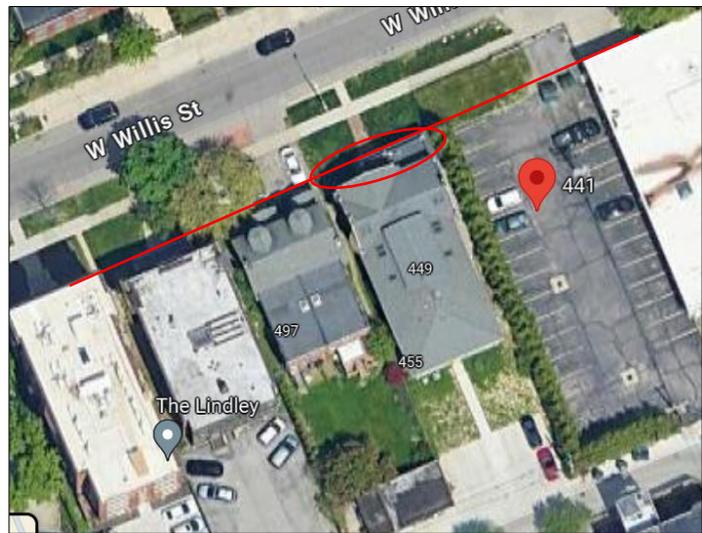
Above: The red line drawn along the front walls of the commercial and residential buildings to the east and west of 441 W. Willis shows the majority of the buildings have identical setbacks, with the exception of 469 W. Willis being set back an additional few feet.

Above left: The applicant’s site plan, using the same red line, shows the adjacent house (449 W. Willis) being significantly set back from the sidewalk. This gives the incorrect impression that the new building will break the rhythm of setbacks for this block.

Comparing the site plan and renderings to the aerial view of the buildings, it is staff’s opinion the dwelling at 449 W. Willis isn’t drawn in the correct location on the site plan and renderings. The front wall of the building proposed at 441 W. Willis should be in line with, or only slightly in front of, the adjacent structures - the rhythm of building setbacks will effectively remain intact.

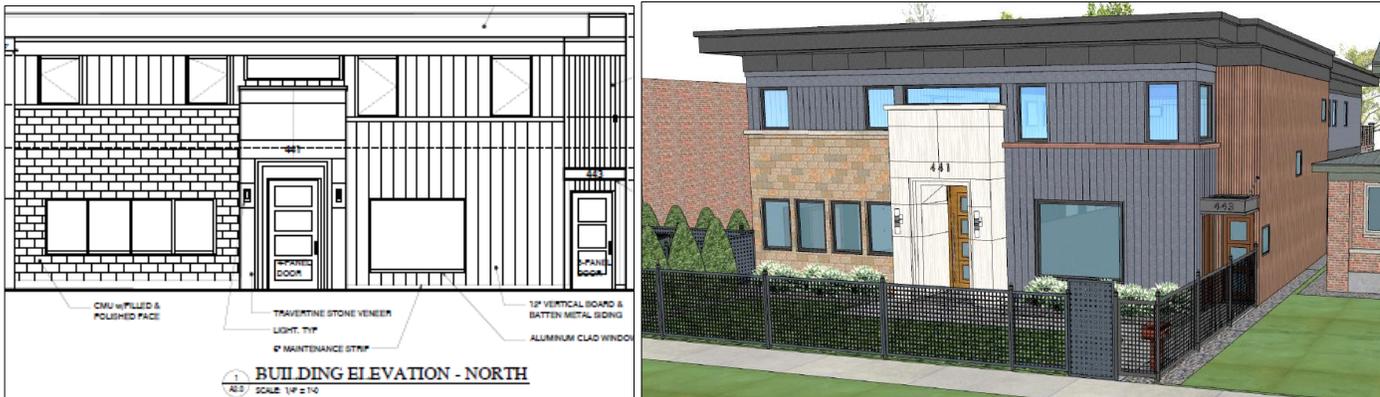
The applicant’s design for the front and side walls is a contemporary design that, in staff’s opinion, does not offer a level of balance, due to the irregular placement, size, and operation of the windows, as well as the competing patterns, dimensions, and materiality of the exterior materials. There isn’t a strong vertical or horizontal expression, which is inconsistent with the rhythms and patterns of the historic and newly constructed buildings on this street.
