CITY OF DETROIT  
**CLARK PARK**

STAKEHOLDER MEETING #2  
6 AUG 2019

HamiltonAnderson

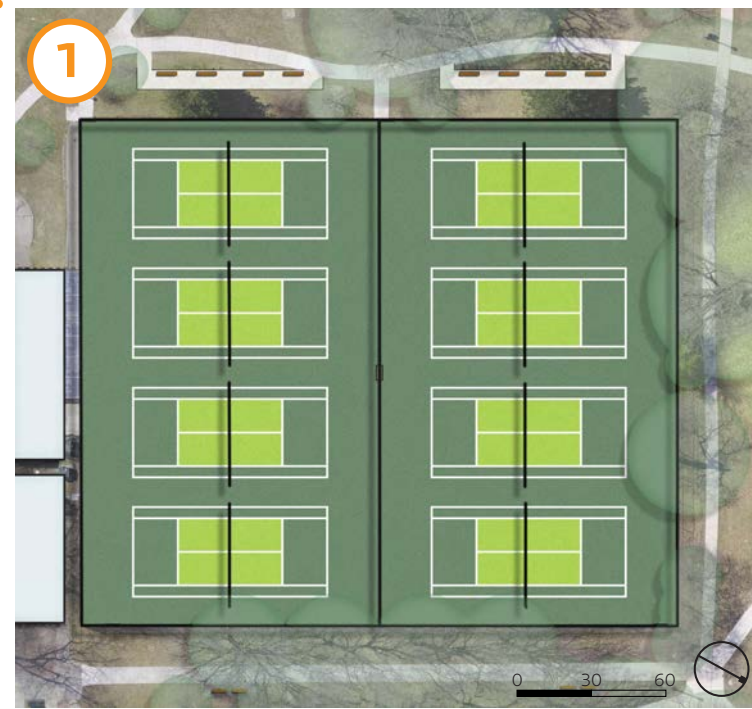
**OPTION 1 - RESTORE COURT SURFACING**  
OPCIÓN 1 - INTEGRAR ASIENTOS EN LA LADERA

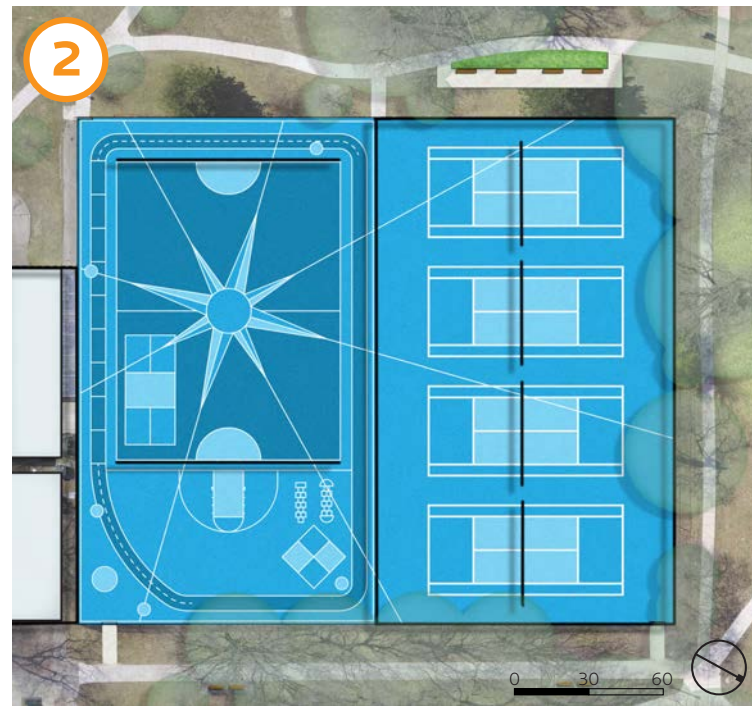
**OPTION 2 - RESTORE COURTS / ADD ACTIVITIES**  
OPCIÓN 2 - RESTAURAR PISTAS / AGREGAR ACTIVIDADES

- NEW COURT SPORTS | NUEVOS DEPORTES DE CANCHA**
- 5 X 5 SOCCER | 5 FOR 5 FÚTBOL
  - BASKETBALL | BALONCESTO
  - PICKLEBALL | PICKLEBALL
  - FOURSQUARE | JUEGO DE FOURSQUARE
  - RUNNING TRACK | PISTA DE CARRERAS

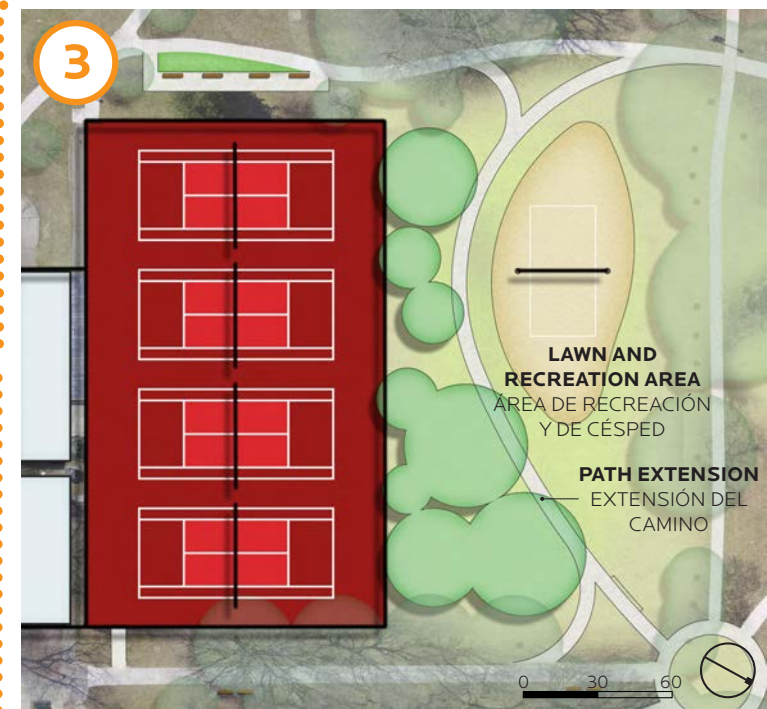
**OPTION 3 - REDUCE COURTS, MAXIMIZE SPACE FOR NEW ACTIVITY**  
OPCIÓN 3 - REDUCIR LAS CANCHAS, AUMENTAR EL ESPACIO PARA LA NUEVA ACTIVIDAD

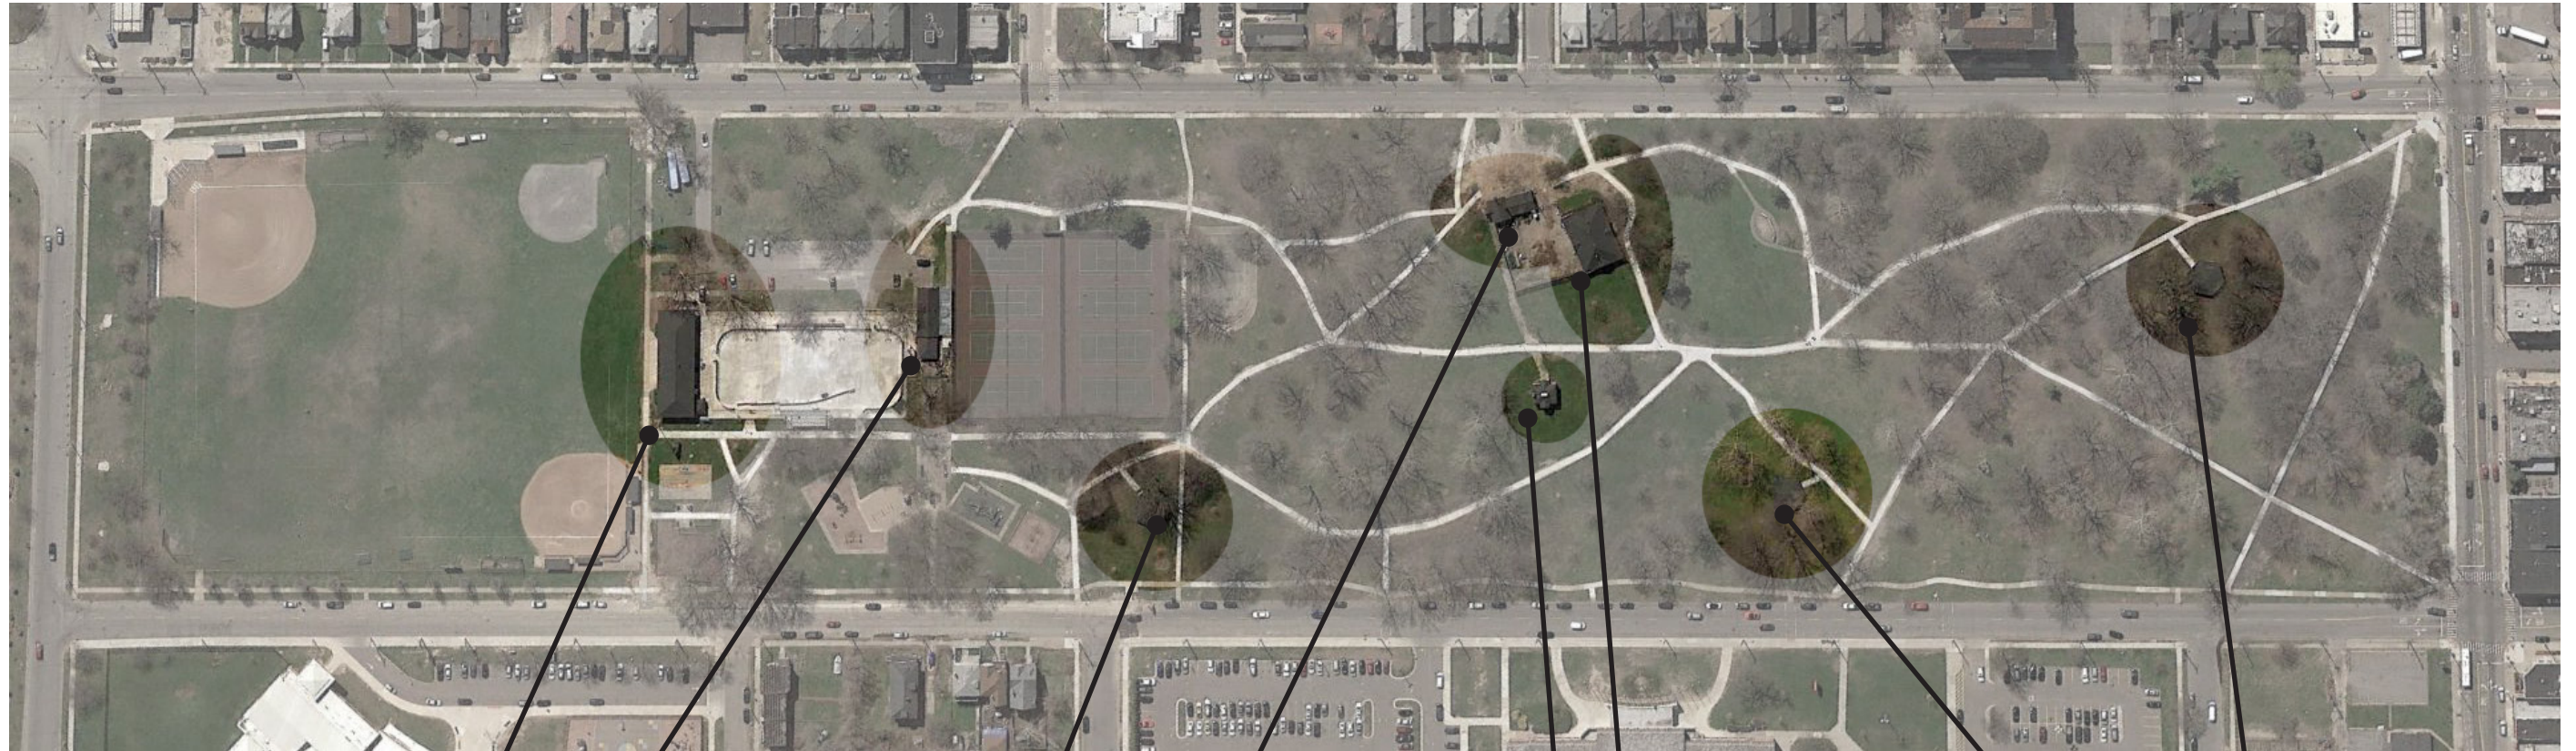
# BUILDING ASSESSMENT

RECREATION CENTER

STORAGE BUILDINGS

GAZEBO #1

MEN'S TOILET ROOM &  
TOOL BUILDING

LARGE PAVILION

WOMEN'S TOILET ROOM

GAZEBO #3

GAZEBO #2

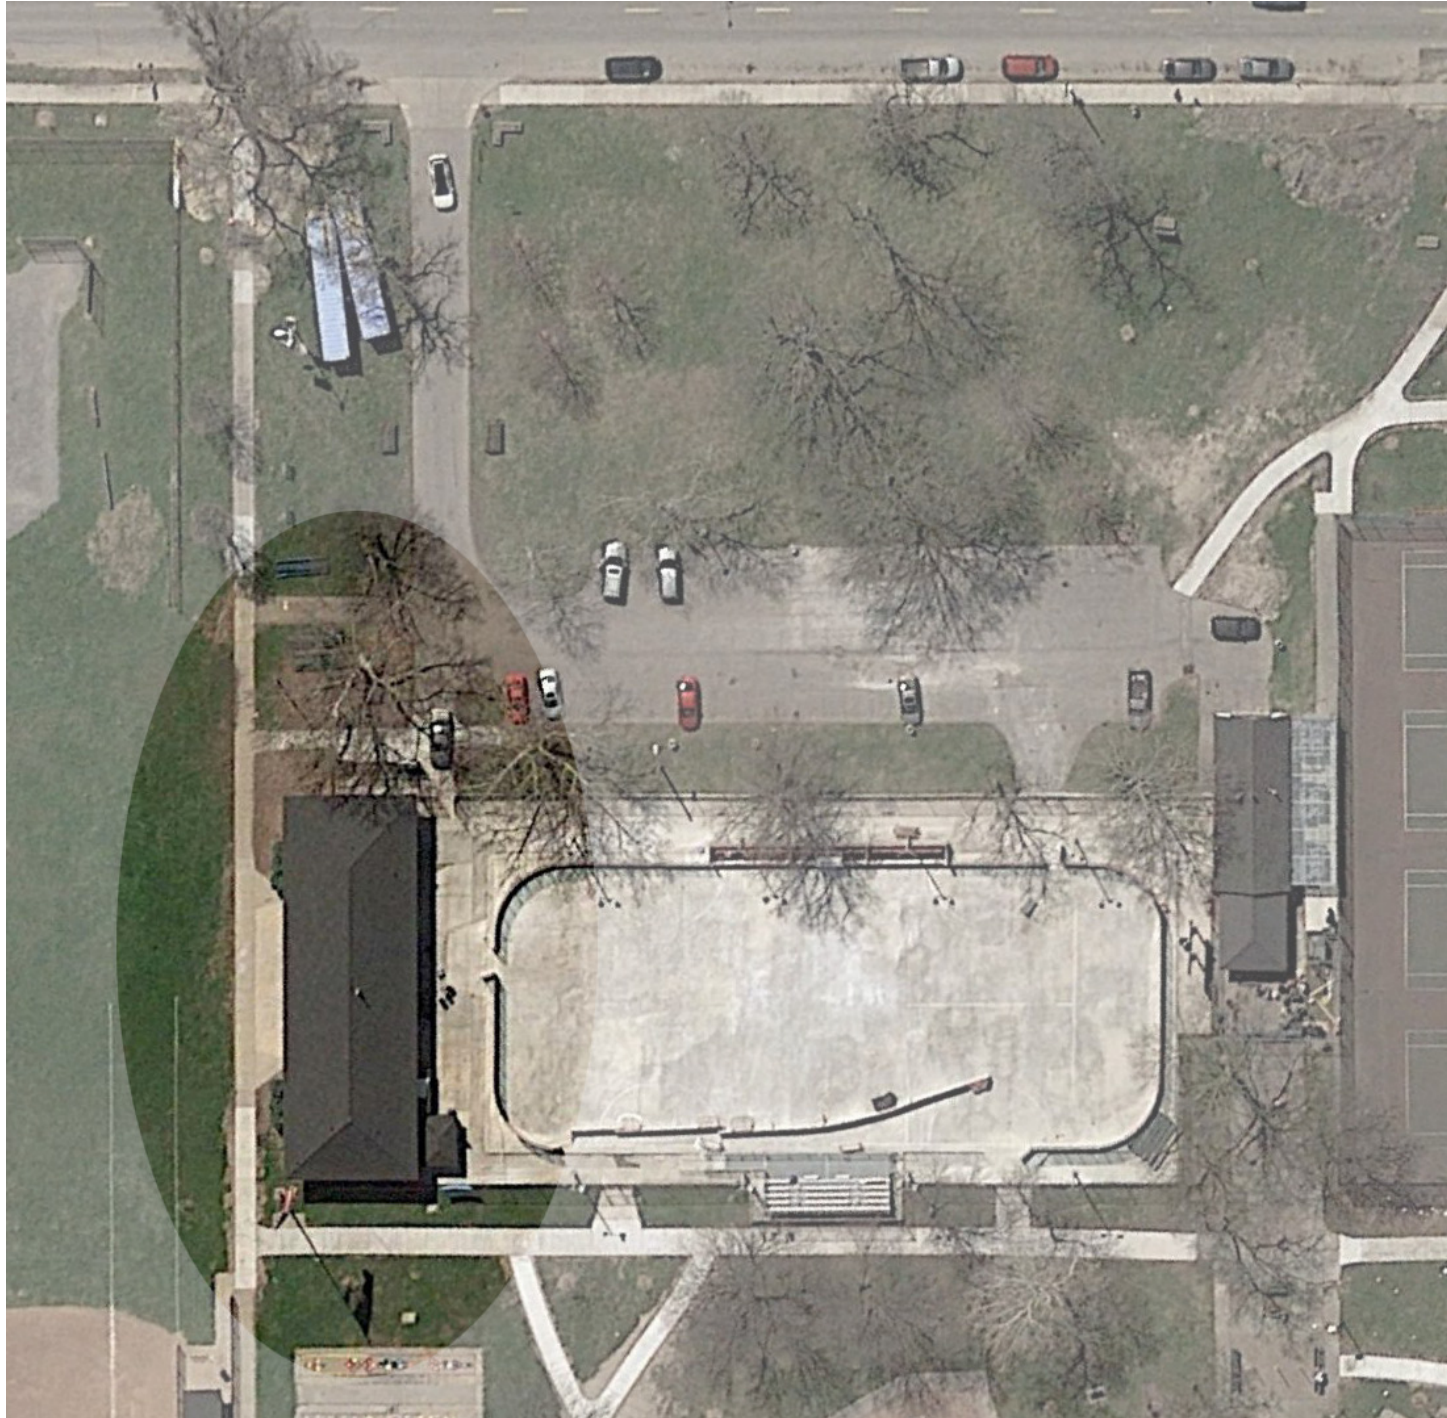
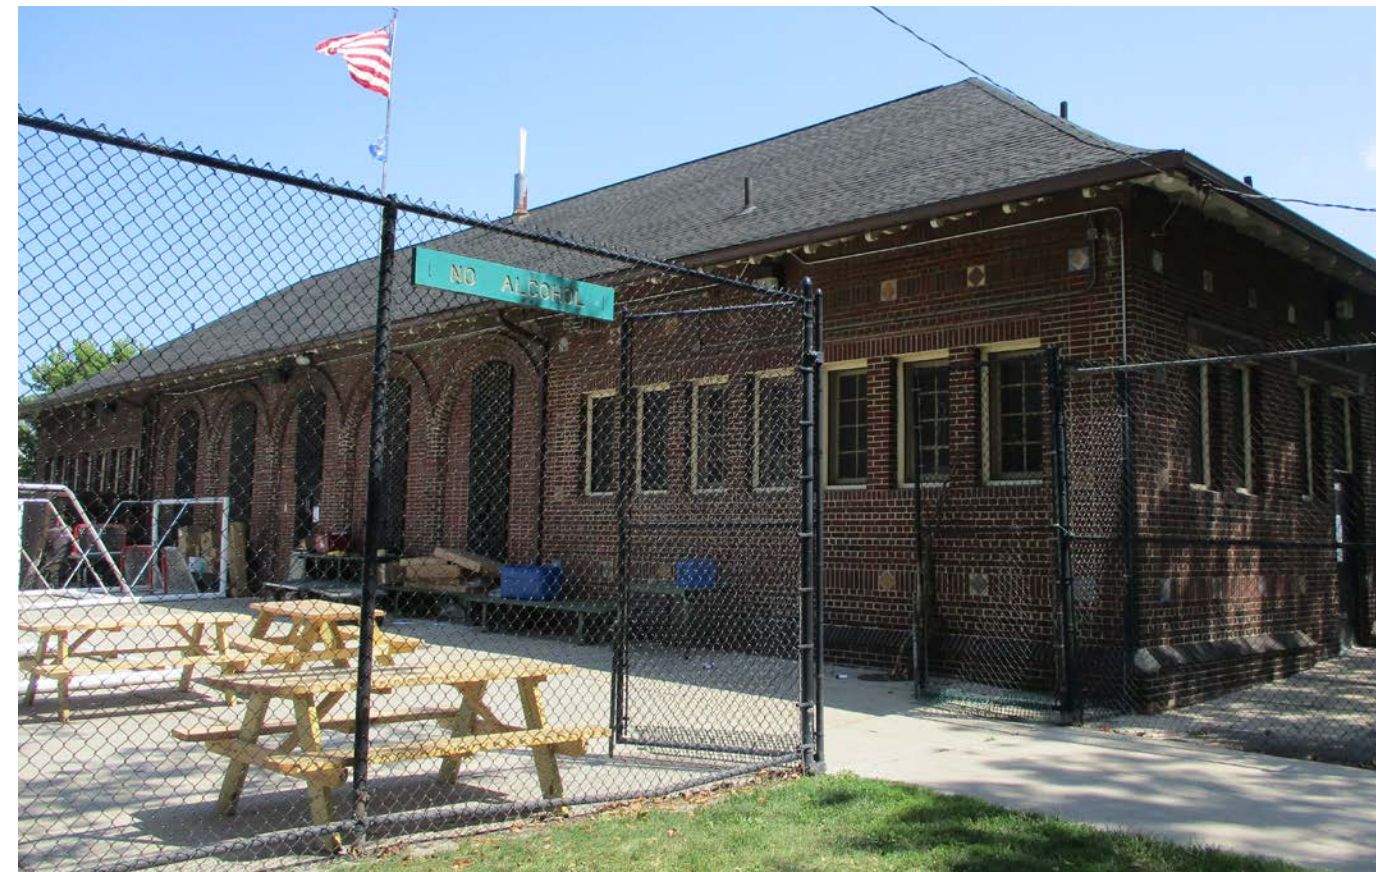
# PRELIMINARY BUILDING ASSESSMENT | RECREATION CENTER

The current Recreation Center building was built between 1922 and 1926 as a “shower bath and toilet building” (*1922 Journal of the Common Council*). The accepted bid was for \$22,000. The five arches on both the north and south facades were open, forming an open air shelter in the center of the one story, rectangular building. The roof is a simple four sided hip configuration, with a slight flare at the eaves. The building underwent a renovation in 1980 which included enclosing the open arches with double wythe brick walls that have vertical window openings and exterior metal security screens. The space was heated and cooled via a new mechanical system with ducts in the attic and above a dropped ceiling.

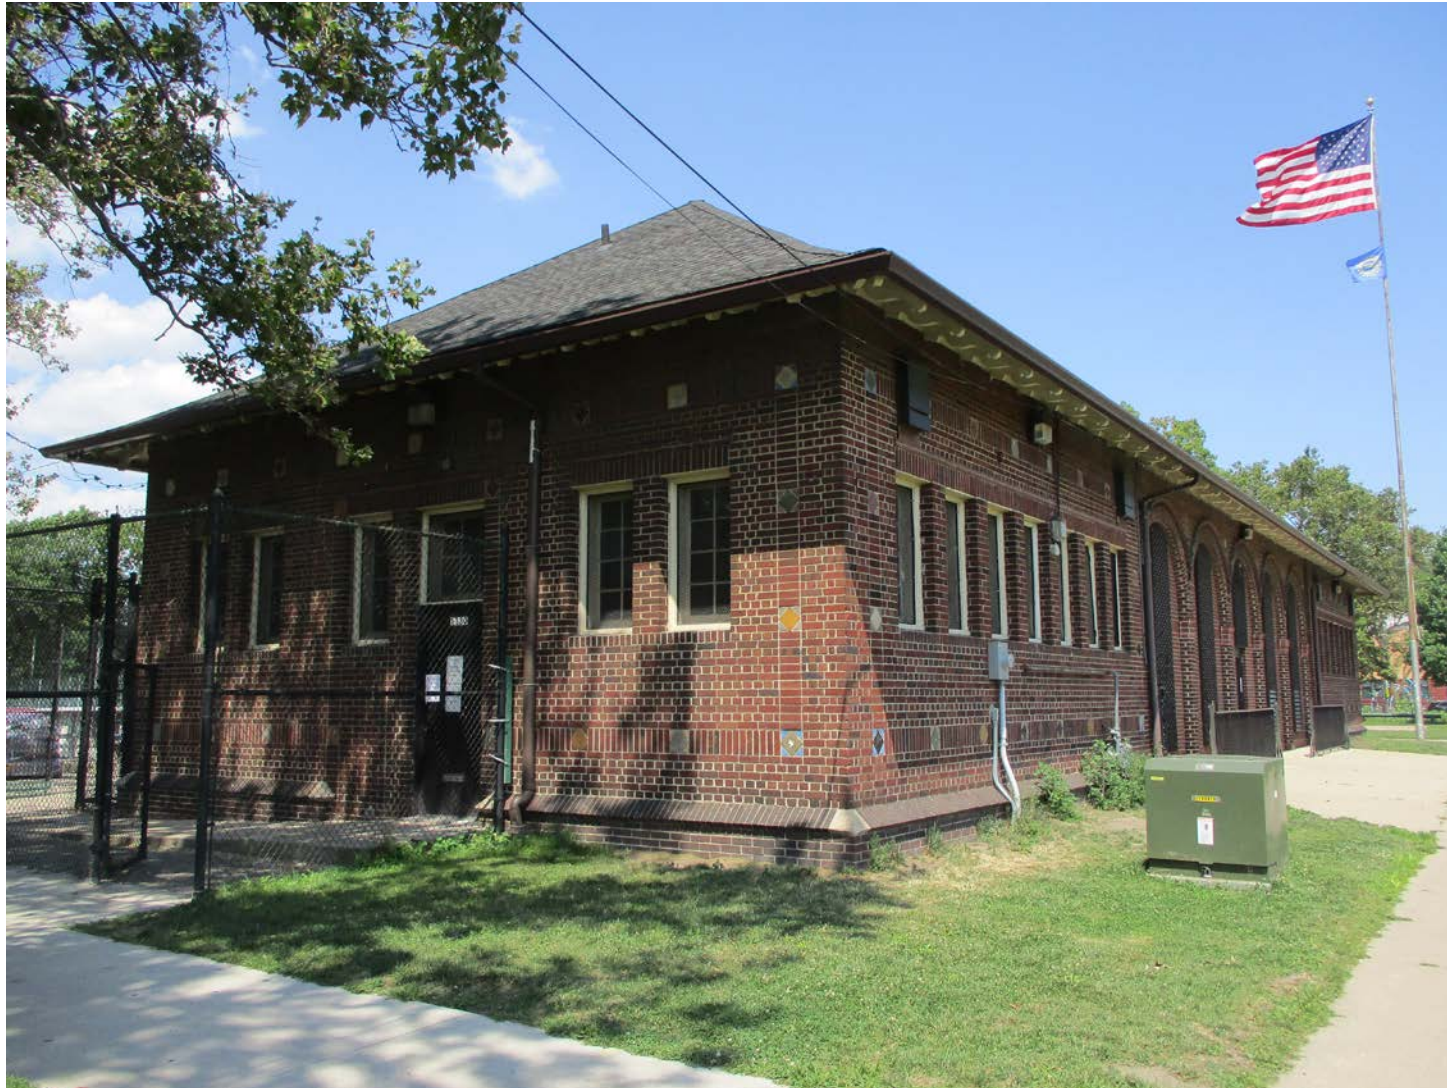
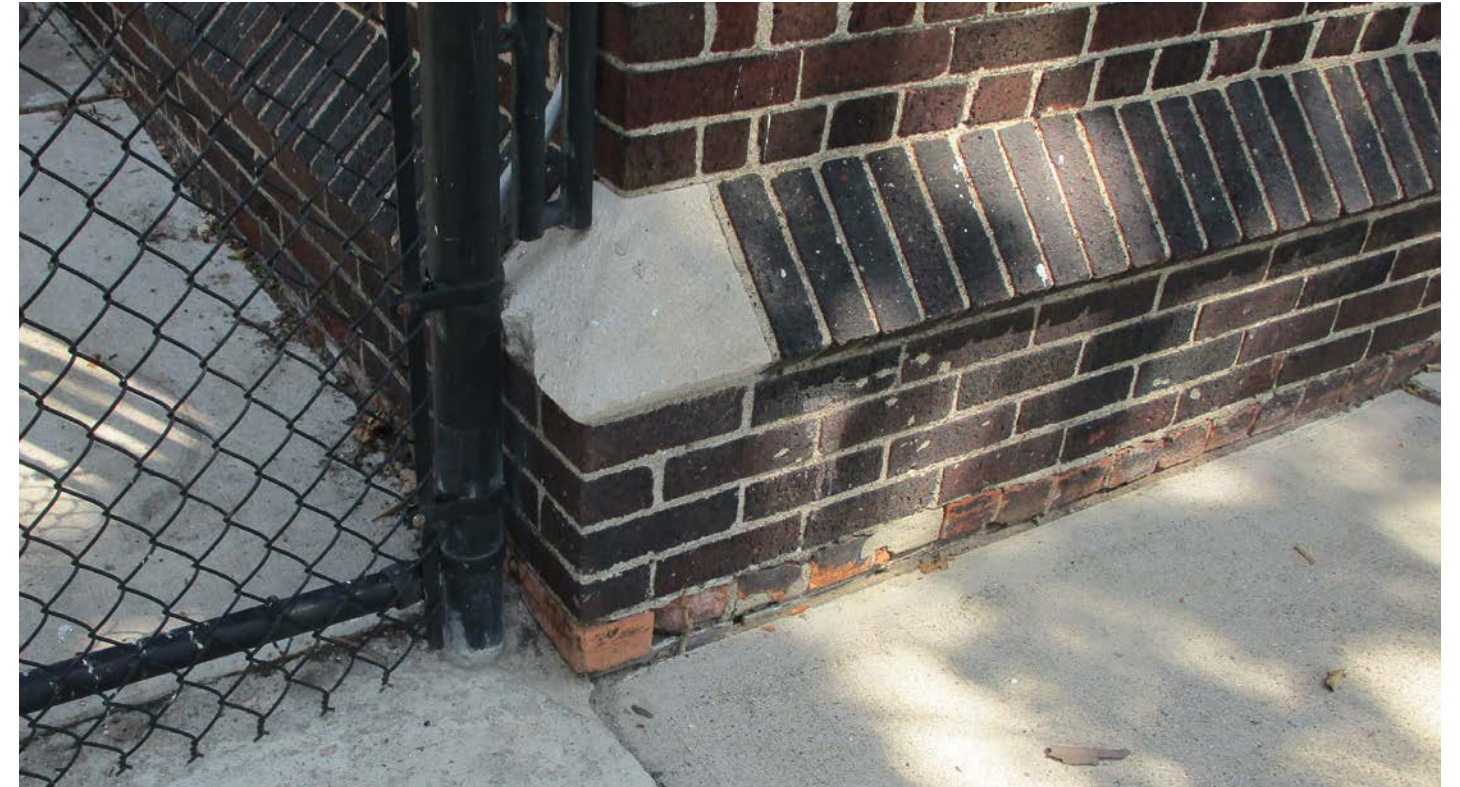
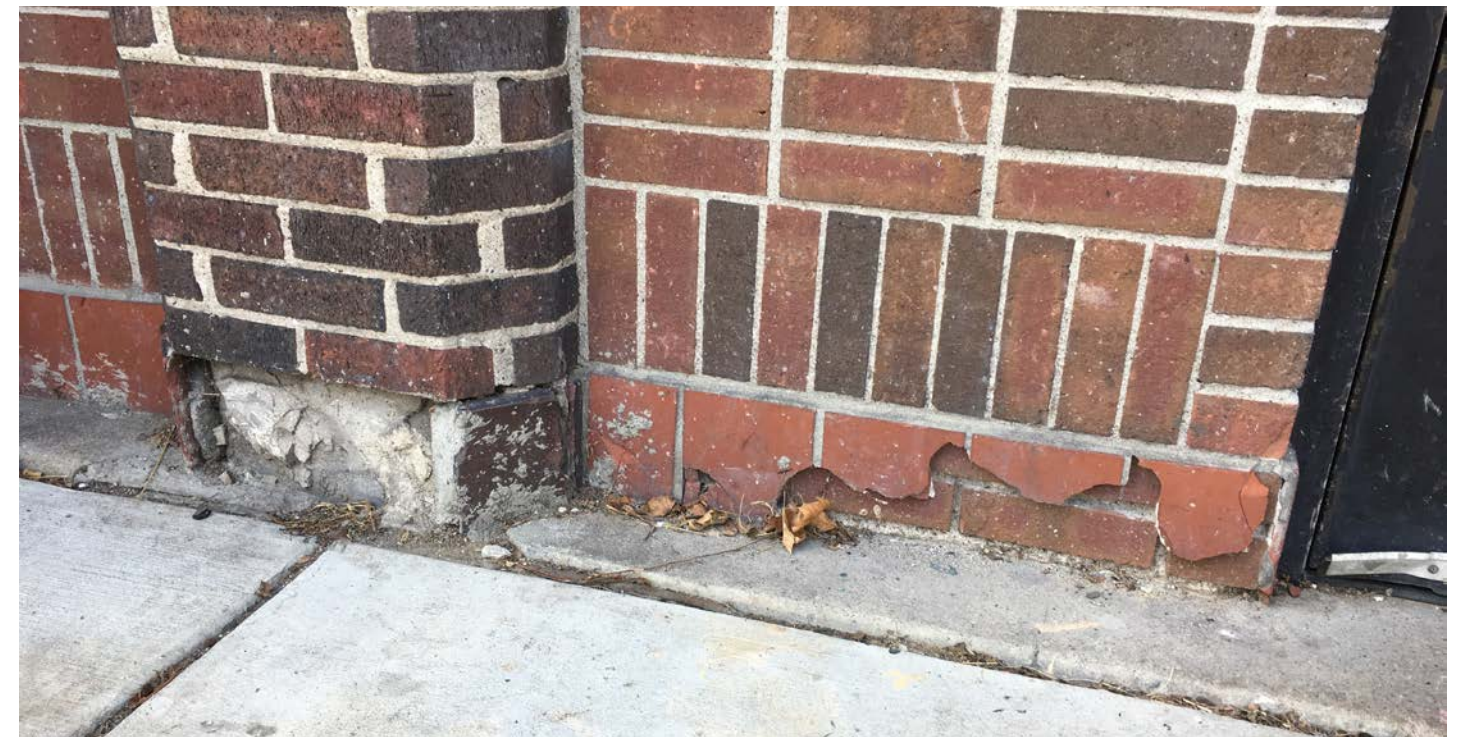
# PRELIMINARY BUILDING ASSESSMENT | RECREATION CENTER

Various interior alterations were also made including the addition of concrete block walls to create a barrier free toilet room, a warm-up kitchen, a meter room, two vestibules and an office. The southern locker room was turned into a women's toilet room and the northern women's toilet room became an office.

8.4.2 *Structural Frame and Building Envelope* consists of concrete block with a standard brick façade, grade slab, and a heavy timber wood-framed roof. The structure is sound and in good condition, with only minor superficial damages to the face brick and the applied tile at the base.

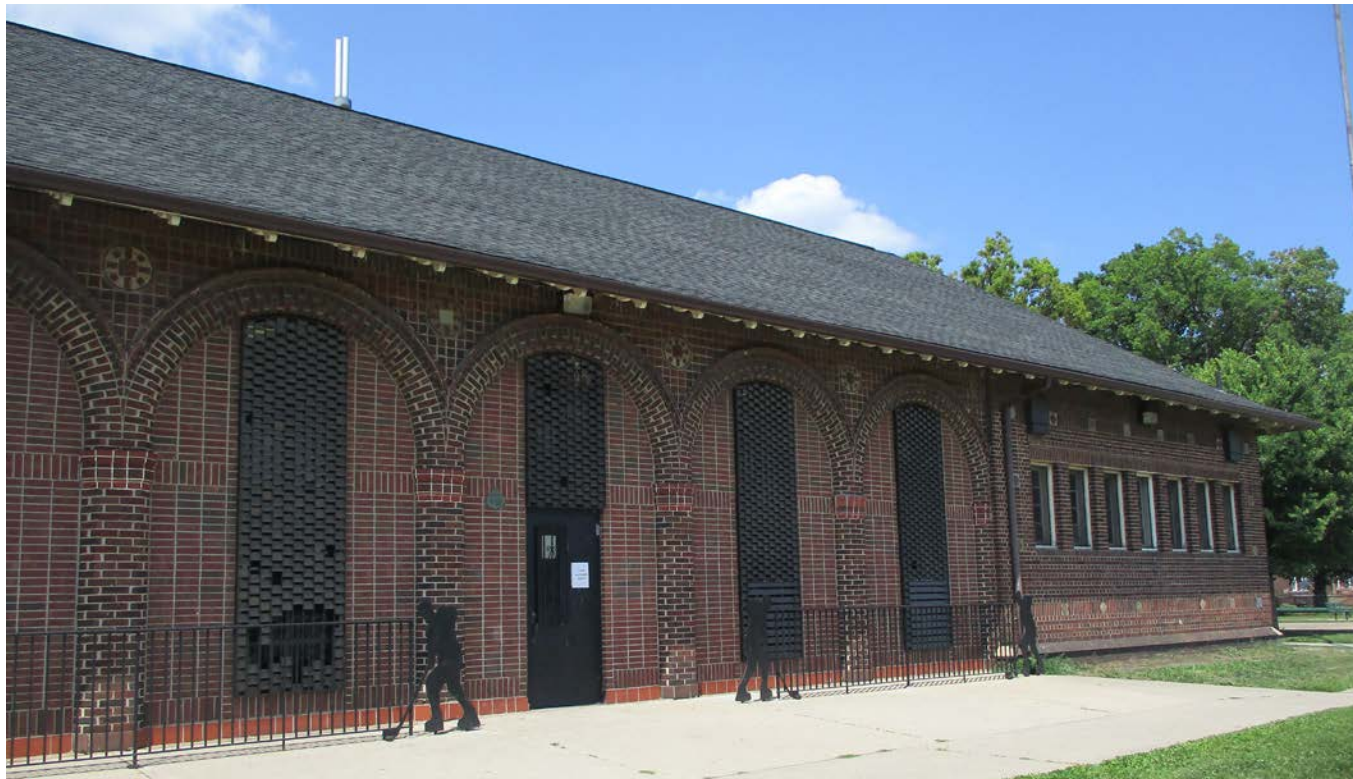
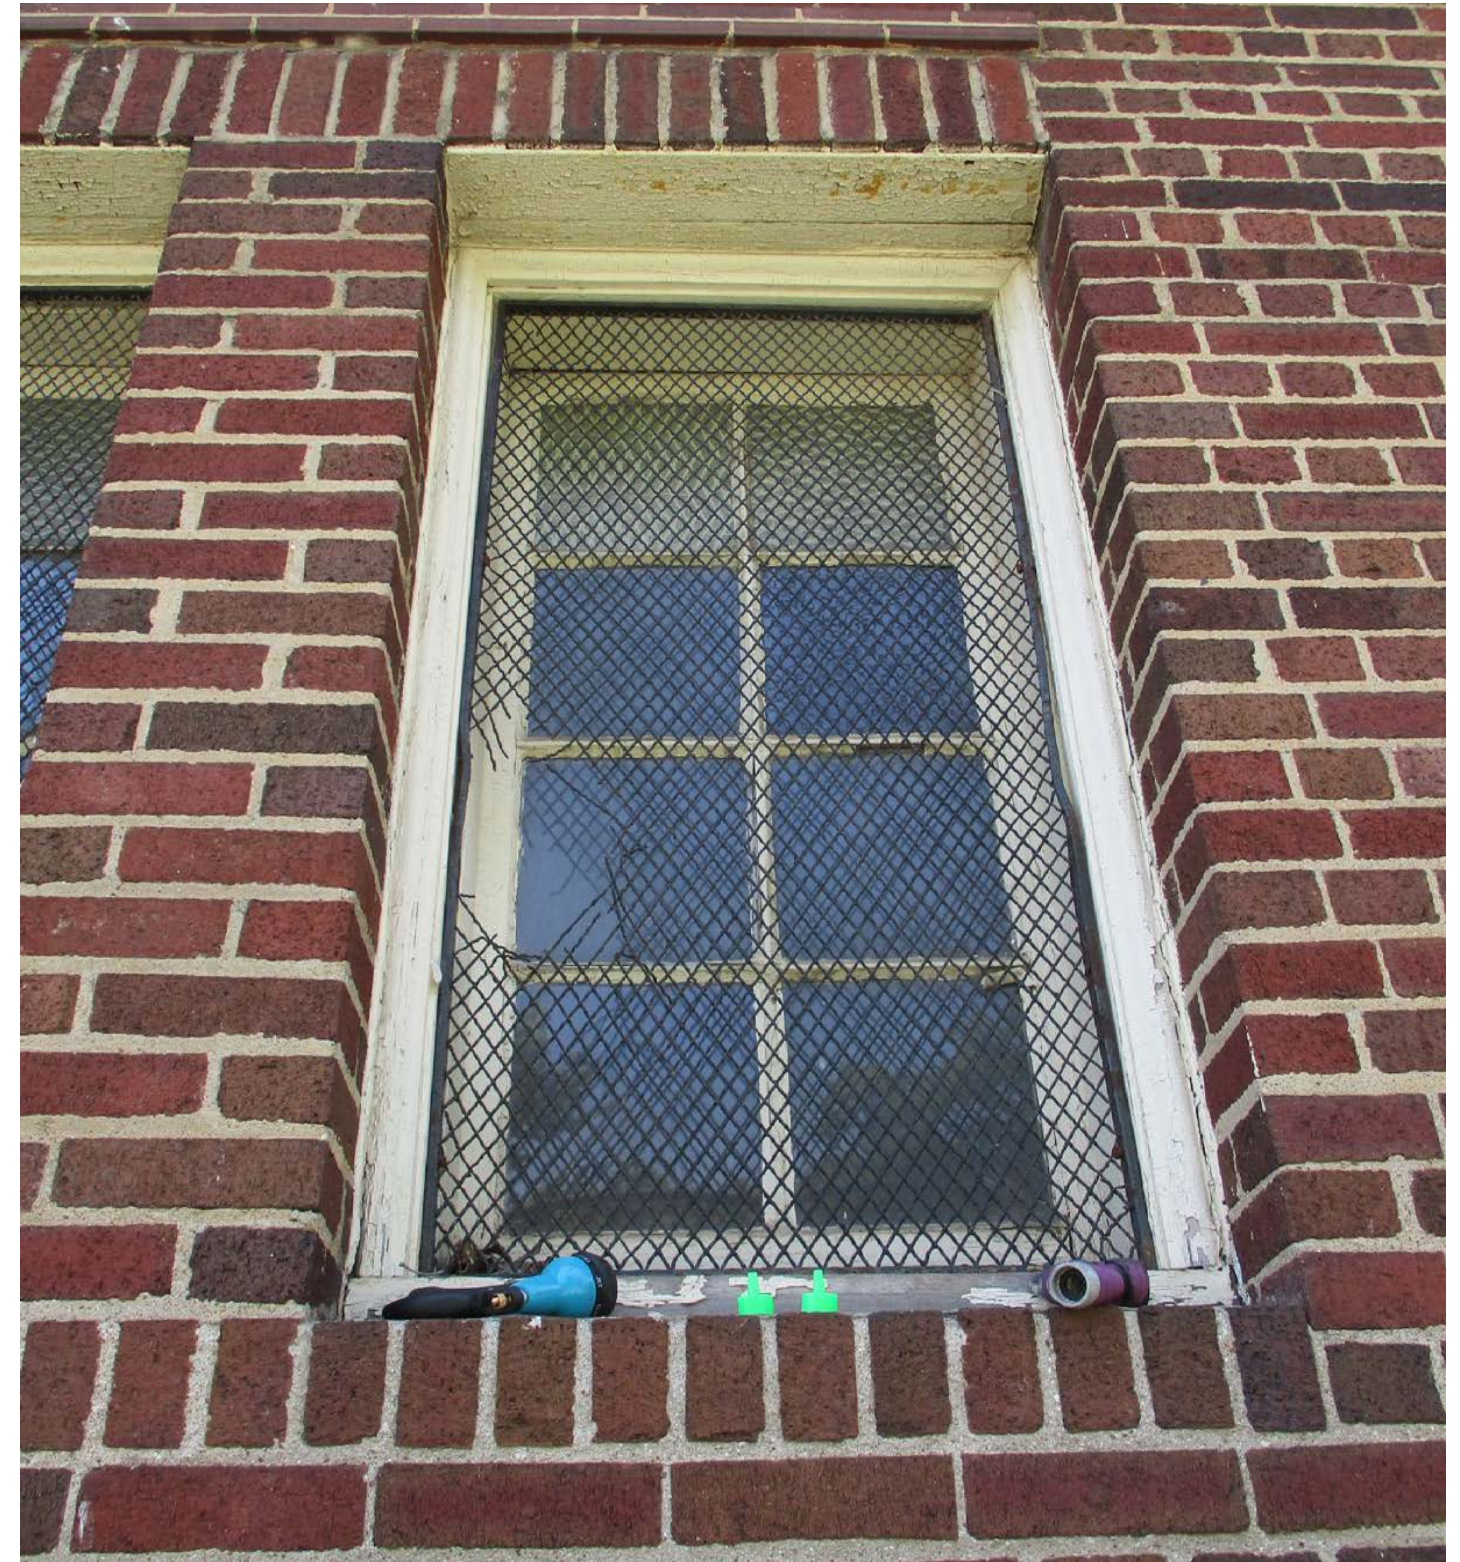
# PRELIMINARY BUILDING ASSESSMENT | RECREATION CENTER

The original wood hopper windows remain on the eastern and western wings of the building. Several are still operable. The condition varies. These windows are protected with wire metal guards, (from 1980), many in poor condition.

The windows and grilles within the arches were added in the 1983 renovation. Many of the grilles are broken and have missing slats. The grilles provide security, hide ductwork at windows, and provide some privacy for changing in the skate room.

*8.4.3 Roofing:* New roofing and gutters appear to have been installed 2004-2005 based on a memorandum from the Recreation Department to the City Council. The warranty is unknown. It is single layer asphalt shingle on plywood underlayment. The plywood, as viewed in the attic, appears to be in good condition and there is ridge ventilation. While baffles appear in the attic to allow for eave ventilation, there are no eave vents. Plumbing vents penetrate the roof. No leaking issues were reported or observed.

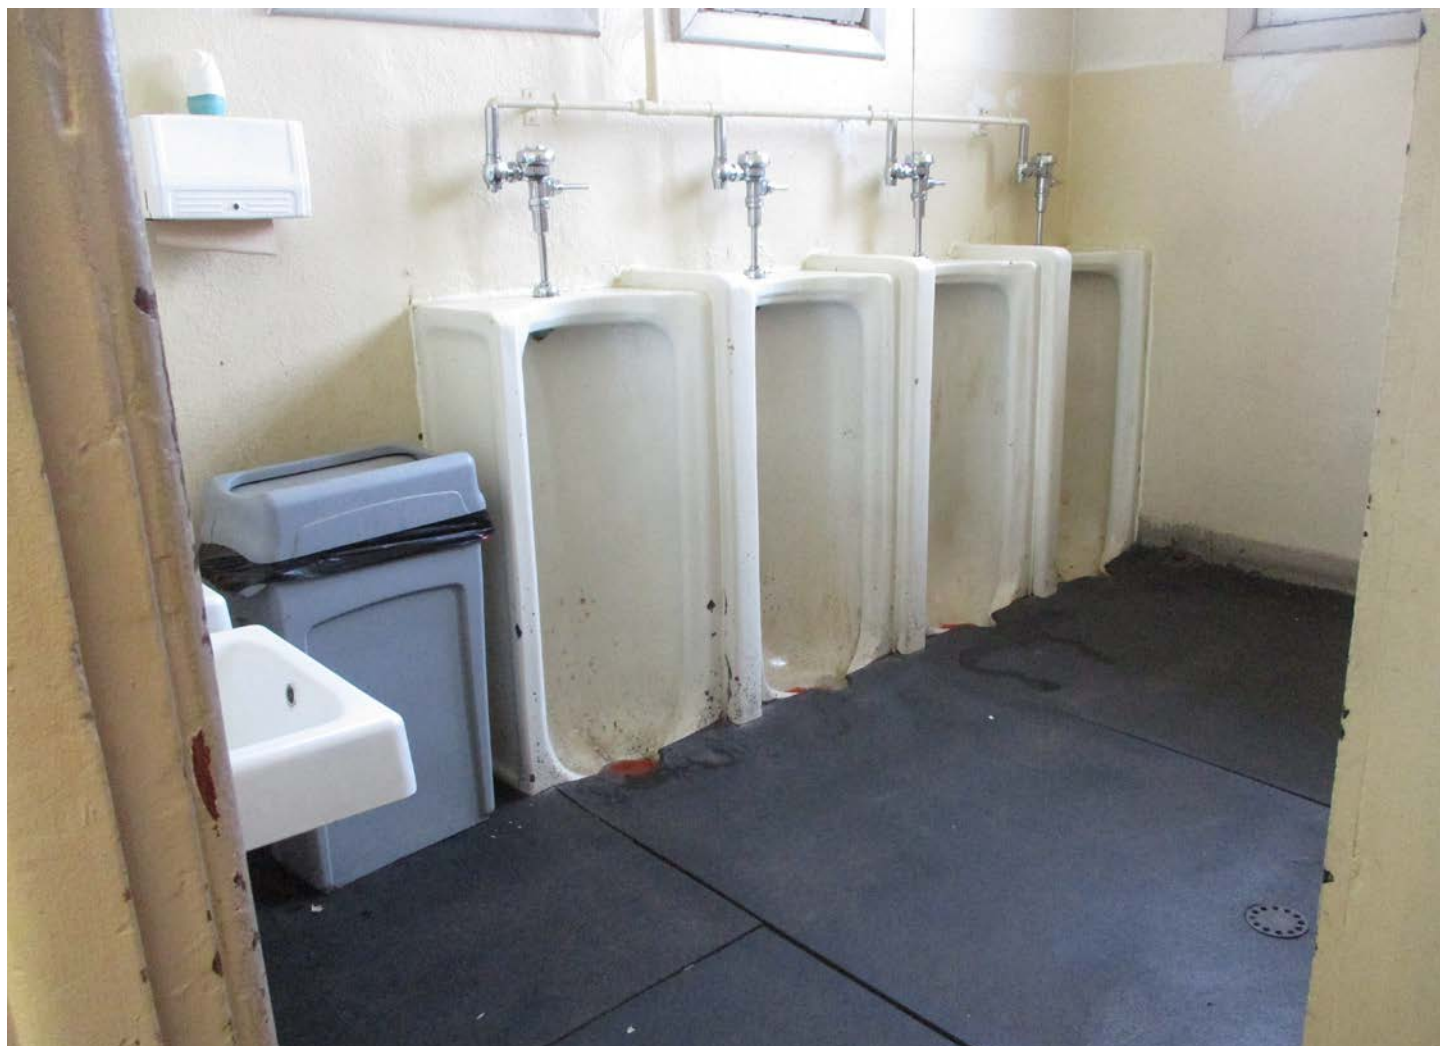
# PRELIMINARY BUILDING ASSESSMENT | RECREATION CENTER

**8.4.4 Plumbing:** The Plumbing is antiquated with visible piping consisting of a mix of galvanized steel and copper. Plumbing was functional. Anthony Benevides of The Clark Park Coalition indicated that the freestanding drinking fountain is being replaced.

**8.4.5 Heating/8.4.6 Air Conditioning and Ventilation:** Mechanically, the building HVAC system consists of two furnaces in an attic space and two matching condensers at grade. The system is functional and satisfies occupants. Condensers are fairly new, 2013 vintage. No rest room or janitorial exhaust was evident.
